**Flood Control Project Maintenance  
Levee Inspections**

**Fall 2012 Levee Maintenance Deficiency Summary Report**

**City of Sacramento**

**Levee Inspection Report By Mile - Fall 2012**

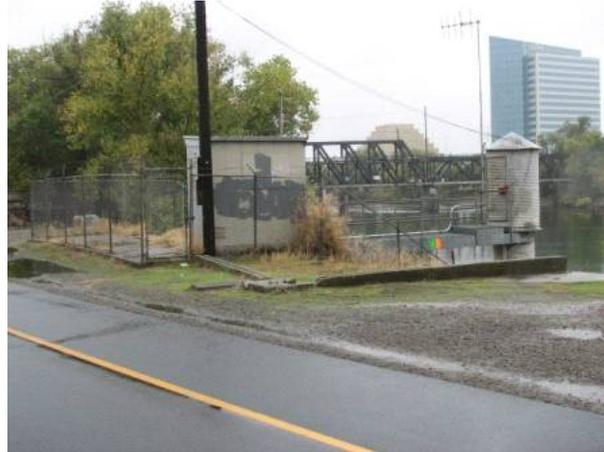
Levee Mile Report Line	5
Start Levee Mile	0.14
End Levee Mile	0.14
Location	Water Side
Category	Earthen Levee
Item	Encroachments

View of the I Street recorder can.

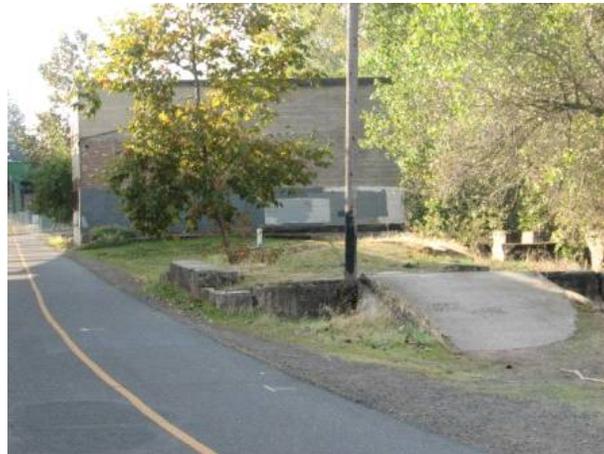
Levee Mile Report Line	6
Start Levee Mile	0.22
End Levee Mile	0.22
Location	Water Side
Category	Earthen Levee
Item	Encroachments

Historical Building with foundations and ramps on upstream and downstream sides. Fall 2011

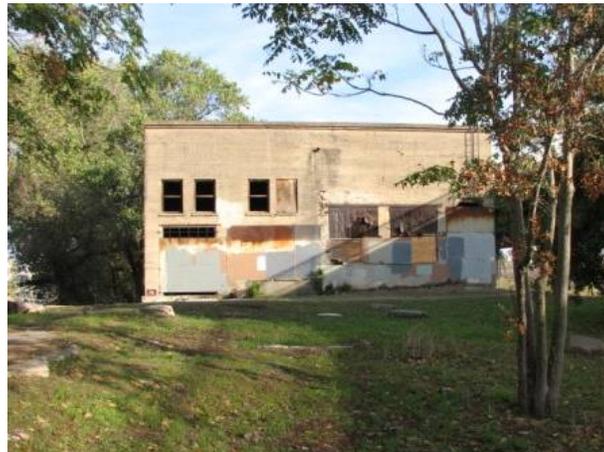
Levee Mile Report Line	6
Start Levee Mile	0.22
End Levee Mile	0.22
Location	Water Side
Category	Earthen Levee
Item	Encroachments

A view of the south side of the building. Fall 2011

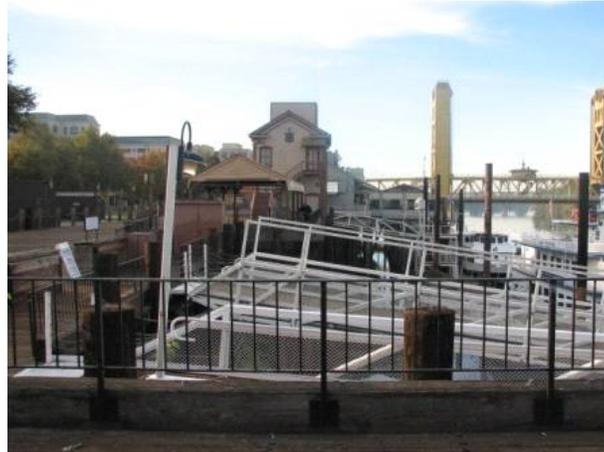
Levee Mile Report Line	7
Start Levee Mile	0.37
End Levee Mile	0.73
Location	Crown
Category	Earthen Levee
Item	Encroachments
Photo looking downstream from the Delta King in Old Sacramento.	
johngw_f_20120911_176.jpg

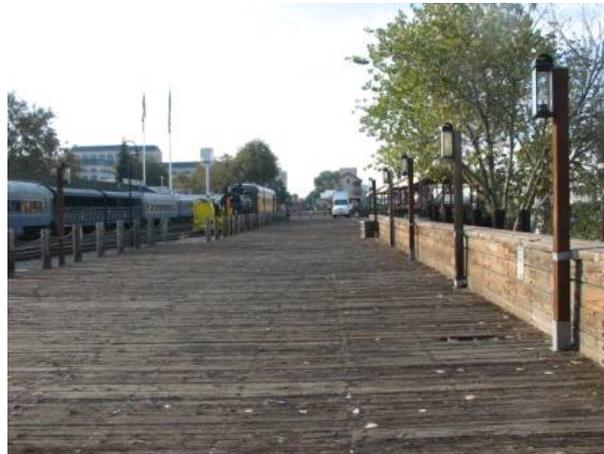
Levee Mile Report Line	7
Start Levee Mile	0.37
End Levee Mile	0.73
Location	Crown
Category	Earthen Levee
Item	Encroachments
The wooden board walk in Old Sacramento on top of the flood wall. Fall 2011	
johngw_f_20120911_177.jpg

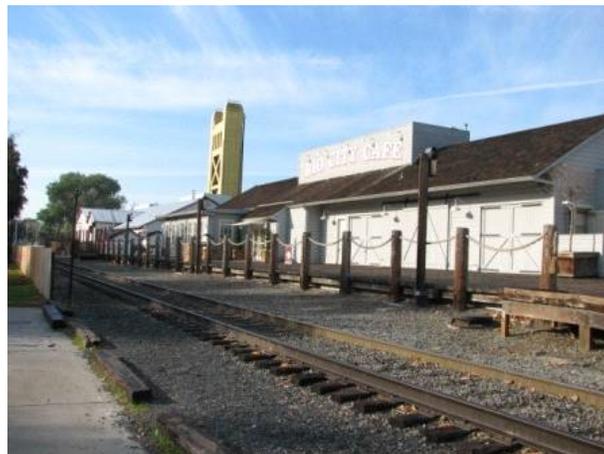
Levee Mile Report Line	7
Start Levee Mile	0.37
End Levee Mile	0.73
Location	Crown
Category	Earthen Levee
Item	Encroachments
The buildings are on top of the flood wall and extend out over the river. Fall 2011	
johngw_f_20120911_178.jpg

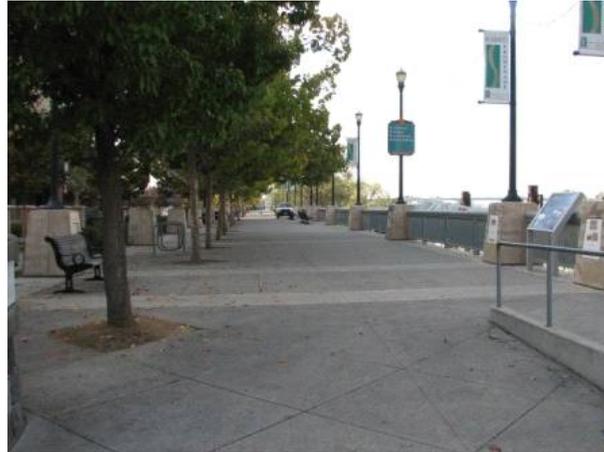
Levee Mile Report Line	8
Start Levee Mile	0.76
End Levee Mile	1.15
Location	Crown
Category	Earthen Levee
Item	Vegetation
The start of the river walk at Tower Bridge. Fall 2011	
johngw_f_20120911_185.jpg

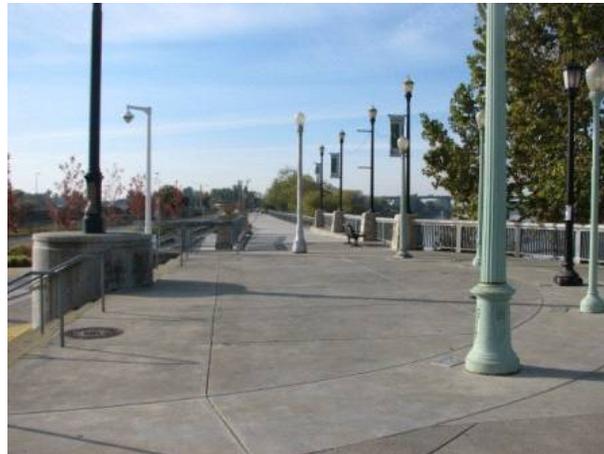
Levee Mile Report Line	8
Start Levee Mile	0.76
End Levee Mile	1.15
Location	Crown
Category	Earthen Levee
Item	Vegetation
The start of the newest extension of the river walk. Fall 2011	
johngw_f_20120911_186.jpg

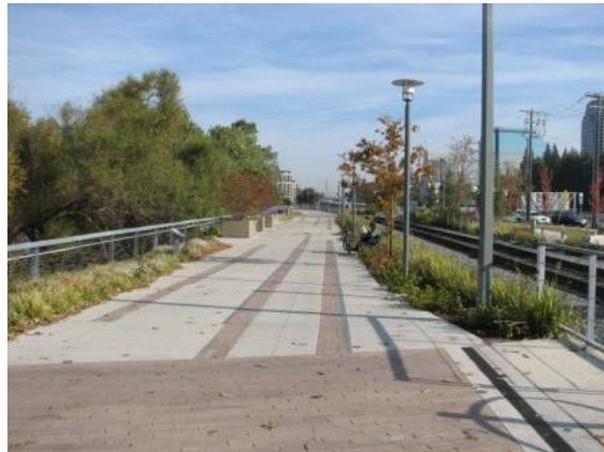
Levee Mile Report Line	8
Start Levee Mile	0.76
End Levee Mile	1.15
Location	Crown
Category	Earthen Levee
Item	Vegetation
The end of the river walk. This is where the bike trails turns off the levee. Fall 2011	
johngw_f_20120911_187.jpg

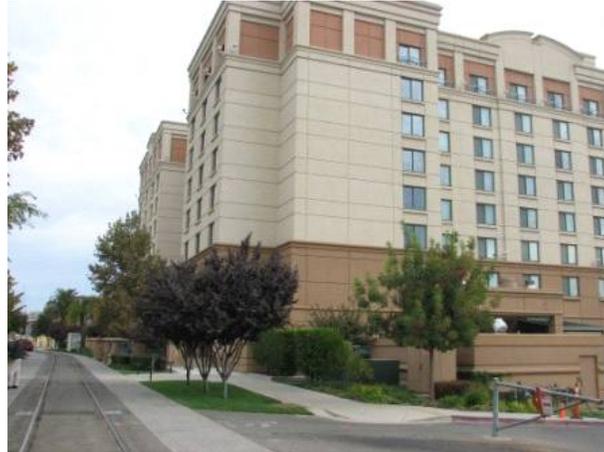
Levee Mile Report Line	9
Start Levee Mile	0.78
End Levee Mile	0.78
Location	Crown
Category	Earthen Levee
Item	Encroachments

Embassy Suites

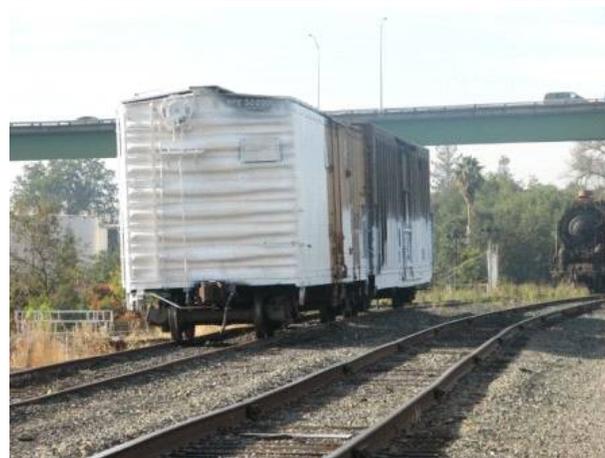
DWR ID:		
11	1.35	1.35	Earthen Levee	Encroachments	CRA/W	Ma	EQ : Equipment Inspector Comments: The two box cars have now replace the sheds. Since the last inspection two more box cars have been added. The total is four now.	38.572587 ° -121.512383 °	38.572587 ° -121.512383 °	3 Y
								DWR ID: DWR_NA0005_01_s_2012_3

Levee Mile Report Line	11
Start Levee Mile	1.35
End Levee Mile	1.35
Location	Crown
Category	Earthen Levee
Item	Encroachments
This is the replacement of the storage bins on the railroad tracks.	
johngw_f_20120911_162.jpg

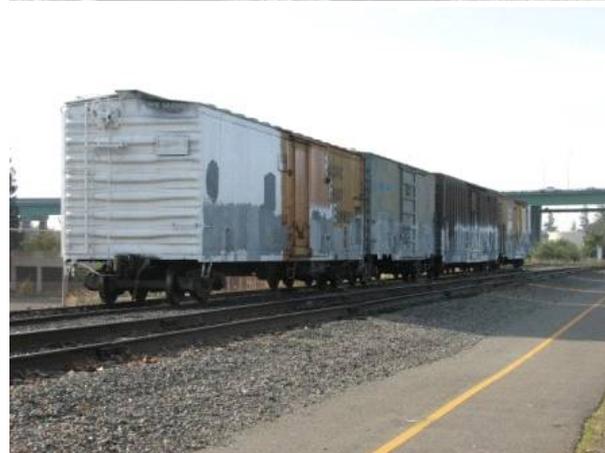
Levee Mile Report Line	11
Start Levee Mile	1.35
End Levee Mile	1.35
Location	Crown
Category	Earthen Levee
Item	Encroachments
There have been an additional two box cars added to this area. Fall 2011	
johngw_f_20120911_163.jpg

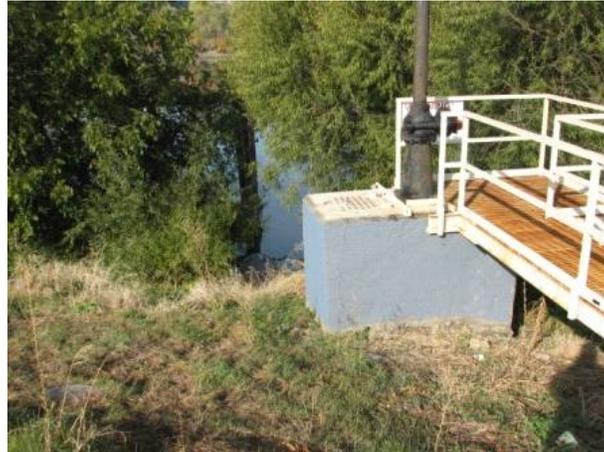
Levee Mile Report Line	12
Start Levee Mile	1.41
End Levee Mile	1.41
Location	Water Side
Category	Earthen Levee
Item	Encroachments
<p>The screw gate is the positive closure for the pipe. Fall 2011</p>	
<p>johngw_f_20120911_165.jpg</p>

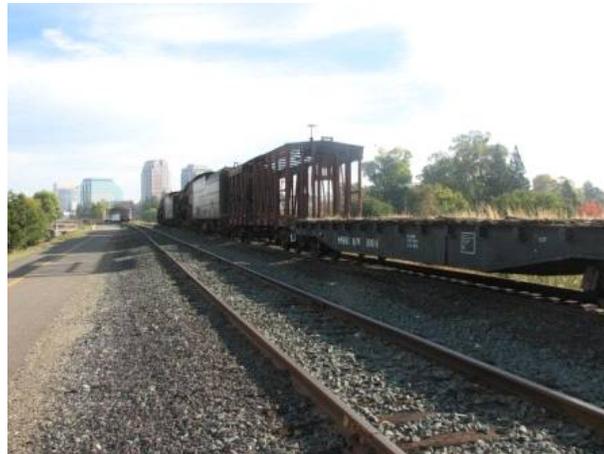
Levee Mile Report Line	13
Start Levee Mile	1.46
End Levee Mile	1.46
Location	Crown
Category	Earthen Levee
Item	Encroachments
<p>The trains that were at 1.54 have been pulled upstream to this location. The CVFPB has asked that they be removed from the levee.</p>	
<p>johngw_f_20120911_169.jpg</p>

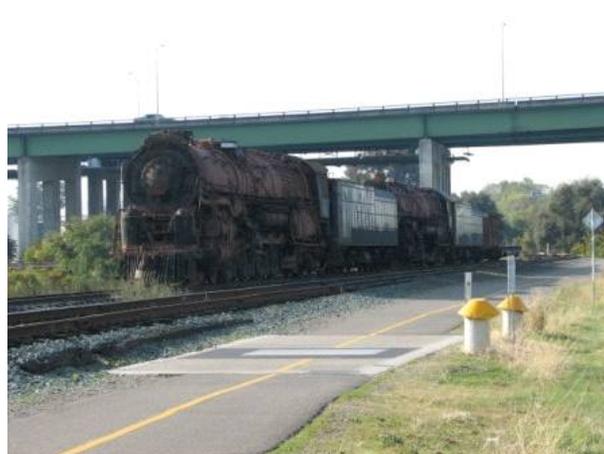
Levee Mile Report Line	13
Start Levee Mile	1.46
End Levee Mile	1.46
Location	Crown
Category	Earthen Levee
Item	Encroachments
<p>The two steam engines and other cars are stored on the levee. There is an agreement being worked on with the Railroad Museum and the City. This is to have the cars moved when necessary. Fall 2011</p>	
<p>johngw_f_20120911_170.jpg</p>

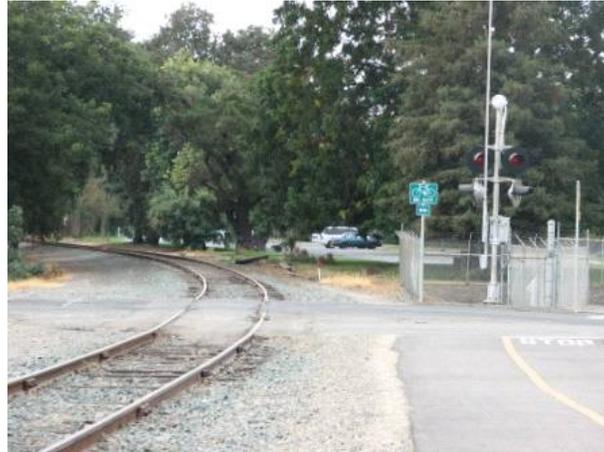
Levee Mile Report Line	14
Start Levee Mile	1.73
End Levee Mile	1.96
Location	Crown
Category	Earthen Levee
Item	Encroachments
Miller Park at Broadway, railroad track and parking area on levee.	
johngw_f_20120911_166.jpg

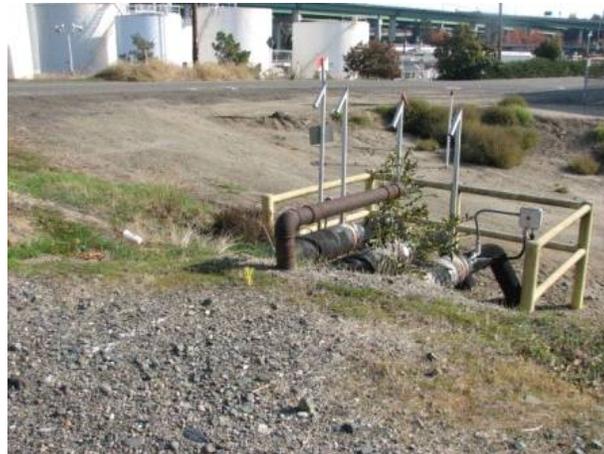
Levee Mile Report Line	15
Start Levee Mile	1.75
End Levee Mile	1.75
Location	Crown
Category	Earthen Levee
Item	Encroachments
A pipe on the landside shoulder crosses under the railroad tracks. Fall 2011	
johngw_f_20120911_188.jpg

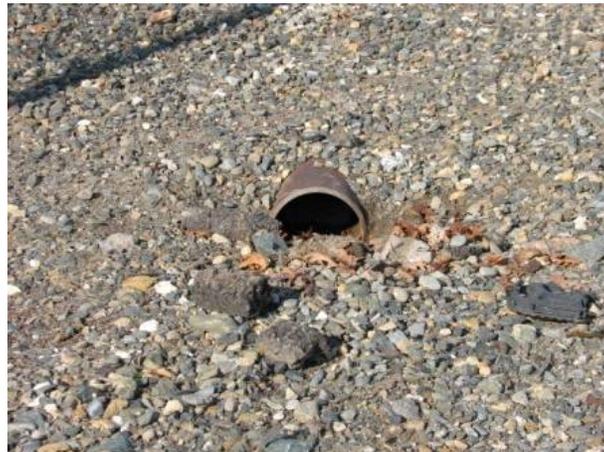
Levee Mile Report Line	15
Start Levee Mile	1.75
End Levee Mile	1.75
Location	Crown
Category	Earthen Levee
Item	Encroachments
This appears to be a drain pipe under a driveway. It is a different pipe then the other photo for this issue. Fall 2011	
johngw_f_20120911_189.jpg

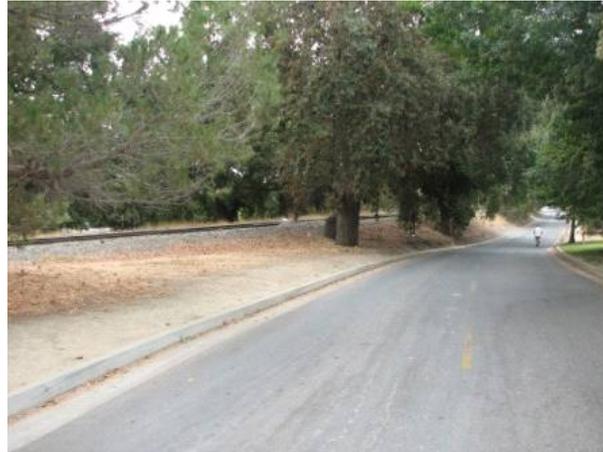
DWR ID: DWR_NA0005_01_s_2012_144										
16	1.96	2.34	Earthen Levee	Encroachments	CR A/W Ma	EQ : Equipment	Inspector Comments: Railroad tracks run on crown of levee, paved roadway runs along toe on waterside. This is Miller Park Marina area.	38.564900 ° -121.516253 °	38.559460 ° -121.515085 °	7 Y
DWR ID: DWR_NA0005_01_s_2012_7										
17	2.04	2.04	Earthen Levee	Encroachments	CR A/W Ma	PI : Pipe	Inspector Comments: The pipe has been repaired by the LMA. The pipe was installed by the Railroad Museum and is in talks with the CVFPB. No permit was issued for them.	38.563720 ° °	-121.515890 ° °	145 Y
DWR ID: DWR_NA0005_01_s_2012_145										
18	2.45	2.45	Earthen Levee	Vegetation	LS A/W Ma	V4 : Elderberries are blocking visibility and flood fight capability.		38.557937 ° -121.514237 °	38.557937 ° -121.514237 °	8 Y
DWR ID: DWR_NA0005_01_s_2012_8										
19	2.46	2.76	Earthen Levee	Vegetation	WSA/W Ob	V8 : Environmental Requirements.		38.557828 ° -121.514193 °	38.553710 ° -121.512863 °	21 Y

Levee Mile Report Line	16
Start Levee Mile	1.96
End Levee Mile	2.34
Location	Crown
Category	Earthen Levee
Item	Encroachments
<p>Railroad tracks are on levee crown. The street is to the boat ramp.</p>	
<p>johngw_f_20120911_167.jpg</p>

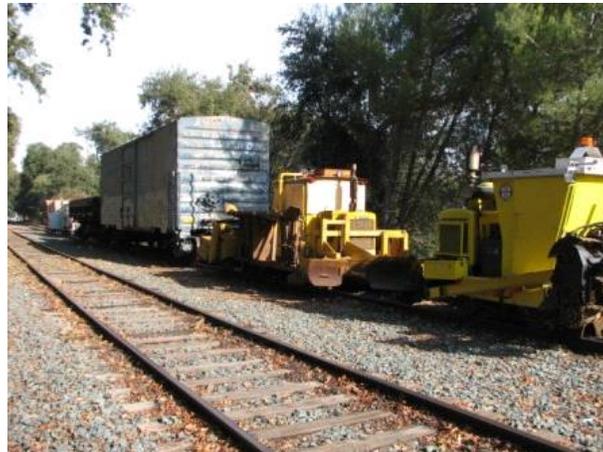
Levee Mile Report Line	16
Start Levee Mile	1.96
End Levee Mile	2.34
Location	Crown
Category	Earthen Levee
Item	Encroachments
<p>The Railroad museum has moved the trains to this area along Miller Park. Fall 2011</p>	
<p>johngw_f_20120911_168.jpg</p>

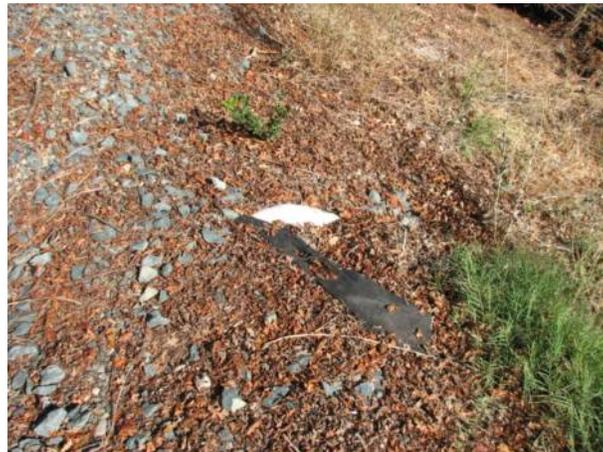
Levee Mile Report Line	17
Start Levee Mile	2.04
End Levee Mile	2.04
Location	Crown
Category	Earthen Levee
Item	Encroachments
<p>The pipe is a French drain under the railroad tracks. Was in the USACE report has not been resolved. Photo fall 2012.</p>	
<p>johngw_f_20121025_822.jpg</p>

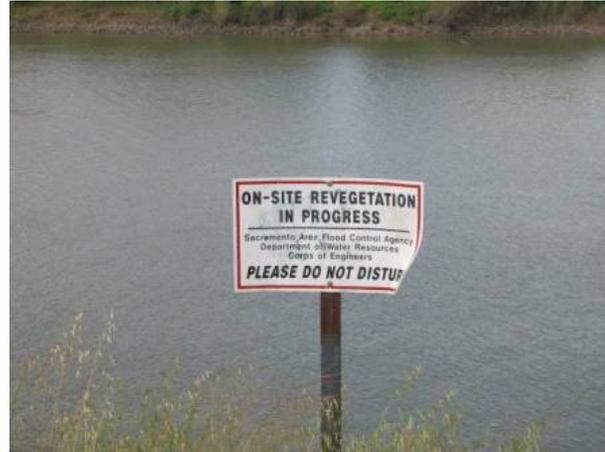
Levee Mile Report Line	19
Start Levee Mile	2.46
End Levee Mile	2.76
Location	Water Side
Category	Earthen Levee
Item	Vegetation

This area is a revegetation site, photo taken spring 2012.

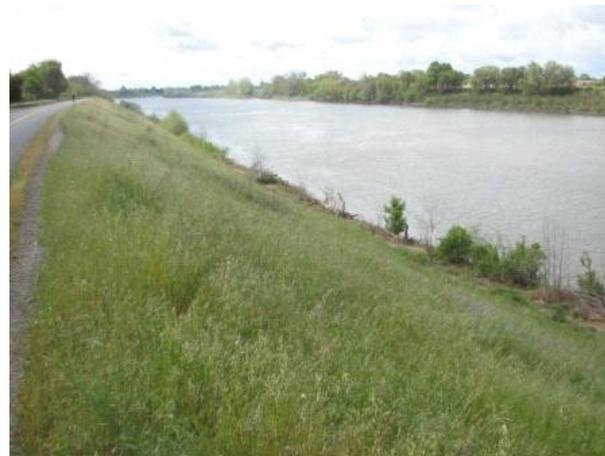
Levee Mile Report Line	19
Start Levee Mile	2.46
End Levee Mile	2.76
Location	Water Side
Category	Earthen Levee
Item	Vegetation

A photo of the revegetation site taken spring 2012.

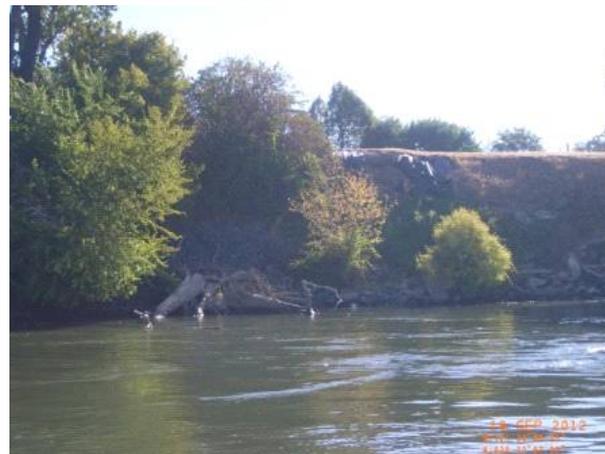
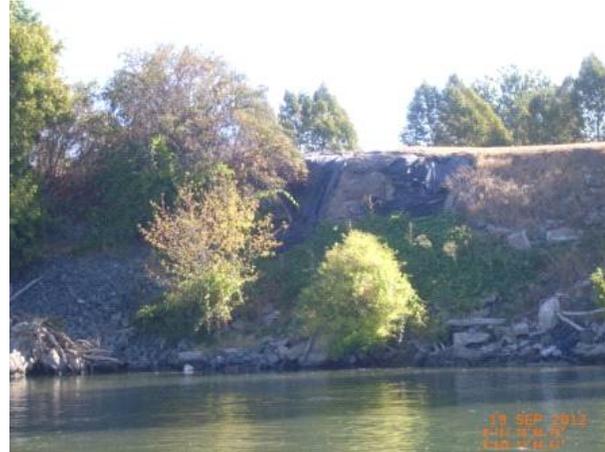
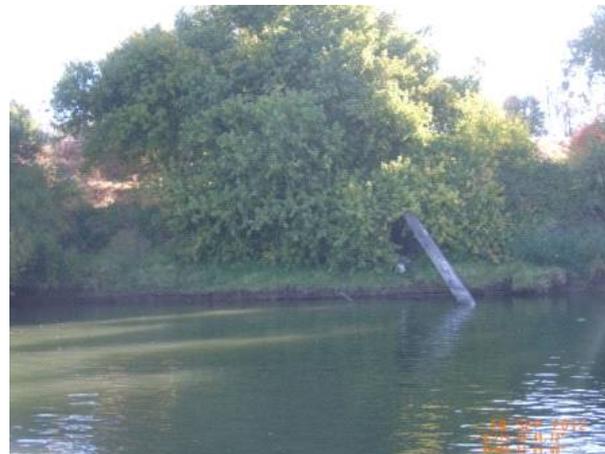
Levee Mile Report Line	20
Start Levee Mile	2.84
End Levee Mile	2.89
Location	Water Side
Category	Supplemental
Item	USACE Erosion Survey

DWR ID: DWR_NA0005_01_s_2012_21										
20	2.84	2.89	Supplemental	USACE Erosion Survey	WS Ma	M	Inspector Comments: 1997 - Erosion at pump station, concrete debris and plastic showing. 2000 - Separation scour of bank due to poor transition. 2004 - New large tree pop out; city dumped fill dirt/rock into hole. 2006 - Minor new erosion at top of bank. 2010 - Some new rock placed in tree pop-out. 2011 - A large tree has fallen and flood fighting was performed by the city on the upper levee slope. 2012: No observed change. [2012 Site ID: SAC_56-6_L]	38.552268 ° -121.512590 °	38.551578 ° -121.512336 °	12 Y
DWR ID:										
21	2.90	2.90	Earthen Levee	Encroachments	CR A/W En	BU : Building		38.551810 ° -121.511838 °	38.551810 ° -121.511838 °	10 Y
DWR ID: DWR_NA0005_01_s_2012_10										
22	3.22	3.22	Earthen Levee	Trim / Thin Trees	WS Ma	N	T5 : Tree stumps.	38.547353 ° -121.510253 °	38.547353 ° -121.510253 °	16 Y

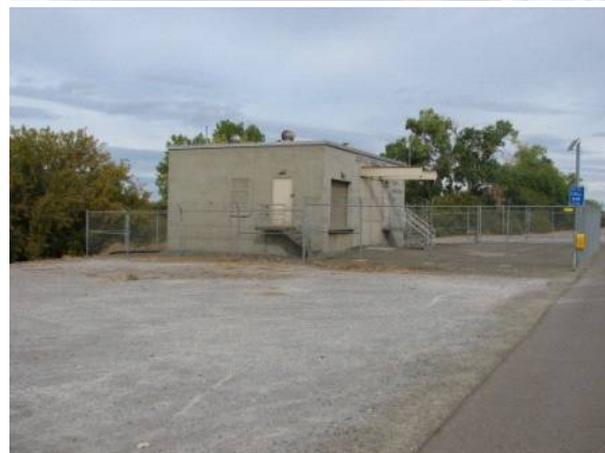
Levee Mile Report Line	21
Start Levee Mile	2.90
End Levee Mile	2.90
Location	Crown
Category	Earthen Levee
Item	Encroachments
City of Sacramento pump station on the waterside of the crown of the levee.	
johngw_f_20120911_171.jpg

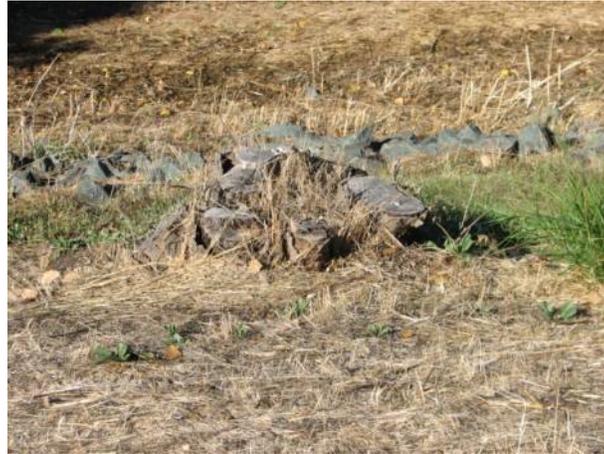
Levee Mile Report Line	22
Start Levee Mile	3.22
End Levee Mile	3.22
Location	Water Side
Category	Earthen Levee
Item	Trim / Thin Trees

There are several tree stumps in this area. The district have been monitoring and spraying the stumps. Photo fall 2012.
