**Flood Control Project Maintenance
Levee Inspections**

**Fall 2013 Levee Maintenance Deficiency Summary Report
Overall LMA & Unit Ratings, including USACE Erosion Survey**

**Flood Control Project Maintenance
Levee Inspections
LMA District Cover Sheet
Fall 2013 Levee Inspection Results**

City of Sacramento

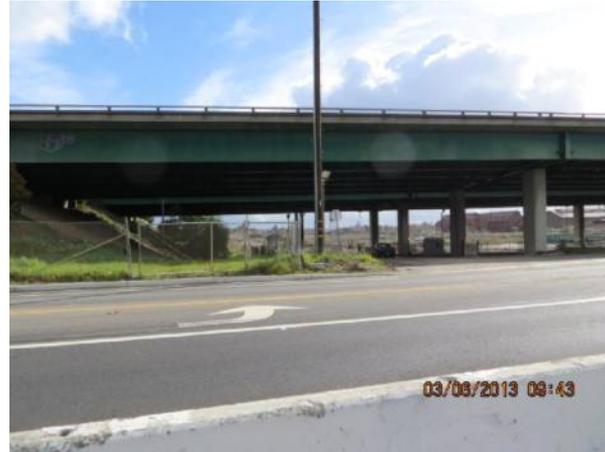
Levee Mile Report Line	4
Start Levee Mile	0.06
End Levee Mile	0.06
Location	Water Side
Category	Supplemental
Item	DWR UCIP Field Study
View of levee crown at crossing--sign visible on landward side near freeway underpass.	
UCIP_12178.jpg

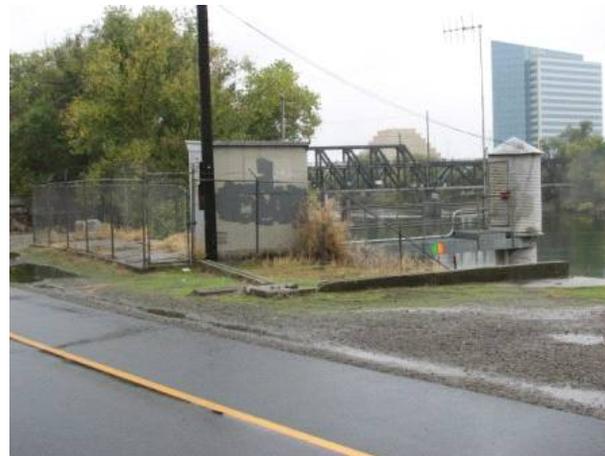
Levee Mile Report Line	5
Start Levee Mile	0.14
End Levee Mile	0.14
Location	Water Side
Category	Earthen Levee
Item	Encroachments
View of the I Street recorder can.	
johngw_f_20130924_952.jpg

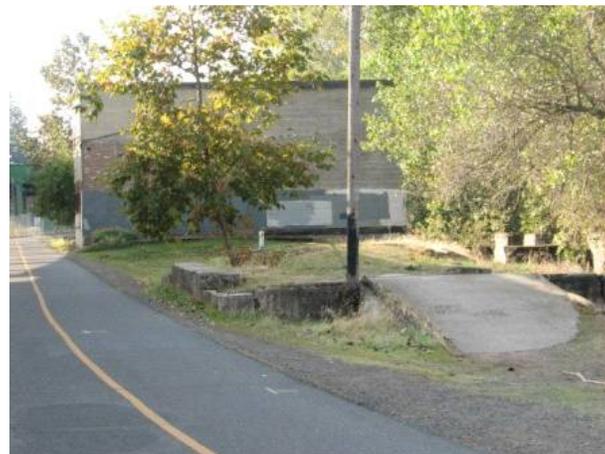
Levee Mile Report Line	6
Start Levee Mile	0.22
End Levee Mile	0.22
Location	Water Side
Category	Earthen Levee
Item	Encroachments
Historical Building with foundations and ramps on upstream and downstream sides. Fall 2011	
johngw_f_20130924_953.jpg

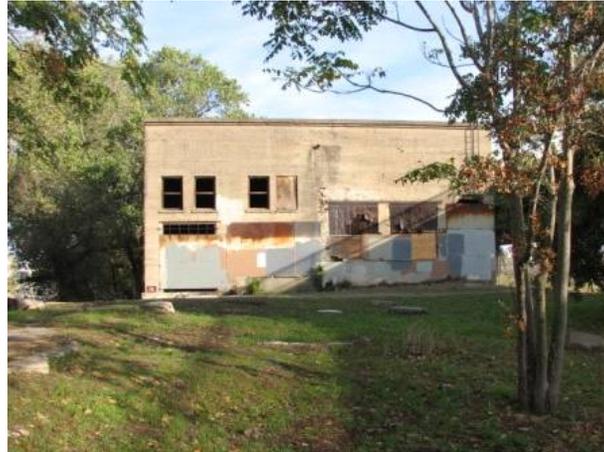
Levee Mile Report Line	6
Start Levee Mile	0.22
End Levee Mile	0.22
Location	Water Side
Category	Earthen Levee
Item	Encroachments
A view of the south side of the building. Fall 2011	
johngw_f_20130924_954.jpg

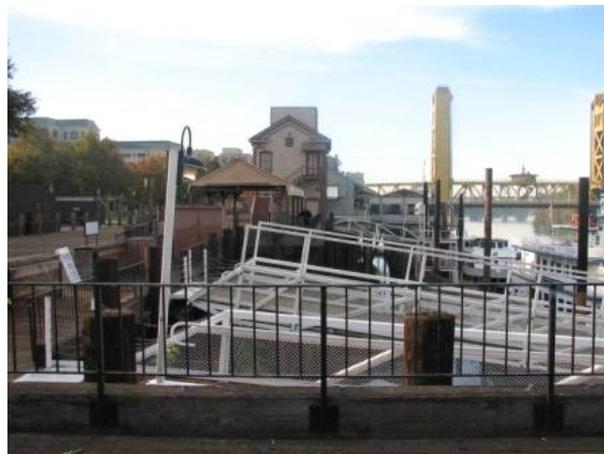
Levee Mile Report Line	7
Start Levee Mile	0.37
End Levee Mile	0.73
Location	Crown
Category	Earthen Levee
Item	Encroachments
Photo looking downstream from the Delta King in Old Sacramento.	
johngw_f_20130924_972.jpg

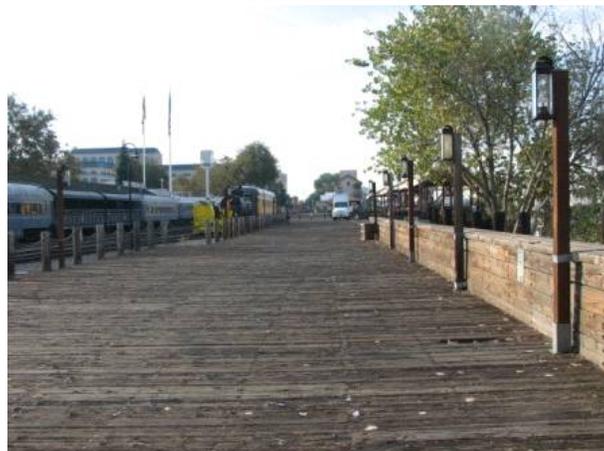
Levee Mile Report Line	7
Start Levee Mile	0.37
End Levee Mile	0.73
Location	Crown
Category	Earthen Levee
Item	Encroachments
The wooden boardwalk in Old Sacramento on top of the flood wall. Fall 2011	
johngw_f_20130924_973.jpg

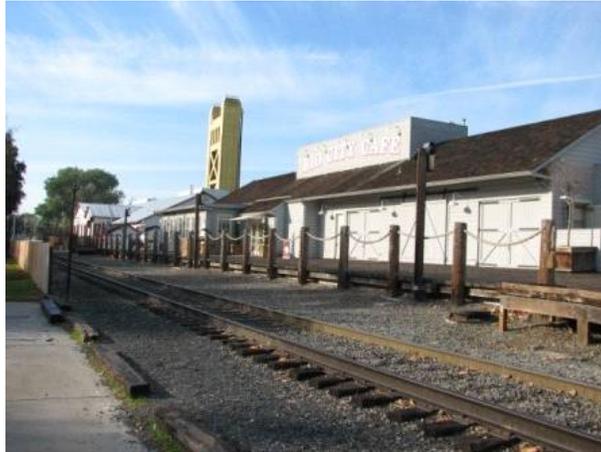
Levee Mile Report Line	7
Start Levee Mile	0.37
End Levee Mile	0.73
Location	Crown
Category	Earthen Levee
Item	Encroachments
The buildings are on top of the flood wall and extend out over the river. Fall 2011	
johngw_f_20130924_974.jpg

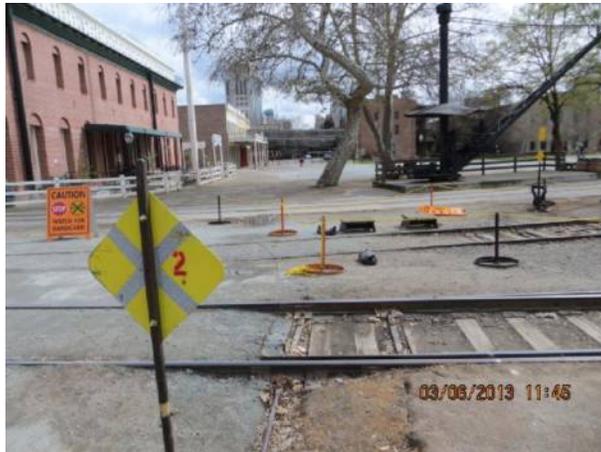
10	0.42	0.42	Supplemental	DWR UCIP Field Study	WS	M En	Inspector Comments: FS_ID:9686 EP_NO: N/A Repair Type: Non-Urgent Crossing Status: Indicator Found UCIP Comments: Only manhole was visible; need to determine condition of crossing; Will need to follow up with the City of Sacramento. FIELD_STRUCT_DESC: 18-inch-diameter storm drain through the levee, 5 feet below the crown. Concrete surge box on the waterward side of the retaining wall. Concrete box spillway. FS Date: 3/6/2013	38.584755 °	38.584755 °	27	
								-121.505559 °	-121.505559 °	Y	
								DWR ID: DWR_NA0005_01_f_2013_27

Levee Mile Report Line	10
Start Levee Mile	0.42
End Levee Mile	0.42
Location	Crown
Category	Supplemental
Item	DWR UCIP Field Study
View of landward side close to railroad museum.	
UCIP_12212.jpg

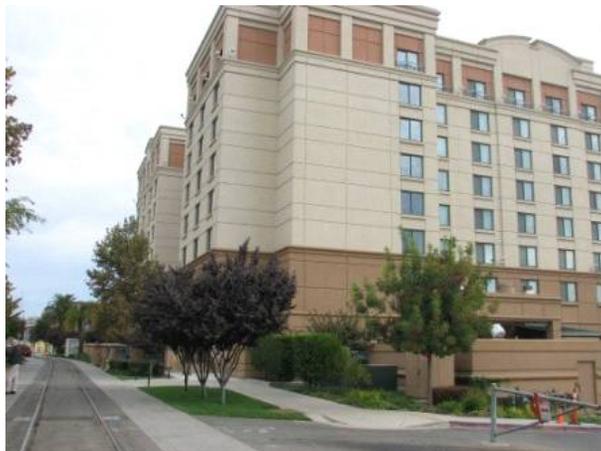
Levee Mile Report Line	11
Start Levee Mile	0.78
End Levee Mile	0.78
Location	Crown
Category	Earthen Levee
Item	Encroachments
Embassy Suites	
johngw_f_20130924_957.jpg

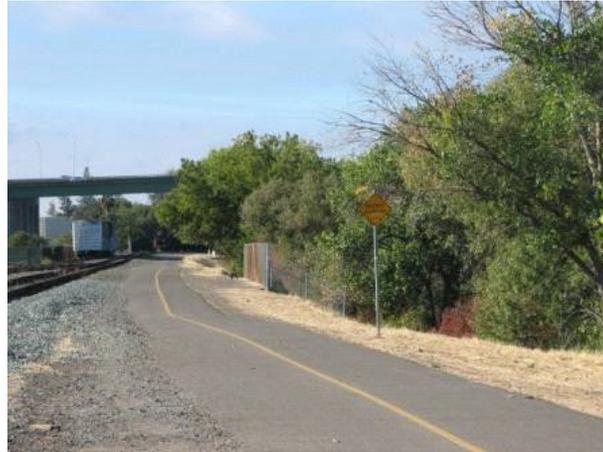
Levee Mile Report Line	12
Start Levee Mile	1.15
End Levee Mile	1.69
Location	Water Side
Category	Earthen Levee
Item	Vegetation
Trees and brush are larger then 2 inches but does not effect visibility. Photo fall 2012.	
johngw_f_20130924_971.jpg

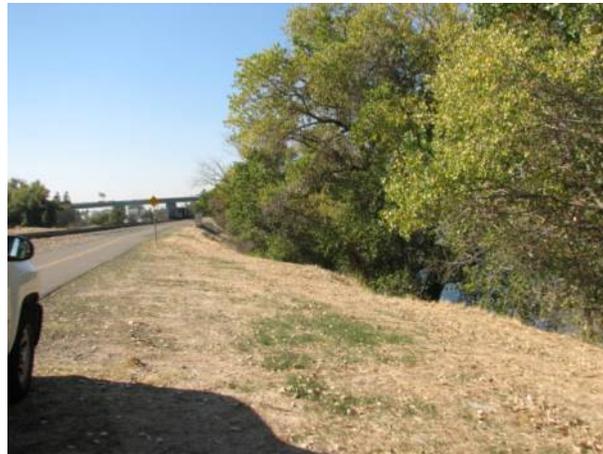
Levee Mile Report Line	12
Start Levee Mile	1.15
End Levee Mile	1.69
Location	Water Side
Category	Earthen Levee
Item	Vegetation
Monitor the trees and woody vegetation along the rivers edge. Fall 2013	
johngw_f_20131021_165.JPG

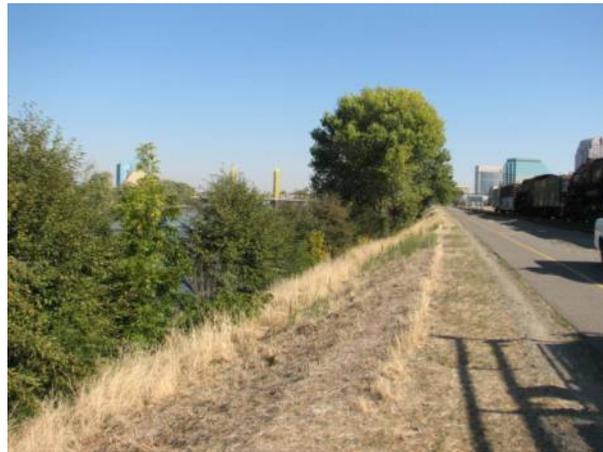
Levee Mile Report Line	12
Start Levee Mile	1.15
End Levee Mile	1.69
Location	Water Side
Category	Earthen Levee
Item	Vegetation
Monitor the trees and vegetation along the rivers edge. Fall 2013	
johngw_f_20131021_166.JPG

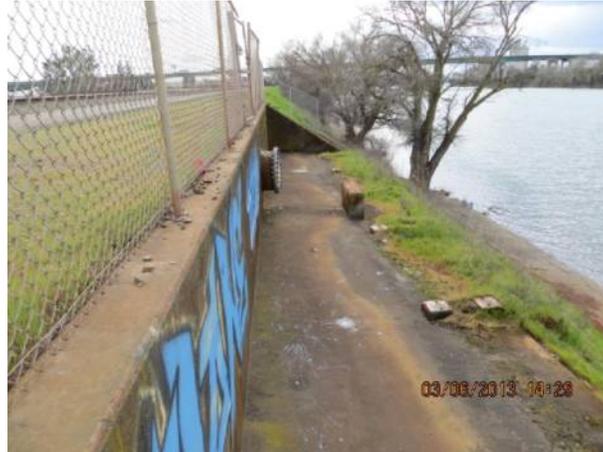
LMR No.	Levee Mile		Category	Item	Location	Rating	Action/Comment	GPS Latitude/Longitude		Issue No. Photo
	Start	End						Start	End	
14	1.23	1.23	Supplemental	DWR UCIP Field Study	WS	M En	Inspector Comments: FS_ID:9742 EP_NO: 5140 Repair Type: Non-Urgent Crossing Status: Indicator Found UCIP Comments: Need to determine more details pertaining to crossing, coordinate with City of Sacramento. FIELD_STRUCT_DESC: 30-inch diameter condensing water pipe sleeved through 40-inch diameter pipe 5 feet below the crown, annular space grouted. Anchor blocks on both ends, concrete pipes under pads over pipe under railroad. Cap on the waterward end. A 1.5 foot thick by 8 foot high by 8 foot wide reinforced concrete headwall supported on a 2 foot thick by 5.5 foot wide by 12 foot long concrete footing. An 8 foot high by 64 foot wide apron constructed around the waterward end of the pipe at the waterward shoulder of the levee. (Permit No. 5140, State of California-Department of General Services-1967) FS Date: 3/6/2013	38.573981 ° -121.510948 °	38.573981 ° -121.510948 °	29 Y

Levee Mile Report Line	14
Start Levee Mile	1.23
End Levee Mile	1.23
Location	Water Side
Category	Supplemental
Item	DWR UCIP Field Study
Headwall with 1 crossing capped off.	
UCIP_12181.jpg

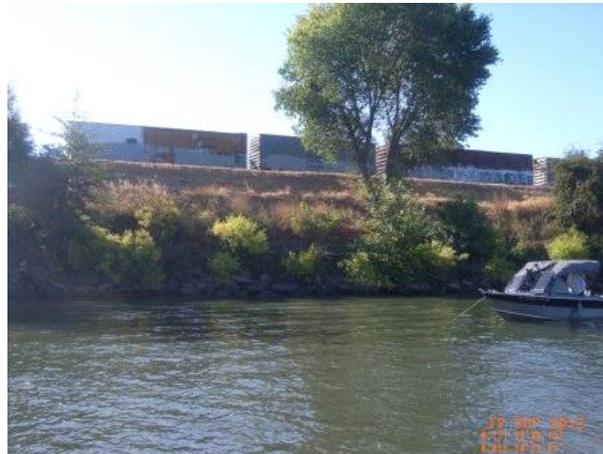
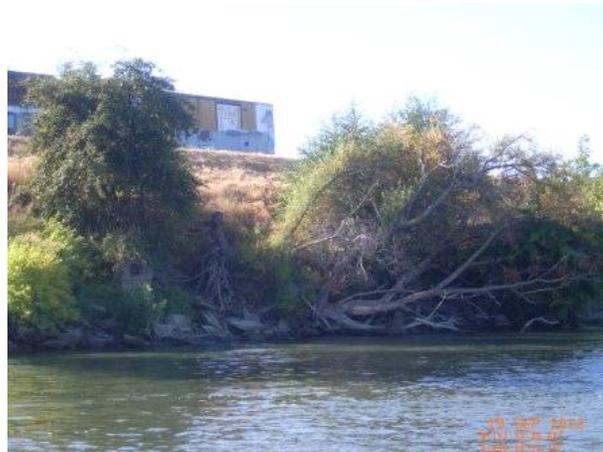
DWR ID: DWR_NA0005_01_f_2013_29										
15	1.32	1.39	Supplemental	USACE Erosion Survey	WS	M Ma	Inspector Comments: 2008 - Oversized levee, should be repaired under maintenance. 2009 - Shallow slumps at the mid bank. 2010 - Some minor erosion at the toe, likely from wave wash. Some new shallow slumps. 2011 - One new tree has fallen. 2012: No observed change. [2012 Site ID: SAC_58-5_L]	38.573069 ° -121.512166 °	38.572277 ° -121.513063 °	11 Y
DWR ID:										
16	1.35	1.35	Earthen Levee	Encroachments	CR A/W	En	EQ : Equipment Inspector Comments: The two box cars have now replace the sheds. Since the last inspection two more box cars have been added. The total is four now.	38.572587 ° -121.512383 °	38.572587 ° -121.512383 °	3 Y
DWR ID: DWR_NA0005_01_s_2012_3										
17	1.41	1.41	Earthen Levee	Encroachments	WS A/W	En	PI : Pipe	38.572008 ° -121.513017 °	38.572008 ° -121.513017 °	5 Y
DWR ID: DWR_NA0005_01_s_2012_5

Levee Mile Report Line	15
Start Levee Mile	1.32
End Levee Mile	1.39
Location	Water Side
Category	Supplemental
Item	USACE Erosion Survey
USACE 2012 Photo #1	
USACE2013_SAC_58-5_L_1.jpg

Levee Mile Report Line	15
Start Levee Mile	1.32
End Levee Mile	1.39
Location	Water Side
Category	Supplemental
Item	USACE Erosion Survey
USACE 2012 Photo #2	
USACE2013_SAC_58-5_L_2.jpg

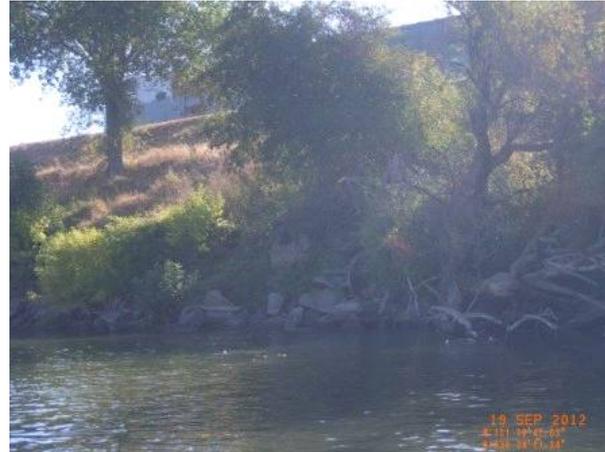
Levee Mile Report Line	15
Start Levee Mile	1.32
End Levee Mile	1.39
Location	Water Side
Category	Supplemental
Item	USACE Erosion Survey
USACE 2012 Photo #3	
USACE2013_SAC_58-5_L_3.jpg

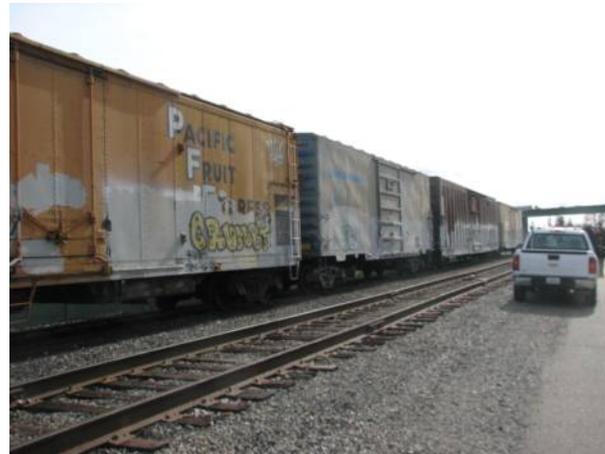
Levee Mile Report Line	16
Start Levee Mile	1.35
End Levee Mile	1.35
Location	Crown
Category	Earthen Levee
Item	Encroachments
The number of box cars are the same and still in the same location Spring 2013	
johngw_f_20130924_956.JPG

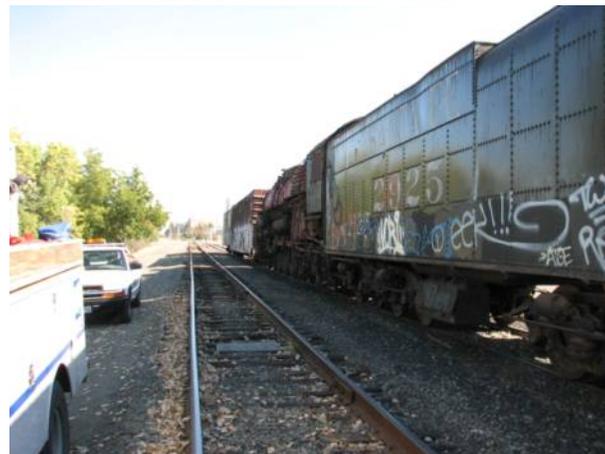
Levee Mile Report Line	16
Start Levee Mile	1.35
End Levee Mile	1.35
Location	Crown
Category	Earthen Levee
Item	Encroachments
Looking upstream at the train cars. Fall 2013	
johngw_f_20131021_167.JPG

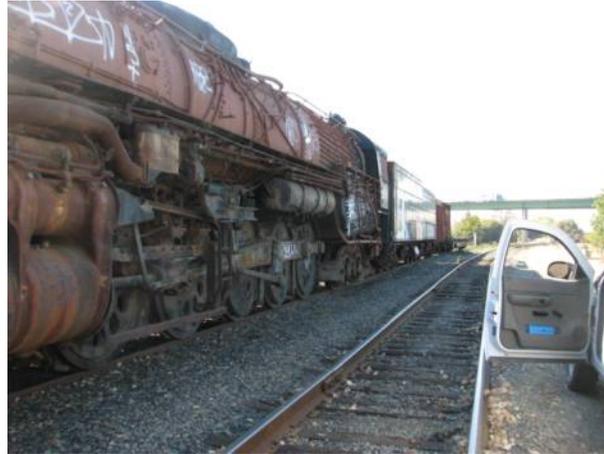
Levee Mile Report Line	16
Start Levee Mile	1.35
End Levee Mile	1.35
Location	Crown
Category	Earthen Levee
Item	Encroachments
Looking downstream at ht e trains parked on the crown. A total of 8 cars are there now. Fall 2013	
johngw_f_20131021_168.JPG

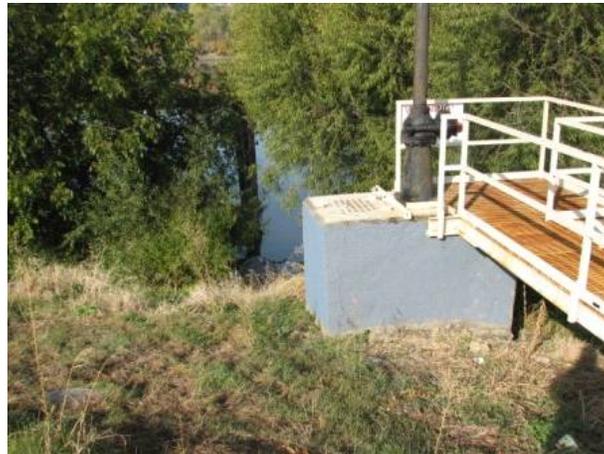
Levee Mile Report Line	17
Start Levee Mile	1.41
End Levee Mile	1.41
Location	Water Side
Category	Earthen Levee
Item	Encroachments
The screw gate is the positive closure for the pipe. Fall 2011	
johngw_f_20130924_958.jpg

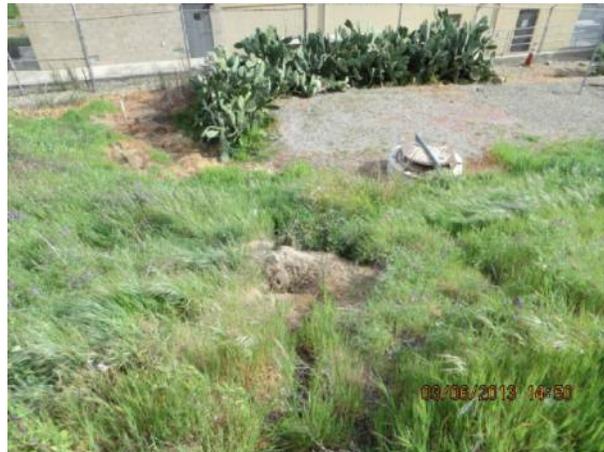
19	1.41	1.41	Supplemental	DWR UCIP Field Study	WS	U En	Inspector Comments: FS_ID:9746 EP_NO: N/A Repair Type: Urgent Crossing Status: Found UCIP Comments: Significant subsidence located on LS berm, unable to tell whether damage is associated with crossing. Issue has been provided to inspector for reporting purposes. FIELD_STRUCT_DESC: 3 of 3: 72-inch sewer line through the levee at low elevation. Slide gate in concrete well on the waterward slope. Manhole located on landward berm. FS Date: 3/6/2013	38.572018 ° -121.513081 °	38.572018 ° -121.513081 °	31 Y
----	------	------	--------------	-------------------------	----	---------	--	------------------------------	------------------------------	---------

Levee Mile Report Line	19
Start Levee Mile	1.41
End Levee Mile	1.41
Location	Water Side
Category	Supplemental
Item	DWR UCIP Field Study
View of landward side--tall grass along slope limit inspection.	
UCIP_12184.jpg

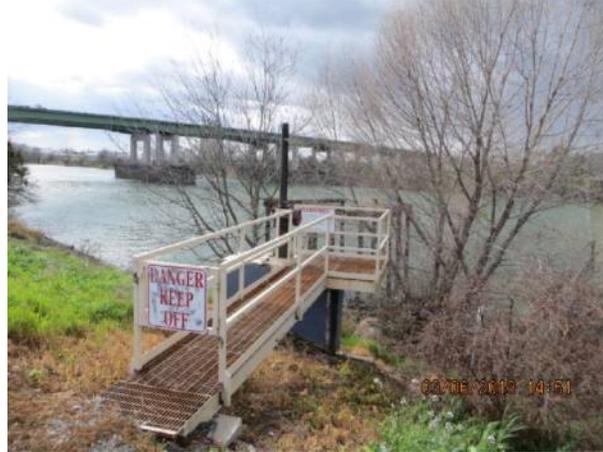
25	1.43	1.43	Supplemental	DWR UCIP Field Study	LS	M En	Inspector Comments: FS_ID:9751 EP_NO: 12196 Repair Type: Non-Urgent Crossing Status: Found UCIP Comments: Vault located on levee crown (bike path) and siphon breaker located on waterward shoulder. Coordinate with City of Sacramento to determine the condition of this crossing and last inspection. FIELD_STRUCT_DESC: 2 or 2: 42-inch RCP wash water intake pipe through levee at approximately 10 feet below crown. Line extends approximately 145 feet waterward from the reservoir to the outfall structure at the waterward shoulder of the levee. Pipe is skewed approximately 12 degrees upstream. Water Intake structure with screen. Waterward slope is armored by rock slope protection. Rock slope protection perimeter exists at river intake. (Permit No. 12196, Sacramento Regional County Sanitation District-1981). Permit 16611 was issued in 1996 to reline the inside of the pipe. FS Date: 3/6/2013	38.571790 ° -121.513323 °	38.571790 ° -121.513323 °	36 Y

Levee Mile Report Line	25
Start Levee Mile	1.43
End Levee Mile	1.43
Location	Crown
Category	Supplemental
Item	DWR UCIP Field Study
Walkway present on waterward shoulder.	
UCIP_12187.jpg

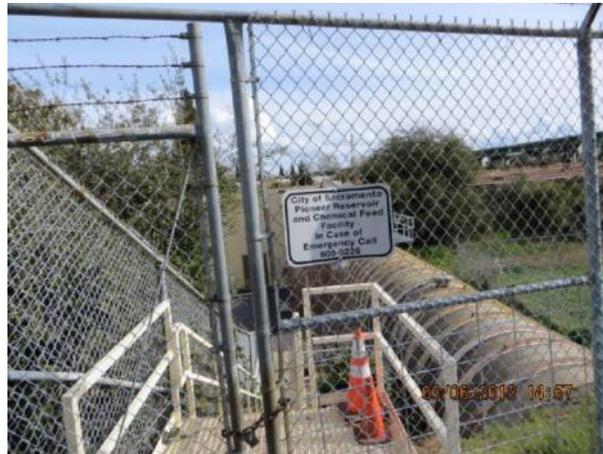
DWR ID: DWR_NA0005_01_f_2013_39										
29	1.43	1.43	Supplemental	DWR UCIP Field Study	CR	M En	Inspector Comments: FS_ID:9750 EP_NO: 12196 Repair Type: Non-Urgent Crossing Status: Found UCIP Comments: Check with City of Sacramento to determine last inspection and condition of crossing. Vegetation on waterward and landward slope makes it difficult to inspect and identify any potential leaks visible from surface. FIELD_STRUCT_DESC: 1 of 2: 120-inch RCP outfall pipe extends approximately 117 feet waterward from the reservoir to a reinforced concrete outfall valve structure located in the levee crown. Waterward slope is armored by rock slope protection. Rock slope protection perimeter exists at outlet. (Permit No. 12196, Sacramento Regional County Sanitation District-1977). (Permit No. 12196, Sacramento Regional Sanitation District-1981). FS Date: 3/6/2013	38.571776 ° -121.513364 °	38.571776 ° -121.513364 °	40 Y

Levee Mile Report Line	29
Start Levee Mile	1.43
End Levee Mile	1.43
Location	Crown
Category	Supplemental
Item	DWR UCIP Field Study
View of landward side--fenced area, walkway, and bldg structure on landward toe.	
UCIP_12195.jpg

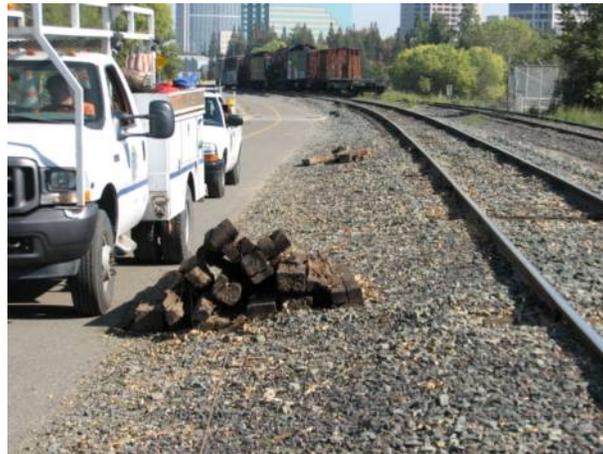
Levee Mile Report Line	30
Start Levee Mile	1.47
End Levee Mile	1.47
Location	Crown
Category	Earthen Levee
Item	Encroachments
Railroad ties are left on the crown of the levee. Fall 2013	
johngw_f_20131021_169.JPG

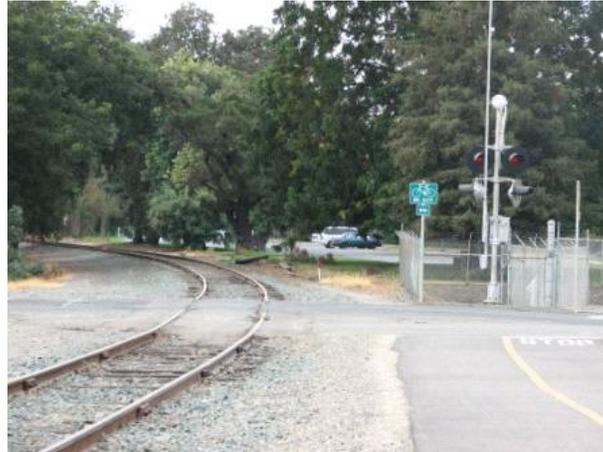
Levee Mile Report Line	31
Start Levee Mile	1.73
End Levee Mile	1.96
Location	Crown
Category	Earthen Levee
Item	Encroachments
Miller Park at Broadway, railroad track and parking area on levee.	
johngw_f_20130924_959.jpg

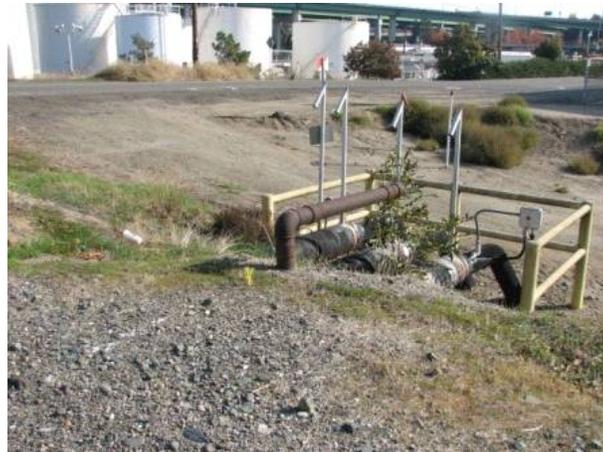
Levee Mile Report Line	32
Start Levee Mile	1.75
End Levee Mile	1.75
Location	Crown
Category	Earthen Levee
Item	Encroachments
A pipe on the landside shoulder crosses under the railroad tracks. Fall 2011	
johngw_f_20130924_983.jpg

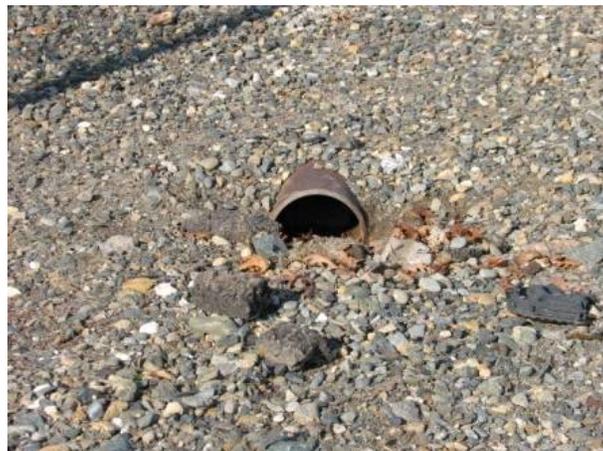
Levee Mile Report Line	32
Start Levee Mile	1.75
End Levee Mile	1.75
Location	Crown
Category	Earthen Levee
Item	Encroachments
This appears to be a drain pipe under a driveway. It is a different pipe then the other photo for this issue. Fall 2011	
johngw_f_20130924_984.jpg

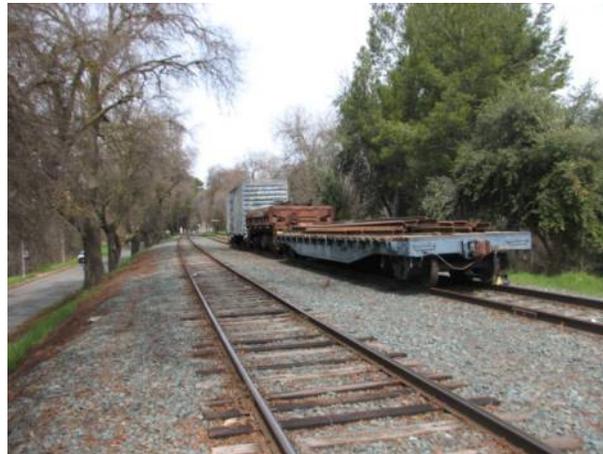
Levee Mile Report Line	33
Start Levee Mile	1.96
End Levee Mile	2.34
Location	Crown
Category	Earthen Levee
Item	Encroachments
<p>The railroad cars remain on the levee crown. Spring 2013</p>	
<p>johngw_f_20130924_961.JPG</p>

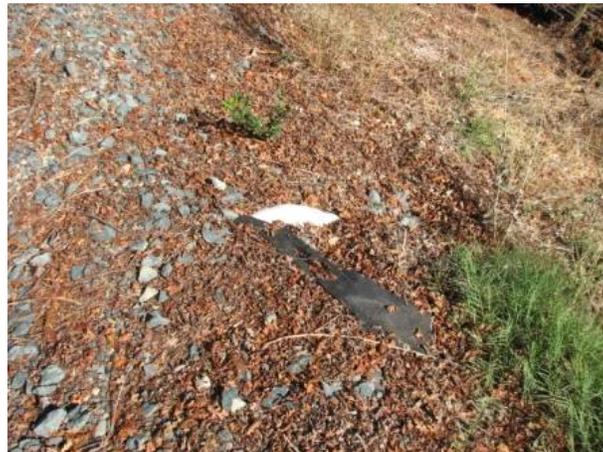
Levee Mile Report Line	34
Start Levee Mile	2.04
End Levee Mile	2.04
Location	Crown
Category	Earthen Levee
Item	Encroachments
<p>The pipe is a french drain under the railroad tracks. Was in the USACE report has not been resolved. Photo fall 2012.</p>	
<p>johngw_f_20130924_985.jpg</p>

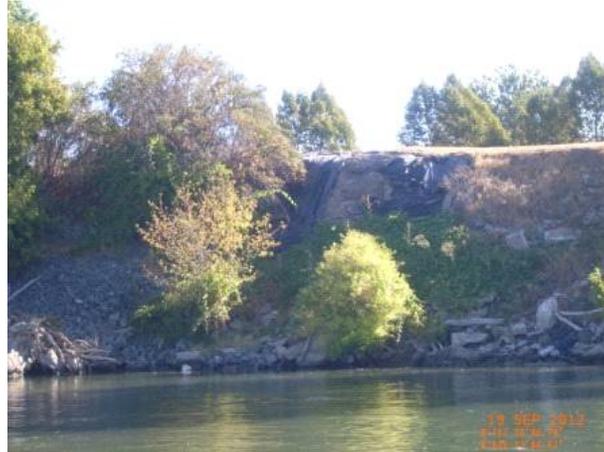
Levee Mile Report Line	38
Start Levee Mile	2.84
End Levee Mile	2.89
Location	Water Side
Category	Supplemental
Item	USACE Erosion Survey
USACE 2012 Photo #2	
USACE2013_SAC_56-6_L_2.jpg

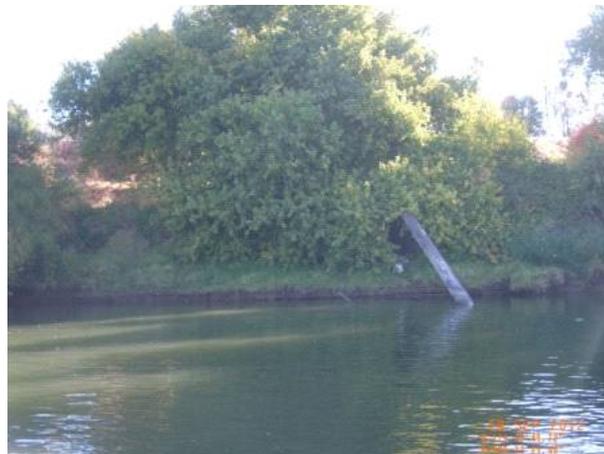
Levee Mile Report Line	38
Start Levee Mile	2.84
End Levee Mile	2.89
Location	Water Side
Category	Supplemental
Item	USACE Erosion Survey
USACE 2012 Photo #3	
USACE2013_SAC_56-6_L_3.jpg

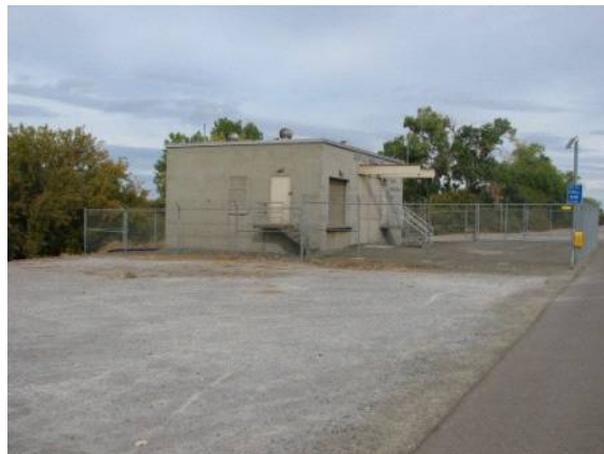
Levee Mile Report Line	40
Start Levee Mile	2.90
End Levee Mile	2.90
Location	Crown
Category	Earthen Levee
Item	Encroachments
City of Sacramento pump station on the waterside of the crown of the levee.	
johngw_f_20130924_964.jpg
