**Flood Control Project Maintenance  
Levee Inspections**

**Fall 2014 Levee Maintenance Deficiency Summary Report**

**Sacramento River Basin**

**City of Sacramento**

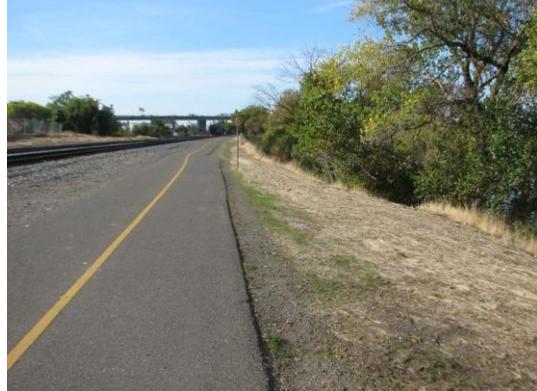
Photo 1 of 1 : FA\_2014\_NA0005\_251\_82\_20141106\_00033.jpg

LM Start	<b>0.00</b>	Rating **	A	Issue No.	<b>82</b>
LM End	<b>3.63</b>	Issue Type +	Ma	Location *	WS
Category	Earthen Levee		GPS Latitude/Longitude		
			Start	End	
Item	Vegetation				
DWR ID	DWR_NA0005_01_f_2014_82				
Action/Comments					
Control annual grass and weeds on the levee slopes and easements.

Levee mile 1017, vegetation on the water side levee slope, railroad tracks on the land side slope. Fall 2014.

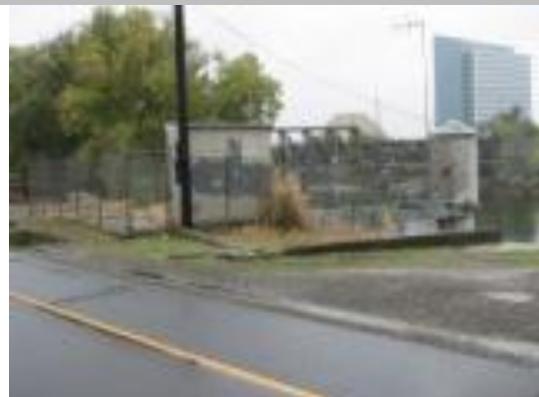
Photo 1 of 1 : FA\_2014\_NA0005\_251\_1\_20141014\_00001.jpg

LM Start	<b>0.14</b>	Rating **	A	Issue No.	<b>1</b>
LM End	<b>0.14</b>	Issue Type +	Ob	Location *	WS
Category	Earthen Levee			GPS Latitude/Longitude	
				Start	End
Item	Encroachments			38.588715 °	38.588715 °
				-121.504885 °	-121.504885 °
DWR ID	DWR_NA0005_01_s_2012_1				
Action/Comments					
Building Inspector Comments: Fenced area around State (DWR) recorder can.

View of the I Street recorder can.

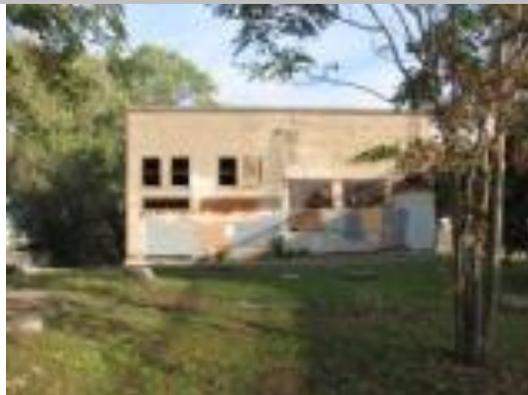
Photo 1 of 2 : FA\_2014\_NA0005\_251\_2\_20141014\_00002.jpg

LM Start	<b>0.22</b>	Rating **	A	Issue No.	<b>2</b>
LM End	<b>0.22</b>	Issue Type +	Ob	Location *	WS
Category	Earthen Levee		GPS Latitude/Longitude		
			Start	End	
Item	Encroachments		38.587592 °	38.587592 °	
			-121.504892 °	-121.504892 °	
DWR ID	DWR_NA0005_01_s_2012_2				
Action/Comments					
Building Inspector Comments: Historical building.

A view of the south side of the building. Fall 2011

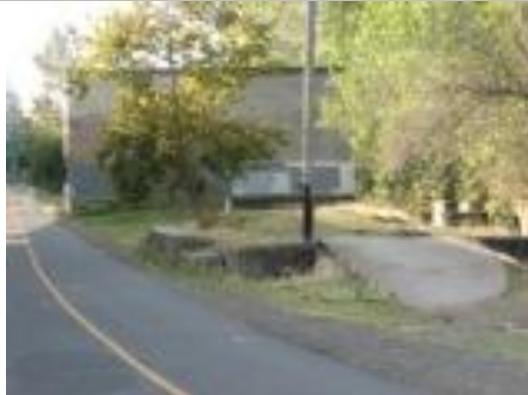
Photo 2 of 2 : FA\_2014\_NA0005\_251\_2\_20141014\_00003.jpg

Historical Building with foundations and ramps on upstream and downstream sides. Fall 2011

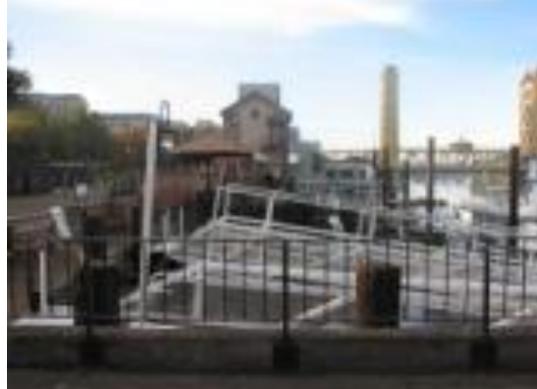
Photo 1 of 3 : FA\_2014\_NA0005\_251\_14\_20141014\_00017.jpg

LM Start	<b>0.37</b>	Rating **	A	Issue No.	<b>14</b>
LM End	<b>0.73</b>	Issue Type +	Ob	Location *	CR
Category	Earthen Levee		GPS Latitude/Longitude		
			Start	End	
Item	Encroachments		38.585525 °	38.580445 °	
			-121.505338 °	-121.506966 °	
DWR ID	DWR_NA0005_01_s_2012_14				
Action/Comments					
Building Inspector Comments: This is the Old Sacramento flood wall. This part is a walking inspection. The vegetation along the waterside of the floodwall has been removed.

Photo looking downstream from the Delta King in Old Sacramento.

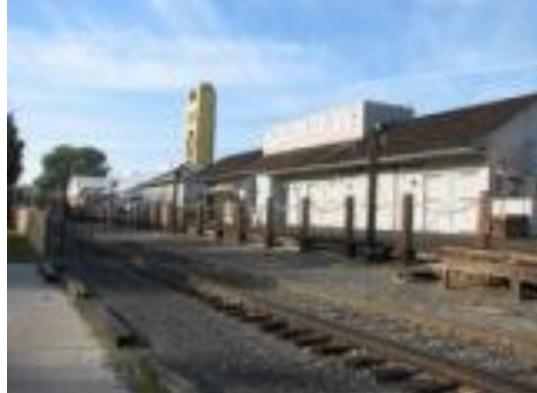
Photo 2 of 3 : FA\_2014\_NA0005\_251\_14\_20141014\_00018.jpg

The buildings are on top of the flood wall and extend out over the river.  
Fall 2011

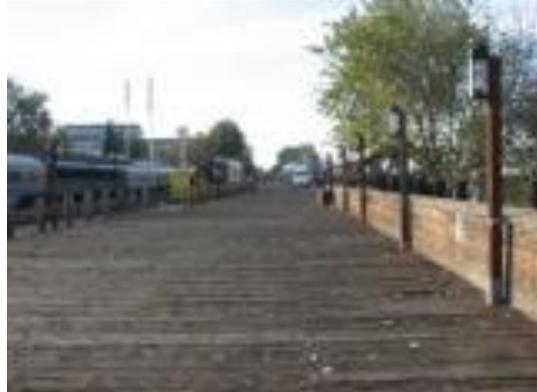
Photo 3 of 3 : FA\_2014\_NA0005\_251\_14\_20141014\_00019.jpg

The wooden boardwalk in Old Sacramento on top of the flood wall. Fall 2011

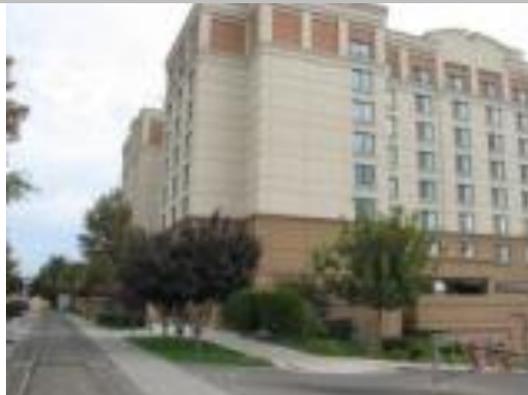
Photo 1 of 1 : FA\_2014\_NA0005\_251\_4\_20141014\_00004.jpg

LM Start	<b>0.78</b>	Rating **	A	Issue No.	<b>4</b>
LM End	<b>0.78</b>	Issue Type +	Ob	Location *	CR
Category	Earthen Levee		GPS Latitude/Longitude		
			Start	End	
Item	Encroachments		38.579712 °	38.579712 °	
			-121.507347 °	-121.507347 °	
DWR ID	DWR_NA0005_01_s_2012_4				
Action/Comments					
Building Inspector Comments: Embassy Suites

Embassy Suites

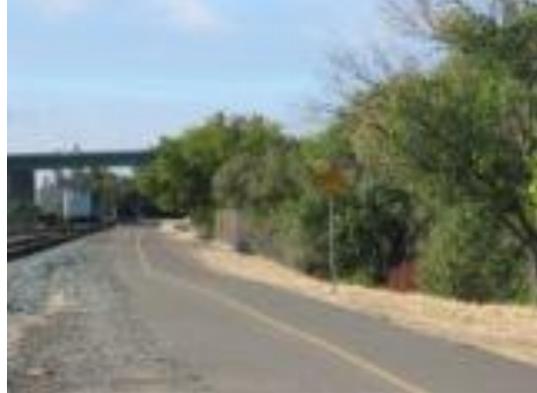
Photo 1 of 3 : FA\_2014\_NA0005\_251\_13\_20141014\_00014.jpg

LM Start	<b>1.15</b>	Rating **	A/W	Issue No.	<b>13</b>
LM End	<b>1.69</b>	Issue Type +	Ma	Location *	WS
Category	Earthen Levee		GPS Latitude/Longitude		
			Start	End	
Item	Vegetation		38.574780 °	38.568757 °	
			-121.510191 °	-121.515930 °	
DWR ID	DWR_NA0005_01_f_2012_13				
Action/Comments					
Trees / Woody Vegetation

Trees and brush are larger than 2 inches but does not effect visibility. Photo fall 2012.

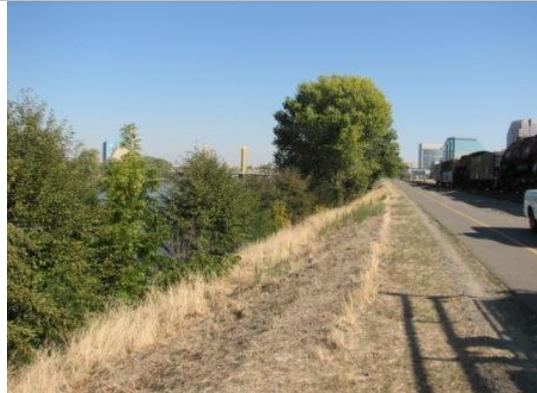
Photo 2 of 3 : FA\_2014\_NA0005\_251\_13\_20141014\_00015.jpg

Monitor the trees and vegetation along the rivers edge. Fall 2013

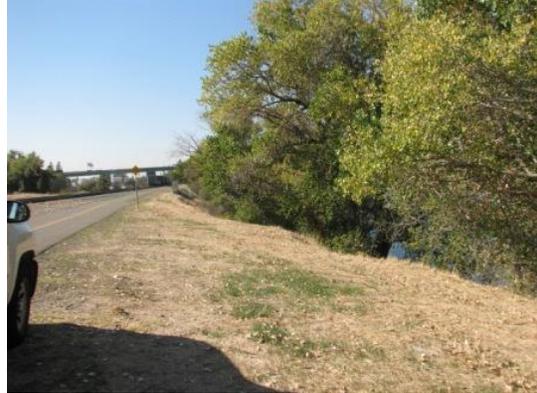
Photo 3 of 3 : FA\_2014\_NA0005\_251\_13\_20141014\_00016.jpg

Monitor the trees and woody vegetation along the rivers edge. Fall 2013

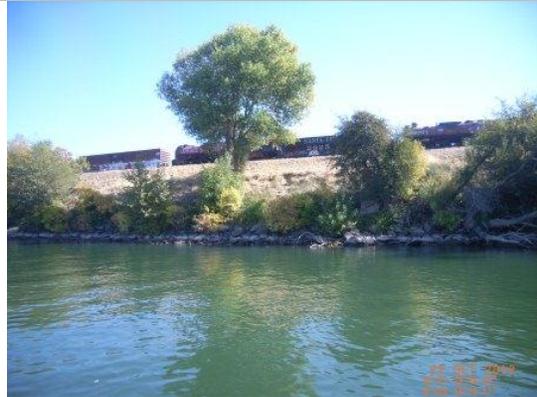
Photo 1 of 2 : FA\_2014\_NA0005\_251\_12\_20141014\_00012.jpg

LM Start	<b>1.31</b>	Rating **	M	Issue No.	<b>12</b>
LM End	<b>1.39</b>	Issue Type +	Ma	Location *	WS
Category	Supplemental			GPS Latitude/Longitude	
				Start	End
Item	USACE Erosion Survey			38.573169 °	38.572277 °
				-121.511998 °	-121.513063 °
DWR ID	DWR_NA0005_01_f_2014_12				
Action/Comments					
Inspector Comments: 2008 - Oversized levee, should be repaired under maintenance. 2009 - Shallow slumps at the mid bank. 2010 - Some minor erosion at the toe, likely from wave wash. Some new shallow slumps. 2011 - One new tree has fallen. 2013: Erosion continues on the slope surface, site extended upstream [2013 Site ID: SAC_58-5_L]

USACE 2013 Photo #1

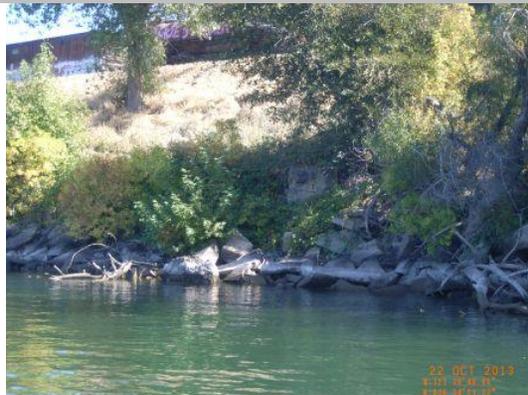
Photo 2 of 2 : FA\_2014\_NA0005\_251\_12\_20141014\_00013.jpg

LM Start	<b>1.31</b>	Rating **	M	Issue No.	<b>12 (cont)</b>
LM End	<b>1.39</b>	Issue Type +	Ma	Location *	WS
Category	Supplemental			GPS Latitude/Longitude	
				Start	End
Item	USACE Erosion Survey			38.573169 °	38.572277 °
				-121.511998 °	-121.513063 °
DWR ID	DWR_NA0005_01_f_2014_12				
Action/Comments					
Inspector Comments: 2008 - Oversized levee, should be repaired under maintenance. 2009 - Shallow slumps at the mid bank. 2010 - Some minor erosion at the toe, likely from wave wash. Some new shallow slumps. 2011 - One new tree has fallen. 2013: Erosion continues on the slope surface, site extended upstream [2013 Site ID: SAC_58-5_L]

USACE 2013 Photo #2

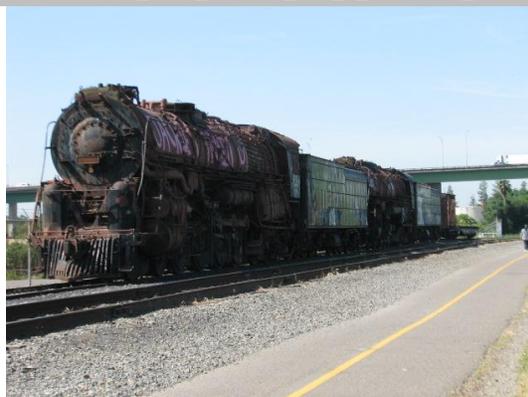
Photo 1 of 1 : FA\_2014\_NA0005\_251\_6\_20141014\_00006.jpg

LM Start	<b>1.33</b>	Rating **	M	Issue No.	<b>6</b>
LM End	<b>1.40</b>	Issue Type +	En	Location *	CR
Category	Earthen Levee			GPS Latitude/Longitude	
				Start	End
Item	Encroachments			38.572791 °	38.572087 °
				-121.512133 °	-121.512892 °
DWR ID	DWR_NA0005_01_s_2012_6				
Action/Comments					
Equipment Inspector Comments: There is two engines and four cars on the levee crown.

The train cars have been relocated upstream on the levee. Spring 2014

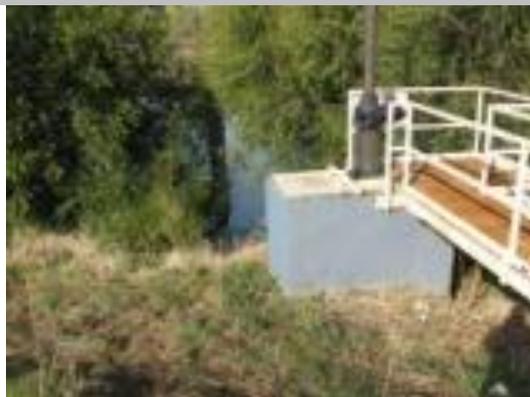
Photo 1 of 1 : FA\_2014\_NA0005\_251\_5\_20141014\_00005.jpg

LM Start	<b>1.41</b>	Rating **	A/W	Issue No.	<b>5</b>
LM End	<b>1.41</b>	Issue Type +	En	Location *	WS
Category	Earthen Levee		GPS Latitude/Longitude		
			Start	End	
Item	Encroachments		38.572008 °	38.572008 °	
			-121.513017 °	-121.513017 °	
DWR ID	DWR_NA0005_01_s_2012_5				
Action/Comments					
Pipe

The screw gate is the positive closure for the pipe. Fall 2011

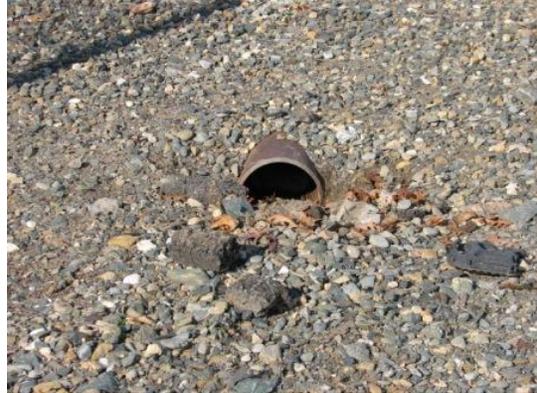
Photo 1 of 2 : FA\_2014\_NA0005\_251\_144\_20141014\_00024.jpg

LM Start	<b>1.75</b>	Rating **	A/W	Issue No.	<b>144</b>
LM End	<b>1.75</b>	Issue Type +	Ma	Location *	CR
Category	Earthen Levee			GPS Latitude/Longitude	
				Start	End
Item	Encroachments			38.567821 °	38.567821 °
				-121.516091 °	-121.516091 °
DWR ID	DWR_NA0005_01_s_2012_144				
Action/Comments					
Pipe

This appears to be a drain pipe under a driveway. It is a different pipe than the other photo for this issue. Fall 2011

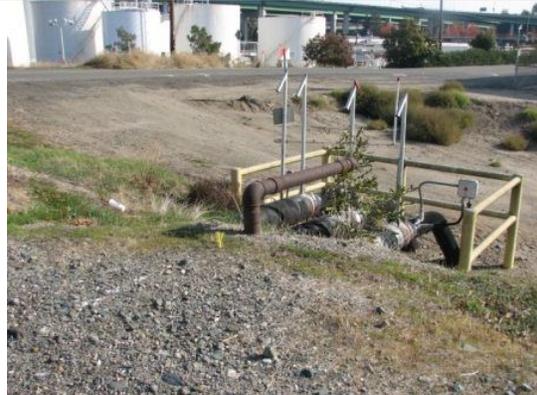
Photo 2 of 2 : FA\_2014\_NA0005\_251\_144\_20141014\_00025.jpg

A pipe on the landside shoulder crosses under the railroad tracks. Fall 2011

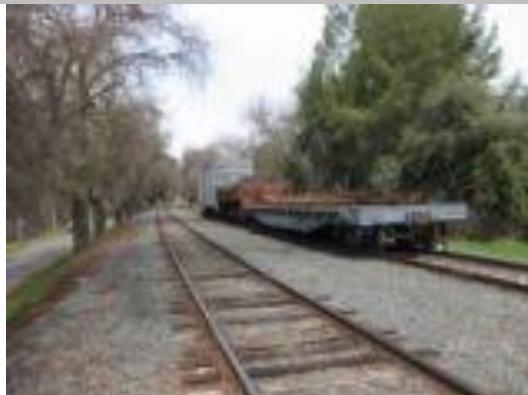
Photo 1 of 2 : FA\_2014\_NA0005\_251\_7\_20141014\_00007.jpg

LM Start	<b>1.96</b>	Rating **	M	Issue No.	<b>7</b>
LM End	<b>2.34</b>	Issue Type +	En	Location *	CR
Category	Earthen Levee		GPS Latitude/Longitude		
			Start	End	
Item	Encroachments		38.564900 °	38.559460 °	
			-121.516253 °	-121.515085 °	
DWR ID	DWR_NA0005_01_s_2012_7				
Action/Comments					
Equipment Inspector Comments: Railroad tracks run on crown of levee, paved roadway runs along toe on waterside. This is Miller Park Marina area.

The railroad cars remain on the levee crown. Spring 2013

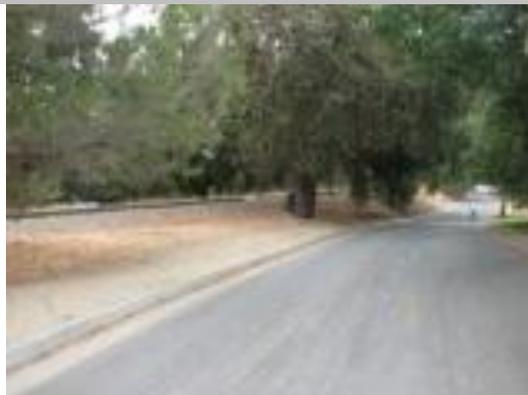
Photo 2 of 2 : FA\_2014\_NA0005\_251\_7\_20141014\_00008.jpg

Railroad tracks are on levee crown. The street is to the boat ramp.

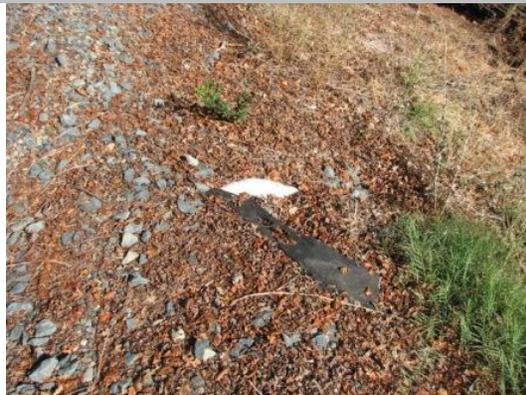
Photo 1 of 1 : FA\_2014\_NA0005\_251\_145\_20141014\_00026.jpg

LM Start	<b>2.04</b>	Rating **	A/W	Issue No.	<b>145</b>
LM End	<b>2.04</b>	Issue Type +	Ma	Location *	CR
Category	Earthen Levee			GPS Latitude/Longitude	
				Start	End
Item	Encroachments			38.563720 °	-121.515890 °
				38.563720 °	-121.515890 °
DWR ID	DWR_NA0005_01_s_2012_145				
Action/Comments					
Pipe Inspector Comments: The pipe has been repaired by the LMA. The pipe was installed by the Railroad Museum and is in talks with the CVFPB. No permit was issued for them.

The pipe is a french drain under the railroad tracks. Was in the USACE report has not been resolved. Photo fall 2012.

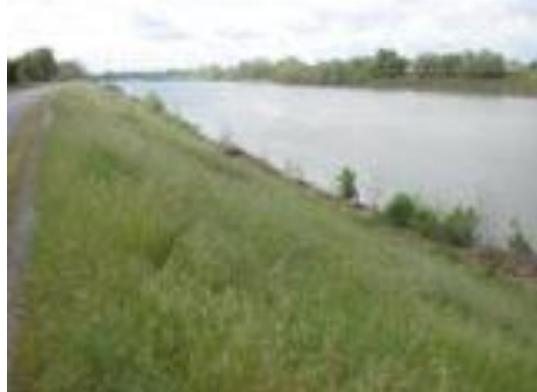
Photo 1 of 2 : FA\_2014\_NA0005\_251\_21\_20141014\_00021.jpg

A photo of the revegetation site taken spring 2012.

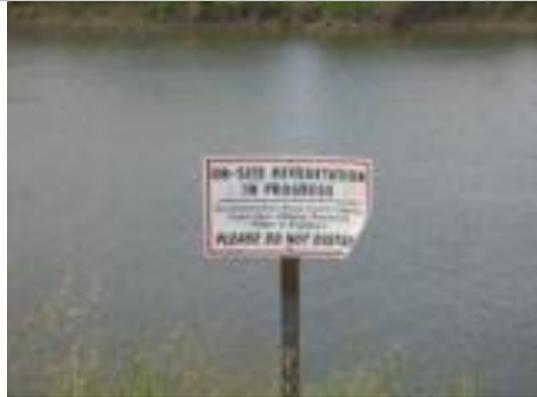
Photo 2 of 2 : FA\_2014\_NA0005\_251\_21\_20141014\_00022.jpg

This area is a revegetation site, photo taken spring 2012.

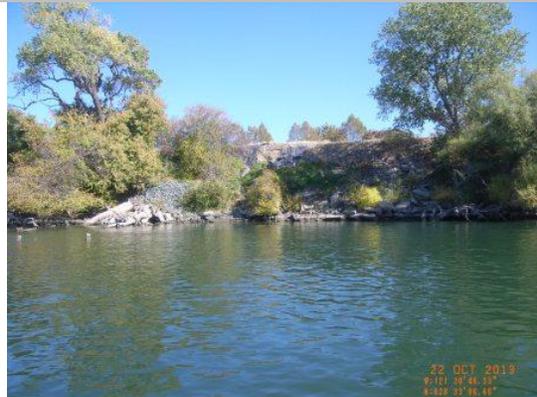
Photo 1 of 1 : FA\_2014\_NA0005\_251\_11\_20141014\_00011.jpg

LM Start	<b>2.84</b>	Rating **	M	Issue No.	<b>11</b>
LM End	<b>2.84</b>	Issue Type +	Ma	Location *	WS
Category	Supplemental		GPS Latitude/Longitude		
			Start	End	
Item	USACE Erosion Survey		38.551578 °	38.552268 °	
			-121.512336 °	-121.512590 °	
DWR ID	DWR_NA0005_01_f_2014_11				
Action/Comments					
Inspector Comments: 1997 - Erosion at pump station, concrete debris and plastic showing. 2000 - Separation scour of bank due to poor transition. 2004 - New large tree pop out; city dumped fill dirt/rock into hole. 2006 - Minor new erosion at top of bank. 2010 - Some new rock placed in tree pop-out. 2011 - A large tree has fallen and flood fighting was performed by the city on the upper levee slope. 2012 - Small rock placed in hole from tree popout. 2013: No observed changes. [2013 Site ID: SAC_56-6_L]

USACE 2013 Photo #1

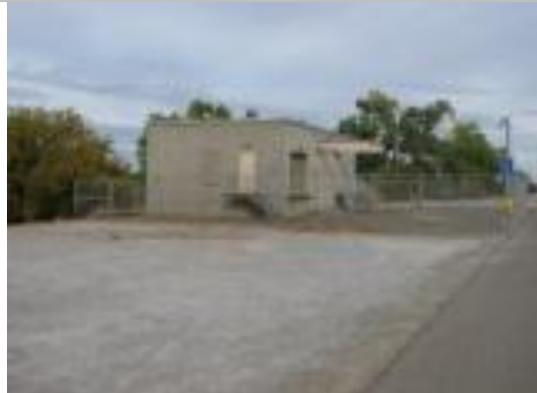
Photo 1 of 1 : FA\_2014\_NA0005\_251\_10\_20141014\_00010.jpg

LM Start	<b>2.90</b>	Rating **	M	Issue No.	<b>10</b>
LM End	<b>2.90</b>	Issue Type +	En	Location *	CR
Category	Earthen Levee		GPS Latitude/Longitude		
			Start	End	
Item	Encroachments		38.551810 °	38.551810 °	
			-121.511838 °	-121.511838 °	
DWR ID	DWR_NA0005_01_s_2012_10				
Action/Comments					
Building

City of Sacramento pump station on the waterside of the crown of the levee.

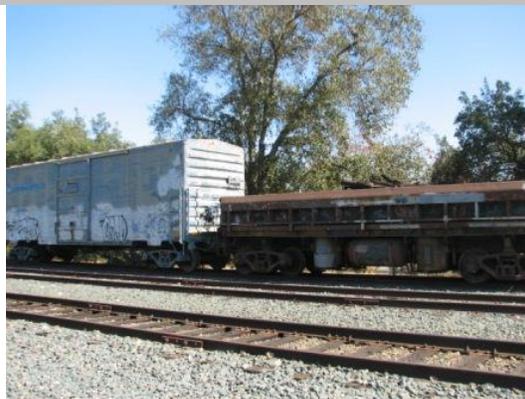
Photo 1 of 1 : FA\_2014\_NA0005\_251\_9\_20141014\_00009.jpg

Trains cars are stored on the crown of the levee. Fall 2013
