**Flood Control Project Maintenance
Levee Inspections**
LMA District Cover Sheet
Spring 2015 Levee Inspection Results
City of Sacramento

**Flood Control Project Maintenance
Levee Inspections
Unit Cover Sheet
Spring 2015 Levee Inspection Results
City of Sacramento**

Waterway	Bank	Unit Miles
Unit No. 01 Sacramento River	Left	3.67

Levee Inspection Report By Mile - Spring 2015

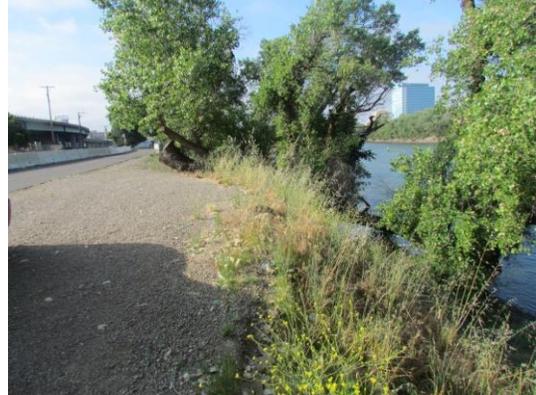
Photo 1 of 1 : SP_2015_NA0005_251_824_20150515_00971.jpg

LM Start	0.01	Rating **	M	Issue No.	824
LM End	0.40	Issue Type +	Ma	Location *	WS
Category	Earthen Levee			GPS Latitude/Longitude	
				Start	End
Item	Vegetation			38.590669 °	38.585149 °
				-121.505302 °	-121.505537 °
DWR ID	DWR_NA0005_01_s_2015_824				
Action/Comments					
Control annual grass and weeds on the levee slopes and easements.

View of the vegetation on the waterward side of the levee looking downstream. Spring 2015.

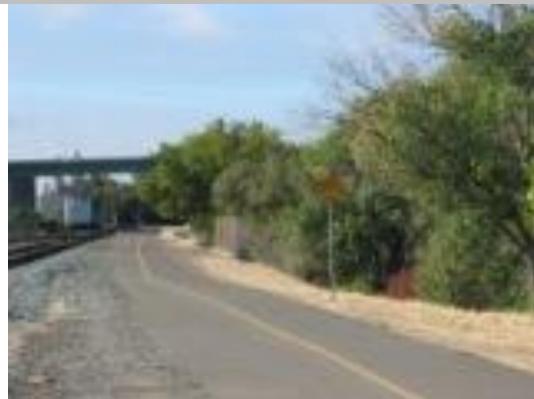
Photo 1 of 3 : SP_2015_NA0005_251_13_20150507_00010.jpg

LM Start	1.16	Rating **	A/W	Issue No.	13
LM End	1.69	Issue Type +	Ma	Location *	WS
Category	Earthen Levee			GPS Latitude/Longitude	
				Start	End
Item	Vegetation			38.574780 °	38.568757 °
				-121.510191 °	-121.515930 °
DWR ID	DWR_NA0005_01_f_2012_13				
Action/Comments					
Trees / Woody Vegetation

Trees and brush are larger than 2 inches but does not effect visibility. Photo fall 2012.

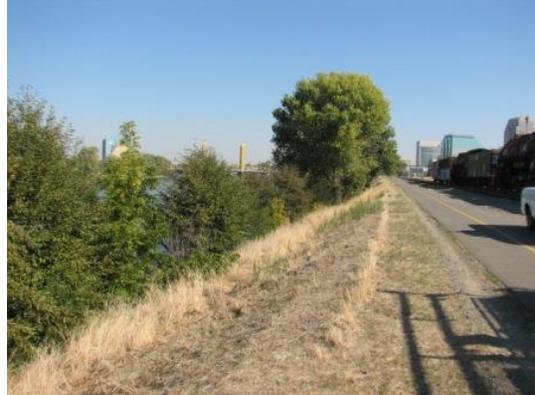
Photo 2 of 3 : SP_2015_NA0005_251_13_20150507_00011.jpg

LM Start	1.16	Rating **	A/W	Issue No.	13 (cont)
LM End	1.69	Issue Type +	Ma	Location *	WS
Category	Earthen Levee		GPS Latitude/Longitude		
			Start	End	
Item	Vegetation		38.574780 °	38.568757 °	
			-121.510191 °	-121.515930 °	
DWR ID	DWR_NA0005_01_f_2012_13				
Action/Comments					
Trees / Woody Vegetation

Monitor the trees and vegetation along the rivers edge. Fall 2013

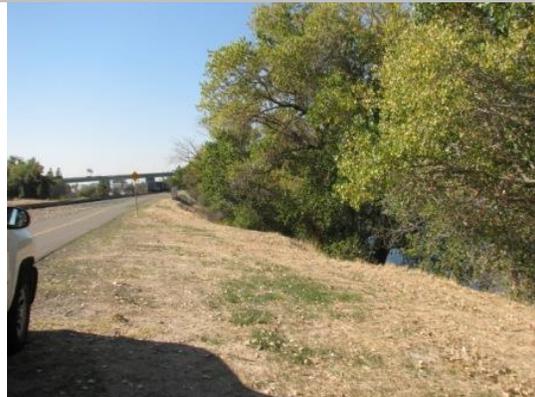
Photo 3 of 3 : SP_2015_NA0005_251_13_20150507_00012.jpg

LM Start	1.16	Rating **	A/W	Issue No.	13 (cont)
LM End	1.69	Issue Type +	Ma	Location *	WS

Monitor the trees and woody vegetation along the rivers edge. Fall 2013

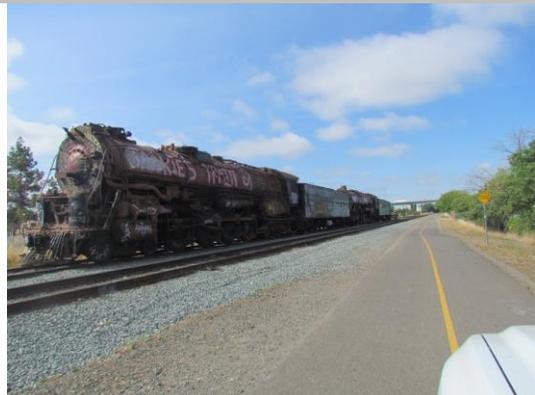
Photo 1 of 1 : SP_2015_NA0005_251_825_20150515_00972.jpg

LM Start	1.20	Rating **	M	Issue No.	825
LM End	1.20	Issue Type +	En	Location *	LS
Category	Earthen Levee		GPS Latitude/Longitude		
			Start	End	
Item	Encroachments		38.574347 °	38.574347 °	
			-121.510569 °	-121.510569 °	
DWR ID	DWR_NA0005_01_s_2015_825				
Action/Comments					
Equipment					
Inspector Comments: There are two engines on the levee crown at this location.

View of the train on the landward side of the levee looking downstream. Spring 2015.

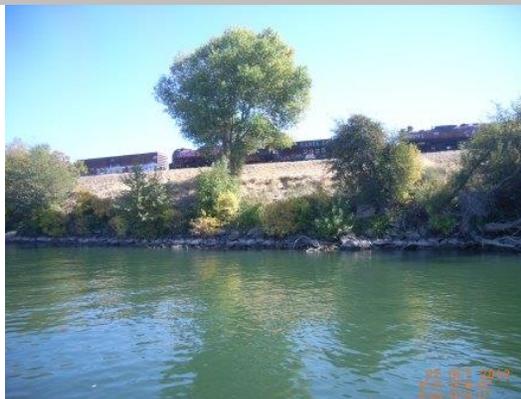
Photo 1 of 2 : SP_2015_NA0005_251_12_20150507_00008.jpg

LM Start	1.31	Rating **	M	Issue No.	12
LM End	1.39	Issue Type +	Ma	Location *	WS
Category	Supplemental			GPS Latitude/Longitude	
				Start	End
Item	USACE Erosion Survey			38.573169 °	38.572277 °
				-121.511998 °	-121.513063 °
DWR ID	DWR_NA0005_01_f_2014_12				
Action/Comments					
Inspector Comments: 2008 - Oversized levee, should be repaired under maintenance. 2009 - Shallow slumps at the mid bank. 2010 - Some minor erosion at the toe, likely from wave wash. Some new shallow slumps. 2011 - One new tree has fallen. 2013: Erosion continues on the slope surface, site extended upstream [2013 Site ID: SAC_58-5_L]

USACE 2013 Photo #1

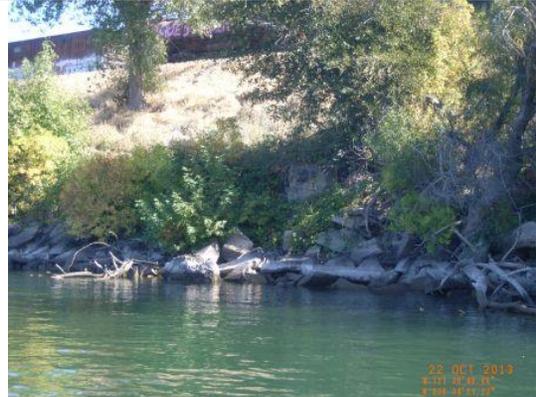
Photo 2 of 2 : SP_2015_NA0005_251_12_20150507_00009.jpg

LM Start	1.31	Rating **	M	Issue No.	12 (cont)
LM End	1.39	Issue Type +	Ma	Location *	WS
Category	Supplemental			GPS Latitude/Longitude	
				Start	End
Item	USACE Erosion Survey			38.573169 °	38.572277 °
				-121.511998 °	-121.513063 °
DWR ID	DWR_NA0005_01_f_2014_12				
Action/Comments					
Inspector Comments: 2008 - Oversized levee, should be repaired under maintenance. 2009 - Shallow slumps at the mid bank. 2010 - Some minor erosion at the toe, likely from wave wash. Some new shallow slumps. 2011 - One new tree has fallen. 2013: Erosion continues on the slope surface, site extended upstream [2013 Site ID: SAC_58-5_L]

USACE 2013 Photo #2

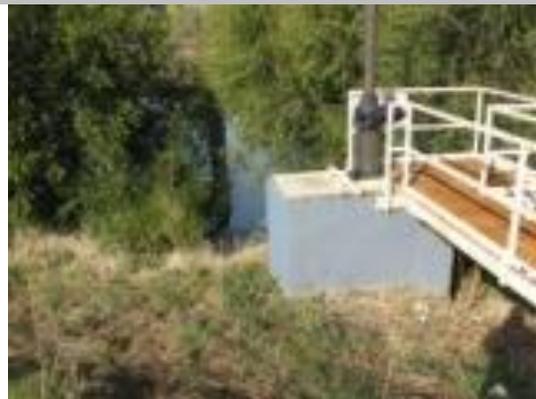
Photo 1 of 1 : SP_2015_NA0005_251_5_20150507_00001.jpg

LM Start	1.40	Rating **	A/W	Issue No.	5
LM End	1.40	Issue Type +	En	Location *	WS
Category	Earthen Levee			GPS Latitude/Longitude	
				Start	End
Item	Encroachments			38.572008 °	38.572008 °
				-121.513017 °	-121.513017 °
DWR ID	DWR_NA0005_01_s_2012_5				
Action/Comments					
Pipe

The screw gate is the positive closure for the pipe. Fall 2011

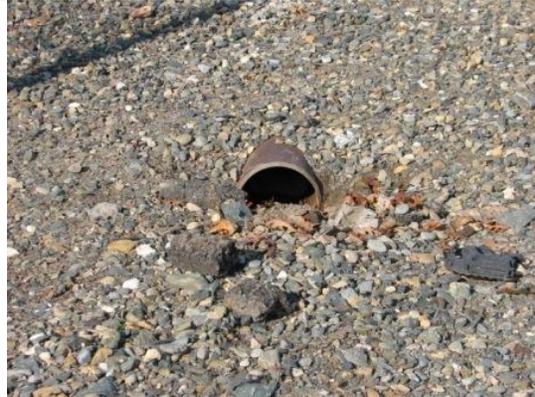
Photo 1 of 2 : SP_2015_NA0005_251_144_20150507_00015.jpg

LM Start	1.75	Rating **	A/W	Issue No.	144
LM End	1.75	Issue Type +	Ma	Location *	CR
Category	Earthen Levee			GPS Latitude/Longitude	
				Start	End
Item	Encroachments			38.567821 °	38.567821 °
				-121.516091 °	-121.516091 °
DWR ID	DWR_NA0005_01_s_2012_144				
Action/Comments					
Pipe

This appears to be a drain pipe under a driveway. It is a different pipe then the other photo for this issue. Fall 2011

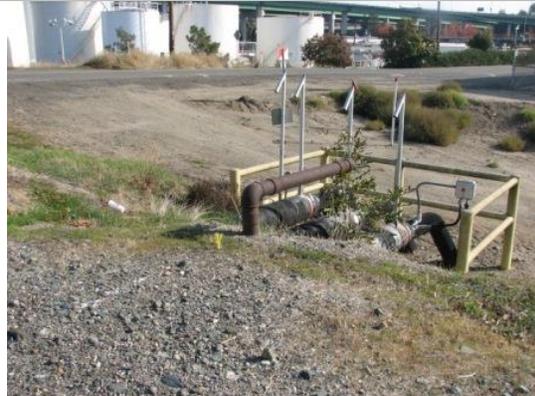
Photo 2 of 2 : SP_2015_NA0005_251_144_20150507_00016.jpg

LM Start	1.75	Rating **	A/W	Issue No.	144 (cont)
LM End	1.75	Issue Type +	Ma	Location *	CR

A pipe on the landside shoulder crosses under the railroad tracks. Fall 2011

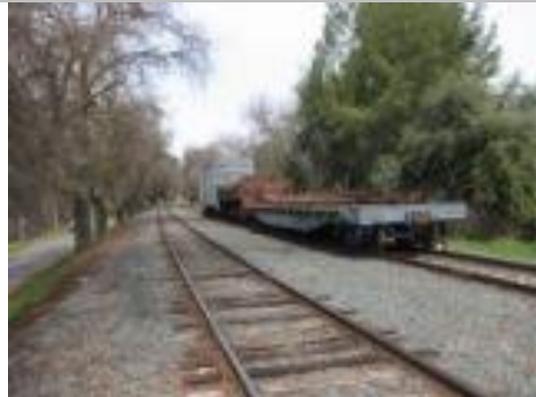
Photo 1 of 2 : SP_2015_NA0005_251_7_20150507_00003.jpg

LM Start	1.95	Rating **	M	Issue No.	7
LM End	2.34	Issue Type +	En	Location *	CR
Category	Earthen Levee			GPS Latitude/Longitude	
				Start	End
Item	Encroachments			38.564900 °	38.559460 °
				-121.516253 °	-121.515085 °
DWR ID	DWR_NA0005_01_s_2012_7				
Action/Comments					
Equipment Inspector Comments: Railroad tracks run on crown of levee, paved roadway runs along toe on waterside. This is Miller Park Marina area.

The railroad cars remain on the levee crown. Spring 2013

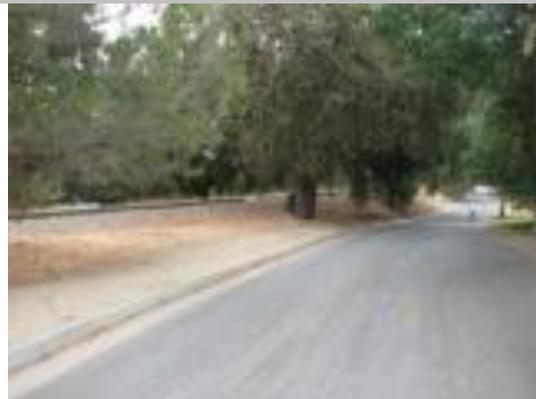
Photo 2 of 2 : SP_2015_NA0005_251_7_20150507_00004.jpg

Railroad tracks are on levee crown. The street is to the boat ramp.

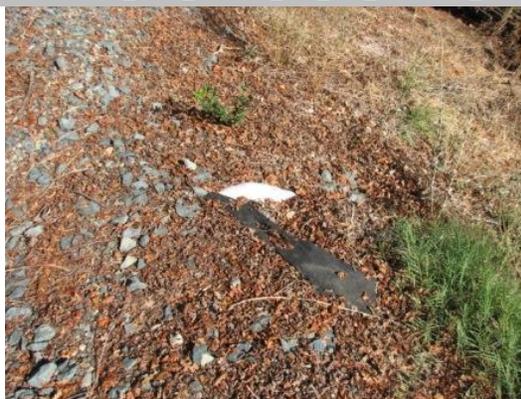
Photo 1 of 1 : SP_2015_NA0005_251_145_20150507_00017.jpg

LM Start	2.04	Rating **	A/W	Issue No.	145
LM End	2.04	Issue Type +	Ma	Location *	CR
Category	Earthen Levee			GPS Latitude/Longitude	
				Start	End
Item	Encroachments			38.563720 °	-121.515890 °
				38.563720 °	-121.515890 °
DWR ID	DWR_NA0005_01_s_2012_145				
Action/Comments					
Pipe Inspector Comments: The pipe has been repaired by the LMA. The pipe was installed by the Railroad Museum and is in talks with the CVFPB. No permit was issued for them.

The pipe is a french drain under the railroad tracks. Was in the USACE report has not been resolved. Photo fall 2012.

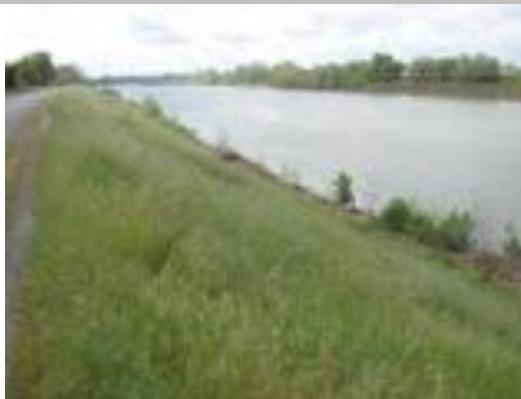
Photo 1 of 2 : SP_2015_NA0005_251_21_20150507_00013.jpg

LM Start	2.46	Rating **	A/W	Issue No.	21
LM End	2.75	Issue Type +	Ma	Location *	WS
Category	Earthen Levee			GPS Latitude/Longitude	
				Start	End
Item	Vegetation			38.557828 °	38.553710 °
				-121.514193 °	-121.512863 °
DWR ID	DWR_NA0005_01_s_2012_21				
Action/Comments					
Environmental Requirements.

A photo of the revegetation site taken spring 2012.

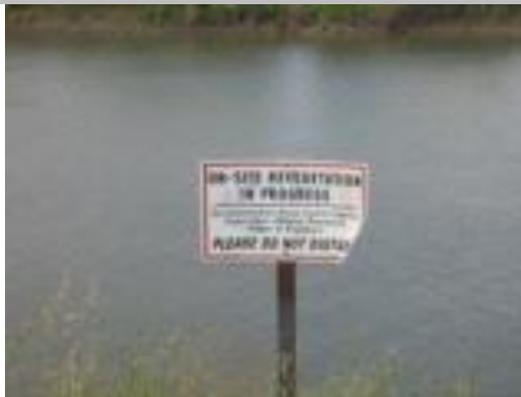
Photo 2 of 2 : SP_2015_NA0005_251_21_20150507_00014.jpg

LM Start	2.46	Rating **	A/W	Issue No.	21 (cont)
LM End	2.75	Issue Type +	Ma	Location *	WS
Category	Earthen Levee			GPS Latitude/Longitude	
				Start	End
Item	Vegetation			38.557828 °	38.553710 °
				-121.514193 °	-121.512863 °
DWR ID	DWR_NA0005_01_s_2012_21				
Action/Comments					
Environmental Requirements.

This area is a revegetation site, photo taken spring 2012.

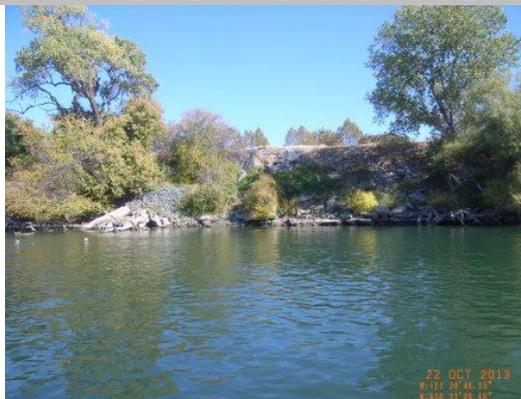
Photo 1 of 1 : SP_2015_NA0005_251_11_20150507_00007.jpg

LM Start	2.84	Rating **	M	Issue No.	11
LM End	2.85	Issue Type +	Ma	Location *	WS
Category	Supplemental			GPS Latitude/Longitude	
				Start	End
Item	USACE Erosion Survey			38.551578 °	38.552268 °
				-121.512336 °	-121.512590 °
DWR ID	DWR_NA0005_01_f_2014_11				
Action/Comments					
Inspector Comments: 1997 - Erosion at pump station, concrete debris and plastic showing. 2000 - Separation scour of bank due to poor transition. 2004 - New large tree pop out; city dumped fill dirt/rock into hole. 2006 - Minor new erosion at top of bank. 2010 - Some new rock placed in tree pop-out. 2011 - A large tree has fallen and flood fighting was performed by the city on the upper levee slope. 2012 - Small rock placed in hole from tree popout. 2013: No observed changes. [2013 Site ID: SAC_56-6_L]

USACE 2013 Photo #1

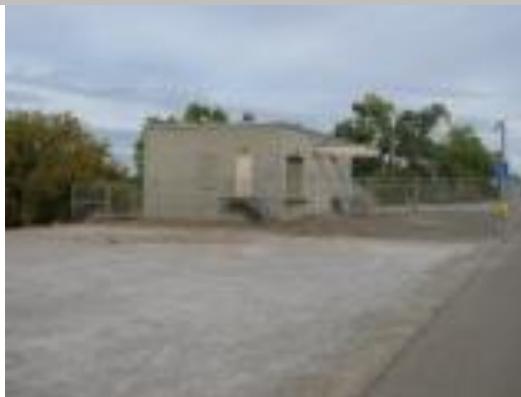
Photo 1 of 1 : SP_2015_NA0005_251_10_20150507_00006.jpg

LM Start	2.89	Rating **	M	Issue No.	10
LM End	2.89	Issue Type +	En	Location *	CR
Category	Earthen Levee			GPS Latitude/Longitude	
				Start	End
Item	Encroachments			38.551810 °	38.551810 °
				-121.511838 °	-121.511838 °
DWR ID	DWR_NA0005_01_s_2012_10				
Action/Comments					
Building

City of Sacramento pump station on the waterside of the crown of the levee.

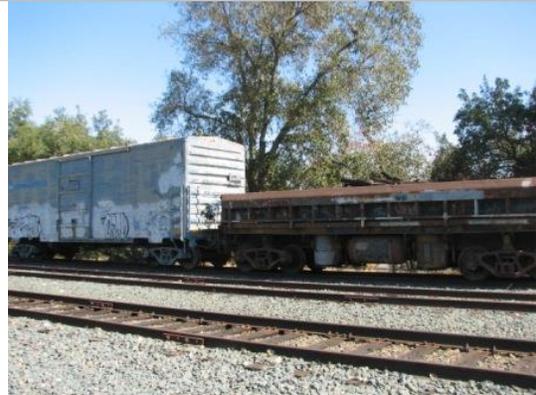
Photo 1 of 1 : SP_2015_NA0005_251_9_20150507_00005.jpg

LM Start	3.29	Rating **	M	Issue No.	9
LM End	3.29	Issue Type +	En	Location *	CR
Category	Earthen Levee			GPS Latitude/Longitude	
				Start	End
Item	Encroachments			38.546302 °	38.546302 °
				-121.510197 °	-121.510197 °
DWR ID	DWR_NA0005_01_f_2013_9				
Action/Comments					
Equipment Inspector Comments: There is four cars on the levee crown.

Trains cars are stored on the crown of the levee. Fall 2013
