**Flood Control Project Maintenance  
Levee Inspections**

**Maintenance Issue Types Only, Levee Inspection Report By Mile - Spring 2015**

**City of Sacramento**

Waterway	Bank	Unit Miles	Inspection Start/End	Inspector
Unit No. 01 Sacramento River	Left	3.67	05/15/2015 05/15/2015	Jai Lor

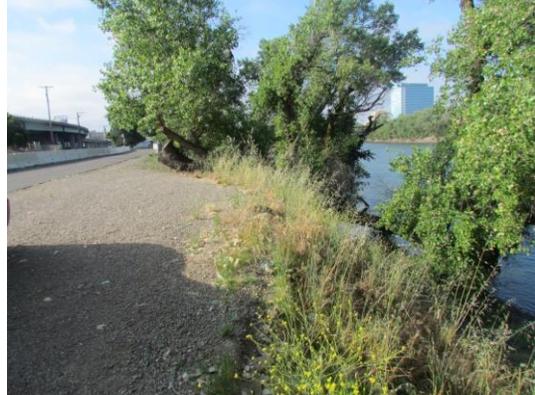
Photo 1 of 1 : SP\_2015\_NA0005\_251\_824\_20150515\_00971.jpg

LM Start	<b>0.01</b>	Rating **	M	Issue No.	<b>824</b>
LM End	<b>0.40</b>	Issue Type +	Ma	Location *	WS
Category	Earthen Levee			GPS Latitude/Longitude	
				Start	End
Item	Vegetation			38.590669 °	38.585149 °
				-121.505302 °	-121.505537 °
DWR ID	DWR_NA0005_01_s_2015_824				
Action/Comments					
Control annual grass and weeds on the levee slopes and easements.

View of the vegetation on the waterward side of the levee looking downstream. Spring 2015.

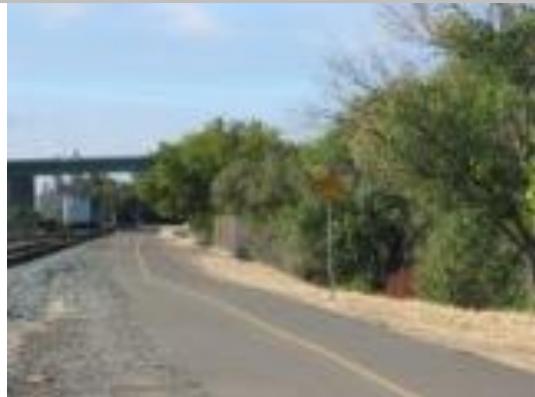
Photo 1 of 3 : SP\_2015\_NA0005\_251\_13\_20150507\_00010.jpg

LM Start	<b>1.16</b>	Rating **	A/W	Issue No.	<b>13</b>
LM End	<b>1.69</b>	Issue Type +	Ma	Location *	WS
Category	Earthen Levee			GPS Latitude/Longitude	
				Start	End
Item	Vegetation			38.574780 °	38.568757 °
				-121.510191 °	-121.515930 °
DWR ID	DWR_NA0005_01_f_2012_13				
Action/Comments					
Trees / Woody Vegetation

Trees and brush are larger than 2 inches but does not effect visibility. Photo fall 2012.

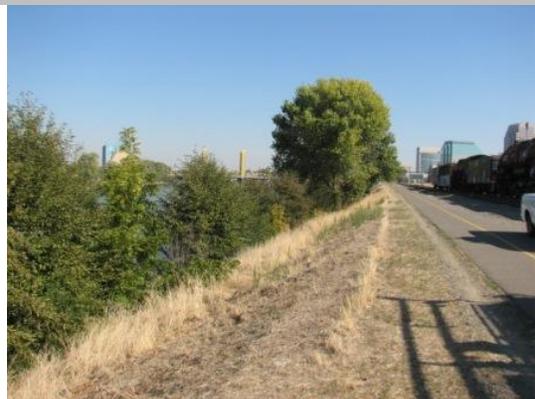
Photo 2 of 3 : SP\_2015\_NA0005\_251\_13\_20150507\_00011.jpg

LM Start	<b>1.16</b>	Rating **	A/W	Issue No.	<b>13 (cont)</b>
LM End	<b>1.69</b>	Issue Type +	Ma	Location *	WS

Monitor the trees and vegetation along the rivers edge. Fall 2013

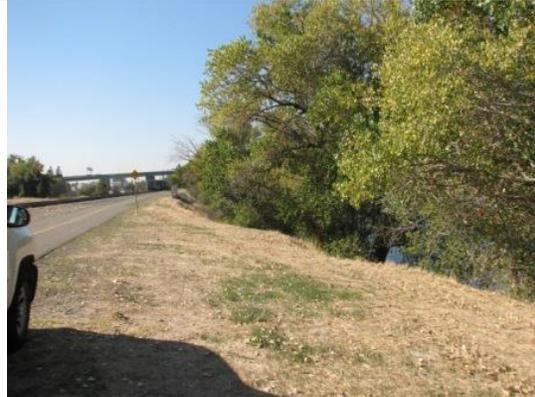
Photo 3 of 3 : SP\_2015\_NA0005\_251\_13\_20150507\_00012.jpg

LM Start	<b>1.16</b>	Rating **	A/W	Issue No.	<b>13 (cont)</b>
LM End	<b>1.69</b>	Issue Type +	Ma	Location *	WS
Category	Earthen Levee			GPS Latitude/Longitude	
				Start	End
Item	Vegetation			38.574780 °	38.568757 °
				-121.510191 °	-121.515930 °
DWR ID	DWR_NA0005_01_f_2012_13				
Action/Comments					
Trees / Woody Vegetation

Monitor the trees and woody vegetation along the rivers edge. Fall 2013

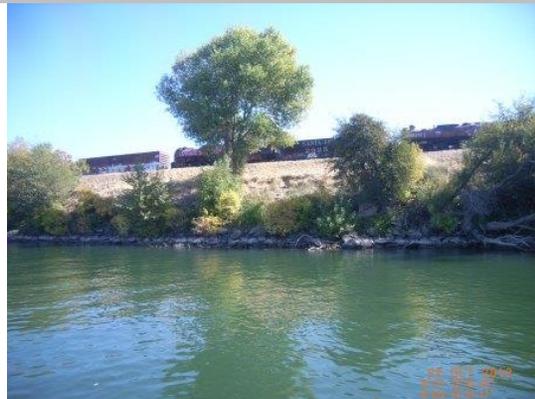
Photo 1 of 2 : SP\_2015\_NA0005\_251\_12\_20150507\_00008.jpg

LM Start	<b>1.31</b>	Rating **	M	Issue No.	<b>12</b>
LM End	<b>1.39</b>	Issue Type +	Ma	Location *	WS
Category	Supplemental			GPS Latitude/Longitude	
				Start	End
Item	USACE Erosion Survey			38.573169 °	38.572277 °
				-121.511998 °	-121.513063 °
DWR ID	DWR_NA0005_01_f_2014_12				
Action/Comments					
Inspector Comments: 2008 - Oversized levee, should be repaired under maintenance. 2009 - Shallow slumps at the mid bank. 2010 - Some minor erosion at the toe, likely from wave wash. Some new shallow slumps. 2011 - One new tree has fallen. 2013: Erosion continues on the slope surface, site extended upstream [2013 Site ID: SAC_58-5_L]

USACE 2013 Photo #1

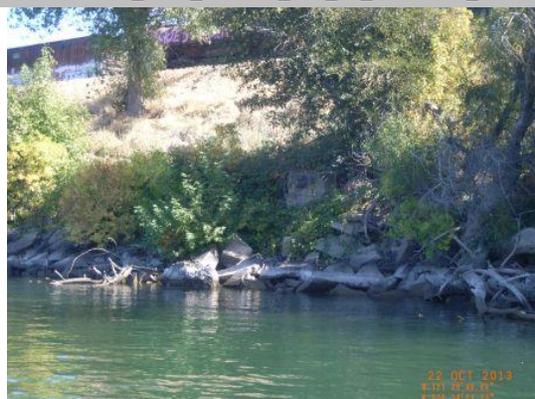
Photo 2 of 2 : SP\_2015\_NA0005\_251\_12\_20150507\_00009.jpg

LM Start	<b>1.31</b>	Rating **	M	Issue No.	<b>12 (cont)</b>
LM End	<b>1.39</b>	Issue Type +	Ma	Location *	WS

USACE 2013 Photo #2

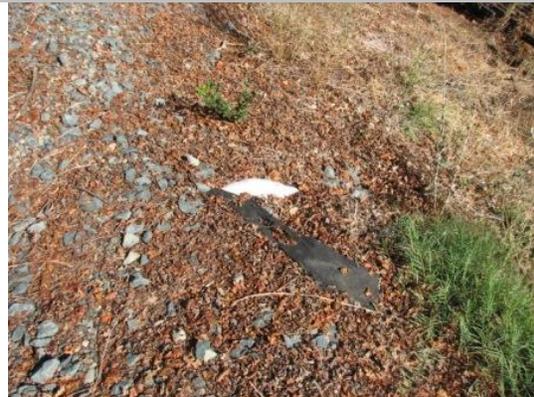
Photo 1 of 1 : SP\_2015\_NA0005\_251\_145\_20150507\_00017.jpg

LM Start	<b>2.04</b>	Rating **	A/W	Issue No.	<b>145</b>
LM End	<b>2.04</b>	Issue Type +	Ma	Location *	CR
Category	Earthen Levee		GPS Latitude/Longitude		
			Start	End	
Item	Encroachments		38.563720 °	-121.515890 °	
			38.563720 °	-121.515890 °	
DWR ID	DWR_NA0005_01_s_2012_145				
Action/Comments					
Pipe Inspector Comments: The pipe has been repaired by the LMA. The pipe was installed by the Railroad Museum and is in talks with the CVFPB. No permit was issued for them.

The pipe is a french drain under the railroad tracks. Was in the USACE report has not been resolved. Photo fall 2012.

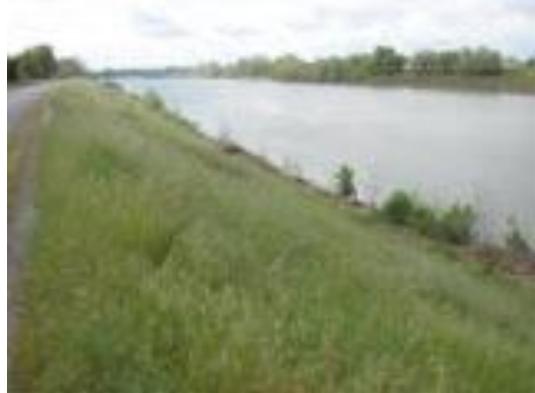
Photo 1 of 2 : SP\_2015\_NA0005\_251\_21\_20150507\_00013.jpg

LM Start	<b>2.46</b>	Rating **	A/W	Issue No.	<b>21</b>
LM End	<b>2.75</b>	Issue Type +	Ma	Location *	WS
Category	Earthen Levee			GPS Latitude/Longitude	
				Start	End
Item	Vegetation			38.557828 °	38.553710 °
				-121.514193 °	-121.512863 °
DWR ID	DWR_NA0005_01_s_2012_21				
Action/Comments					
Environmental Requirements.

A photo of the revegetation site taken spring 2012.

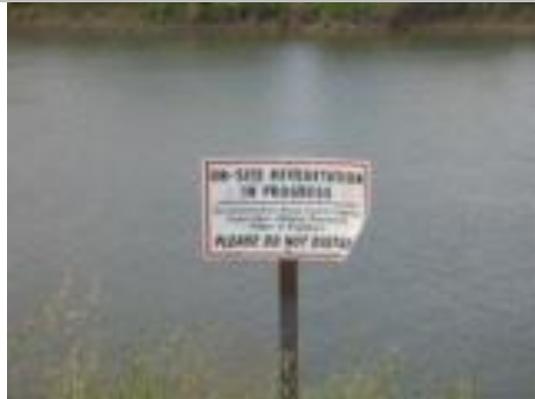
Photo 2 of 2 : SP\_2015\_NA0005\_251\_21\_20150507\_00014.jpg

LM Start	<b>2.46</b>	Rating **	A/W	Issue No.	<b>21 (cont)</b>
LM End	<b>2.75</b>	Issue Type +	Ma	Location *	WS

This area is a revegetation site, photo taken spring 2012.

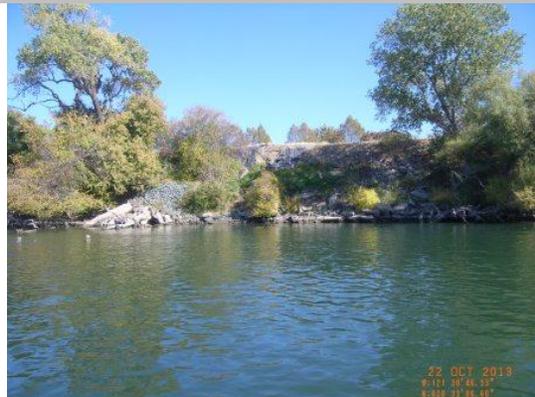
Photo 1 of 1 : SP\_2015\_NA0005\_251\_11\_20150507\_00007.jpg

LM Start	<b>2.84</b>	Rating **	M	Issue No.	<b>11</b>
LM End	<b>2.85</b>	Issue Type +	Ma	Location *	WS
Category	Supplemental			GPS Latitude/Longitude	
				Start	End
Item	USACE Erosion Survey			38.551578 °	38.552268 °
				-121.512336 °	-121.512590 °
DWR ID	DWR_NA0005_01_f_2014_11				
Action/Comments					
Inspector Comments: 1997 - Erosion at pump station, concrete debris and plastic showing. 2000 - Separation scour of bank due to poor transition. 2004 - New large tree pop out; city dumped fill dirt/rock into hole. 2006 - Minor new erosion at top of bank. 2010 - Some new rock placed in tree pop-out. 2011 - A large tree has fallen and flood fighting was performed by the city on the upper levee slope. 2012 - Small rock

USACE 2013 Photo #1
