**Flood Control Project Maintenance
Levee Inspections**
LMA District Cover Sheet
Spring 2009 Levee Inspection Results

**Flood Control Project Maintenance
Levee Inspections
Unit Cover Sheet
Spring 2009 Levee Inspection Results
City of Sacramento**

Levee Inspection Report By Mile - Spring 2009

Waterway	Bank	Unit Miles	Inspection Start/End	Inspector
Unit No. 01 City of Sacramento	Left	3.60	05/05/2009 05/05/2009	John Williamson

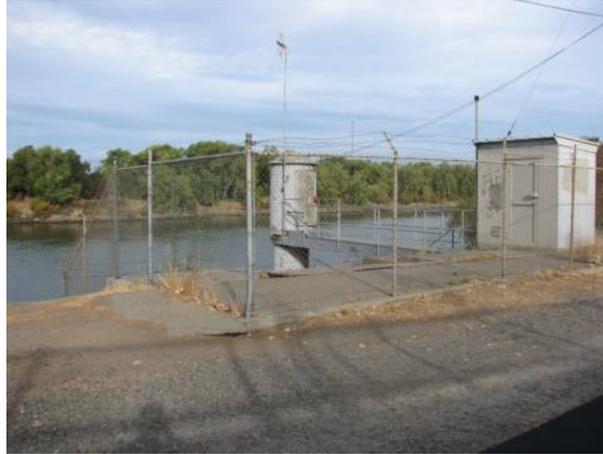
Levee Mile Report Line	1
Start Levee Mile	0.14
End Levee Mile	0.14
Location	Water Side
Category	Earthen Levee
Item	Encroachments
Recorder can (DWR)

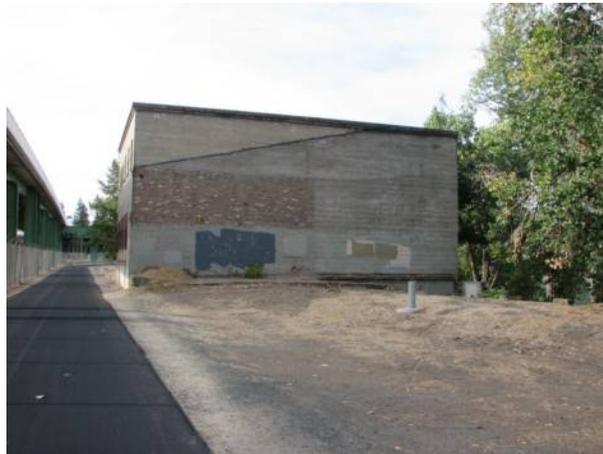
Levee Mile Report Line	2
Start Levee Mile	0.16
End Levee Mile	0.16
Location	Water Side
Category	Earthen Levee
Item	Encroachments
Historical Building : State Parks & Recreations

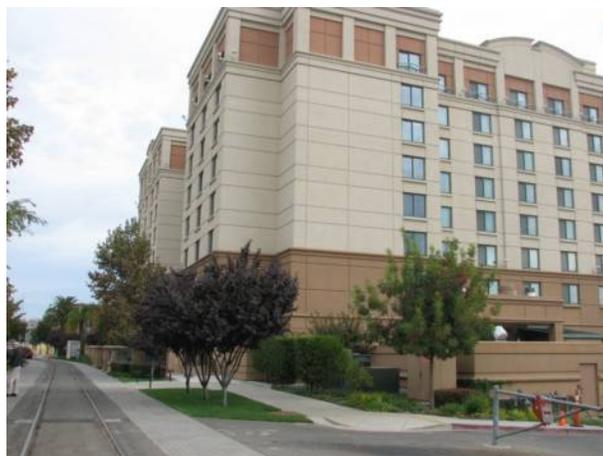
Levee Mile Report Line	3
Start Levee Mile	0.78
End Levee Mile	0.78
Location	Crown
Category	Earthen Levee
Item	Encroachments
Embassy Suites

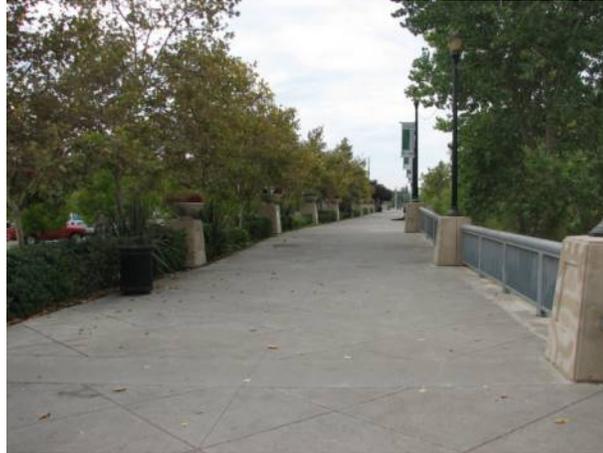
Levee Mile Report Line	4
Start Levee Mile	0.78
End Levee Mile	0.93
Location	Crown
Category	Earthen Levee
Item	Encroachments
River walk crown with landscaping

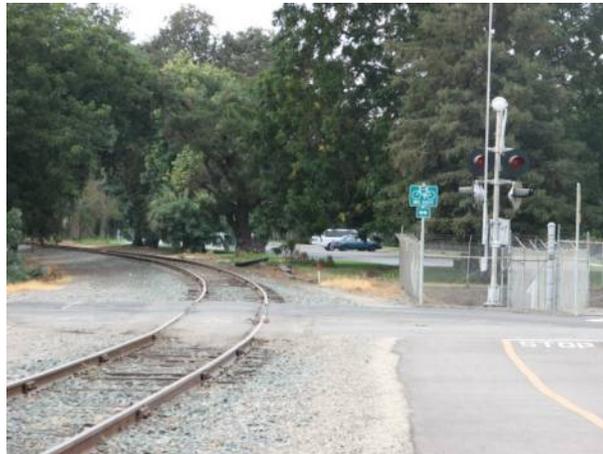
Levee Mile Report Line	5
Start Levee Mile	1.73
End Levee Mile	1.96
Location	Crown
Category	Earthen Levee
Item	Encroachments
Miller Park at Broadway rail road track and parking area on levee

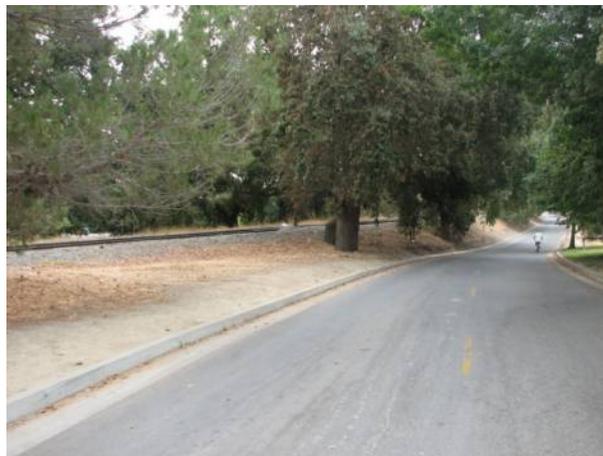
6	1.96	2.34	Earthen Levee	Encroachments	CR	PO	Equipment Inspector Comments: Railroad tracks run on crown of levee, paved roadway runs along toe on waterside this is Miller Park Marina area.	38.564900 ° -121.516253 °	38.559460 ° -121.515085 °	Y	7
7	2.45	2.45	Earthen Levee	Vegetation	LS	M	Elderberries are blocking visibility and flood fight capability.	38.557937 ° -121.514237 °	38.557937 ° -121.514237 °		8
8	2.90	2.90	Earthen Levee	Encroachments	CR	PO	Buildings	38.551810 ° -121.511838 °	38.551810 ° -121.511838 °	Y	10
9	2.92	3.58	Earthen Levee	Vegetation	WS	M	Control annual grass and weeds on the levee slopes and easements. Inspector Comments: Waterside slope cannot be mowed until June 15, requirements by Fish & Game. Sacramento City will comply with requirements and mow after that date.	38.551453 ° -121.511738 °	38.541792 ° -121.510987 °		12

Levee Mile Report Line	6
Start Levee Mile	1.96
End Levee Mile	2.34
Location	Crown
Category	Earthen Levee
Item	Encroachments
Rail road tracks on levee crown street to boat ramp

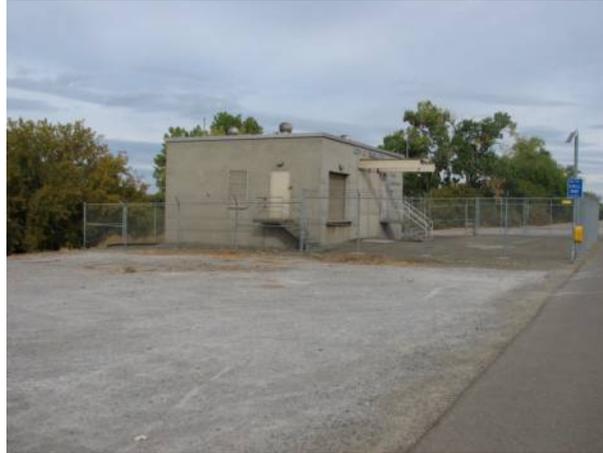
Levee Mile Report Line	8
Start Levee Mile	2.90
End Levee Mile	2.90
Location	Crown
Category	Earthen Levee
Item	Encroachments
pump station city of Sacramento crown of levee waterside
