Flood Control Project Maintenance
2008 Structure Summary Report
Overall Unit and Item Ratings

Magpie Creek Pumping Plant

2008 Pumping Plant Inspection Results

Date of Inspection	11/5/2008
DWR Inspector	David Pesavento
Pumping Plant Rating	A

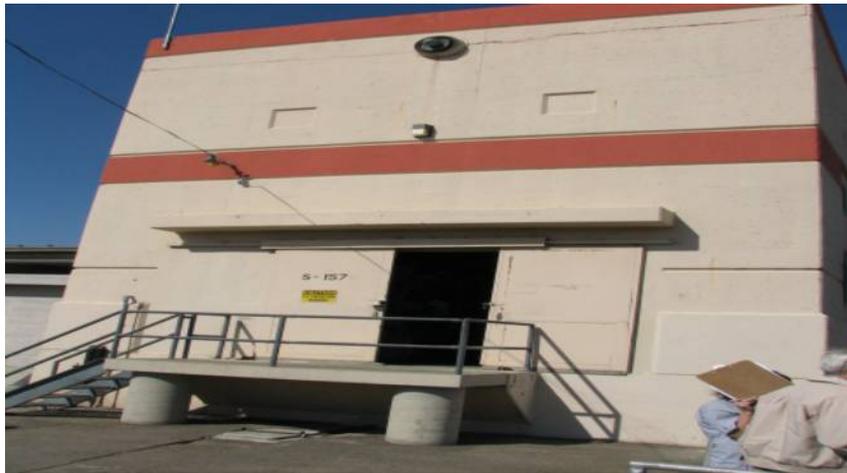
Report Line	3
Location	
Category	Pump Stations
Item	Plant Building

View of south side of pump building.

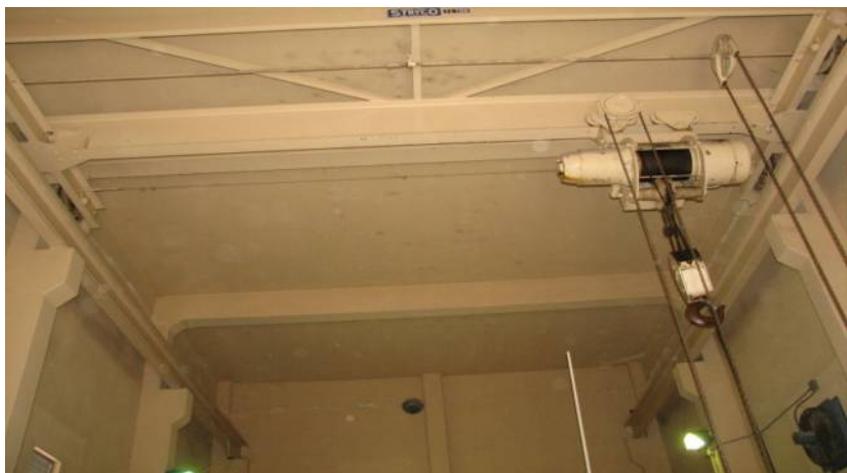
Report Line	6
Location	
Category	Pump Stations
Item	Cranes

View of the overhead crane located inside the building.

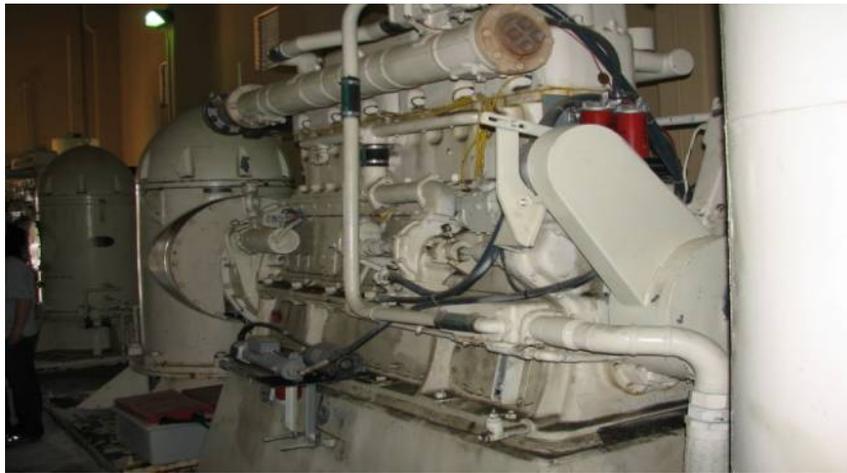
Report Line	7
Location	
Category	Pump Stations
Item	Pumps

7	Pump Stations	Pumps		A	Pumps were not operating at the time of the inspection but appear well maintained and able to perform adequately.	°	Y	16
8	Pump Stations	Power		A	The pump station is equiped with gas powered pumps in case of power failure. No evidence of electrical issues observed at the site.	°	Y	18
9	Pump Stations	Motors, Engines, Fans & Gear Reducers		A		°	Y	20
10	Pump Stations	Pump Control Systems		A	The city has a control system that can be operated remotely or onsite. The gas powered pumps must be switched on manually. No defects in the control systems noted.	°	Y	21
11	Pump Stations	Sumps/Wet Well		A	No significant debris observed in sumps.	°	Y	7
12	Pump Stations	Trash Racks		A	Trash racks are in place and properly maintained.	°	Y	9
13	Pump Stations	Trash Rakes		N	No trash rakes on trash rack. Racks are manually cleared, tool was observed on site.	°		8
14	Pump Stations	Sluice / Slide Gates		A		°		10

View of one of the gas operated pumps located inside the building.

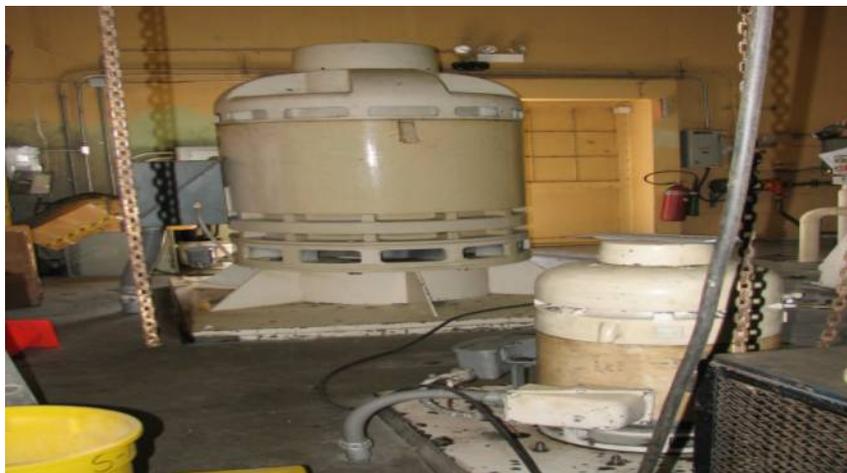
Report Line	7
Location	
Category	Pump Stations
Item	Pumps

View of one of the large (background) and one of the small (foreground) electric pumps located inside the building.

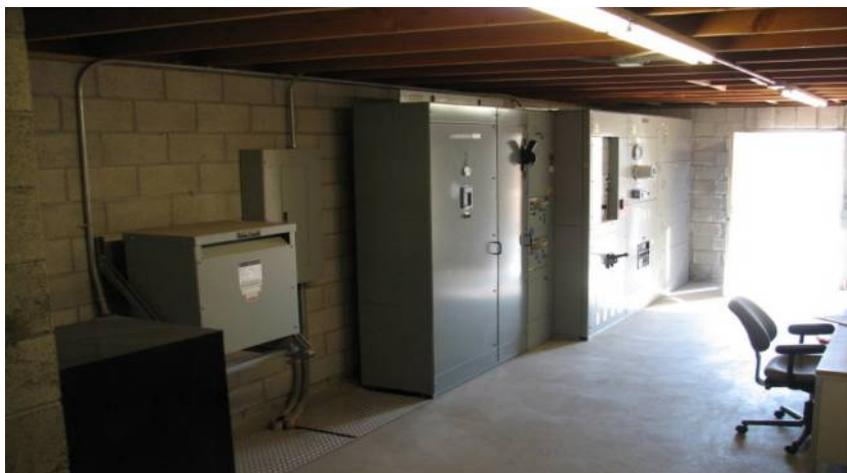
Report Line	8
Location	
Category	Pump Stations
Item	Power

View of electrical switchgear for pumps.

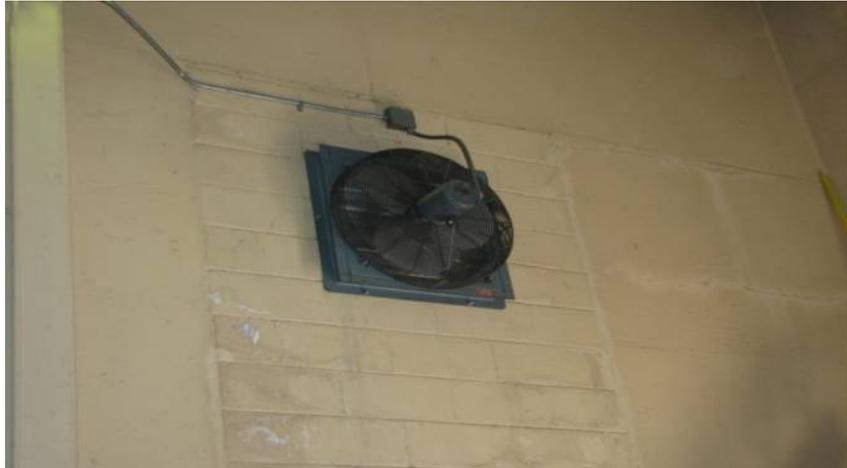
Report Line	9
Location	
Category	Pump Stations
Item	Motors, Engines, Fans & Gear Reducers
View of one of the fans located inside the building.

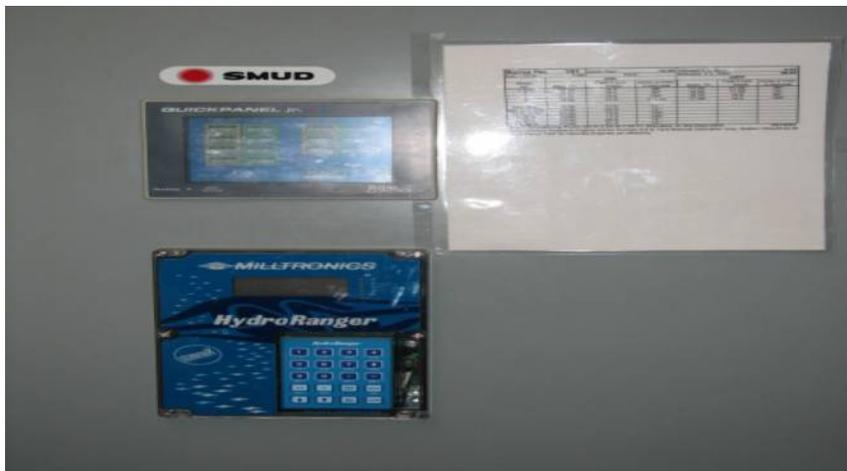
Report Line	10
Location	
Category	Pump Stations
Item	Pump Control Systems
View of the city's control system equipment.

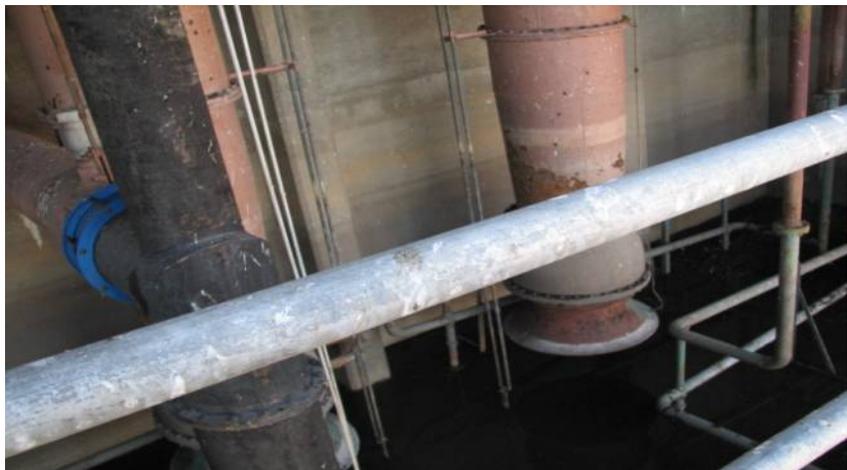
Report Line	11
Location	
Category	Pump Stations
Item	Sumps/Wet Well
Sump/pipe intakes on south side.

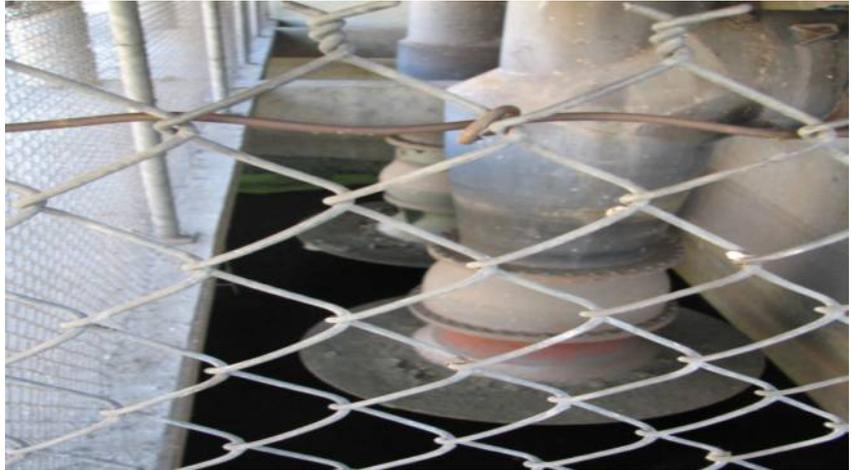
Report Line	11
Location	
Category	Pump Stations
Item	Sumps/Wet Well
Sump/pipe intakes on north side.

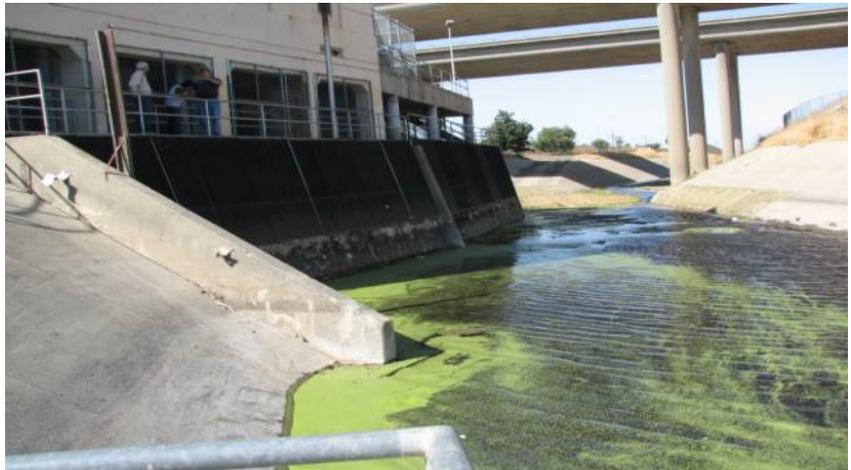
Report Line	12
Location	
Category	Pump Stations
Item	Trash Racks
View of trash racks from landside of channel looking north toward I-80.

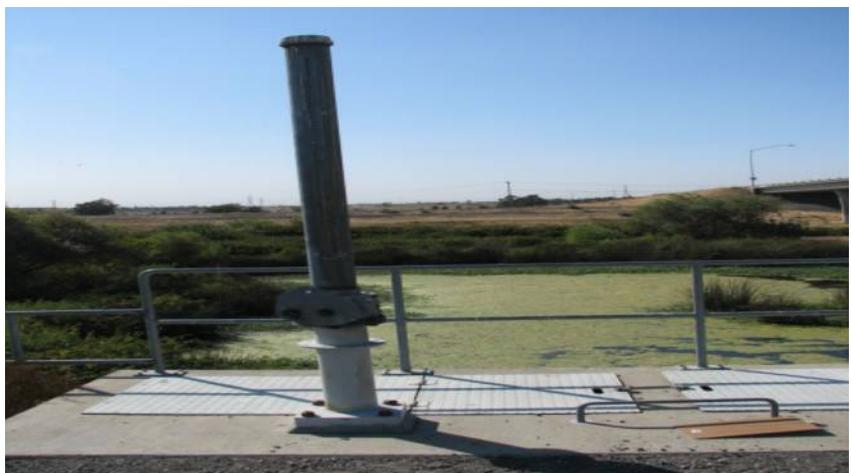
15	Pump Stations	Electric Gate Operators		N	Station does not have any automatic/electric actuators on gates.	°		11
16	Pump Stations	Manual Gate Operators		A	No significant defects observed at screws for opening and closing side gates. City crews have access to manual and portable mechanized actuating equipment.	°	Y	12

Report Line	16
Location	
Category	Pump Stations
Item	Manual Gate Operators
View of southernmost slide gate screw.

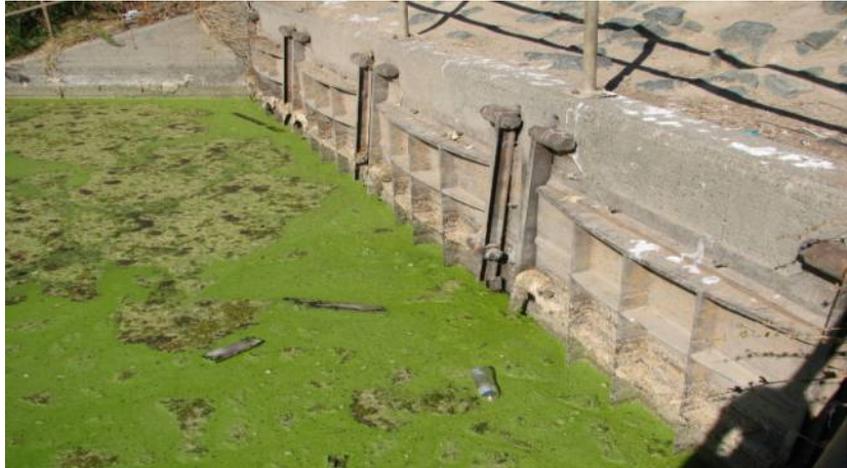
Report Line	18
Location	
Category	Pump Stations
Item	Flap Gates

View of north bank of discharge pipes and flap gates on waterside of levee.

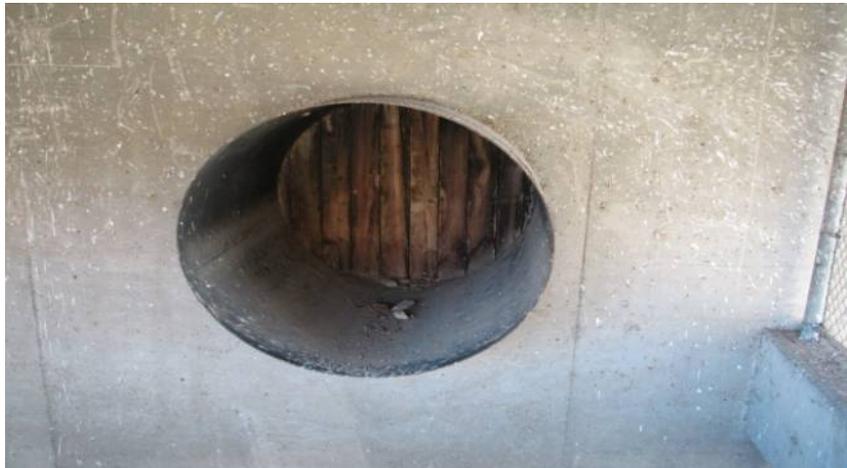
Report Line	21
Location	
Category	Pump Stations
Item	Intake and Discharge Pipes

View of inactive and blocked intake pipe. The waterside of this pipe is welded shut.
