**Flood Control Project Maintenance**  
**2009 Structure Summary Report**  
**Overall Unit and Item Ratings**

**City of Sacramento**

**El Camino Avenue Bridge**

**Levee Inspection Report By Mile - Structure 2009**

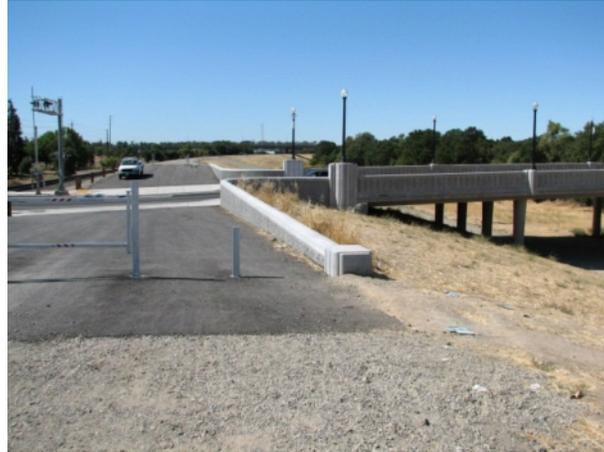
LMR No.	Levee Mile		Category	Item	Location *	Rating **	Action/Comment	GPS Latitude/Longitude		Photo	Issue No.
	Start	End						Start	End		
1	0.00	0.00	Structures	Photo Documentation			Inspector Comments: W. El Camino bridge is inspected as a structure because the bridge deck is below the design water surface elevation causing the wingwalls and guard railing to act as flood walls during high water events.	38.611100 ° 121.467500 °	38.611100 ° 121.467500 °	Y	1
2	0.00	0.00	Structures	Vegetation & Obstructions		A	Inspector Comments: Minimal, scattered obstructions or vegetation. The flow is not impeded.	°	°		2
3	0.00	0.00	Structures	Shoaling / Sedimentation		A	Inspector Comments: No visible shoaling or sedimentation present.	°	°		3
4	0.00	0.00	Structures	Erosion / Bank Caving		A	Inspector Comments: No active erosion or bank caving observed on the landward or on the riverward side of the levee near the bridge.	°	°		4

Levee Mile Report Line	1
Start Levee Mile	0.00
End Levee Mile	0.00
Location	
Category	Structures
Item	Photo Documentation
West El Camino bridge crossing Natomas East Main Drainage Canal	
jpaasch_20090804_10.jpg

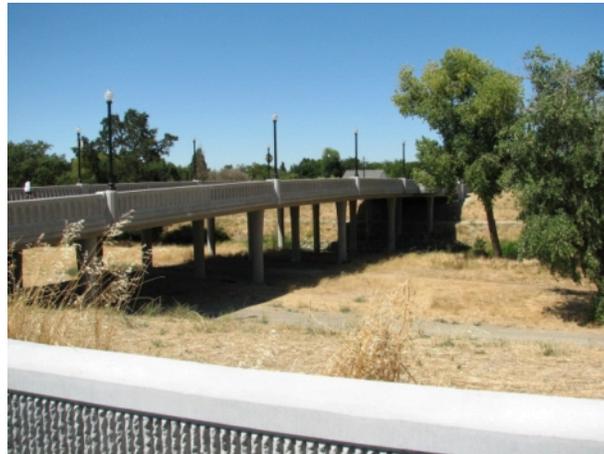
Levee Mile Report Line	17
Start Levee Mile	0.00
End Levee Mile	0.00
Location	
Category	Structures
Item	Concrete Foundations
Photo of concrete piers and abutment.	
jpaasch_20090810_25.jpg

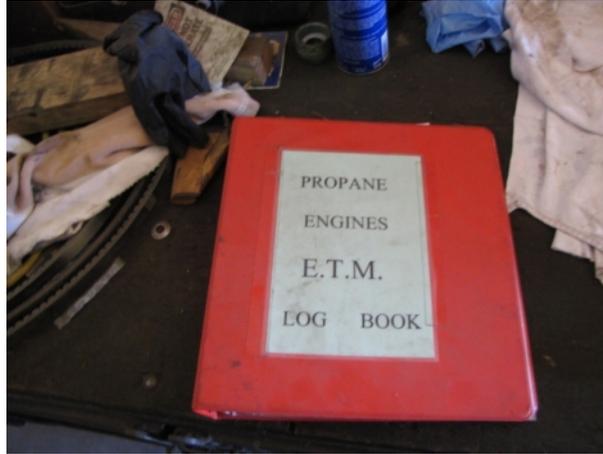
LMR No.	Levee Mile		Category	Item	Location*	Rating**	Action/Comment	GPS Latitude/Longitude		Photo	Issue No.
	Start	End						Start	End		
1	0.00	0.00	Pump Stations	Operating Log		A	Inspector Comments: City uses an online application to keep track of maintenance performed. Some paper logs at the plant are also kept.	°	°	Y	1
2	0.00	0.00	Pump Stations	Operation & Maintenance Manual		A	Inspector Comments: City keeps a copy in the downtown facility. Inspector requested that a copy be kept at the pump station in the future.	°	°		2
3	0.00	0.00	Pump Stations	Plant Building		A	Inspector Comments: The building has minor cracking, and some electrical items were not operational at the time of the inspection due to upgrades being performed, but the building appeared to be in good repair and able to be safely occupied by equipment and personnel.	°	°	Y	3
4	0.00	0.00	Pump Stations	Communications		A	Inspector Comments: Plant operators have use of the city radio system, cell phones, and a land line in the plant building.	°	°		4

Levee Mile Report Line	1
Start Levee Mile	0.00
End Levee Mile	0.00
Location	
Category	Pump Stations
Item	Operating Log
Log book kept for operation of the propane engine powered pumps.	
dpesaven_20090728_1.jpg

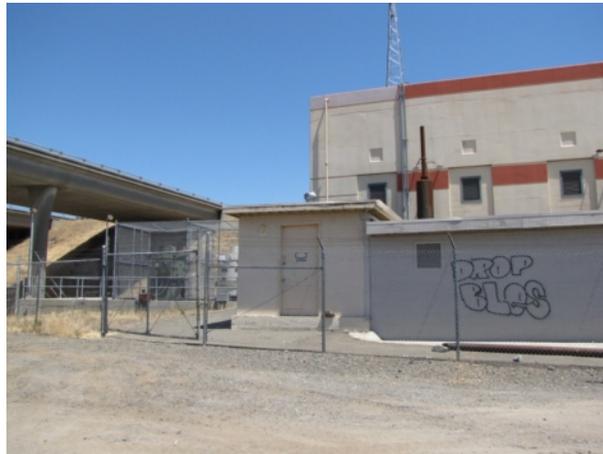
Levee Mile Report Line	3
Start Levee Mile	0.00
End Levee Mile	0.00
Location	
Category	Pump Stations
Item	Plant Building
View of exterior of plant building.	
dpesaven_20090728_2.jpg

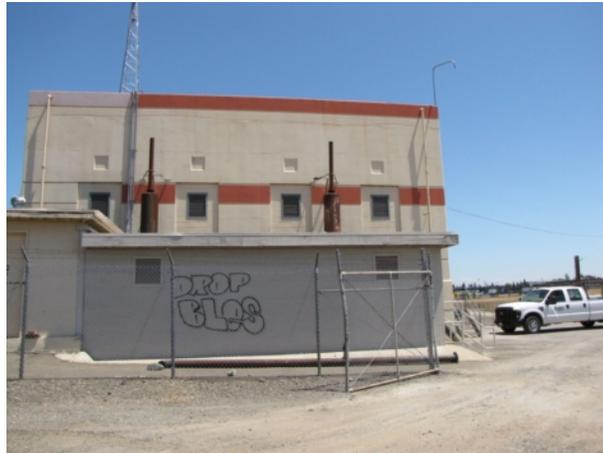
Levee Mile Report Line	3
Start Levee Mile	0.00
End Levee Mile	0.00
Location	
Category	Pump Stations
Item	Plant Building
Additional view of exterior of plant building.	
dpesaven_20090728_3.jpg

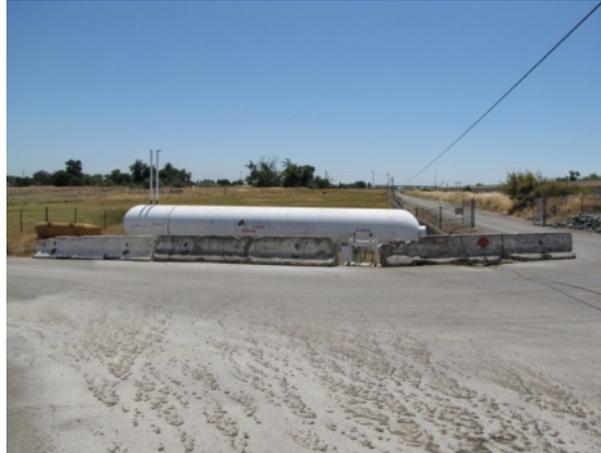
5	0.00	0.00	Pump Stations	Safety		A	Inspector Comments: There do not appear to be any safety hazards that pose a significant hazard to personnel at the plant. Concrete barriers have been placed around the propane tank to protect it from vehicular traffic; a previous concern that has now been corrected.	°	°	Y	5
6	0.00	0.00	Pump Stations	Cranes		A	Item inspected visually only. Item was not operated during the inspection. Inspector Comments: The pumping plant appears to be in good working order. At the time of the inspection, the OSHA crane permit had expired a few days prior and should be renewed as soon as possible.	°	°	Y	6
7	0.00	0.00	Pump Stations	Pumps		A	Item inspected visually only. Item was not operated during the inspection. Inspector Comments: The pumps appears to be well maintained and capable of performing as intended.	°	°		7
8	0.00	0.00	Pump Stations	Power		A	Inspector Comments: The power source appears to be reliable and several of the pumps run on propane and diesel fuel, not electricity.	°	°	Y	8

Levee Mile Report Line	5
Start Levee Mile	0.00
End Levee Mile	0.00
Location	
Category	Pump Stations
Item	Safety
View of the propane tank with recently placed concrete barriers protecting it from vehicular traffic.	
dpesaven_20090728_4.jpg

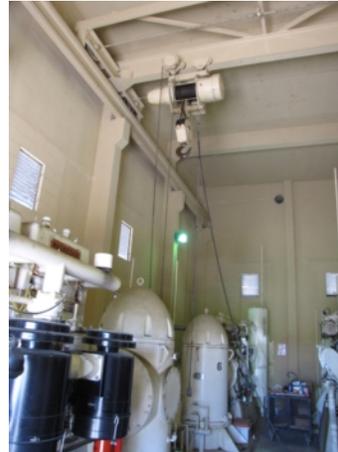
Levee Mile Report Line	6
Start Levee Mile	0.00
End Levee Mile	0.00
Location	
Category	Pump Stations
Item	Cranes
View of the overhead crane in the pumping plant.	
dpesaven_20090728_5.jpg

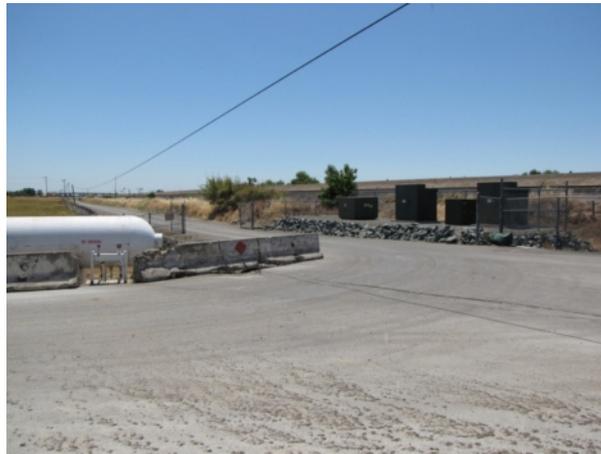
Levee Mile Report Line	8
Start Levee Mile	0.00
End Levee Mile	0.00
Location	
Category	Pump Stations
Item	Power
View of part of the propane tank and the electrical transformers.	
dpesaven_20090728_13.jpg

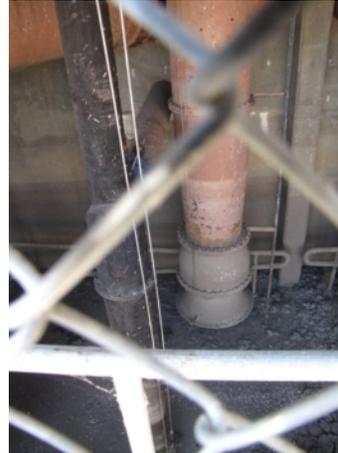
Levee Mile Report Line	11
Start Levee Mile	0.00
End Levee Mile	0.00
Location	
Category	Pump Stations
Item	Sumps/Wet Well
View of the sump under the pump building. There does not appear to be a significant amount of sediment built up under the pump intakes.	
dpesaven_20090728_6.jpg

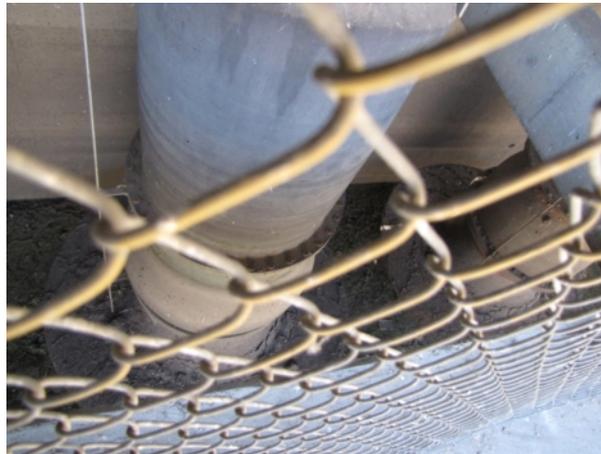
Levee Mile Report Line	11
Start Levee Mile	0.00
End Levee Mile	0.00
Location	
Category	Pump Stations
Item	Sumps/Wet Well
Sump under the pumps to the north of the plant building.	
dpesaven_20090728_7.jpg

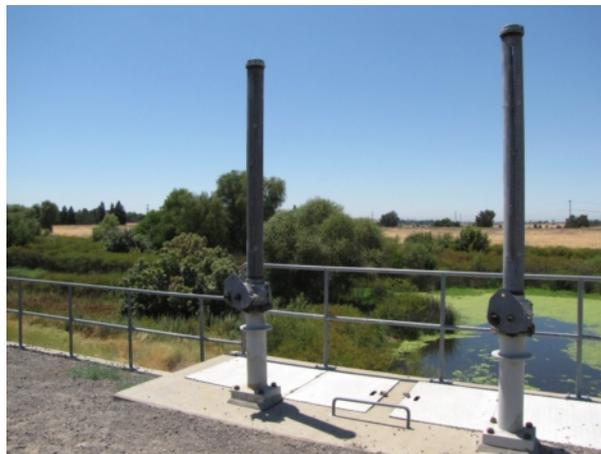
Levee Mile Report Line	16
Start Levee Mile	0.00
End Levee Mile	0.00
Location	
Category	Pump Stations
Item	Manual Gate Operators
View of two of the gate operators.	
dpesaven_20090728_10.jpg

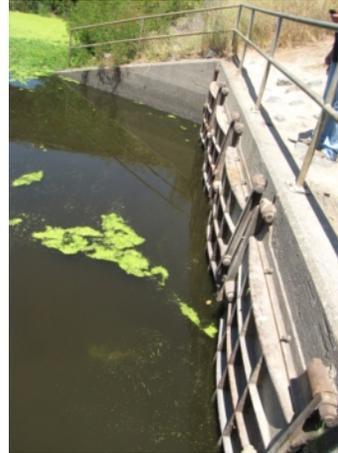
Levee Mile Report Line	18
Start Levee Mile	0.00
End Levee Mile	0.00
Location	
Category	Pump Stations
Item	Flap Gates
Flap gates for from first bank of pumps.	
dpesaven_20090728_8.jpg

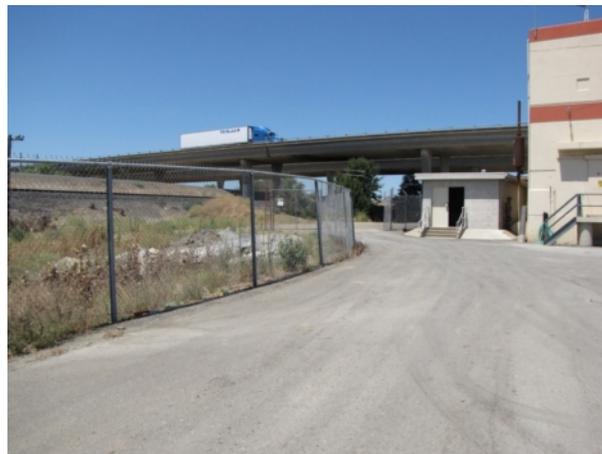
20	0.00	0.00	Pump Stations	Security Fencing		A	Inspector Comments: The security fencing appears to be in resonable repair.	°	°	Y	20

Levee Mile Report Line	20
Start Levee Mile	0.00
End Levee Mile	0.00
Location	
Category	Pump Stations
Item	Security Fencing
View of some of the security fencing around the pumping plant.	
dpesaven_20090728_11.jpg

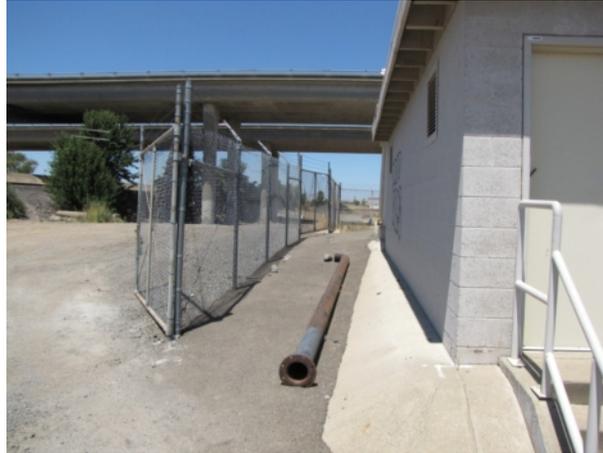
Levee Mile Report Line	20
Start Levee Mile	0.00
End Levee Mile	0.00
Location	
Category	Pump Stations
Item	Security Fencing
Additional view of some of the security fencing around the pumping plant.	
dpesaven_20090728_12.jpg
