Flood Control Project Maintenance
2015 Structure Summary Report
Overall Unit and Item Ratings

City of Sacramento

El Camino Avenue Bridge

Magpie Creek Pumping Plant

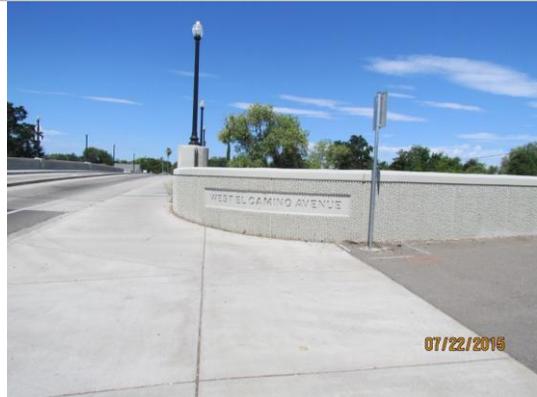
Photo 1 of 2 : ST_2015_NA0005_221_1_20150807_00012.jpg

LM Start	0.00	Rating **	N	Issue No.	1
LM End	0.00	Issue Type +	Ma	Location *	
Category	Structures & Concrete Lined Channels		GPS Latitude/Longitude		
			Start	End	
Item	Photo Documentation		38.611365 °	38.611365 °	
			-121.466557 °	-121.466557 °	
DWR ID	DWR_NA0005_221_t_2012_1				
Action/Comments					
Inspector Comments: West El Camino bridge is inspected as a structure because the bridge deck is below the design water surface elevation causing the wingwalls and guard railing to act as flood walls during high water events.

View of the bridge which acts as a flood wall.

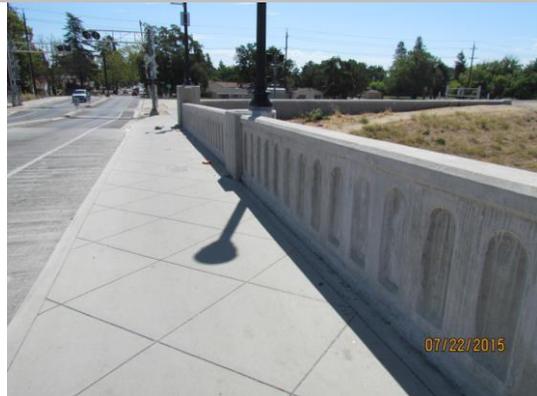
Photo 2 of 2 : ST_2015_NA0005_221_1_20150807_00013.jpg

View of the wing wall to act as a flood wall at this structure.

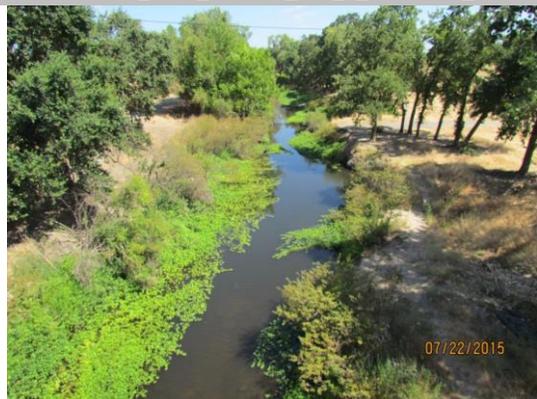
Photo 1 of 2 : ST_2015_NA0005_221_2_20150807_00014.jpg

LM Start	0.00	Rating **	A	Issue No.	2
LM End	0.00	Issue Type +	Ma	Location *	
Category	Structures & Concrete Lined Channels		GPS Latitude/Longitude		
			Start	End	
Item	Vegetation & Obstructions		38.611365 °	38.611365 °	
			-121.466557 °	-121.466557 °	
DWR ID	DWR_NA0005_221_t_2012_2				
Action/Comments					
Inspector Comments: The channel appeared to be free of any vegetation growth that would impede flows.

View of the channel under the bridge. The picture was taken looking upstream.

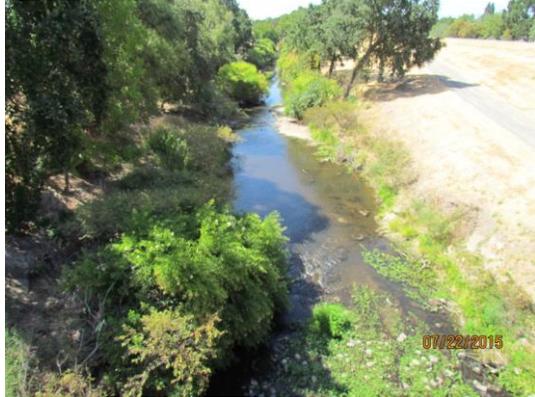
Photo 2 of 2 : ST_2015_NA0005_221_2_20150807_00015.jpg

LM Start	0.00	Rating **	A	Issue No.	2 (cont)
LM End	0.00	Issue Type +	Ma	Location *	
Category	Structures & Concrete Lined Channels		GPS Latitude/Longitude		
			Start	End	
Item	Vegetation & Obstructions		38.611365 °	38.611365 °	
			-121.466557 °	-121.466557 °	
DWR ID	DWR_NA0005_221_t_2012_2				
Action/Comments					
Inspector Comments: The channel appeared to be free of any vegetation growth that would impede flows.

View of the channel under the bridge. The picture was taken looking downstream.

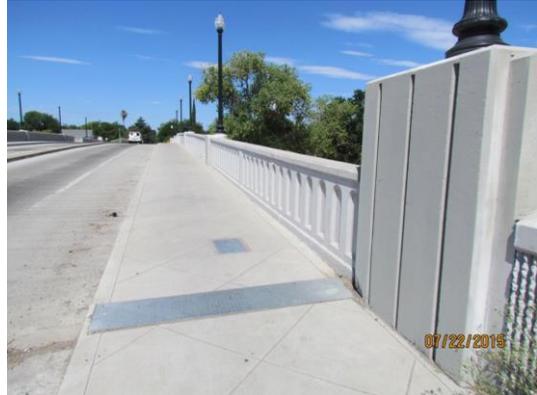
Photo 1 of 2 : ST_2015_NA0005_221_15_20150807_00016.jpg

LM Start	0.00	Rating **	A	Issue No.	15
LM End	0.00	Issue Type +	Ma	Location *	
Category	Structures & Concrete Lined Channels		GPS Latitude/Longitude		
			Start	End	
Item	Concrete Surfaces		38.611365 °	38.611365 °	
			-121.466557 °	-121.466557 °	
DWR ID	DWR_NA0005_221_t_2012_15				
Action/Comments					
Inspector Comments: The concrete surface didn't have any spalling or cracking which would threaten the integrity of the bridge.

View of the flood wall.

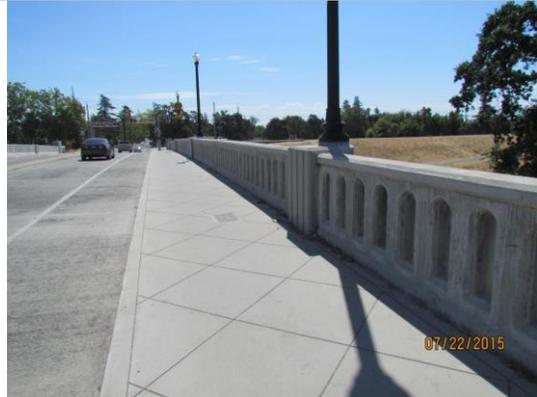
Photo 2 of 2 : ST_2015_NA0005_221_15_20150807_00017.jpg

View of the flood wall.

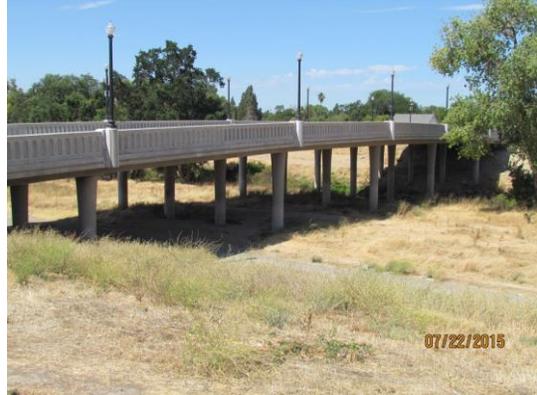
Photo 1 of 1 : ST_2015_NA0005_221_17_20150807_00018.jpg

LM Start	0.00	Rating **	A	Issue No.	17
LM End	0.00	Issue Type +	Ma	Location *	
Category	Structures & Concrete Lined Channels		GPS Latitude/Longitude		
			Start	End	
Item	Concrete Foundations		38.611365 °	38.611365 °	
			-121.466557 °	-121.466557 °	
DWR ID	DWR_NA0005_221_t_2012_17				
Action/Comments					
Inspector Comments: No sign of scouring or erosion was visible at the footings of the structure.

View below the bridge.

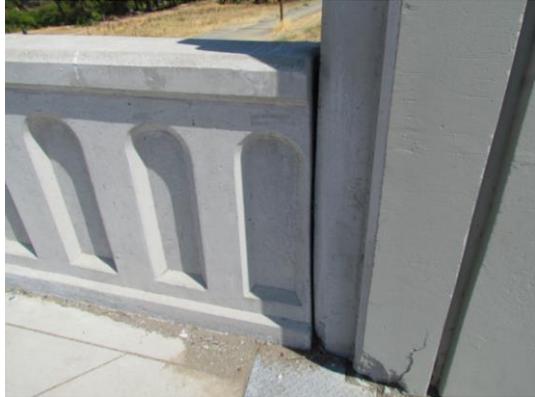
Photo 1 of 3 : ST_2015_NA0005_221_22_20150710_00009.jpg

LM Start	0.00	Rating **	A	Issue No.	22
LM End	0.00	Issue Type +	Ma	Location *	
Category	Structures & Concrete Lined Channels		GPS Latitude/Longitude		
			Start	End	
Item	Monolith Joints		38.611365 °	38.611365 °	
			-121.466557 °	-121.466557 °	
DWR ID	DWR_NA0005_221_t_2012_22				
Action/Comments					
Inspector Comments: The monolithic joint material was in good condition on the flood walls.

View of the flood walls with monolith joints.

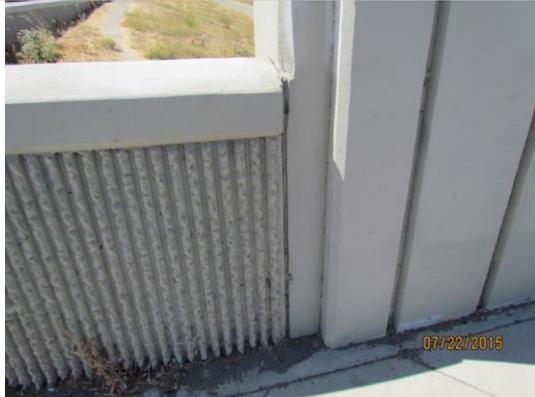
Photo 2 of 3 : ST_2015_NA0005_221_22_20150807_00019.jpg

View of the flood walls with monolith joints.

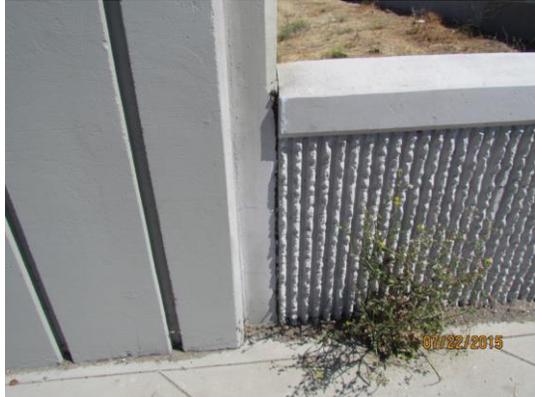
Photo 3 of 3 : ST_2015_NA0005_221_22_20150807_00020.jpg

View of the flood walls with monolith joints.

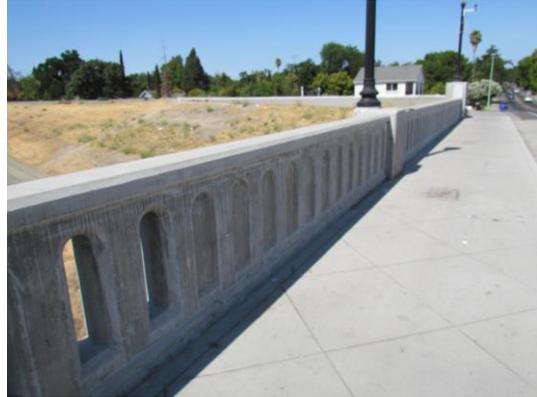
Photo 1 of 1 : ST_2015_NA0005_221_23_20150710_00011.jpg

LM Start	0.00	Rating **	A	Issue No.	23
LM End	0.00	Issue Type +	Ma	Location *	
Category	Structures & Concrete Lined Channels		GPS Latitude/Longitude		
			Start	End	
Item	Safety		38.611365 °	38.611365 °	
			-121.466557 °	-121.466557 °	
DWR ID	DWR_NA0005_221_t_2012_23				
Action/Comments					
Inspector Comments: The walls around the structure provide adequate protection against fall hazards.

View of the flood walls which also provides protection against fall hazards.

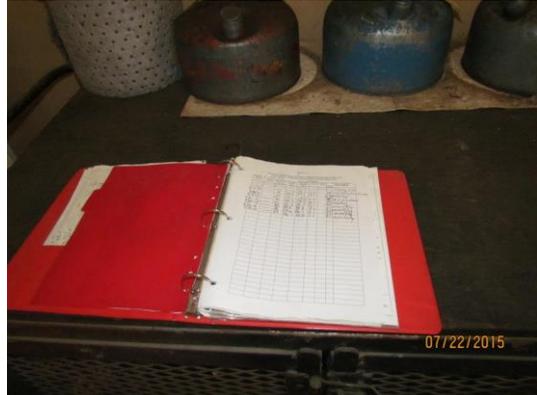
Photo 1 of 1 : ST_2015_NA0005_16_1_20150807_00021.jpg

LM Start	0.00	Rating **	A	Issue No.	1
LM End	0.00	Issue Type +	Ma	Location *	
Category	Pump Stations		GPS Latitude/Longitude		
			Start	End	
Item	Operating Log		38.640967 °	38.640967 °	
			-121.471106 °	-121.471106 °	
DWR ID	DWR_NA0005_16_t_2012_1				
Action/Comments					
Inspector Comments: The operation log was maintained up to date and it was present inside the pump station.

View of the maintenance log in the pumping plant.

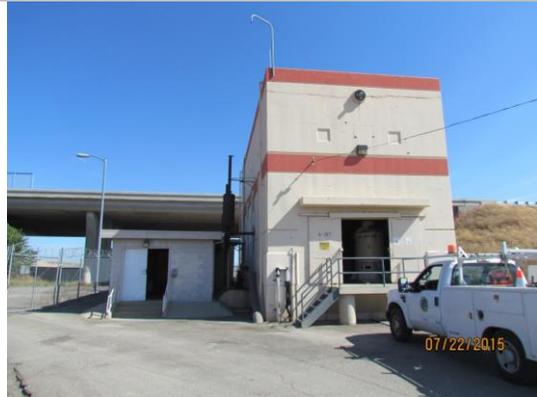
Photo 1 of 2 : ST_2015_NA0005_16_3_20150807_00022.jpg

LM Start	0.00	Rating **	A	Issue No.	3
LM End	0.00	Issue Type +	Ma	Location *	
Category	Pump Stations		GPS Latitude/Longitude		
			Start	End	
Item	Plant Building		38.640967 °	38.640967 °	
			-121.471106 °	-121.471106 °	
DWR ID	DWR_NA0005_16_t_2012_3				
Action/Comments					
Inspector Comments: The plant building was in good condition without any visible cracks or structural damage.

View of the pumping plant and the control room.

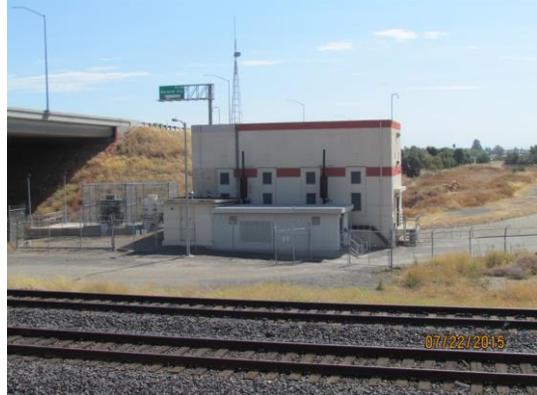
Photo 2 of 2 : ST_2015_NA0005_16_3_20150807_00023.jpg

LM Start	0.00	Rating **	A	Issue No.	3 (cont)
LM End	0.00	Issue Type +	Ma	Location *	
Category	Pump Stations		GPS Latitude/Longitude		
			Start	End	
Item	Plant Building		38.640967 °	38.640967 °	
			-121.471106 °	-121.471106 °	
DWR ID	DWR_NA0005_16_t_2012_3				
Action/Comments					
Inspector Comments: The plant building was in good condition without any visible cracks or structural damage.

View of the pumping plant looking east.

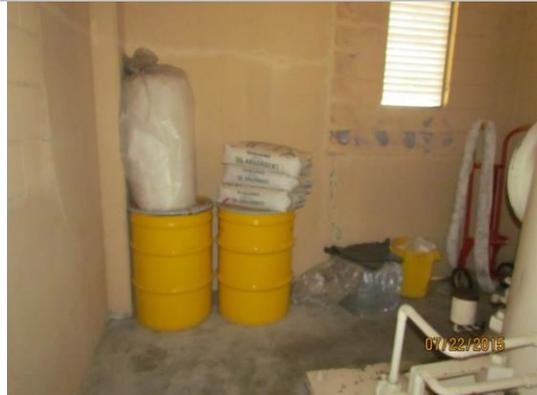
Photo 1 of 3 : ST_2015_NA0005_16_5_20150807_00024.jpg

Safety material for oil spills was present inside the pumping plant.

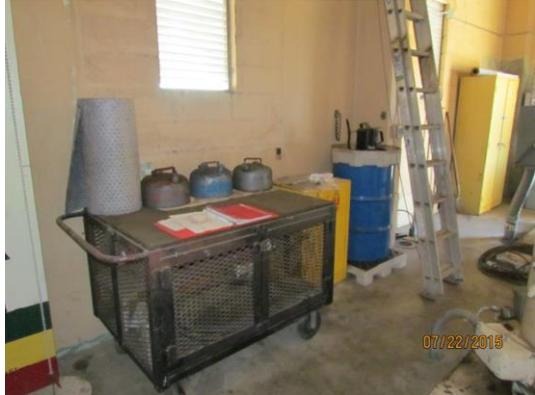
Photo 2 of 3 : ST_2015_NA0005_16_5_20150807_00025.jpg

Various safety material were present inside the pumping plant.

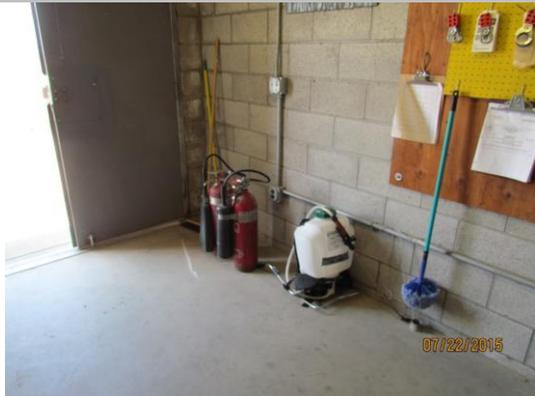
Photo 3 of 3 : ST_2015_NA0005_16_5_20150807_00026.jpg

View of the fire extinguishers inside the pumping plant.

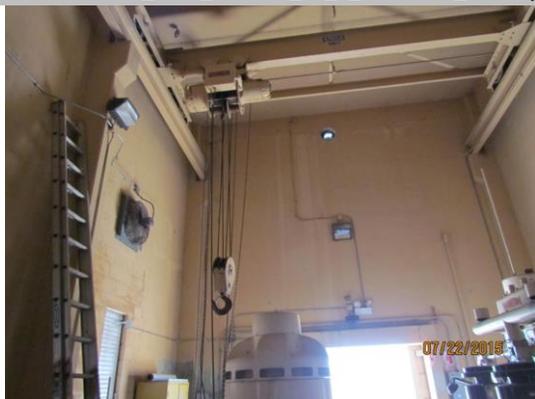
Photo 1 of 1 : ST_2015_NA0005_16_6_20150807_00027.jpg

LM Start	0.00	Rating **	A	Issue No.	6
LM End	0.00	Issue Type +	Ma	Location *	
Category	Pump Stations			GPS Latitude/Longitude	
				Start	End
Item	Cranes			38.640967 °	38.640967 °
				-121.471106 °	-121.471106 °
DWR ID	DWR_NA0005_16_t_2012_6				
Action/Comments					
Inspector Comments: The crane appeared to be in good working condition inside the pumping plant.

View of the crane inside the pumping plant.

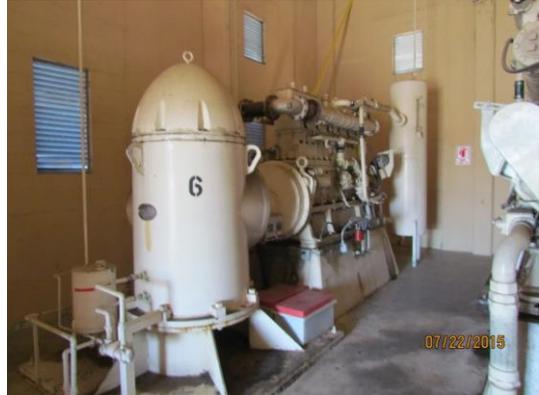
Photo 1 of 4 : ST_2015_NA0005_16_7_20150807_00028.jpg

LM Start	0.00	Rating **	A	Issue No.	7
LM End	0.00	Issue Type +	Ma	Location *	
Category	Pump Stations		GPS Latitude/Longitude		
			Start	End	
Item	Pumps		38.640967 °	38.640967 °	
			-121.471106 °	-121.471106 °	
DWR ID	DWR_NA0005_16_t_2012_7				
Action/Comments					
Inspector Comments: The pumps didn't show any signs of corrosion and all the pumps appeared to be properly maintained and periodically tested.

View of one of the propane powered pumps inside the plant.

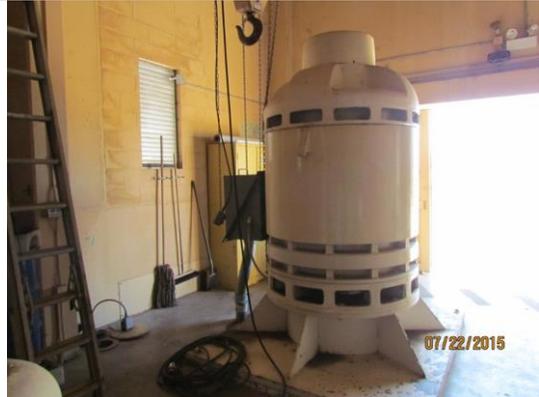
Photo 2 of 4 : ST_2015_NA0005_16_7_20150807_00029.jpg

View of another propane powered pumps inside the plant.

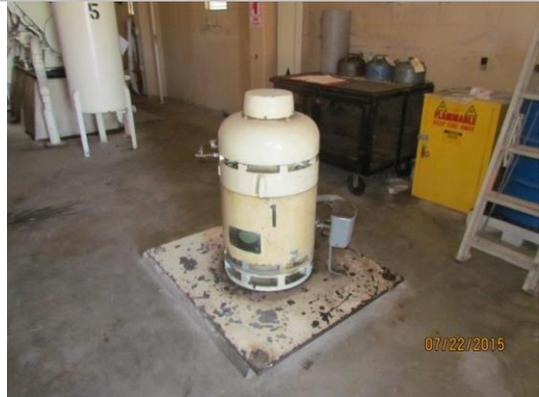
Photo 3 of 4 : ST_2015_NA0005_16_7_20150807_00030.jpg

View of one of the electric pumps inside the plant.

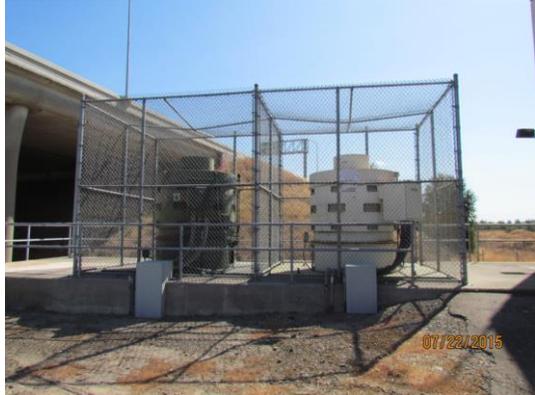
Photo 4 of 4 : ST_2015_NA0005_16_7_20150807_00031.jpg

LM Start	0.00	Rating **	A	Issue No.	7 (cont)
LM End	0.00	Issue Type +	Ma	Location *	
Category	Pump Stations		GPS Latitude/Longitude		
			Start	End	
Item	Pumps		38.640967 °	38.640967 °	
			-121.471106 °	-121.471106 °	
DWR ID	DWR_NA0005_16_t_2012_7				
Action/Comments					
Inspector Comments: The pumps didn't show any signs of corrosion and all the pumps appeared to be properly maintained and periodically tested.

View of the electric pumps outside of the pumping plant.

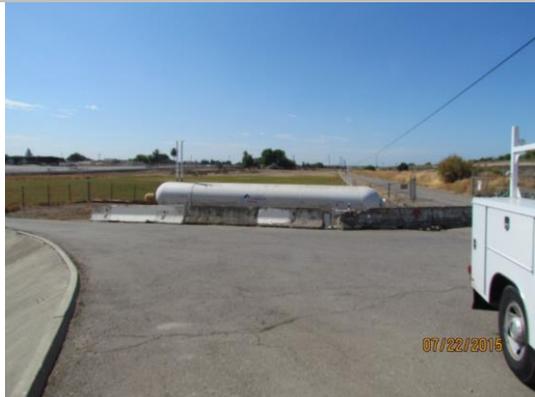
Photo 1 of 2 : ST_2015_NA0005_16_8_20150807_00032.jpg

LM Start	0.00	Rating **	A	Issue No.	8
LM End	0.00	Issue Type +	Ma	Location *	
Category	Pump Stations		GPS Latitude/Longitude		
			Start	End	
Item	Power		38.640967 °	38.640967 °	
			-121.471106 °	-121.471106 °	
DWR ID	DWR_NA0005_16_t_2012_8				
Action/Comments					
Inspector Comments: The power sources appeared to be safe and reliable and some pumps are able to operate using propane as a fuel source.

View of the propane tank outside the pumping plant.

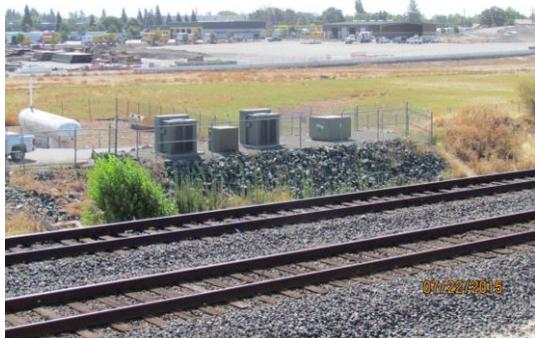
Photo 2 of 2 : ST_2015_NA0005_16_8_20150807_00033.jpg

View of the electrical boxes outside the pumping plant.

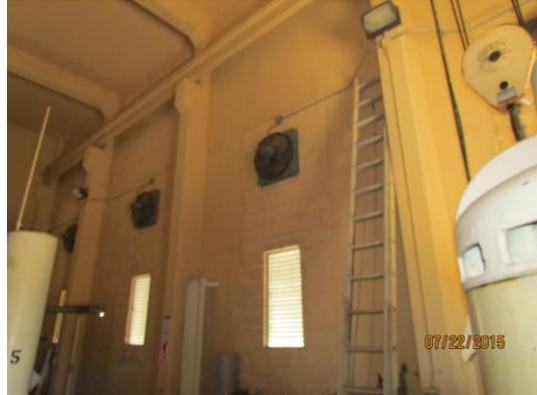
Photo 1 of 1 : ST_2015_NA0005_16_10_20150807_00034.jpg

View of the ventilation fan inside the plant.

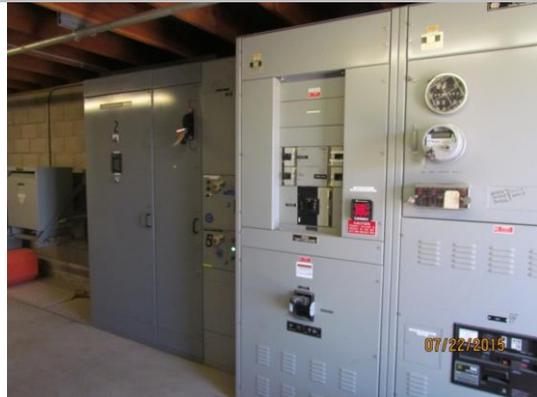
Photo 1 of 2 : ST_2015_NA0005_16_11_20150807_00035.jpg

LM Start	0.00	Rating **	A	Issue No.	11
LM End	0.00	Issue Type +	Ma	Location *	
Category	Pump Stations		GPS Latitude/Longitude		
			Start	End	
Item	Pump Control Systems		38.640967 °	38.640967 °	
			-121.471106 °	-121.471106 °	
DWR ID	DWR_NA0005_16_t_2012_11				
Action/Comments					
Inspector Comments: All the pump control systems appeared to be in a good condition.

View of the pump control systems in the pump control building.

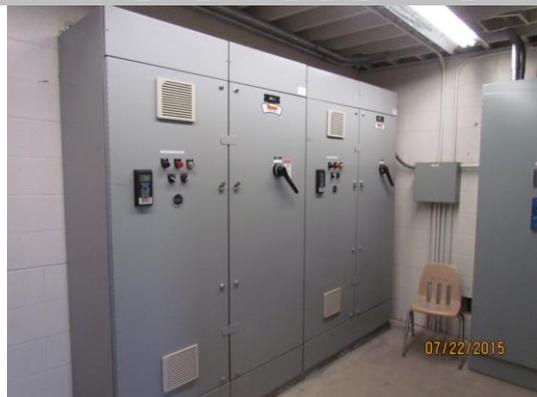
Photo 2 of 2 : ST_2015_NA0005_16_11_20150807_00036.jpg

View of the pump control systems inside the control building.

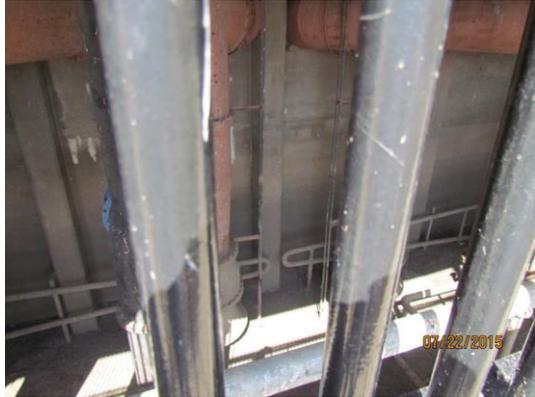
Photo 1 of 1 : ST_2015_NA0005_16_12_20150807_00037.jpg

View of the wet well.

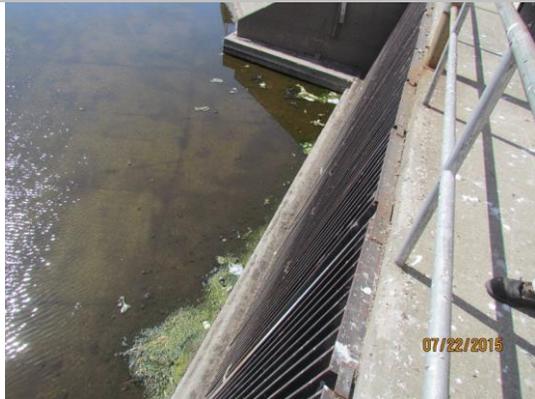
Photo 1 of 1 : ST_2015_NA0005_16_13_20150807_00038.jpg

LM Start	0.00	Rating **	A	Issue No.	13
LM End	0.00	Issue Type +	Ma	Location *	
Category	Pump Stations		GPS Latitude/Longitude		
			Start	End	
Item	Trash Racks		38.640967 °	38.640967 °	
			-121.471106 °	-121.471106 °	
DWR ID	DWR_NA0005_16_t_2012_13				
Action/Comments					
Inspector Comments: Trash rack appeared to be clean and clear of any debris.

View of the trash rack.

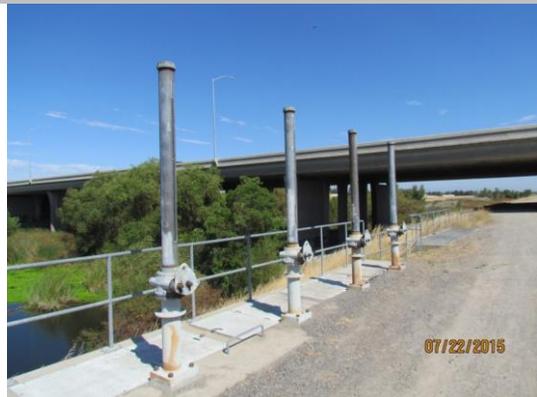
Photo 1 of 1 : ST_2015_NA0005_16_17_20150807_00039.jpg

LM Start	0.00	Rating **	A	Issue No.	17
LM End	0.00	Issue Type +	Ma	Location *	
Category	Pump Stations		GPS Latitude/Longitude		
			Start	End	
Item	Manual Gate Operators		38.640967 °	38.640967 °	
			-121.471106 °	-121.471106 °	
DWR ID	DWR_NA0005_16_t_2012_17				
Action/Comments					
Inspector Comments: The slide gate appeared to be in good working condition.

View of the slide gate operators.

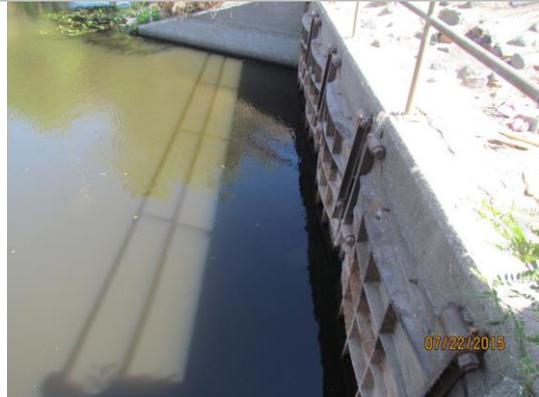
Photo 1 of 1 : ST_2015_NA0005_16_19_20150807_00040.jpg

LM Start	0.00	Rating **	A	Issue No.	19
LM End	0.00	Issue Type +	Ma	Location *	
Category	Pump Stations		GPS Latitude/Longitude		
			Start	End	
Item	Flap Gates		38.640967 °	38.640967 °	
			-121.471106 °	-121.471106 °	
DWR ID	DWR_NA0005_16_t_2012_19				
Action/Comments					
Inspector Comments: The flap gates appeared to be in good condition and free of any obstructions.

View of the flap gates.

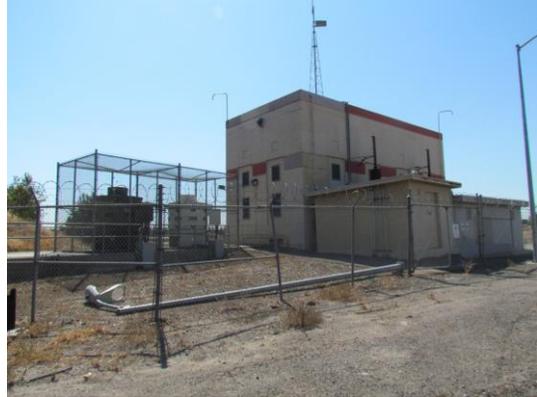
Photo 1 of 1 : ST_2015_NA0005_16_21_20150710_00019.jpg

LM Start	0.00	Rating **	A	Issue No.	21
LM End	0.00	Issue Type +	Ma	Location *	
Category	Pump Stations		GPS Latitude/Longitude		
			Start	End	
Item	Security Fencing		38.640967 °	38.640967 °	
			-121.471106 °	-121.471106 °	
DWR ID	DWR_NA0005_16_t_2012_21				
Action/Comments					
Inspector Comments: The security fencing around the structures appeared to be in good condition and should provide protection against unauthorized access.

View of the security fencing around the structure.

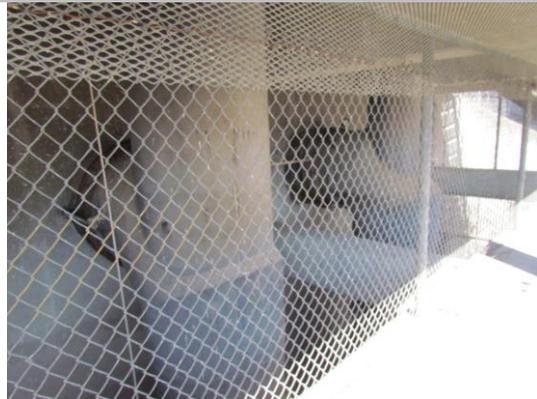
Photo 1 of 1 : ST_2015_NA0005_16_22_20150710_00020.jpg

LM Start	0.00	Rating **	A	Issue No.	22
LM End	0.00	Issue Type +	Ma	Location *	
Category	Pump Stations		GPS Latitude/Longitude		
			Start	End	
Item	Intake and Discharge Pipes		38.640967 °	38.640967 °	
			-121.471106 °	-121.471106 °	
DWR ID	DWR_NA0005_16_t_2012_22				
Action/Comments					
Inspector Comments: The intake pipes appeared to be in good condition.

View of the intake pipes.
