**Flood Control Project Maintenance  
Levee Inspections**

**Fall 2014 Levee Maintenance Deficiency Summary Report  
Overall LMA & Unit Ratings, including USACE Erosion Survey**

**Eastern Honcut Creek**

**Levee Inspection Report By Mile - Fall 2014**

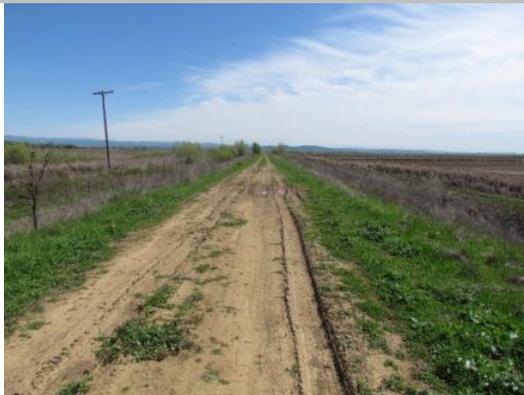
Photo 1 of 2 : FA\_2014\_NA0006\_252\_1\_20141013\_00001.jpg

LM Start	<b>0.01</b>	Rating **	<b>U</b>	Issue No.	<b>1</b>
LM End	<b>1.50</b>	Issue Type +	<b>Ma</b>	Location *	<b>LS</b>
Category	Earthen Levee		GPS Latitude/Longitude		
			Start	End	
Item	Vegetation		39.298521 °	39.295267 °	
			-121.569497 °	-121.546559 °	
DWR ID	DWR_NA0006_01_s_2012_1				
Action/Comments					
Remove the wild growth other than native grasses from the levee slopes.

This photo was taken from the levee crown facing east looking at typical vegetation on both the landward and waterward levee slopes. Spring 2014.

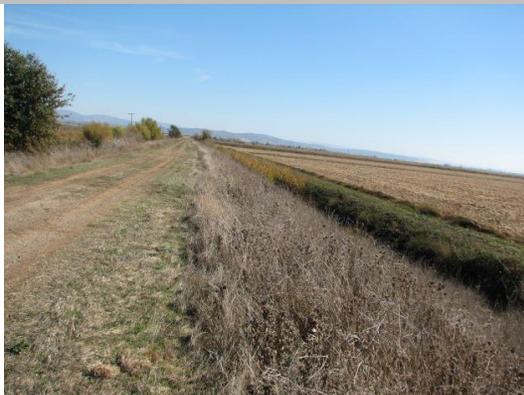
Photo 2 of 2 : FA\_2014\_NA0006\_252\_1\_20141013\_00002.jpg

This photo shows the landside of the levee at levee mile 0.10.

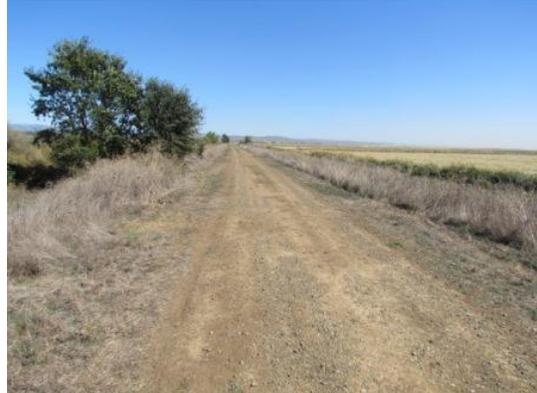
Photo 1 of 1 : FA\_2014\_NA0006\_252\_3\_20141013\_00003.jpg

LM Start	<b>0.05</b>	Rating **	<b>U</b>	Issue No.	<b>3</b>
LM End	<b>1.50</b>	Issue Type +	<b>Ma</b>	Location *	<b>WS</b>
Category	Earthen Levee		GPS Latitude/Longitude		
			Start	End	
Item	Vegetation		39.298849 °	39.295267 °	
			-121.569419 °	-121.546560 °	
DWR ID	DWR_NA0006_01_s_2012_3				
Action/Comments					
Remove the wild growth other than native grasses from the levee slopes.

This photo was taken from the levee crown facing east looking at the vegetation on both the landward and waterward levee slopes.

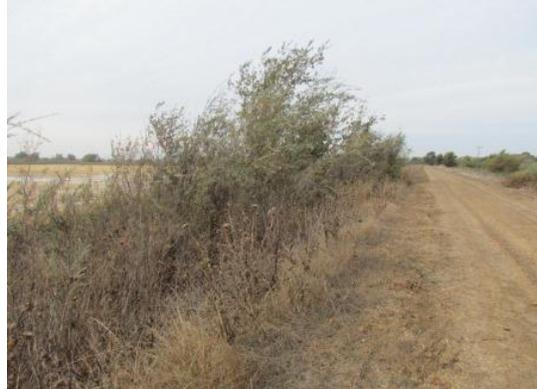
Photo 1 of 1 : FA\_2014\_NA0006\_252\_16\_20141017\_00012.jpg

LM Start	<b>0.24</b>	Rating **	U	Issue No.	<b>16</b>
LM End	<b>0.24</b>	Issue Type +	Ma	Location *	LS
Category	Earthen Levee		GPS Latitude/Longitude		
			Start	End	
Item	Trim / Thin Trees		39.298786 °	39.298786 °	
			-121.566159 °	-121.566159 °	
DWR ID	DWR_NA0006_01_f_2014_16				
Action/Comments					
Thin trees to allow visibility of the ground and room to flood fight. Inspector Comments: Trees should be trimmed up or removed to maintain visibility of landward levee slope.

This photo was taken from the crown facing west looking down the landward levee slope at trees that either need to be trimmed up or removed to provide slope visibility. Fall 2014.

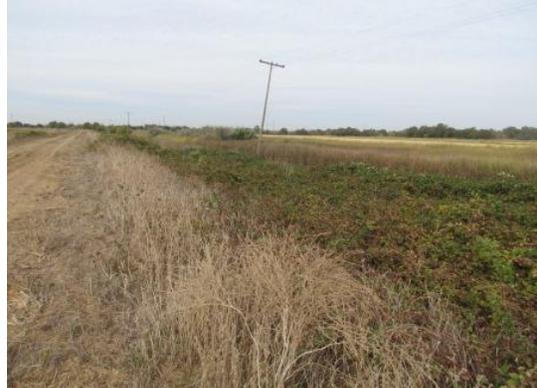
Photo 1 of 1 : FA\_2014\_NA0006\_252\_15\_20141017\_00011.jpg

LM Start	<b>0.46</b>	Rating **	U	Issue No.	<b>15</b>
LM End	<b>0.46</b>	Issue Type +	Ma	Location *	WS
Category	Earthen Levee		GPS Latitude/Longitude		
			Start	End	
Item	Vegetation		39.298283 °	39.298283 °	
			-121.562021 °	-121.562021 °	
DWR ID	DWR_NA0006_01_f_2014_15				
Action/Comments					
Remove the wild growth other than native grasses from the levee slopes. Inspector Comments: Berry bushes on waterward levee slope need to be trimmed back.

This photo was taken from the crown facing west looking down the waterward levee slope at berry bushes needing removal. Fall 2014.

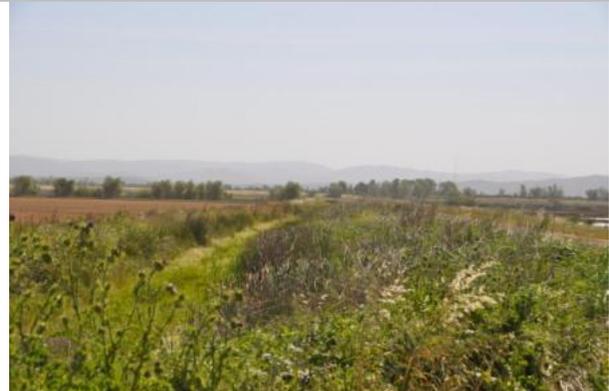
Photo 1 of 1 : FA\_2014\_NA0006\_252\_5\_20141013\_00004.jpg

LM Start	<b>0.66</b>	Rating **	M	Issue No.	<b>5</b>
LM End	<b>1.19</b>	Issue Type +	En	Location *	WS
Category	Earthen Levee		GPS Latitude/Longitude		
			Start	End	
Item	Encroachments		39.297661 °	39.295134 °	
			-121.558334 °	-121.551805 °	
DWR ID	DWR_NA0006_01_s_2012_5				
Action/Comments					
Ditch

Toe ditch parallel to levee @ w/s toe. Heavy vegetation in ditch.

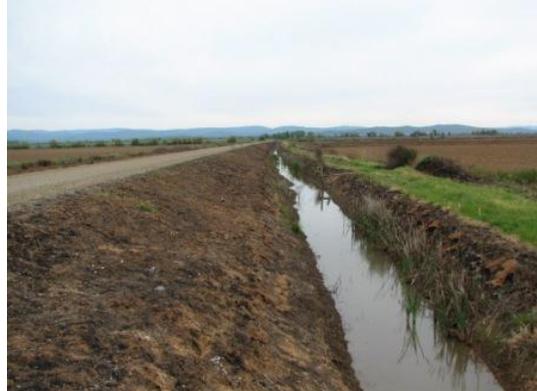
Photo 1 of 1 : FA\_2014\_NA0006\_252\_8\_20141013\_00005.jpg

LM Start	<b>0.68</b>	Rating **	M	Issue No.	<b>8</b>
LM End	<b>1.46</b>	Issue Type +	En	Location *	LS
Category	Earthen Levee			GPS Latitude/Longitude	
				Start	End
Item	Encroachments			39.297480 °	39.295261 °
				-121.558325 °	-121.546759 °
DWR ID	DWR_NA0006_01_s_2012_8				
Action/Comments					
Ditch

Levee mile 0.85, this photo is looking upstream at a ditch on the landside toe.
