**Flood Control Project Maintenance
Levee Inspections**

**Fall 2015 Levee Maintenance Deficiency Summary Report
Overall LMA & Unit Ratings, including USACE Erosion Survey**

Eastern Honcut Creek

Levee Inspection Report By Mile - Fall 2015

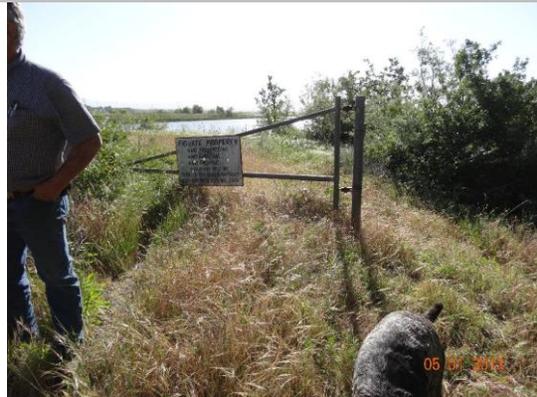
Photo 2 of 3 : UCIP_FA_2015_1060.jpg

View of crown looking east.

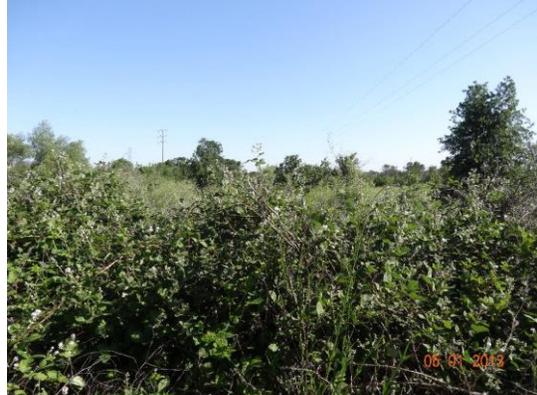
Photo 3 of 3 : UCIP_FA_2015_1061.jpg

Dense vegetation on waterward side obstructing inspection.

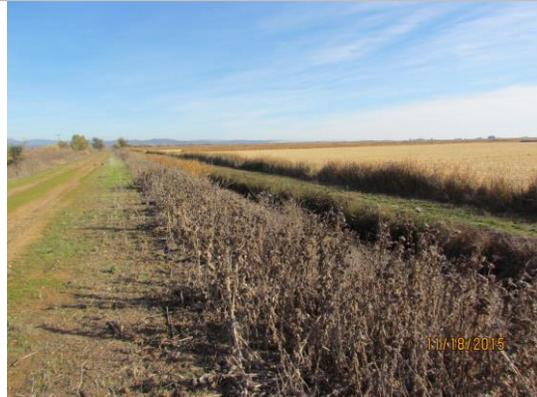
Photo 1 of 1 : FA_2015_NA0006_252_13_20151120_00015.jpg

LM Start	0.02	Rating **	U	Issue No.	13
LM End	0.57	Issue Type +	Ma	Location *	LS
Category	Earthen Levee			GPS Latitude/Longitude	
				Start	End
Item	Vegetation			39.298502 °	39.297998 °
				-121.569482 °	-121.559940 °
DWR ID	DWR_NA0006_01_f_2015_13				
Action/Comments					
Remove the wild growth other than native grasses from the levee slopes. Inspector Comments: Remove the vegetation from the landside slope.

View of the vegetation on the landside slope.

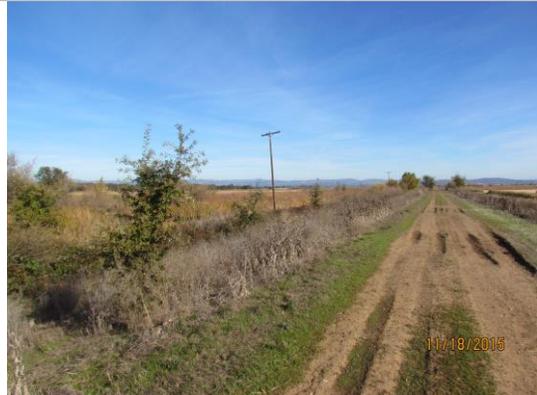
Photo 1 of 1 : FA_2015_NA0006_252_14_20151120_00016.jpg

LM Start	0.02	Rating **	U	Issue No.	14
LM End	0.57	Issue Type +	Ma	Location *	WS
Category	Earthen Levee			GPS Latitude/Longitude	
				Start	End
Item	Vegetation			39.298502 °	39.297998 °
				-121.569482 °	-121.559940 °
DWR ID	DWR_NA0006_01_f_2015_14				
Action/Comments					
Remove the wild growth other than native grasses from the levee slopes. Inspector Comments: remove the vegetation from the waterside slope.

View of the vegetation on the waterside slope.

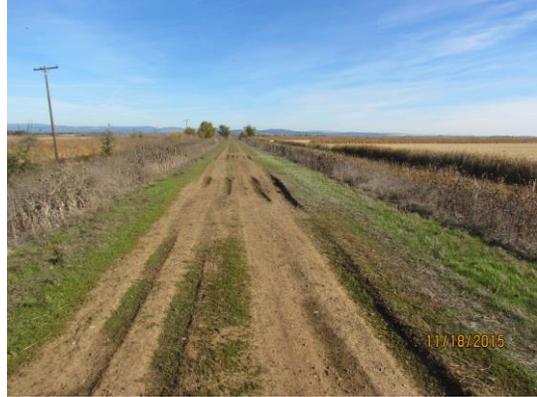
Photo 1 of 1 : FA_2015_NA0006_252_21_20151120_00017.jpg

LM Start	0.07	Rating **	M	Issue No.	21
LM End	0.66	Issue Type +	Ma	Location *	CR
Category	Earthen Levee			GPS Latitude/Longitude	
				Start	End
Item	Crown Surface / Depressions / Rutting			39.299158 °	39.297595 °
				-121.569024 °	-121.558310 °
DWR ID	DWR_NA0006_01_s_2015_21				
Action/Comments					
Repair depressions or ruts in the crown or slope. Inspector Comments: Place appropriate gravel on the crown roadway to make it a all weather road.

View of the ruts on the crown roadway.

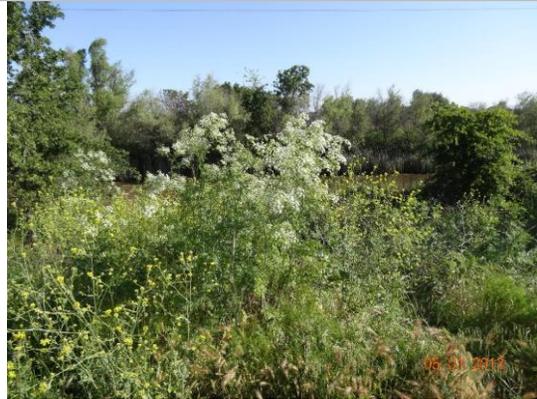
Photo 1 of 3 : UCIP_FA_2015_1062.jpg

LM Start	0.09	Rating **	M	Issue No.	23
LM End	0.09	Issue Type +	En	Location *	CR
Category	Supplemental			GPS Latitude/Longitude	
				Start	End
Item	DWR UCIP Field Study			39.299106 °	39.299106 °
				-121.568749 °	-121.568749 °
DWR ID					
Action/Comments					
Inspector Comments: FS_ID:14732 DS_ID:19168 EP_NO: N/A FS_HLM: 0.0911 Repair Type: Non-Urgent Crossing Status: Found UCIP Comments: Dense vegetation on waterward side and landward side obstructs inspection. Need to clear vegetation on slopes to conduct proper crossing evaluation. FIELD_STRUCT_DESC: 24-inch corrugated metal pipe through the levee 10 feet below the crown. Flap gate on the waterward end. Originally included in the O&M manual, 1953. FS Date: 05/01/2013

Dense vegetation obstructing waterward slope.

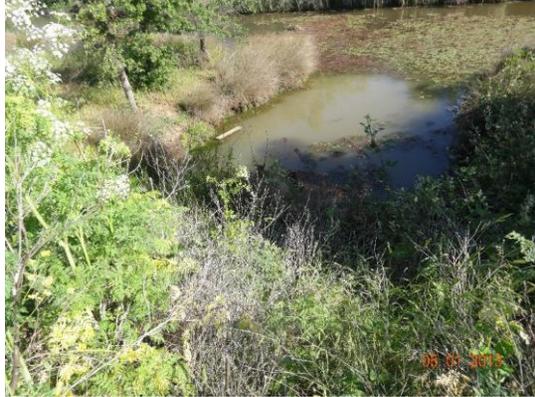
Photo 2 of 3 : UCIP_FA_2015_1063.jpg

Overview of waterward side (outlet).

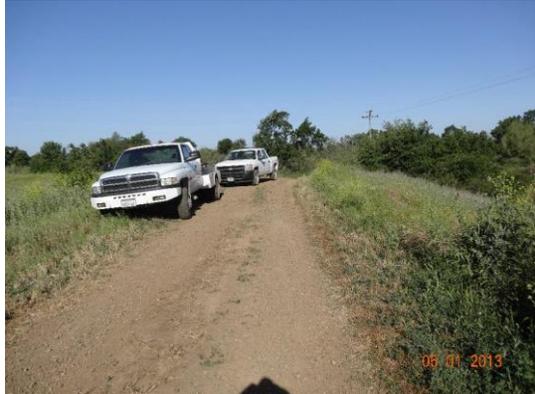
Photo 3 of 3 : UCIP_FA_2015_1064.jpg

Overview of levee crown at crossing looking upstream.

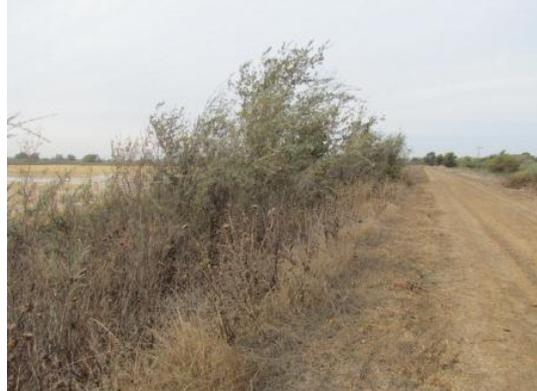
Photo 1 of 1 : FA_2015_NA0006_252_16_20151109_00006.jpg

LM Start	0.22	Rating **	U	Issue No.	16
LM End	0.22	Issue Type +	Ma	Location *	LS
Category	Earthen Levee		GPS Latitude/Longitude		
			Start	End	
Item	Trim / Thin Trees		39.298827 °	39.298827 °	
			-121.566401 °	-121.566401 °	
DWR ID	DWR_NA0006_01_f_2014_16				
Action/Comments					
Thin trees to allow visibility of the ground and room to flood fight. Inspector Comments: Trees should be trimmed up or removed to maintain visibility of landward levee slope.

This photo was taken from the crown facing west looking down the landward levee slope at trees that either need to be trimmed up or removed to provide slope visibility. Fall 2014.

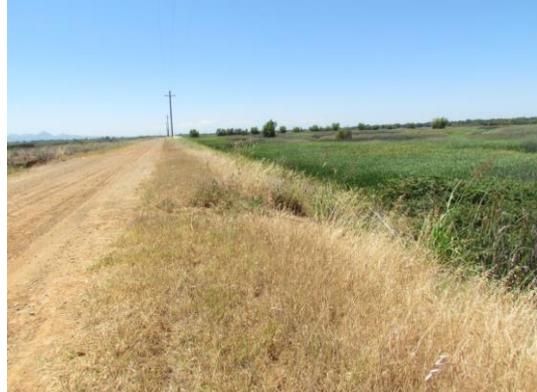
Photo 1 of 1 : FA_2015_NA0006_252_3_20151109_00002.jpg

LM Start	0.57	Rating **	M	Issue No.	3
LM End	1.46	Issue Type +	Ma	Location *	WS
Category	Earthen Levee		GPS Latitude/Longitude		
			Start	End	
Item	Vegetation		39.298019 °	39.295255 °	
			-121.559940 °	-121.546436 °	
DWR ID	DWR_NA0006_01_s_2012_3				
Action/Comments					
Remove the wild growth other than native grasses from the levee slopes.

View of the vegetaion on the waterside of the levee facing downstream.

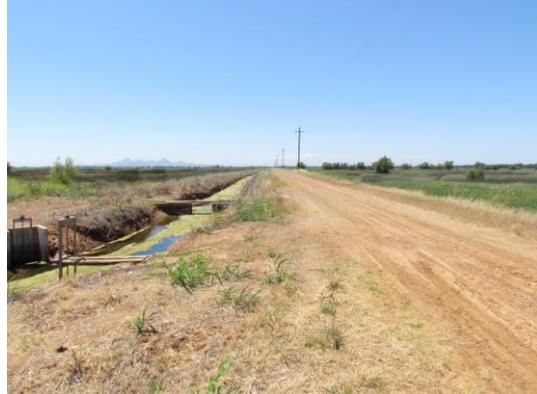
Photo 1 of 1 : FA_2015_NA0006_252_1_20151109_00001.jpg

LM Start	0.57	Rating **	M	Issue No.	1
LM End	1.46	Issue Type +	Ma	Location *	LS
Category	Earthen Levee		GPS Latitude/Longitude		
			Start	End	
Item	Vegetation		39.298018 °	39.295254 °	
			-121.559940 °	-121.546437 °	
DWR ID	DWR_NA0006_01_s_2012_1				
Action/Comments					
Remove the wild growth other than native grasses from the levee slopes.

View of the vegetation on the landside of the levee facing downstream.

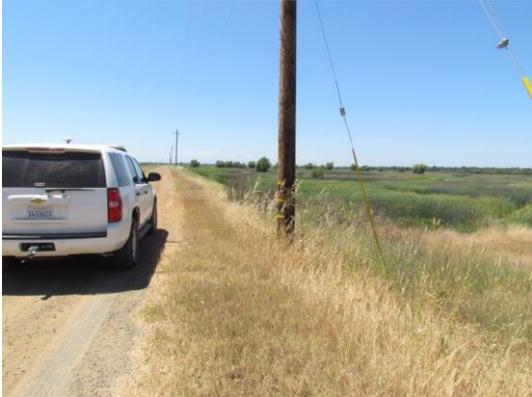
Photo 1 of 1 : FA_2015_NA0006_252_17_20151109_00007.jpg

LM Start	0.66	Rating **	M	Issue No.	17
LM End	1.45	Issue Type +	En	Location *	WS
Category	Earthen Levee		GPS Latitude/Longitude		
			Start	End	
Item	Encroachments		39.297629 °	39.295257 °	
			-121.558337 °	-121.546579 °	
DWR ID	DWR_NA0006_01_s_2015_17				
Action/Comments					
Pole

View of the pole on the waterside of the levee facing downstream.

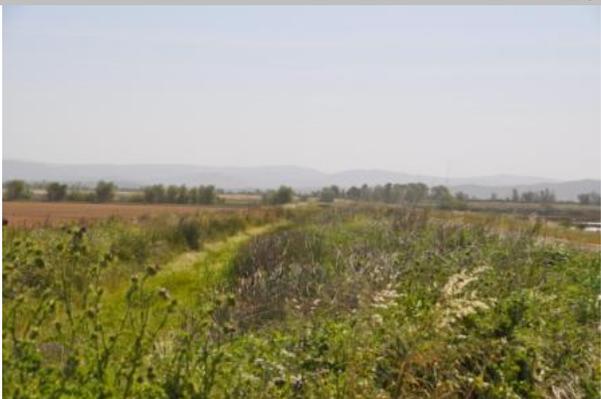
Photo 1 of 1 : FA_2015_NA0006_252_5_20151109_00003.jpg

LM Start	0.67	Rating **	M	Issue No.	5
LM End	1.17	Issue Type +	En	Location *	WS
Category	Earthen Levee		GPS Latitude/Longitude		
			Start	End	
Item	Encroachments		39.297472 °	39.295134 °	
			-121.558327 °	-121.551805 °	
DWR ID	DWR_NA0006_01_s_2012_5				
Action/Comments					
Ditch

Toe ditch parallel to levee @ w/s toe. Heavy vegetation in ditch.

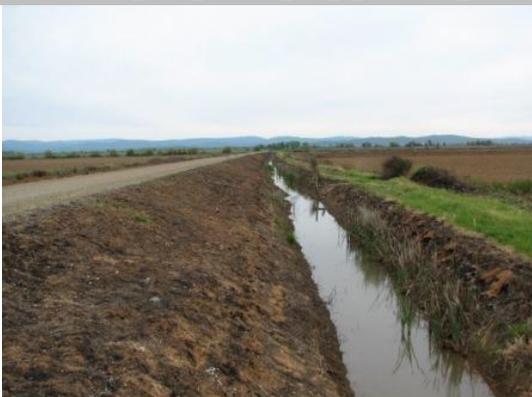
Photo 1 of 1 : FA_2015_NA0006_252_8_20151109_00004.jpg

LM Start	0.67	Rating **	M	Issue No.	8
LM End	1.44	Issue Type +	En	Location *	LS
Category	Earthen Levee		GPS Latitude/Longitude		
			Start	End	
Item	Encroachments		39.297472 °	39.295261 °	
			-121.558327 °	-121.546759 °	
DWR ID	DWR_NA0006_01_s_2012_8				
Action/Comments					
Ditch

Levee mile 0.85, this photo is looking upstream at a ditch on the landside toe.

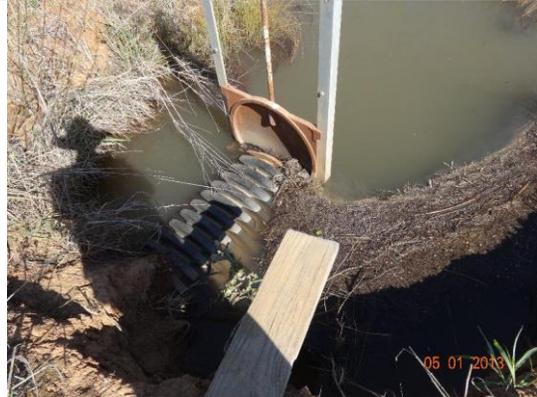
Photo 1 of 3 : UCIP_FA_2015_1077.jpg

Inspector Comments: FS_ID:14733
 DS_ID:19172
 EP_NO: 9610
 FS_HLM: 0.996
 Repair Type: Non-Urgent
 Crossing Status: Found
 UCIP Comments: Scouring occurring directly across pipe on access road. Need to determine permit authorizing updates to crossing. Crossing appears to be no more than 10 years old.
 FIELD_STRUCT_DESC: 1 of 2: 24-inch corrugated metal irrigation pipe through the levee 6 feet below the crown. Slide gates are installed on waterward end of pipe (Permit No. 9610, 1974). Originally included in the O&M manual, 1953.
 FS Date: 05/01/2013

Positive closure device on waterward side.

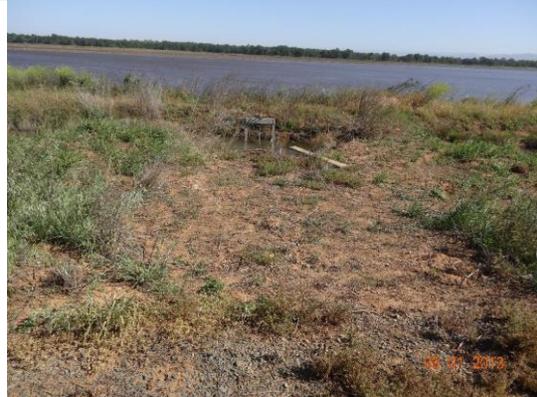
Photo 2 of 3 : UCIP_FA_2015_1133.jpg

View of waterward side.

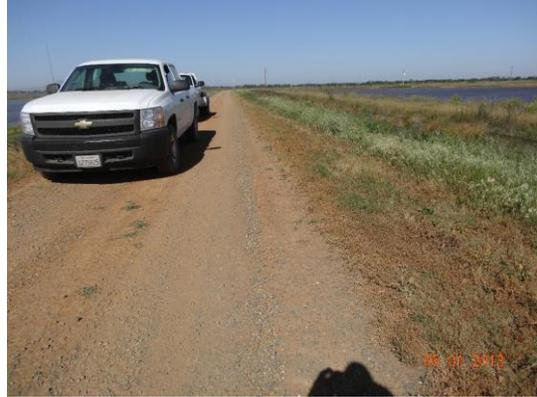
Photo 3 of 3 : UCIP_FA_2015_1134.jpg

Overview of levee crown looking upstream at crossing.

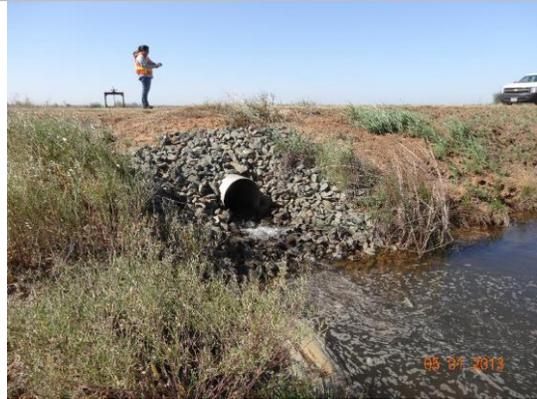
Photo 1 of 3 : UCIP_FA_2015_1135.jpg

LM Start	1.17	Rating **	M	Issue No.	25
LM End	1.17	Issue Type +	En	Location *	LS
Category	Supplemental			GPS Latitude/Longitude	
				Start	End
Item	DWR UCIP Field Study			39.295099 °	39.295099 °
				-121.551839 °	-121.551839 °
DWR ID					
Action/Comments					
Inspector Comments: FS_ID:14734 DS_ID:19174 EP_NO: N/A FS_HLM: 1.191 Repair Type: Non-Urgent Crossing Status: Found UCIP Comments: Recent repair will need to contact owner to follow-up. FIELD_STRUCT_DESC: 24-inch corrugated metal pipe through the level 10 feet below the crown. Flapgate on waterward side. FS Date: 05/01/2013

View of waterward side crossing looks fairly new.

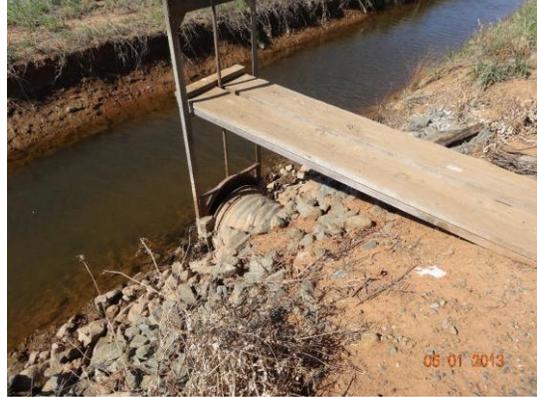
Photo 2 of 3 : UCIP_FA_2015_1136.jpg

View of landward side: positive closure device, walkway, and rip rap on slope.

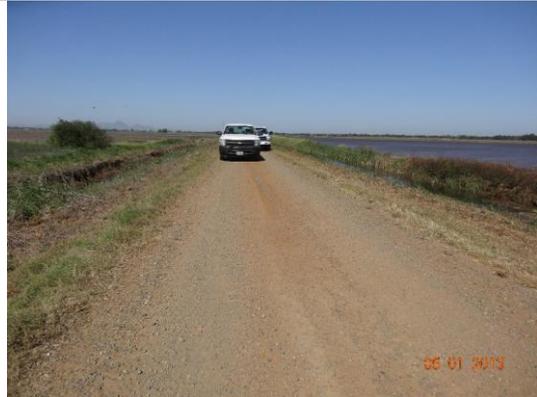
Photo 3 of 3 : UCIP_FA_2015_1137.jpg

Overview of levee crown looking upstream from crossing.

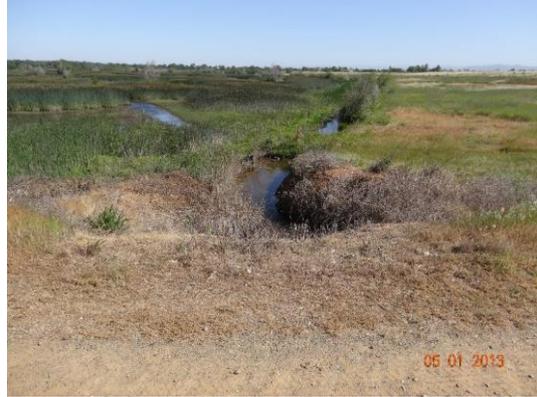
Photo 1 of 3 : UCIP_FA_2015_1138.jpg

LM Start	1.44	Rating **	M	Issue No.	26
LM End	1.44	Issue Type +	En	Location *	LS
Category	Supplemental			GPS Latitude/Longitude	
				Start	End
Item	DWR UCIP Field Study			39.295238 °	39.295238 °
				-121.546755 °	-121.546755 °
DWR ID					
Action/Comments					
Inspector Comments: FS_ID:14736 DS_ID:19169 EP_NO: N/A FS_HLM: 1.468 Repair Type: Non-Urgent Crossing Status: Found

View of waterward side.

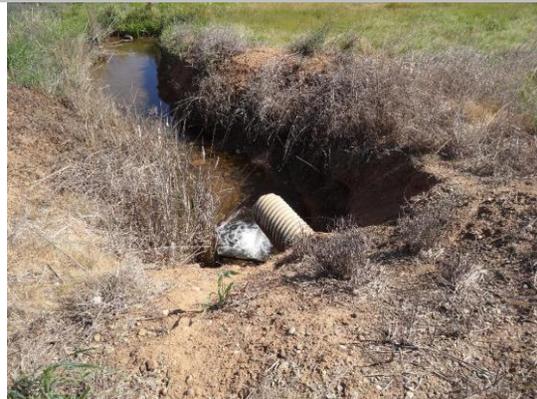
Photo 2 of 3 : UCIP_FA_2015_1139.jpg

Crossing visible on waterward side.

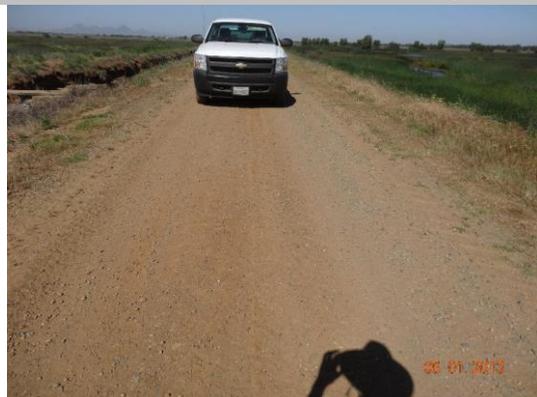
Photo 3 of 3 : UCIP_FA_2015_1140.jpg

View of levee crown looking upstream at crossing.
