**Flood Control Project Maintenance
Levee Inspections**
LMA District Cover Sheet
Spring 2014 Levee Inspection Results
Eastern Honcut Creek

Levee Inspection Report By Mile - Spring 2014

Eastern Honcut Creek

Waterway	Bank	Unit Miles	Inspection Start/End	Inspector
Unit No. 01 Van Tress	Left	1.50	03/21/2014 03/21/2014	Matthew Hoffman

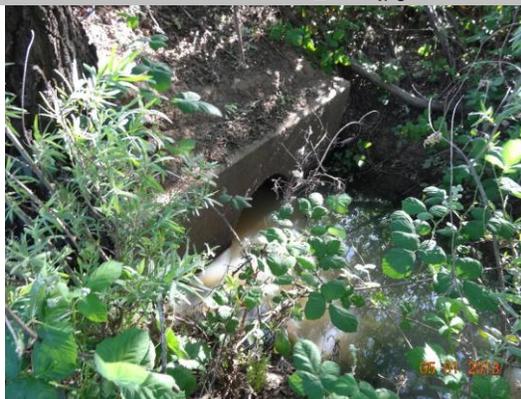
Photo 1 of 1 : UCIP_1107.jpg

LM Start	0.01	Rating **	M	Issue No.	2
LM End	0.01	Issue Type +	En	Location *	LS
Category	Supplemental			GPS Latitude/Longitude	
				Start	End
Item	DWR UCIP Field Study			39.298483 °	39.298483 °
				-121.569609 °	-121.569609 °
DWR ID	DWR_NA0006_01_s_2014_2				
Action/Comments					
Inspector Comments: FS_ID:14731 EP_NO: N/A Repair Type: Crossing Status: UCIP Comments: Dense vegetation on landward side obstructs inspection. Vegetation needs to be cleared to perform utility crossing inspection. FIELD_STRUCT_DESC: 24-inch corrugated metal drain pipe through the levee 12.0 feet below the crown. Flap gate on waterward end. Originally included the O&M manual, 1953. FS Date: 5/1/2013

View of concrete headwall on landward side (south portion of levee).

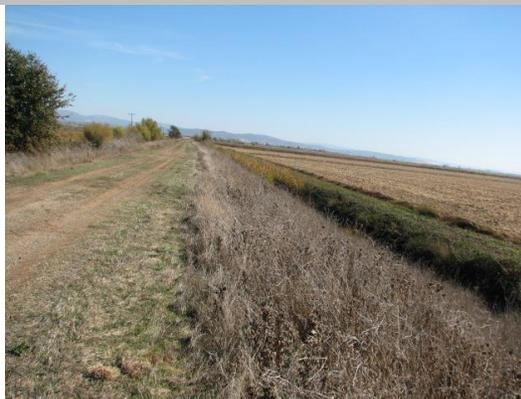
Photo 1 of 2 : mhoffman_s_20140306_124.jpg

This photo shows the landside of the levee at levee mile 0.10.

LM Start	0.01	Rating **	M	Issue No.	1
LM End	1.50	Issue Type +	Ma	Location *	LS
Category	Earthen Levee			GPS Latitude/Longitude	
				Start	End
Item	Vegetation			39.298521 °	39.295267 °
				-121.569497 °	-121.546559 °
DWR ID	DWR_NA0006_01_s_2012_1				
Action/Comments					
Remove the wild growth other than native grasses from the levee slopes.

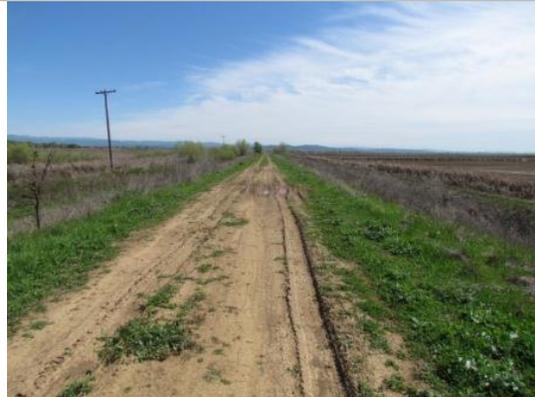
Photo 2 of 2 : mhoffman_s_20140324_272.jpg

This photo was taken from the levee crown facing east looking at typical vegetation on both the landward and waterward levee slopes. Spring 2014.

LM Start	0.01	Rating **	M	Issue No.	1 (cont)
LM End	1.50	Issue Type +	Ma	Location *	LS
Category	Earthen Levee			GPS Latitude/Longitude	
				Start	End
Item	Vegetation			39.298521 °	39.295267 °
				-121.569497 °	-121.546559 °
DWR ID	DWR_NA0006_01_s_2012_1				
Action/Comments					
Remove the wild growth other than native grasses from the levee slopes.

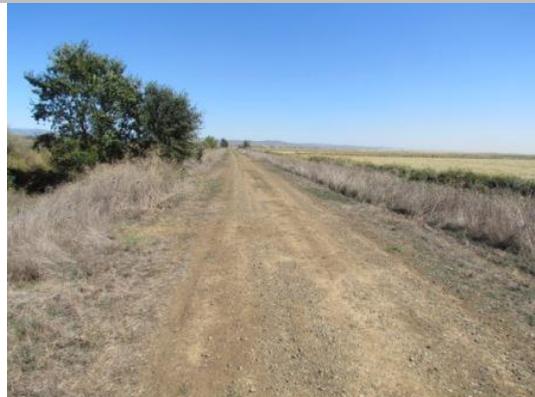
Photo 1 of 1 : mhoffman_s_20140306_125.jpg

This photo was taken from the levee crown facing east looking at the vegetation on both the landward and waterward levee slopes.

LM Start	0.05	Rating **	M	Issue No.	3
LM End	1.50	Issue Type +	Ma	Location *	WS
Category	Earthen Levee			GPS Latitude/Longitude	
				Start	End
Item	Vegetation			39.298849 °	39.295267 °
				-121.569419 °	-121.546560 °
DWR ID	DWR_NA0006_01_s_2012_3				
Action/Comments					
Remove the wild growth other than native grasses from the levee slopes.

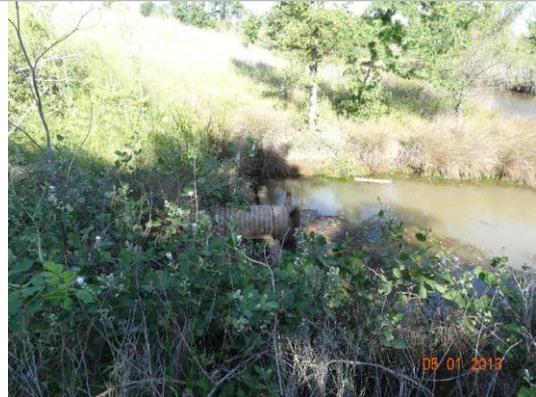
Photo 1 of 1 : UCIP_1111.jpg

LM Start	0.09	Rating **	M	Issue No.	4
LM End	0.09	Issue Type +	En	Location *	WS
Category	Supplemental			GPS Latitude/Longitude	
				Start	End
Item	DWR UCIP Field Study			39.299106 °	39.299106 °
				-121.568748 °	-121.568748 °
DWR ID	DWR_NA0006_01_s_2014_4				
Action/Comments					
Inspector Comments: FS_ID:14732 EP_NO: N/A Repair Type: Crossing Status: UCIP Comments: Dense vegetation on waterward side and landward side obstructs inspection. Need to clear vegetation on slopes to conduct proper crossing evaluation. FIELD_STRUCT_DESC: 24-inch corrugated metal pipe through the levee 10 feet below the crown. Flap gate on the waterward end. Originally included in the O&M manual, 1953. FS Date: 5/1/2013

View of crossing and flap gate on waterward side.

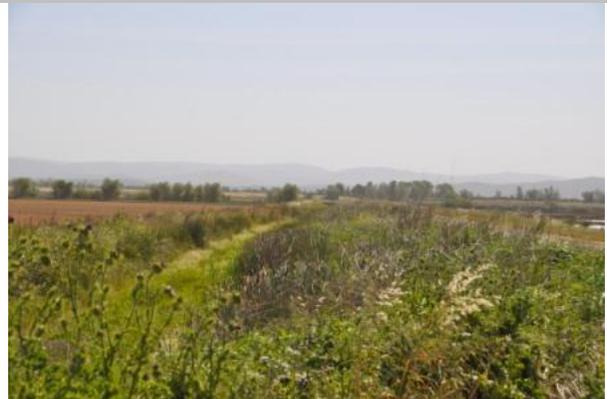
Photo 1 of 1 : mhoffman_s_20140306_126.jpg

LM Start	0.66	Rating **	M	Issue No.	5
LM End	1.19	Issue Type +	En	Location *	WS
Category	Earthen Levee			GPS Latitude/Longitude	
				Start	End
Item	Encroachments			39.297661 °	39.295134 °
				-121.558334 °	-121.551805 °
DWR ID	DWR_NA0006_01_s_2012_5				
Action/Comments					
Ditch

Toe ditch parallel to levee @ w/s toe. Heavy vegetation in ditch.

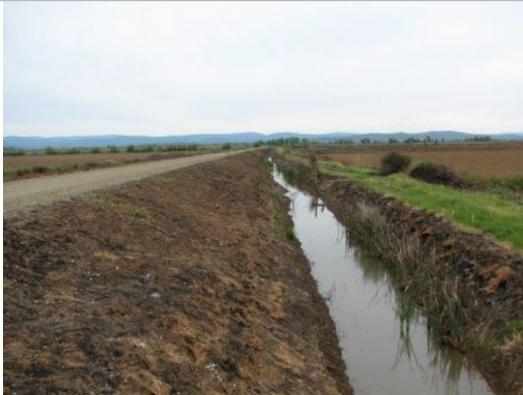
Photo 1 of 1 : mhoffman_s_20140306_127.jpg

LM Start	0.68	Rating **	M	Issue No.	8
LM End	1.46	Issue Type +	En	Location *	LS
Category	Earthen Levee			GPS Latitude/Longitude	
				Start	End
Item	Encroachments			39.297480 °	39.295261 °
				-121.558325 °	-121.546759 °
DWR ID	DWR_NA0006_01_s_2012_8				
Action/Comments					
Ditch

Levee mile 0.85, this photo is looking upstream at a ditch on the landside toe.

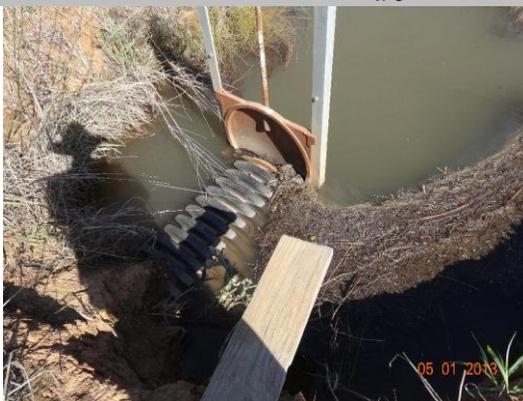
Photo 1 of 1 : UCIP_1119.jpg

LM Start	1.00	Rating **	M	Issue No.	7
LM End	1.00	Issue Type +	En	Location *	LS
Category	Supplemental			GPS Latitude/Longitude	
				Start	End
Item	DWR UCIP Field Study			39.295026 °	39.295026 °
				-121.555439 °	-121.555439 °
DWR ID	DWR_NA0006_01_s_2014_7				
Action/Comments					
Inspector Comments: FS_ID:14733 EP_NO: 9610 Repair Type: Crossing Status: UCIP Comments: Scouring occurring directly across pipe on access road. Need to determine permit authorizing updates to crossing. Crossing appears to be no more than 10 years old. FIELD_STRUCT_DESC: 1 of 2: 24-inch corrugated metal irrigation pipe through the levee 6 feet below the crown. Slide gates are installed on waterward end of pipe (Permit No. 9610, 1974). Originally included in the O&M manual, 1953. FS Date: 5/1/2013

Positive closure device on waterward side.

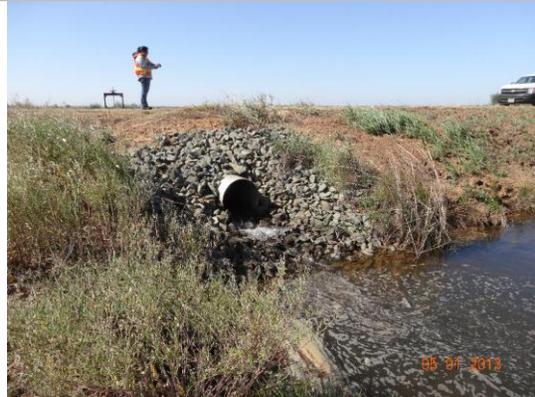
Photo 1 of 1 : UCIP_1122.jpg

LM Start	1.19	Rating **	M	Issue No.	13
LM End	1.19	Issue Type +	En	Location *	LS
Category	Supplemental			GPS Latitude/Longitude	
				Start	End
Item	DWR UCIP Field Study			39.295099 °	39.295099 °
				-121.551839 °	-121.551839 °
DWR ID	DWR_NA0006_01_s_2014_13				
Action/Comments					
Inspector Comments: FS_ID:14734 EP_NO: N/A Repair Type: Crossing Status: UCIP Comments: Recent repair will need to contact owner to follow-up. FIELD_STRUCT_DESC: 24-inch corrugated metal pipe through the level 10 feet below the crown. Flapgate on waterward side. FS Date: 5/1/2013

View of waterward side crossing looks fairly new.

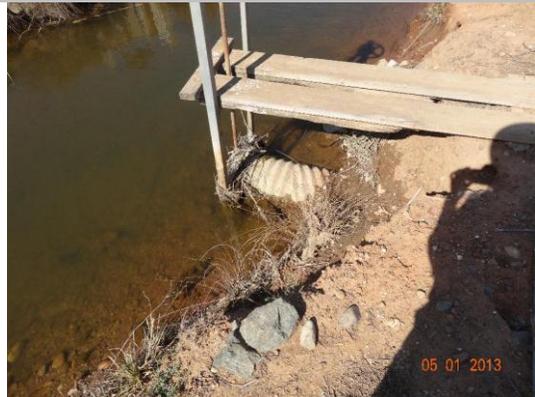
Photo 1 of 1 : UCIP_1125.jpg

LM Start	1.47	Rating **	M	Issue No.	14
LM End	1.47	Issue Type +	En	Location *	LS
Category	Supplemental			GPS Latitude/Longitude	
				Start	End
Item	DWR UCIP Field Study			39.295238 °	39.295238 °
				-121.546755 °	-121.546755 °
DWR ID	DWR_NA0006_01_s_2014_14				
Action/Comments					
Inspector Comments: FS_ID:14736 EP_NO: N/A Repair Type: Crossing Status: UCIP Comments: Need to determine permit authorizing work. FIELD_STRUCT_DESC: 18-inch corrugated metal pipe through the levee 8 feet below the crown. Slide gate on the landward end. Shot rock revetment on the landside near slide-gate. FS Date: 5/1/2013

Walkway and positive closure device located on landward side.
