**Flood Control Project Maintenance
Levee Inspections**
LMA District Cover Sheet
Spring 2016 Levee Inspection Results
Eastern Honcut Creek

Spring 2016 Levee Inspection Results

Eastern Honcut Creek

Waterway	Bank	Unit Miles
Unit No. 01 Van Tress	Left	1.46

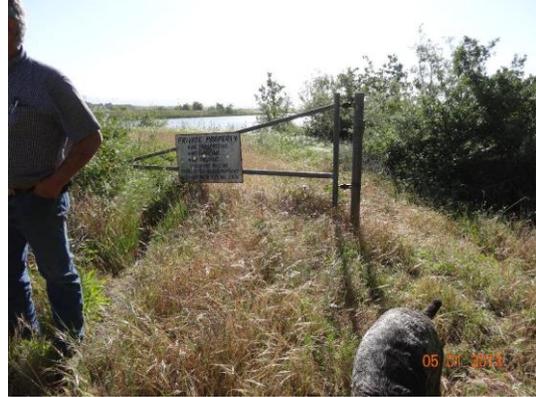
Photo 1 of 2 : UCIP_SP_2016_14731_24228.jpg

LM Start	0.01	Rating **	M	Issue No.	22
LM End	0.01	Issue Type +	En	Location *	CR
Category	Supplemental		GPS Latitude/Longitude		
			Start	End	
Item	DWR UCIP Field Study		39.298484 °	39.298484 °	
			-121.569610 °	-121.569610 °	
DWR ID					
Comment Code					
Inspector Comment					
FS_ID:14731 DS_ID:19167 EP_NO: N/A Repair Type: Non-Urgent Crossing Status: Found UCIP Comments: Dense vegetation on landward side obstructs inspection. Vegetation needs to be cleared to perform utility crossing inspection. FIELD_STRUCT_DESC: 24-inch corrugated metal drain pipe through the levee 12.0 feet below the crown. Flap gate on waterward end. Originally included the O&M manual, 1953. FS Date: 5/1/2013

View of crown looking east.

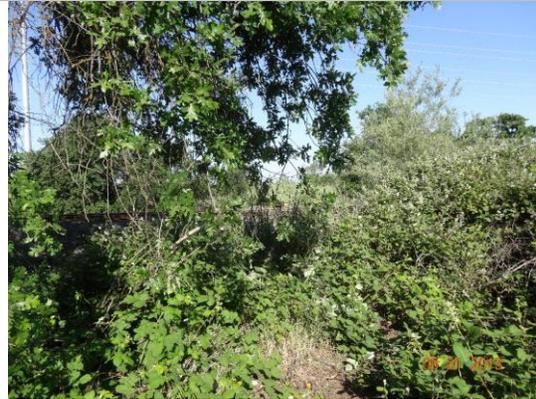
Photo 2 of 2 : UCIP_SP_2016_14731_24225.jpg

View of railroad looking west of crossing.

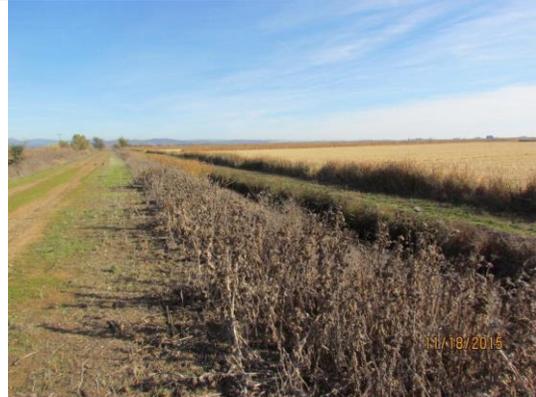
Photo 1 of 1 : SP_2016_NA0006_252_13_20160307_00005.jpg

LM Start	0.02	Rating **	U	Issue No.	13
LM End	0.57	Issue Type +	Ma	Location *	LS
Category	Earthen Levee		GPS Latitude/Longitude		
			Start	End	
Item	Vegetation		39.298502 °	39.297998 °	
			-121.569482 °	-121.559940 °	
DWR ID	DWR_NA0006_01_f_2015_13				
Comment Code					
V2 : Remove the wild growth other than native grasses from the levee slopes.					
Inspector Comment					
Remove the vegetation from the landside slope.

View of the vegetation on the landside slope.

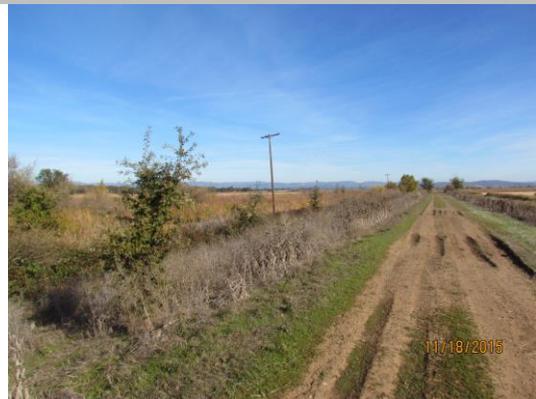
Photo 1 of 1 : SP_2016_NA0006_252_14_20160307_00006.jpg

LM Start	0.02	Rating **	U	Issue No.	14
LM End	0.57	Issue Type +	Ma	Location *	WS
Category	Earthen Levee		GPS Latitude/Longitude		
			Start	End	
Item	Vegetation		39.298502 °	39.297998 °	
			-121.569482 °	-121.559940 °	
DWR ID	DWR_NA0006_01_f_2015_14				
Comment Code					
V2 : Remove the wild growth other than native grasses from the levee slopes.					
Inspector Comment					
remove the vegetation from the waterside slope.

View of the vegetation on the waterside slope.

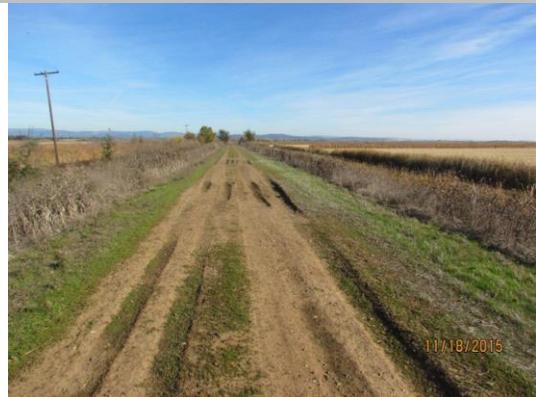
Photo 1 of 1 : SP_2016_NA0006_252_21_20160307_00009.jpg

LM Start	0.07	Rating **	M	Issue No.	21
LM End	0.66	Issue Type +	Ma	Location *	CR
Category	Earthen Levee		GPS Latitude/Longitude		
			Start	End	
Item	Crown Surface / Depressions / Rutting		39.299158 °	39.297595 °	
			-121.569024 °	-121.558310 °	
DWR ID	DWR_NA0006_01_s_2015_21				
Comment Code					
C2 : Repair depressions or ruts in the crown or slope.					
Inspector Comment					
Place appropriate gravel on the crown roadway to make it a all weather road.

View of the ruts on the crown roadway.

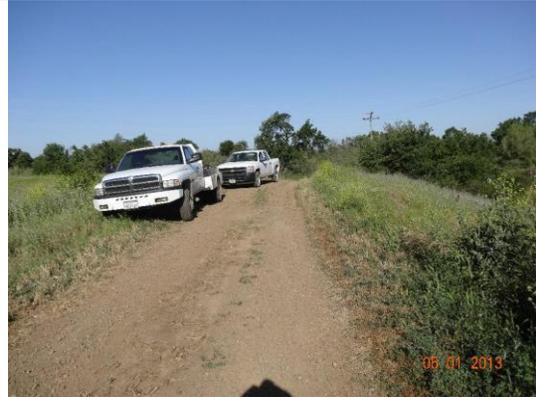
Photo 1 of 2 : UCIP_SP_2016_14732_24241.jpg

LM Start	0.09	Rating **	M	Issue No.	23
LM End	0.09	Issue Type +	En	Location *	CR
Category	Supplemental			GPS Latitude/Longitude	
				Start	End
Item	DWR UCIP Field Study			39.299106°	39.299106°
				-121.568749°	-121.568749°
DWR ID					
Comment Code					
Inspector Comment					
FS_ID:14732 DS_ID:19168 EP_NO: N/A Repair Type: Non-Urgent Crossing Status: Found UCIP Comments: Dense vegetation on waterward side and landward side obstructs inspection. Need to clear vegetation on slopes to conduct proper crossing evaluation. FIELD_STRUCT_DESC: 24-inch corrugated metal pipe through the levee 10 feet below the crown. Flap gate on the waterward end. Originally included in the O&M manual, 1953. FS Date: 5/1/2013

Overview of levee crown at crossing looking upstream.

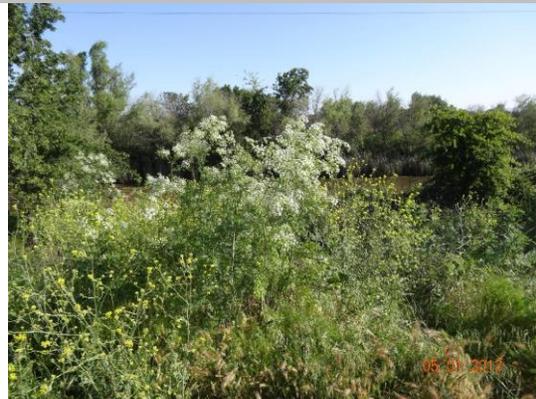
Photo 2 of 2 : UCIP_SP_2016_14732_24236.jpg

Dense vegetation obstructing waterward slope.

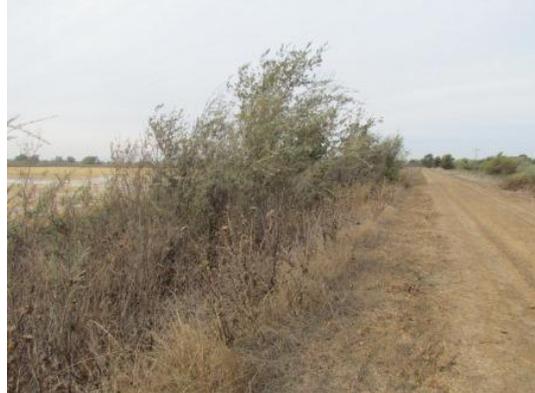
Photo 1 of 1 : SP_2016_NA0006_252_16_20160307_00007.jpg

LM Start	0.22	Rating **	U	Issue No.	16
LM End	0.22	Issue Type +	Ma	Location *	LS
Category	Earthen Levee		GPS Latitude/Longitude		
			Start	End	
Item	Trim / Thin Trees		39.298827 °	39.298827 °	
			-121.566401 °	-121.566401 °	
DWR ID	DWR_NA0006_01_f_2014_16				
Comment Code					
T2 : Thin trees to allow visibility of the ground and room to flood fight.					
Inspector Comment					
Trees should be trimmed up or removed to maintain visibility of landward levee slope.

This photo was taken from the crown facing west looking down the landward levee slope. Small trees 4" in diameter at chest height should be removed before they get to big.. Fall 2014.

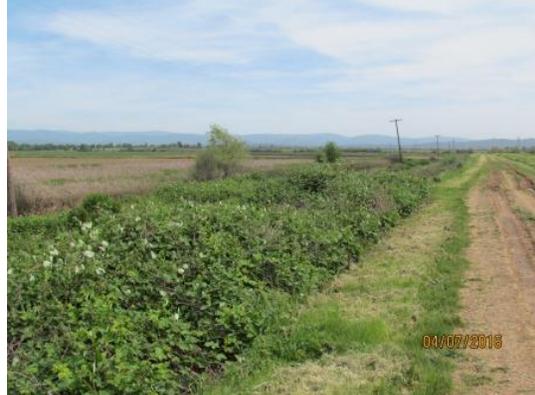
Photo 1 of 1 : SP_2016_NA0006_252_15_20160418_00027.jpg

LM Start	0.42	Rating **	M	Issue No.	15
LM End	0.42	Issue Type +	Ma	Location *	WS
Category	Earthen Levee		GPS Latitude/Longitude		
			Start	End	
Item	Vegetation		39.298377 °	39.298377 °	
			-121.562700 °	-121.562700 °	
DWR ID	DWR_NA0006_01_s_2016_15				
Comment Code					
V2 : Remove the wild growth other than native grasses from the levee slopes.					
Inspector Comment					
Blackberries taking over waterside slope.

Vegetation waterside looking upstream.

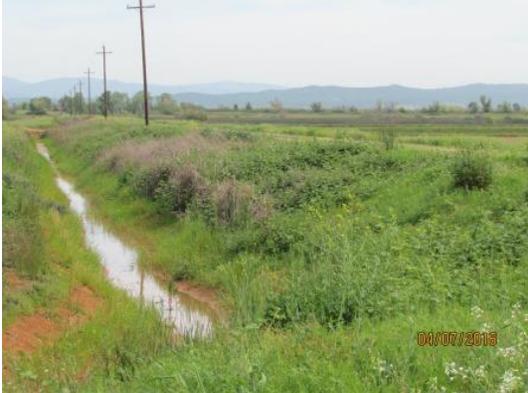
Photo 1 of 1 : SP_2016_NA0006_252_3_20160418_00028.jpg

LM Start	0.57	Rating **	M	Issue No.	3
LM End	1.46	Issue Type +	Ma	Location *	WS
Category	Earthen Levee		GPS Latitude/Longitude		
			Start	End	
Item	Vegetation		39.298019 °	39.295255 °	
			-121.559940 °	-121.546436 °	
DWR ID	DWR_NA0006_01_s_2012_3				
Comment Code					
V2 : Remove the wild growth other than native grasses from the levee slopes.					
Inspector Comment

Vegetation on waterside looking upstream.

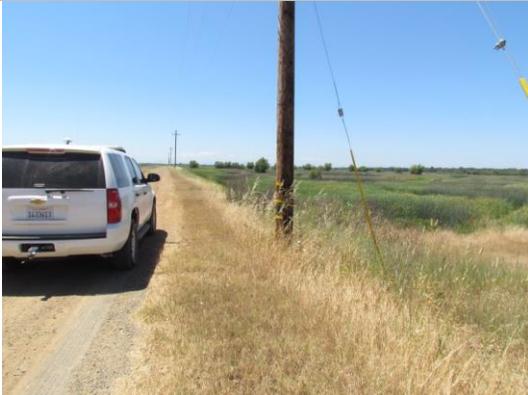
Photo 1 of 1 : SP_2016_NA0006_252_17_20160307_00008.jpg

LM Start	0.66	Rating **	M	Issue No.	17
LM End	1.45	Issue Type +	En	Location *	WS
Category	Earthen Levee		GPS Latitude/Longitude		
			Start	End	
Item	Encroachments		39.297629 °	39.295257 °	
			-121.558337 °	-121.546579 °	
DWR ID	DWR_NA0006_01_s_2015_17				
Comment Code					
PO : Pole					
Inspector Comment

View of the pole on the waterside of the levee facing downstream.

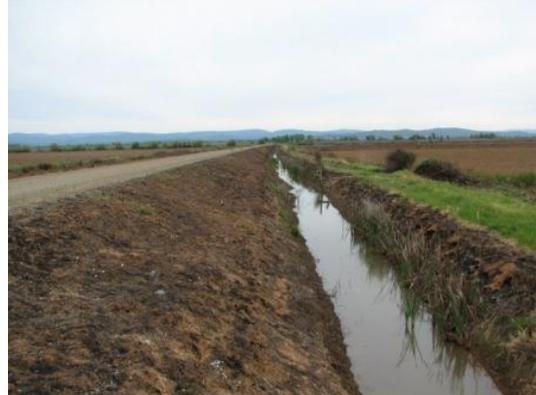
Photo 1 of 1 : SP_2016_NA0006_252_8_20160307_00004.jpg

LM Start	0.67	Rating **	M	Issue No.	8
LM End	1.44	Issue Type +	En	Location *	LS
Category	Earthen Levee		GPS Latitude/Longitude		
			Start	End	
Item	Encroachments		39.297472 °	39.295261 °	
			-121.558327 °	-121.546759 °	
DWR ID	DWR_NA0006_01_s_2012_8				
Comment Code					
DT : Ditch					
Inspector Comment

Levee mile 0.85, this photo is looking upstream at a ditch on the landside toe.

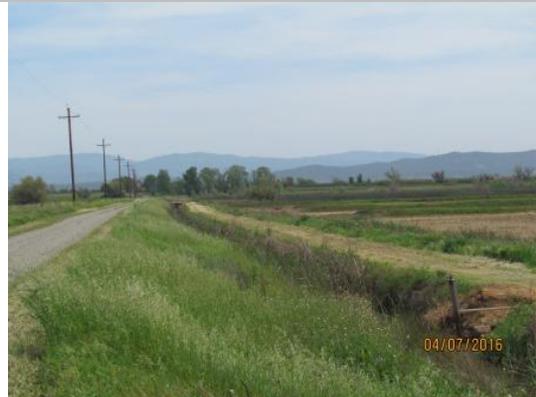
Photo 1 of 1 : SP_2016_NA0006_252_18_20160418_00029.jpg

LM Start	0.86	Rating **	M	Issue No.	18
LM End	1.45	Issue Type +	Ma	Location *	LS
Category	Earthen Levee		GPS Latitude/Longitude		
			Start	End	
Item	Vegetation		39.294995 °	39.295288 °	
			-121.557643 °	-121.546672 °	
DWR ID	DWR_NA0006_01_s_2016_18				
Comment Code					
V1 : Control annual grass and weeds on the levee slopes and easements.					
Inspector Comment

Vegetation on the landside looking upstream.

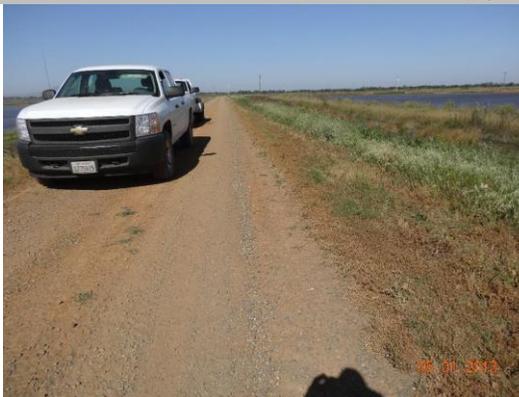
Photo 1 of 2 : UCIP_SP_2016_14733_24253.jpg

LM Start	0.98	Rating **	M	Issue No.	24
LM End	0.98	Issue Type +	En	Location *	LS
Category	Supplemental			GPS Latitude/Longitude	
				Start	End
Item	DWR UCIP Field Study			39.295026 °	39.295026 °
				-121.555440 °	-121.555440 °
DWR ID					
Comment Code					
Inspector Comment					
FS_ID:14733 DS_ID:19172 EP_NO: 9610 Repair Type: Non-Urgent Crossing Status: Found UCIP Comments: Scouring occurring directly across pipe on access road. Need to determine permit authorizing updates to crossing. Crossing appears to be no more than 10 years old. FIELD_STRUCT_DESC: 1 of 2: 24-inch corrugated metal irrigation pipe through the levee 6 feet below the crown. Slide gates are installed on waterward end of pipe (Permit No. 9610, 1974). Originally included in the O&M manual, 1953. FS Date: 5/1/2013

Overview of levee crown looking upstream at crossing.

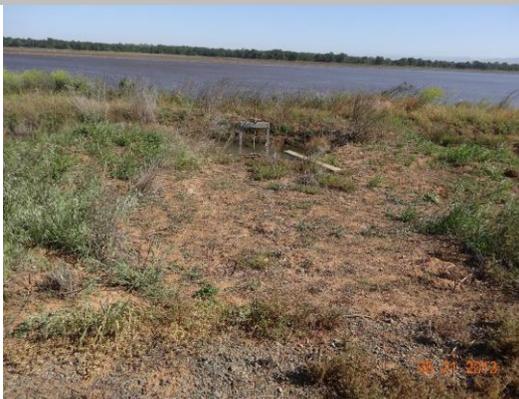
Photo 2 of 2 : UCIP_SP_2016_14733_24252.jpg

View of waterward side.

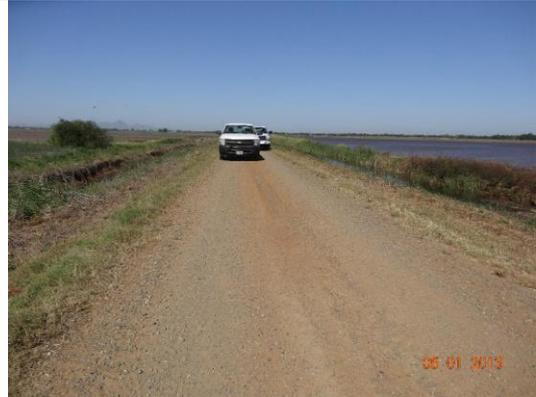
Photo 1 of 2 : UCIP_SP_2016_14734_24259.jpg

LM Start	1.17	Rating **	M	Issue No.	25
LM End	1.17	Issue Type +	En	Location *	LS
Category	Supplemental			GPS Latitude/Longitude	
				Start	End
Item	DWR UCIP Field Study			39.295099 °	39.295099 °
				-121.551839 °	-121.551839 °
DWR ID					
Comment Code					
Inspector Comment					
FS_ID:14734 DS_ID:19174 EP_NO: N/A Repair Type: Non-Urgent Crossing Status: Found UCIP Comments: Recent repair will need to contact owner to follow-up. FIELD_STRUCT_DESC: 24-inch corrugated metal pipe through the level 10 feet below the crown. Flapgate on waterward side. FS Date: 5/1/2013

Overview of levee crown looking upstream from crossing.

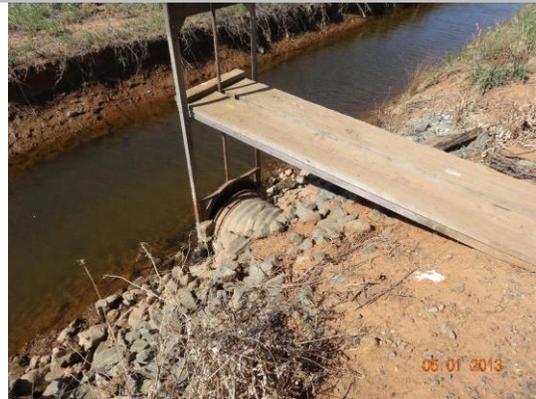
Photo 2 of 2 : UCIP_SP_2016_14734_24258.jpg

View of landward side: positive closure device, walkway, and rip rap on slope.

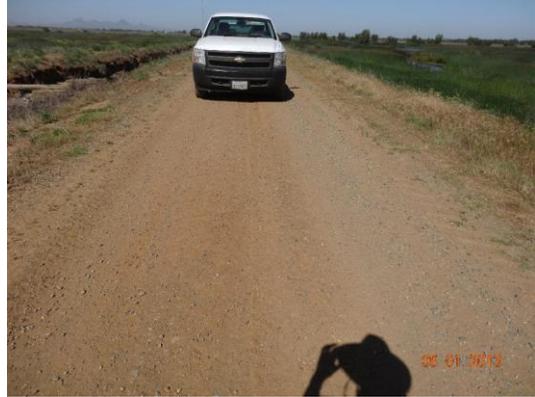
Photo 1 of 2 : UCIP_SP_2016_14736_24275.jpg

LM Start	1.44	Rating **	M	Issue No.	26
LM End	1.44	Issue Type +	En	Location *	LS
Category	Supplemental			GPS Latitude/Longitude	
				Start	End
Item	DWR UCIP Field Study			39.295238 °	39.295238 °
				-121.546755 °	-121.546755 °
DWR ID					
Comment Code					
Inspector Comment					
FS_ID:14736 DS_ID:19169 EP_NO: N/A Repair Type: Non-Urgent Crossing Status: Found UCIP Comments: Need to determine permit authorizing work. FIELD_STRUCT_DESC: 18-inch corrugated metal pipe through the levee 8 feet below the crown. Slide gate on the landward end. Shot rock revetment on the landside near slide-gate. FS Date: 5/1/2013

View of levee crown looking upstream at crossing.

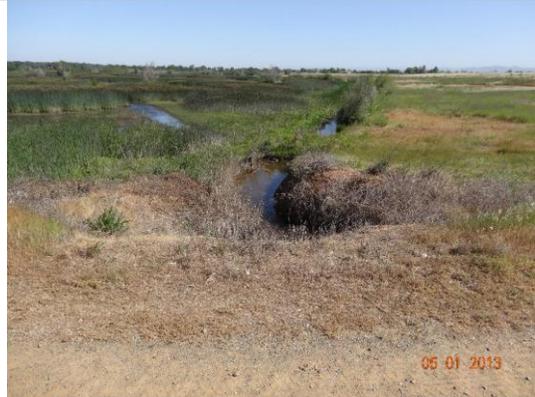
Photo 2 of 2 : UCIP_SP_2016_14736_24272.jpg

View of waterward side.
