**Flood Control Project Maintenance
Levee Inspections**

Maintenance Issue Types Only, Levee Inspection Report By Mile - Fall 2015

Eastern Honcut Creek

Waterway	Bank	Unit Miles	Inspection Start/End	Inspector
Unit No. 01 Van Tress	Left	1.46	11/18/2015 11/18/2015	Bob Duffey

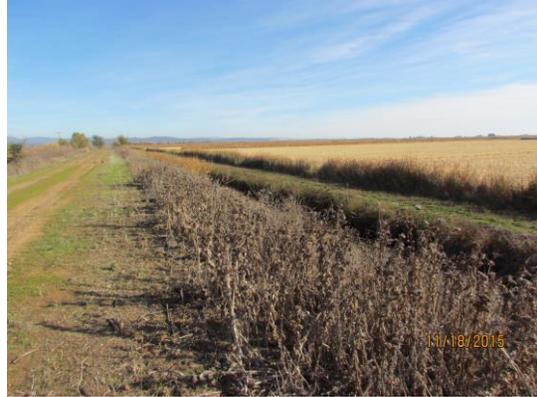
Photo 1 of 1 : FA_2015_NA0006_252_13_20151120_00015.jpg

LM Start	0.02	Rating **	U	Issue No.	13
LM End	0.57	Issue Type +	Ma	Location *	LS
Category	Earthen Levee		GPS Latitude/Longitude		
			Start	End	
Item	Vegetation		39.298502 °	39.297998 °	
			-121.569482 °	-121.559940 °	
DWR ID	DWR_NA0006_01_f_2015_13				
Action/Comments					
Remove the wild growth other than native grasses from the levee slopes. Inspector Comments: Remove the vegetation from the landside slope.

View of the vegetation on the landside slope.

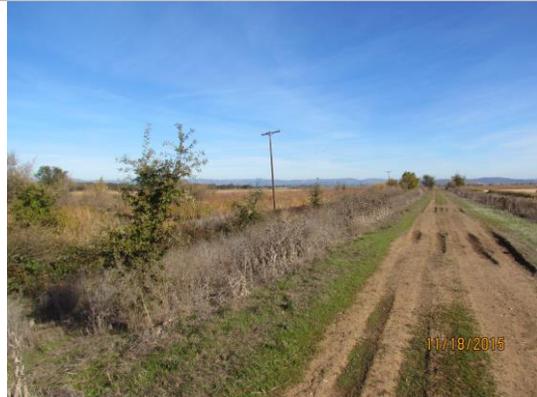
Photo 1 of 1 : FA_2015_NA0006_252_14_20151120_00016.jpg

LM Start	0.02	Rating **	U	Issue No.	14
LM End	0.57	Issue Type +	Ma	Location *	WS
Category	Earthen Levee		GPS Latitude/Longitude		
			Start	End	
Item	Vegetation		39.298502 °	39.297998 °	
			-121.569482 °	-121.559940 °	
DWR ID	DWR_NA0006_01_f_2015_14				
Action/Comments					
Remove the wild growth other than native grasses from the levee slopes. Inspector Comments: remove the vegetation from the waterside slope.

View of the vegetation on the waterside slope.

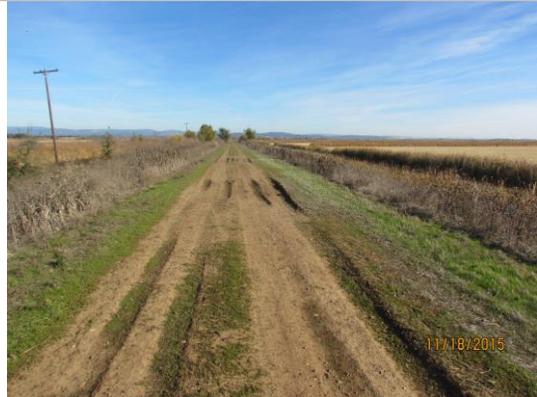
Photo 1 of 1 : FA_2015_NA0006_252_21_20151120_00017.jpg

LM Start	0.07	Rating **	M	Issue No.	21
LM End	0.66	Issue Type +	Ma	Location *	CR
Category	Earthen Levee		GPS Latitude/Longitude		
			Start	End	
Item	Crown Surface / Depressions / Rutting		39.299158 °	39.297595 °	
			-121.569024 °	-121.558310 °	
DWR ID	DWR_NA0006_01_s_2015_21				
Action/Comments					
Repair depressions or ruts in the crown or slope. Inspector Comments: Place appropriate gravel on the crown roadway to make it a all weather road.

View of the ruts on the crown roadway.
