**Flood Control Project Maintenance  
Levee Inspections**

**Maintenance Issue Types Only, Levee Inspection Report By Mile - Spring 2015**

**Eastern Honcut Creek**

Waterway	Bank	Unit Miles	Inspection Start/End	Inspector
Unit No. 01 Van Tress	Left	1.46	05/26/2015 05/26/2015	Michael Pitta

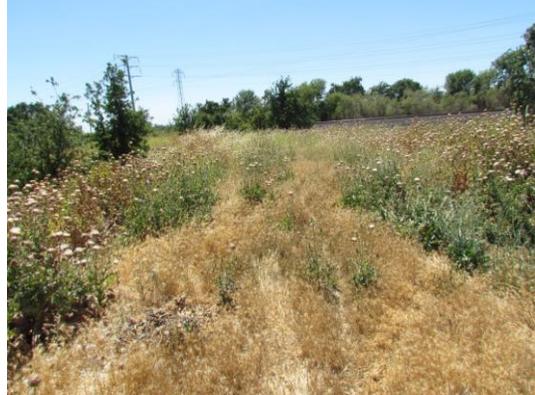
Photo 1 of 1 : SP\_2015\_NA0006\_252\_23\_20150529\_00016.jpg

LM Start	<b>0.07</b>	Rating **	U	Issue No.	<b>23</b>
LM End	<b>0.07</b>	Issue Type +	Ma	Location *	CR
Category	Earthen Levee		GPS Latitude/Longitude		
			Start	End	
Item	Vegetation		39.299162 °	39.299162 °	
			-121.569041 °	-121.569041 °	
DWR ID	DWR_NA0006_01_s_2015_23				
Action/Comments					
Keep the crown roadway free of vegetation.

View of the vegetation on the crown facing upstream.

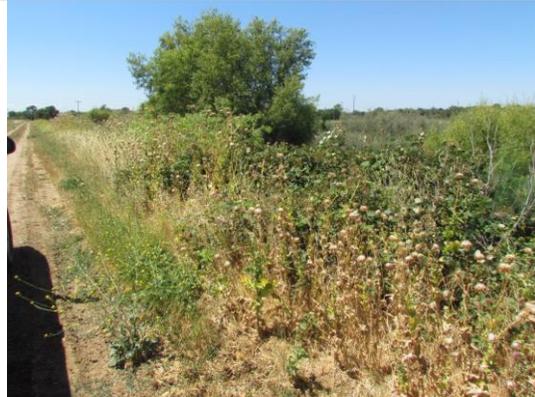
Photo 1 of 1 : SP\_2015\_NA0006\_252\_22\_20150529\_00017.jpg

LM Start	<b>0.22</b>	Rating **	U	Issue No.	<b>22</b>
LM End	<b>0.22</b>	Issue Type +	Ma	Location *	WS
Category	Earthen Levee		GPS Latitude/Longitude		
			Start	End	
Item	Vegetation		39.298823 °	39.298823 °	
			-121.566421 °	-121.566421 °	
DWR ID	DWR_NA0006_01_s_2015_22				
Action/Comments					
Remove the wild growth other than native grasses from the levee slopes.

View of the vegetation on the waterside of the levee facing downstream.

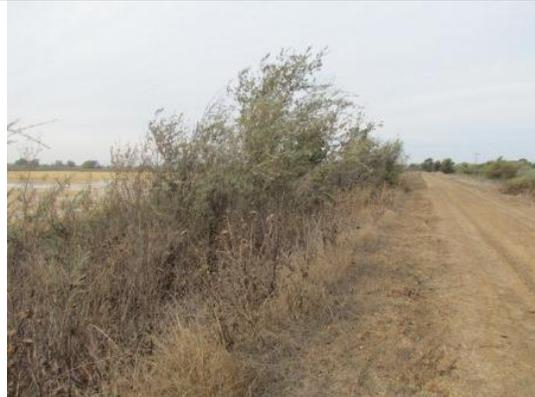
Photo 1 of 1 : SP\_2015\_NA0006\_252\_16\_20150401\_00007.jpg

LM Start	<b>0.22</b>	Rating **	U	Issue No.	<b>16</b>
LM End	<b>0.22</b>	Issue Type +	Ma	Location *	LS
Category	Earthen Levee		GPS Latitude/Longitude		
			Start	End	
Item	Trim / Thin Trees		39.298827 °	39.298827 °	
			-121.566401 °	-121.566401 °	
DWR ID	DWR_NA0006_01_f_2014_16				
Action/Comments					
Thin trees to allow visibility of the ground and room to flood fight. Inspector Comments: Trees should be trimmed up or removed to maintain visability of landward levee slope.

This photo was taken from the crown facing west looking down the landward levee slope at trees that either need to be trimmed up or removed to provide slope visibility. Fall 2014.

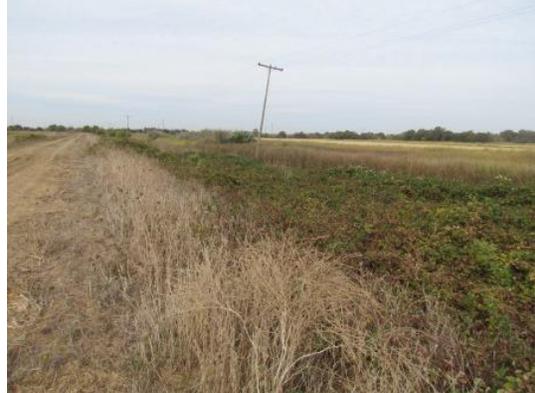
Photo 1 of 1 : SP\_2015\_NA0006\_252\_15\_20150401\_00006.jpg

LM Start	<b>0.45</b>	Rating **	U	Issue No.	<b>15</b>
LM End	<b>0.45</b>	Issue Type +	Ma	Location *	WS
Category	Earthen Levee		GPS Latitude/Longitude		
			Start	End	
Item	Vegetation		39.298283 °	39.298283 °	
			-121.562021 °	-121.562021 °	
DWR ID	DWR_NA0006_01_f_2014_15				
Action/Comments					
Remove the wild growth other than native grasses from the levee slopes. Inspector Comments: Berry bushes on waterward levee slope need to be trimmed back.

This photo was taken from the crown facing west looking down the waterward levee slope at berry bushes needing removal. Fall 2014.

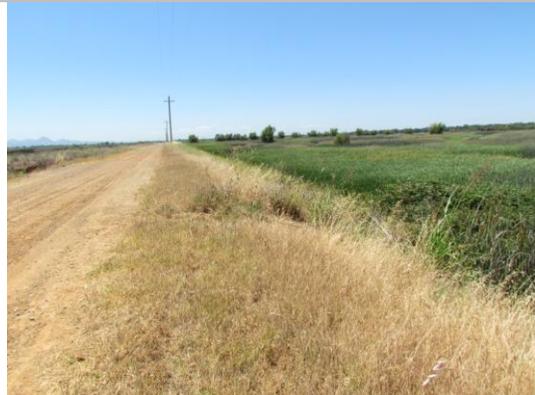
Photo 1 of 1 : SP\_2015\_NA0006\_252\_3\_20150529\_00018.jpg

LM Start	<b>0.57</b>	Rating **	U	Issue No.	<b>3</b>
LM End	<b>1.46</b>	Issue Type +	Ma	Location *	WS
Category	Earthen Levee		GPS Latitude/Longitude		
			Start	End	
Item	Vegetation		39.298019 °	39.295255 °	
			-121.559940 °	-121.546436 °	
DWR ID	DWR_NA0006_01_s_2012_3				
Action/Comments					
Remove the wild growth other than native grasses from the levee slopes.

View of the vegetation on the waterside of the levee facing downstream.

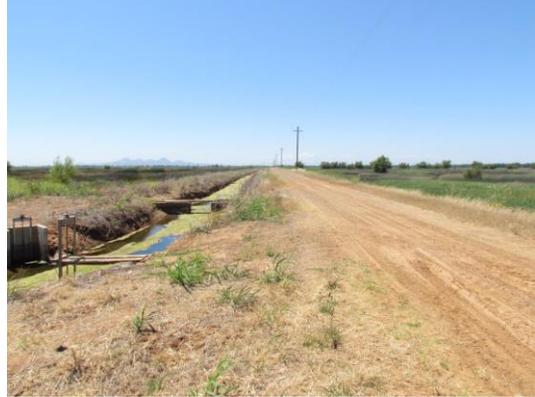
Photo 1 of 1 : SP\_2015\_NA0006\_252\_1\_20150529\_00019.jpg

LM Start	<b>0.57</b>	Rating **	M	Issue No.	<b>1</b>
LM End	<b>1.46</b>	Issue Type +	Ma	Location *	LS
Category	Earthen Levee		GPS Latitude/Longitude		
			Start	End	
Item	Vegetation		39.298018 °	39.295254 °	
			-121.559940 °	-121.546437 °	
DWR ID	DWR_NA0006_01_s_2012_1				
Action/Comments					
Remove the wild growth other than native grasses from the levee slopes.

View of the vegetation on the landside of the levee facing downstream.
