**Flood Control Project Maintenance
Levee Inspections**

Maintenance Issue Types Only, Levee Inspection Report By Mile - Spring 2016

Eastern Honcut Creek

Waterway	Bank	Unit Miles	Inspection Start/End	Inspector
Unit No. 01 Van Tress	Left	1.46	04/07/2016 04/07/2016	Sterling York

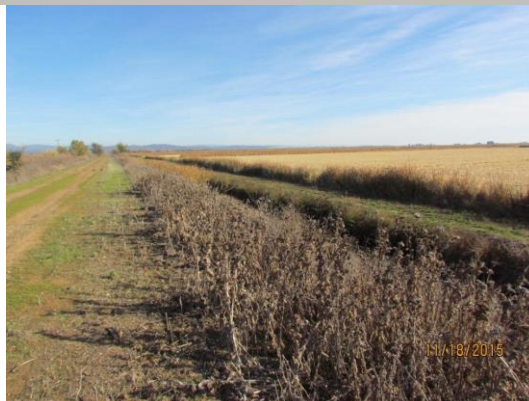
Photo 1 of 1 : SP_2016_NA0006_252_13_20160307_00005.jpg

LM Start	0.02	Rating **	U	Issue No.	13
LM End	0.57	Issue Type +	Ma	Location *	LS
Category	Earthen Levee			GPS Latitude/Longitude	
				Start	End
Item	Vegetation			39.298502 °	39.297998 °
				-121.569482 °	-121.559940 °
DWR ID	DWR_NA0006_01_f_2015_13				
Comment Code					
V2 : Remove the wild growth other than native grasses from the levee slopes.					
Inspector Comment					
Remove the vegetation from the landside slope.

View of the vegetation on the landside slope.

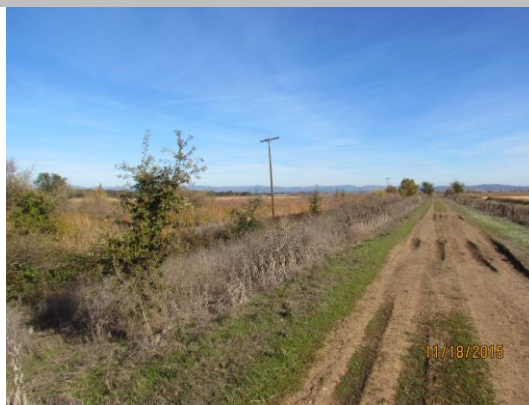
Photo 1 of 1 : SP_2016_NA0006_252_14_20160307_00006.jpg

LM Start	0.02	Rating **	U	Issue No.	14
LM End	0.57	Issue Type +	Ma	Location *	WS
Category	Earthen Levee			GPS Latitude/Longitude	
				Start	End
Item	Vegetation			39.298502 °	39.297998 °
				-121.569482 °	-121.559940 °
DWR ID	DWR_NA0006_01_f_2015_14				
Comment Code					
V2 : Remove the wild growth other than native grasses from the levee slopes.					
Inspector Comment					
remove the vegetation from the waterside slope.

View of the vegetation on the waterside slope.

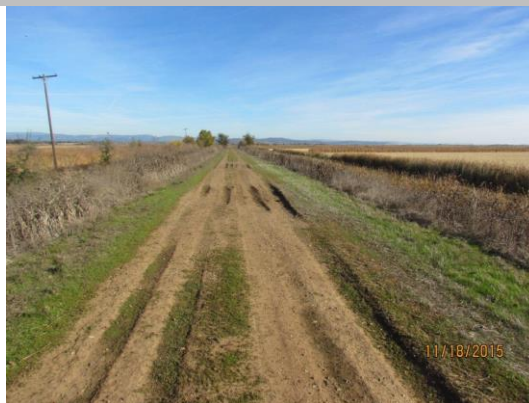
Photo 1 of 1 : SP_2016_NA0006_252_21_20160307_00009.jpg

LM Start	0.07	Rating **	M	Issue No.	21
LM End	0.66	Issue Type +	Ma	Location *	CR
Category	Earthen Levee			GPS Latitude/Longitude	
				Start	End
Item	Crown Surface / Depressions / Rutting			39.299158 °	39.297595 °
				-121.569024 °	-121.558310 °
DWR ID	DWR_NA0006_01_s_2015_21				
Comment Code					
C2 : Repair depressions or ruts in the crown or slope.					
Inspector Comment					
Place appropriate gravel on the crown roadway to make it a all weather road.

View of the ruts on the crown roadway.

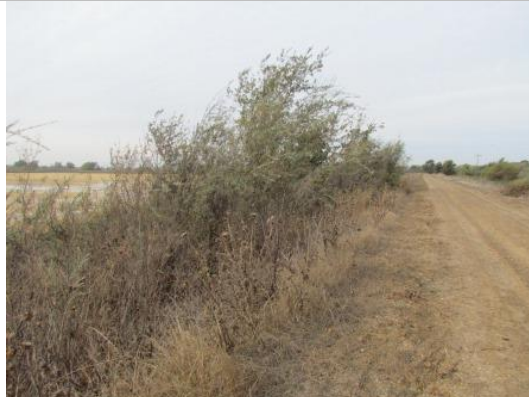
Photo 1 of 1 : SP_2016_NA0006_252_16_20160307_00007.jpg

LM Start	0.22	Rating **	U	Issue No.	16
LM End	0.22	Issue Type +	Ma	Location *	LS
Category	Earthen Levee			GPS Latitude/Longitude	
				Start	End
Item	Trim / Thin Trees			39.298827 °	39.298827 °
				-121.566401 °	-121.566401 °
DWR ID	DWR_NA0006_01_f_2014_16				
Comment Code					
T2 : Thin trees to allow visibility of the ground and room to flood fight.					
Inspector Comment					
Trees should be trimmed up or removed to maintain visibility of landward levee slope.

This photo was taken from the crown facing west looking down the landward levee slope. Small trees 4" in diameter at chest height should be removed before they get to big.. Fall 2014.

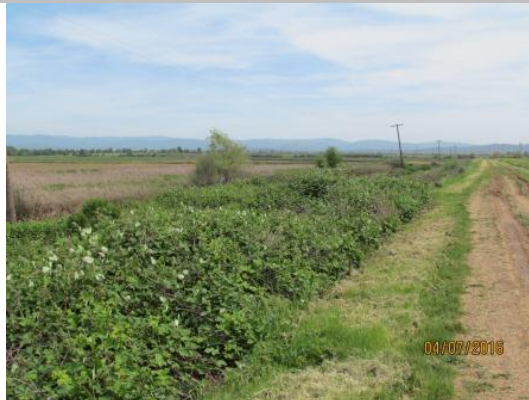
Photo 1 of 1 : SP_2016_NA0006_252_15_20160418_00027.jpg

LM Start	0.42	Rating **	M	Issue No.	15
LM End	0.42	Issue Type +	Ma	Location *	WS
Category	Earthen Levee			GPS Latitude/Longitude	
				Start	End
Item	Vegetation			39.298377 °	39.298377 °
				-121.562700 °	-121.562700 °
DWR ID	DWR_NA0006_01_s_2016_15				
Comment Code					
V2 : Remove the wild growth other than native grasses from the levee slopes.					
Inspector Comment					
Blackberries taking over waterside slope.

Vegetation waterside looking upstream.

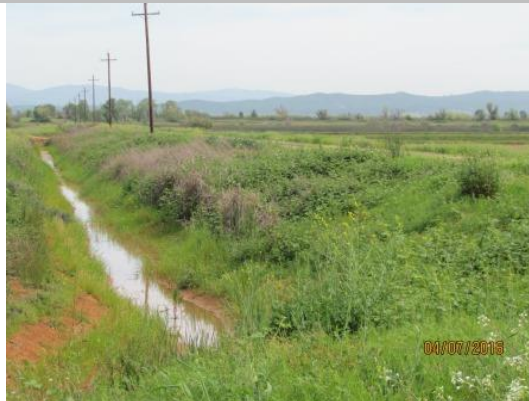
Photo 1 of 1 : SP_2016_NA0006_252_3_20160418_00028.jpg

LM Start	0.57	Rating **	M	Issue No.	3
LM End	1.46	Issue Type +	Ma	Location *	WS
Category	Earthen Levee			GPS Latitude/Longitude	
				Start	End
Item	Vegetation			39.298019 °	39.295255 °
				-121.559940 °	-121.546436 °
DWR ID	DWR_NA0006_01_s _ 2012_3				
Comment Code					
V2 : Remove the wild growth other than native grasses from the levee slopes.					
Inspector Comment

Vegetation on waterside looking upstream.

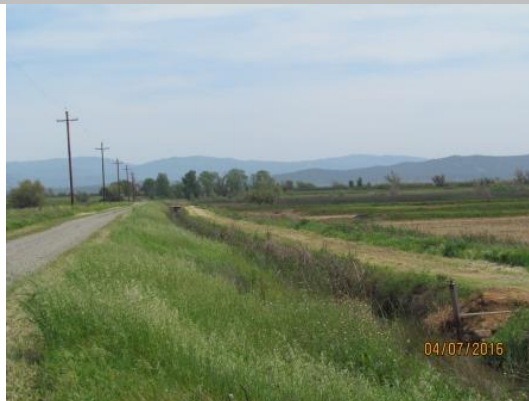
Photo 1 of 1 : SP_2016_NA0006_252_18_20160418_00029.jpg

LM Start	0.86	Rating **	M	Issue No.	18
LM End	1.45	Issue Type +	Ma	Location *	LS
Category	Earthen Levee			GPS Latitude/Longitude	
				Start	End
Item	Vegetation			39.294995 °	39.295288 °
				-121.557643 °	-121.546672 °
DWR ID	DWR_NA0006_01_s _ 2016_18				
Comment Code					
V1 : Control annual grass and weeds on the levee slopes and easements.					
Inspector Comment

Vegetation on the landside looking upstream.
