**Flood Control Project Maintenance
Levee Inspections**

Maintenance Issue Types Only, Levee Inspection Report By Mile - Spring 2017

Eastern Honcut Creek

Waterway	Bank	Unit Miles	Inspection Start/End	Inspector
Unit No. 01 Van Tress	Left	1.46	04/06/2017 04/06/2017	Sterling York

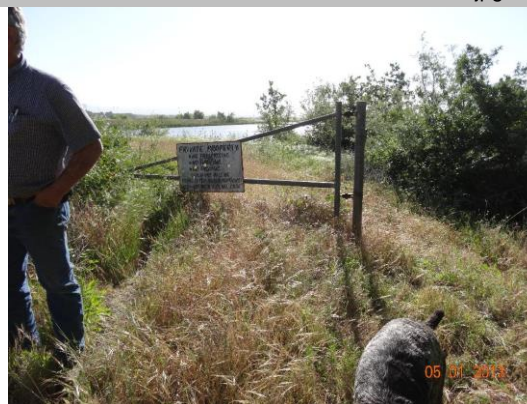
Photo 1 of 3 : UCIP_SP_2017_14731_24228.jpg

LM Start	0.01	Rating **	M	Issue No.	27
LM End	0.01	Issue Type +	Ma	Location *	N/A
Category	Supplemental		GPS Latitude/Longitude		
			Start	End	
Item	DWR UCIP LMA Responsibility		39.298484 °	39.298484 °	
			-121.569610 °	-121.569610 °	
DWR ID					
Comment Code					
Inspector Comment					
FS_ID:14731 DS_ID:19167 EP_NO: N/A Repair Type: Non-Urgent Crossing Status: Found UCIP Comments: Dense vegetation on landward side obstructs inspection. Vegetation needs to be cleared to perform utility crossing inspection. FIELD_STRUCT_DESC: 24-inch corrugated metal drain pipe through the levee 12.0 feet below the crown. Flap gate on waterward end. Originally included the O&M manual, 1953. FS Date: 5/1/2013

View of crown looking east.

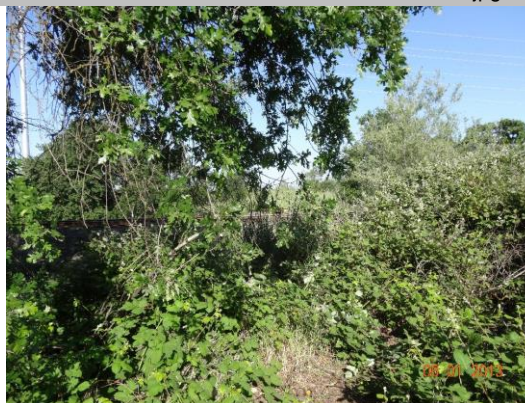
Photo 2 of 3 : UCIP_SP_2017_14731_24225.jpg

View of railroad looking west of crossing.

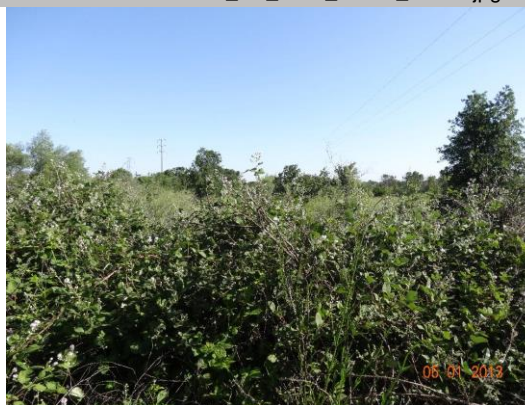
Photo 3 of 3 : UCIP_SP_2017_14731_24229.jpg

Dense vegetation on waterward side obstructing inspection.

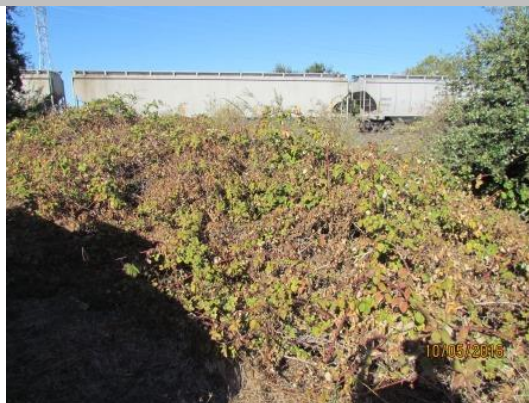
Photo 1 of 1 : SP_2017_NA0006_252_19_20170316_00008.jpg

LM Start	0.02	Rating **	U	Issue No.	19
LM End	0.02	Issue Type +	Ma	Location *	WS
Category	Earthen Levee			GPS Latitude/Longitude	
				Start	End
Item	Vegetation			39.298500 °	39.298500 °
				-121.569508 °	-121.569508 °
DWR ID	DWR_NA0006_01_f_2016_19				
Comment Code					
V2 : Remove the wild growth other than native grasses from the levee slopes.					
Inspector Comment					
Remove Blackberry bushes covering waterside levee slope.

View of Blackberry bushes covering waterside levee slope.

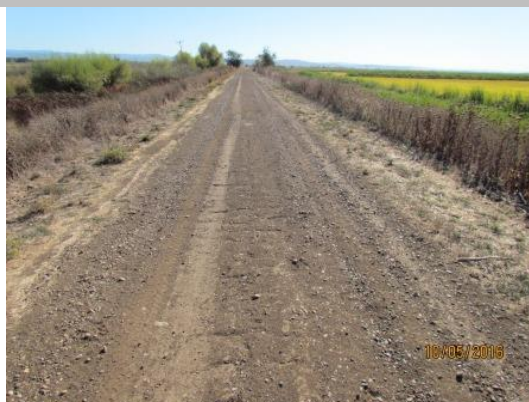
Photo 1 of 1 : SP_2017_NA0006_252_21_20170316_00010.jpg

LM Start	0.02	Rating **	U	Issue No.	21
LM End	0.66	Issue Type +	Ma	Location *	CR
Category	Earthen Levee			GPS Latitude/Longitude	
				Start	End
Item	Crown Surface / Depressions / Rutting			39.298504 °	39.297595 °
				-121.569502 °	-121.558310 °
DWR ID	DWR_NA0006_01_s_2015_21				
Comment Code					
C3 : Add appropriate gravel or road base. Grade and compact.					
Inspector Comment					
Place appropriate gravel on the crown roadway to make it an all weather road.

View of the crown looking upstream of a section of road that needs all weather surface. Fall 2016

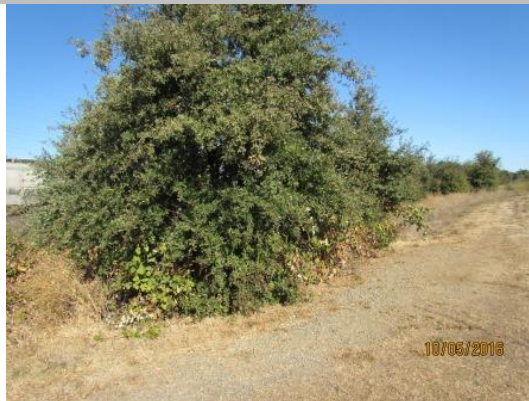
Photo 1 of 1 : SP_2017_NA0006_252_20_20170316_00009.jpg

LM Start	0.02	Rating **	U	Issue No.	20
LM End	0.02	Issue Type +	Ma	Location *	WS
Category	Earthen Levee			GPS Latitude/Longitude	
				Start	End
Item	Trim / Thin Trees			39.298563 °	39.298563 °
				-121.569432 °	-121.569432 °
DWR ID	DWR_NA0006_01_f_2016_20				
Comment Code					
T1 : Trim trees to at least five feet above ground level.					
Inspector Comment					
A tree that needs the limbs trimmed up 5' for visibility and access on the waterside. Fall 2016.

View of a tree that needs the limbs trimmed up 5' for visibility and access on the waterside. Fall 2016.

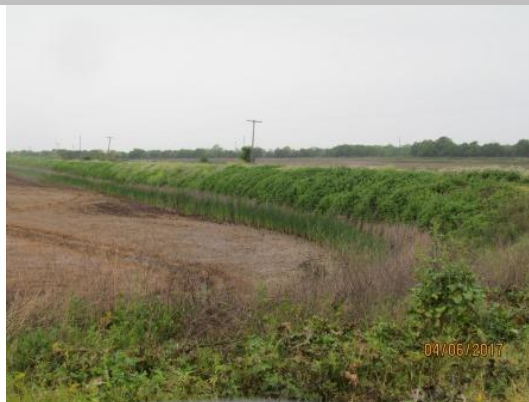
Photo 1 of 1 : SP_2017_NA0006_252_8_20170410_00034.jpg

LM Start	0.02	Rating **	U	Issue No.	8
LM End	0.67	Issue Type +	Ma	Location *	LS
Category	Earthen Levee			GPS Latitude/Longitude	
				Start	End
Item	Vegetation			39.298570 °	39.297562 °
				-121.569427 °	-121.558337 °
DWR ID	DWR_NA0006_01_s_2017_8				
Comment Code					
V2 : Remove the wild growth other than native grasses from the levee slopes.					
Inspector Comment					
Broad leaf thistle covering landside slope, Spring 2017.

View looking downstream of broad leaf thistle covering landside slope, Spring 2017.

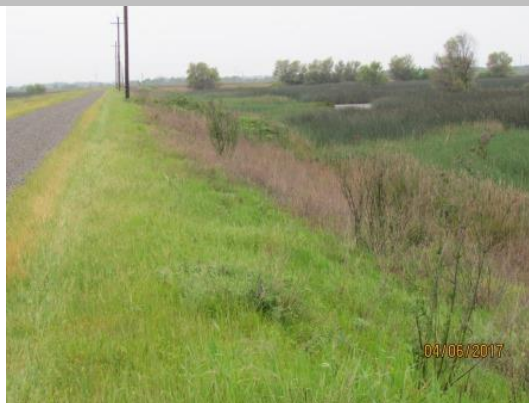
Photo 1 of 1 : SP_2017_NA0006_252_18_20170410_00033.jpg

LM Start	0.02	Rating **	M	Issue No.	18
LM End	1.45	Issue Type +	Ma	Location *	WS
Category	Earthen Levee			GPS Latitude/Longitude	
				Start	End
Item	Vegetation			39.298570 °	39.295263 °
				-121.569427 °	-121.546580 °
DWR ID	DWR_NA0006_01_f_2016_18				
Comment Code					
V1 : Control annual grass and weeds on the levee slopes and easements.					
Inspector Comment					
Annual vegetation needs to be maintained. Spring 2017.

View looking downstream waterside of annual vegetation that needs to be maintained. Spring 2017.

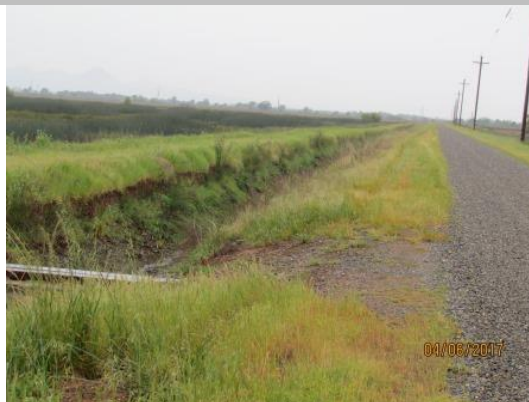
Photo 1 of 1 : SP_2017_NA0006_252_12_20170410_00032.jpg

LM Start	0.02	Rating **	M	Issue No.	12
LM End	1.45	Issue Type +	Ma	Location *	LS
Category	Earthen Levee			GPS Latitude/Longitude	
				Start	End
Item	Vegetation			39.298570 °	39.295263 °
				-121.569426 °	-121.546580 °
DWR ID	DWR_NA0006_01_f_2016_12				
Comment Code					
V1 : Control annual grass and weeds on the levee slopes and easements.					
Inspector Comment					
Annual vegetation needs to be maintained. Spring 2017.

View looking downstream landside of annual vegetation that needs to be maintained. Spring 2017.

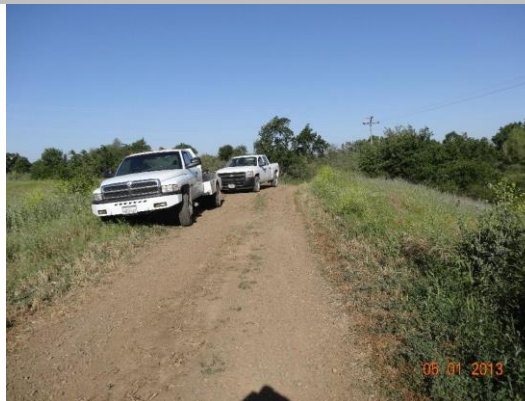
Photo 1 of 3 : UCIP_SP_2017_14732_24241.jpg

LM Start	0.09	Rating **	M	Issue No.	28
LM End	0.09	Issue Type +	Ma	Location *	LS
Category	Supplemental			GPS Latitude/Longitude	
				Start	End
Item	DWR UCIP LMA Responsibility			39.299106 °	39.299106 °
				-121.568749 °	-121.568749 °
DWR ID					
Comment Code					
Inspector Comment					
FS_ID:14732					
DS_ID:19168					
EP_NO: N/A					
Repair Type: Non-Urgent					
Crossing Status: Found					
UCIP Comments: Dense vegetation on waterward side and landward side obstructs inspection. Need to clear vegetation on slopes to conduct proper crossing evaluation.					
FIELD_STRUCT_DESC: 24-inch corrugated metal pipe through the levee 10 feet below the crown. Flap gate on the waterward end.					
Originally included in the O&M manual, 1953.					
FS Date: 5/1/2013

Overview of levee crown at crossing looking upstream.

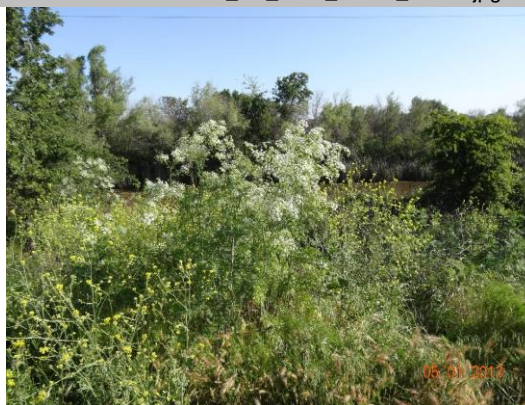
Photo 2 of 3 : UCIP_SP_2017_14732_24236.jpg

Dense vegetation obstructing waterward slope.

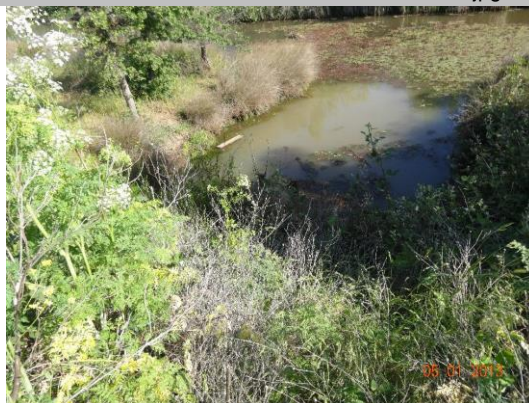
Photo 3 of 3 : UCIP_SP_2017_14732_24238.jpg

LM Start	0.09	Rating **	M	Issue No.	28 (cont)
LM End	0.09	Issue Type +	Ma	Location *	LS
Category	Supplemental			GPS Latitude/Longitude	
				Start	End
Item	DWR UCIP LMA Responsibility			39.299106 °	39.299106 °
				-121.568749 °	-121.568749 °
DWR ID					
Comment Code					
Inspector Comment					
FS_ID:14732					
DS_ID:19168					
EP_NO: N/A					
Repair Type: Non-Urgent					
Crossing Status: Found					
UCIP Comments: Dense vegetation on waterward side and landward side obstructs inspection. Need to clear vegetation on slopes to conduct proper crossing evaluation.					
FIELD_STRUCT_DESC: 24-inch corrugated metal pipe through the levee 10 feet below the crown. Flap gate on the waterward end.					
Originally included in the O&M manual, 1953.					
FS Date: 5/1/2013

Overview of waterward side (outlet).

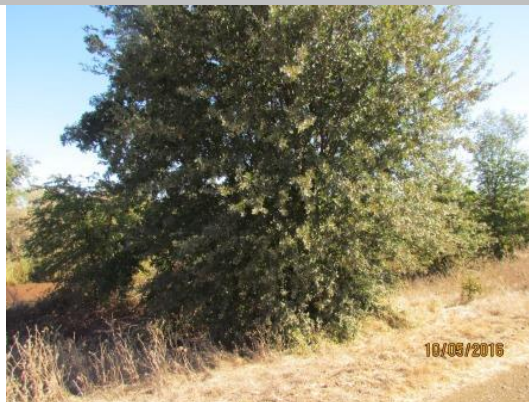
Photo 1 of 1 : SP_2017_NA0006_252_22_20170316_00011.jpg

LM Start	0.10	Rating **	M	Issue No.	22
LM End	0.10	Issue Type +	Ma	Location *	WS
Category	Earthen Levee			GPS Latitude/Longitude	
				Start	End
Item	Trim / Thin Trees			39.299078 °	39.299078 °
				-121.568633 °	-121.568633 °
DWR ID	DWR_NA0006_01_f_2016_22				
Comment Code					
T1 : Trim trees to at least five feet above ground level.					
Inspector Comment					
A tree that needs the limbs trimmed up 5' for visibility and access on the waterside. Fall 2016.

View of a tree that needs the limbs trimmed up 5' for visibility and access on the waterside. Fall 2016.

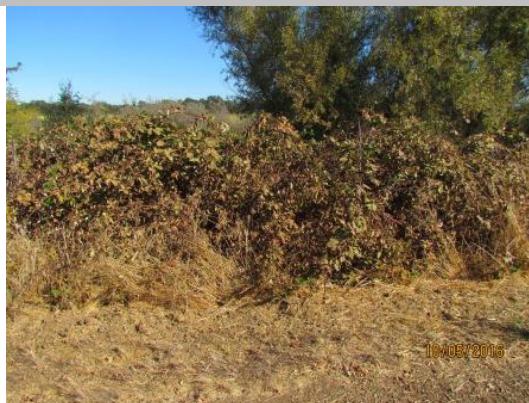
Photo 1 of 1 : SP_2017_NA0006_252_24_20170316_00013.jpg

LM Start	0.21	Rating **	U	Issue No.	24
LM End	0.24	Issue Type +	Ma	Location *	WS
Category	Earthen Levee			GPS Latitude/Longitude	
				Start	End
Item	Vegetation			39.298836 °	39.298768 °
				-121.566572 °	-121.565921 °
DWR ID	DWR_NA0006_01_f_2016_24				
Comment Code					
V2 : Remove the wild growth other than native grasses from the levee slopes.					
Inspector Comment					
Remove Blackberry bushes covering the waterside slope.

View of Blackberry bushes that cover the waterside slope. Fall 2016.

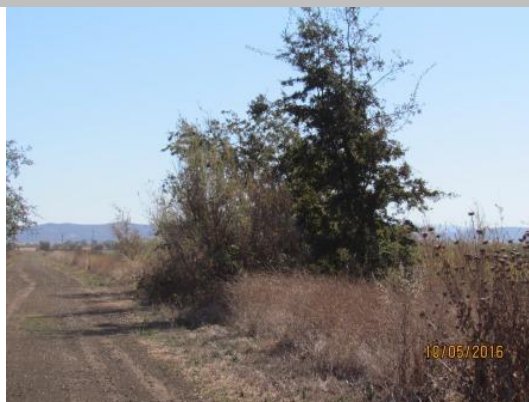
Photo 1 of 1 : SP_2017_NA0006_252_23_20170316_00012.jpg

LM Start	0.21	Rating **	U	Issue No.	23
LM End	0.21	Issue Type +	Ma	Location *	LS
Category	Earthen Levee			GPS Latitude/Longitude	
				Start	End
Item	Trim / Thin Trees			39.298816 °	39.298816 °
				-121.566529 °	-121.566529 °
DWR ID	DWR_NA0006_01_f_2016_23				
Comment Code					
T3 : Trim and thin trees to allow visibility of the ground and room to flood fight.					
Inspector Comment					
Trees that needs the limbs trimmed up 5' for visibility and access on the landside. Fall 2016.

View of trees that needs the limbs trimmed up 5' for visibility and access on the landside. Fall 2016.

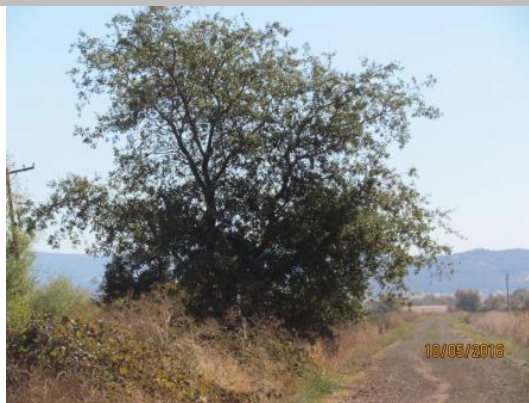
Photo 1 of 1 : SP_2017_NA0006_252_25_20170316_00014.jpg

LM Start	0.23	Rating **	M	Issue No.	25
LM End	0.23	Issue Type +	Ma	Location *	WS
Category	Earthen Levee			GPS Latitude/Longitude	
				Start	End
Item	Trim / Thin Trees			39.298776 °	39.298776 °
				-121.566158 °	-121.566158 °
DWR ID	DWR_NA0006_01_f_2016_25				
Comment Code					
T1 : Trim trees to at least five feet above ground level.					
Inspector Comment					
Tree that needs the limbs trimmed up 5' for visibility and access on the waterside. Fall 2016.

View of a tree that needs the limbs trimmed up 5' for visibility and access on the waterside. Fall 2016.

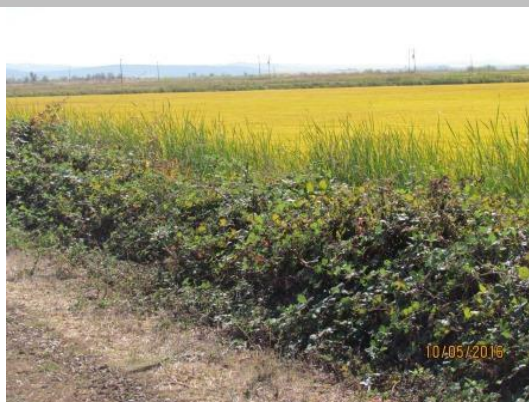
Photo 1 of 1 : SP_2017_NA0006_252_26_20170316_00015.jpg

LM Start	0.41	Rating **	U	Issue No.	26
LM End	0.41	Issue Type +	Ma	Location *	LS
Category	Earthen Levee			GPS Latitude/Longitude	
				Start	End
Item	Vegetation			39.298367 °	39.298367 °
				-121.562820 °	-121.562820 °
DWR ID	DWR_NA0006_01_f_2016_26				
Comment Code					
V2 : Remove the wild growth other than native grasses from the levee slopes.					
Inspector Comment					
Remove Blackberry bushes covering landside slope.

View of Blackberry bushes that cover the landside slope. Looking upstream. Fall 2016.

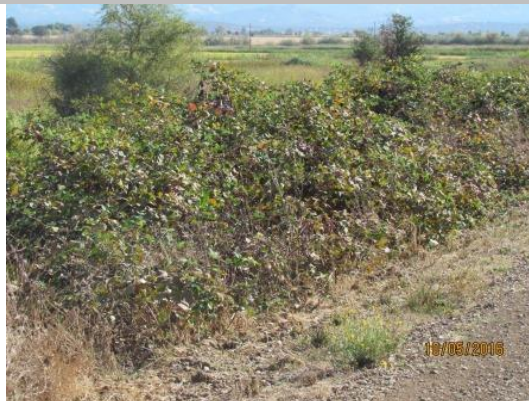
Photo 1 of 1 : SP_2017_NA0006_252_16_20170316_00004.jpg

LM Start	0.42	Rating **	U	Issue No.	16
LM End	0.45	Issue Type +	Ma	Location *	WS
Category	Earthen Levee			GPS Latitude/Longitude	
				Start	End
Item	Vegetation			39.298355 °	39.298280 °
				-121.562702 °	-121.562032 °
DWR ID	DWR_NA0006_01_f_2016_16				
Comment Code					
V2 : Remove the wild growth other than native grasses from the levee slopes.					
Inspector Comment					
Remove Blackberry bushes covering waterside slope.

View of Blackberry bushes that cover the waterside slope. Looking upstream. Fall 2016.

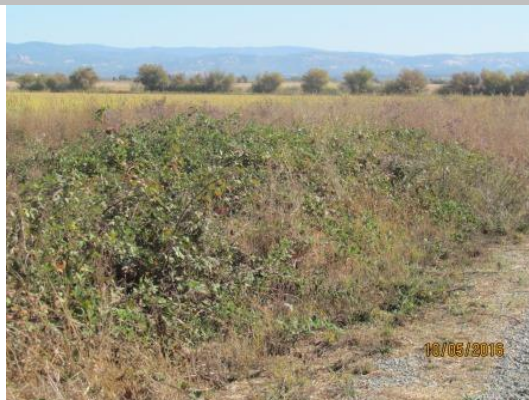
Photo 1 of 1 : SP_2017_NA0006_252_1_20170316_00001.jpg

LM Start	0.85	Rating **	M	Issue No.	1
LM End	0.96	Issue Type +	Ma	Location *	WS
Category	Earthen Levee			GPS Latitude/Longitude	
				Start	End
Item	Vegetation			39.294995 °	39.295021 °
				-121.557823 °	-121.555813 °
DWR ID	DWR_NA0006_01_f_2016_1				
Comment Code					
V2 : Remove the wild growth other than native grasses from the levee slopes.					
Inspector Comment					
Remove Blackberry bushes starting to take over waterside slope. Spring 2017.

View of Blackberry bushes that are starting to cover the waterside slope. Looking upstream. Fall 2016.
