**Flood Control Project Maintenance
Levee Inspections**

Maintenance Issue Types Only, Levee Inspection Report By Mile - Spring 2018

Eastern Honcut Creek

Waterway	Bank	Unit Miles	Inspection Start/End	Inspector
Unit No. 01 Van Tress	Left	1.46	05/03/2018 05/03/2018	Sterling York

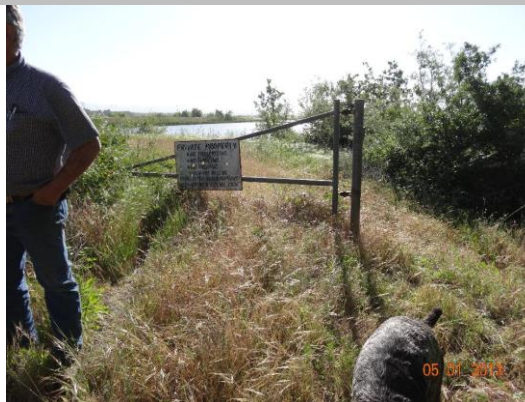
Photo 1 of 3 : UCIP_SP_2018_14731_24228.jpg

LM Start	0.01	Rating **	M	Issue No.	27
LM End	0.01	Issue Type +	Ma	Location *	
Category	Supplemental		GPS Latitude/Longitude		
			Start	End	
Item	DWR UCIP LMA Responsibility		39.298484 °	39.298484 °	
			-121.569610 °	-121.569610 °	
DWR ID					
Comment Code					
Inspector Comment					
FS_ID:14731 DS_ID:19167 EP_NO: N/A Repair Type: Non-Urgent Crossing Status: Found UCIP Comments: Dense vegetation on landward side obstructs inspection. Vegetation needs to be cleared to perform utility crossing inspection. FIELD_STRUCT_DESC: 24-inch corrugated metal drainage pipe through the levee, 12 feet below the crown. Flap gate located on the waterside (WS) end. [Additional Reference(s): DWR Levee Logs, 2005. USACE Sacramento O&M Manual Unit No. 151, November 1953, (Station 0+60)] FS Date: 5/1/2013

View of crown looking east.

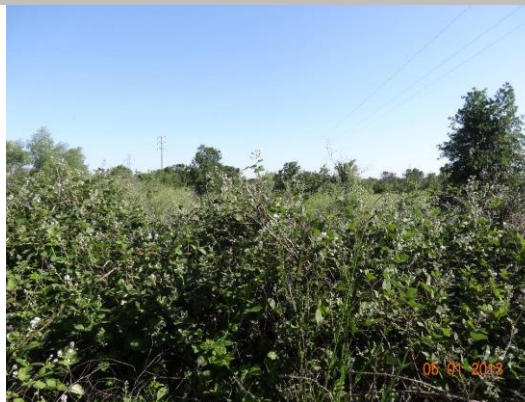
Photo 3 of 3 : UCIP_SP_2018_14731_24229.jpg

Dense vegetation on waterward side obstructing inspection.

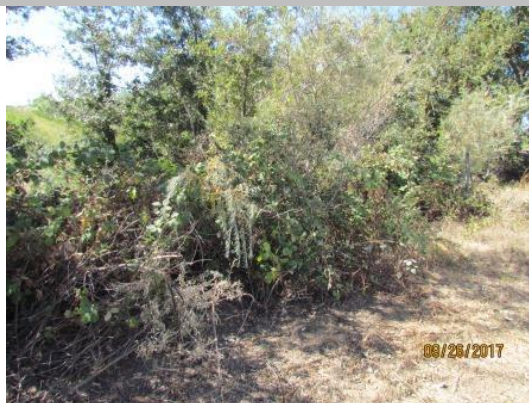
Photo 1 of 1 : SP_2018_NA0006_252_8_20180302_00002.jpg

LM Start	0.02	Rating **	U	Issue No.	8
LM End	0.06	Issue Type +	Ma	Location *	LS
Category	Earthen Levee			GPS Latitude/Longitude	
				Start	End
Item	Vegetation			39.298486 °	39.299052 °
				-121.569504 °	-121.569277 °
DWR ID	DWR_NA0006_01_s_2017_8				
Comment Code					
V2 : Remove the wild growth other than native grasses from the levee slopes.					
Inspector Comment					
Broad leaf thistle and bushes covering landside slope, Fall 2017.

View looking downstream of broad leaf thistle & bushes covering landside slope, Fall 2017.

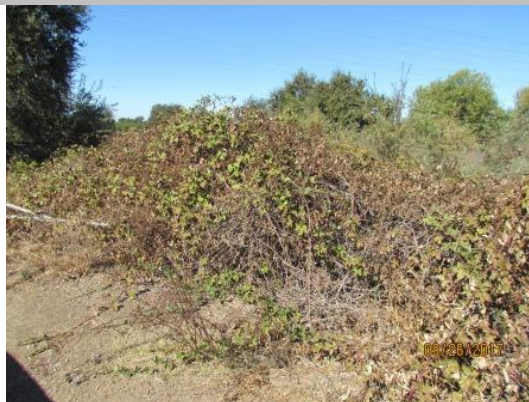
Photo 1 of 1 : SP_2018_NA0006_252_19_20180302_00007.jpg

LM Start	0.02	Rating **	U	Issue No.	19
LM End	0.05	Issue Type +	Ma	Location *	WS
Category	Earthen Levee			GPS Latitude/Longitude	
				Start	End
Item	Vegetation			39.298500 °	39.298995 °
				-121.569508 °	-121.569334 °
DWR ID	DWR_NA0006_01_f_2016_19				
Comment Code					
V2 : Remove the wild growth other than native grasses from the levee slopes.					
Inspector Comment					
Remove Blackberry bushes covering waterside levee slope, Fall 2017.

View of Blackberry bushes covering waterside levee slope, Fall 2017.

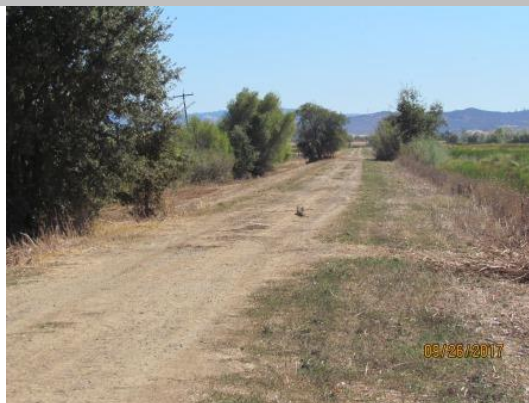
Photo 1 of 1 : SP_2018_NA0006_252_21_20180302_00009.jpg

LM Start	0.02	Rating **	U	Issue No.	21
LM End	0.66	Issue Type +	Ma	Location *	CR
Category	Earthen Levee			GPS Latitude/Longitude	
				Start	End
Item	Crown Surface / Depressions / Rutting			39.298504 °	39.297595 °
				-121.569502 °	-121.558310 °
DWR ID	DWR_NA0006_01_s_2015_21				
Comment Code					
C3 : Add appropriate gravel or road base. Grade and compact.					
Inspector Comment					
Place appropriate gravel on the crown roadway to make it an all weather road, Fall 2017.

View of the crown looking upstream of a section of road that needs all weather surface. Fall 2017.

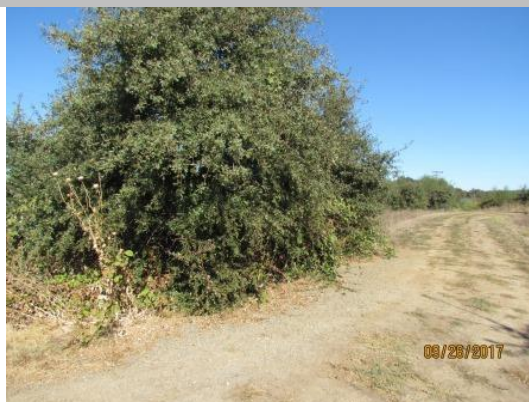
Photo 1 of 1 : SP_2018_NA0006_252_20_20180302_00008.jpg

LM Start	0.02	Rating **	U	Issue No.	20
LM End	0.02	Issue Type +	Ma	Location *	WS
Category	Earthen Levee			GPS Latitude/Longitude	
				Start	End
Item	Trim / Thin Trees			39.298563 °	39.298563 °
				-121.569432 °	-121.569432 °
DWR ID	DWR_NA0006_01_f_2016_20				
Comment Code					
T1 : Trim trees to at least five feet above ground level.					
Inspector Comment					
A tree that needs the limbs trimmed up 5' for visibility and access on the waterside. Fall 2017.

View of a tree that needs the limbs trimmed up 5' for visibility and access on the waterside looking upstream, Fall 2017.

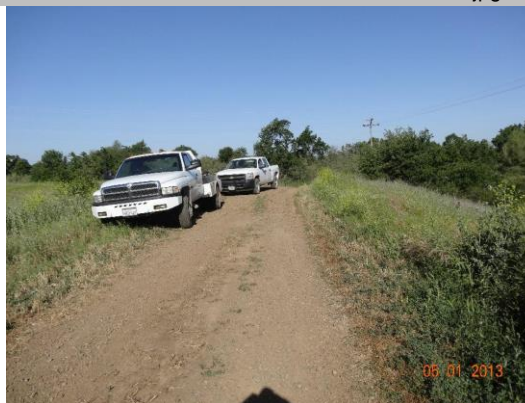
Photo 1 of 3 : UCIP_SP_2018_14732_24241.jpg

LM Start	0.09	Rating **	M	Issue No.	28	
LM End	0.09	Issue Type +	Ma	Location *		
Category	Supplemental			GPS Latitude/Longitude		
				Start		End
Item	DWR UCIP LMA Responsibility			39.299106 °		39.299106 °
				-121.568749 °		-121.568749 °
DWR ID						
Comment Code						
Inspector Comment						
FS_ID:14732 DS_ID:19168 EP_NO: N/A Repair Type: Non-Urgent Crossing Status: Found UCIP Comments: Dense vegetation on waterward side and landward side obstructs inspection. Need to clear vegetation on slopes to conduct proper crossing evaluation. FIELD_STRUCT_DESC: 24-inch corrugated metal drainage pipe through the levee, 10 feet below the crown. Flap gate located on the waterside (WS) end. [Additional Reference(s): DWR Levee Logs, 2005. USACE Sacramento O&M Manual Unit No. 151, November 1953, (Station 5+65)] FS Date: 5/1/2013

Overview of levee crown at crossing looking upstream.

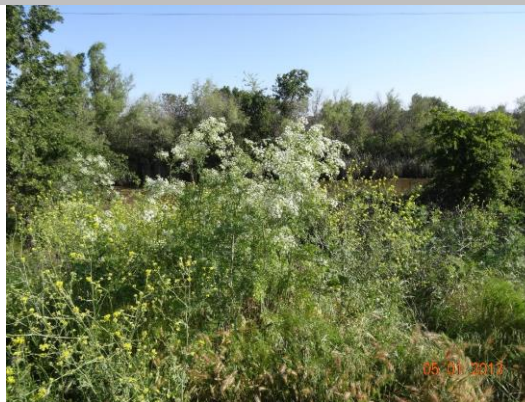
Photo 2 of 3 : UCIP_SP_2018_14732_24236.jpg

Dense vegetation obstructing waterward slope.

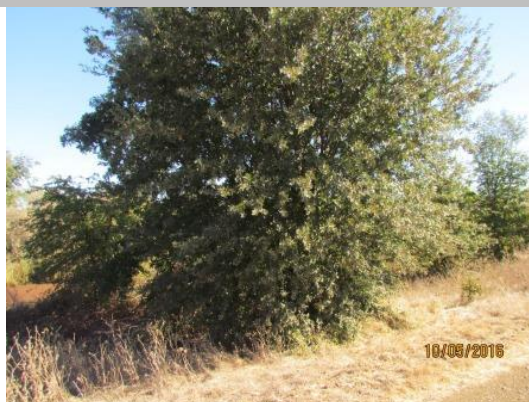
Photo 1 of 1 : SP_2018_NA0006_252_22_20180302_00010.jpg

LM Start	0.10	Rating **	M	Issue No.	22
LM End	0.10	Issue Type +	Ma	Location *	WS
Category	Earthen Levee			GPS Latitude/Longitude	
				Start	End
Item	Trim / Thin Trees			39.299078 °	39.299078 °
				-121.568633 °	-121.568633 °
DWR ID	DWR_NA0006_01_f_2016_22				
Comment Code					
T1 : Trim trees to at least five feet above ground level.					
Inspector Comment					
A tree that needs the limbs trimmed up 5' for visibility and access on the waterside. Fall 2016.

View of a tree that needs the limbs trimmed up 5' for visibility and access on the waterside. Fall 2016.

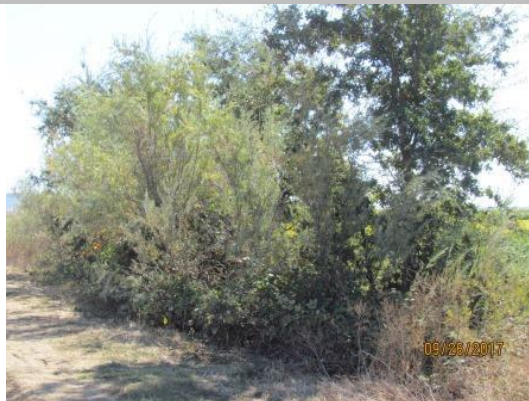
Photo 1 of 1 : SP_2018_NA0006_252_23_20180302_00011.jpg

LM Start	0.21	Rating **	U	Issue No.	23
LM End	0.21	Issue Type +	Ma	Location *	LS
Category	Earthen Levee			GPS Latitude/Longitude	
				Start	End
Item	Trim / Thin Trees			39.298816 °	39.298816 °
				-121.566529 °	-121.566529 °
DWR ID	DWR_NA0006_01_f_2016_23				
Comment Code					
T3 : Trim and thin trees to allow visibility of the ground and room to flood fight.					
Inspector Comment					
Trees that needs the limbs trimmed up 5' for visibility and access on the landside. Fall 2017.

View looking upstream landside of trees that needs the limbs trimmed up 5' for visibility and access on the landside, Fall 2017.

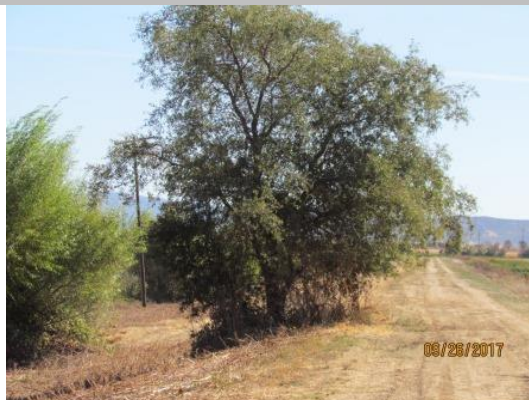
Photo 1 of 1 : SP_2018_NA0006_252_25_20180302_00012.jpg

LM Start	0.23	Rating **	M	Issue No.	25
LM End	0.23	Issue Type +	Ma	Location *	WS
Category	Earthen Levee			GPS Latitude/Longitude	
				Start	End
Item	Trim / Thin Trees			39.298776 °	39.298776 °
				-121.566158 °	-121.566158 °
DWR ID	DWR_NA0006_01_f_2016_25				
Comment Code					
T1 : Trim trees to at least five feet above ground level.					
Inspector Comment					
Tree that needs the limbs trimmed up 5' for visibility and access on the waterside. Fall 2017.

View looking upstream waterside of a tree that needs the limbs trimmed up 5' for visibility and access on the waterside, Fall 2017.

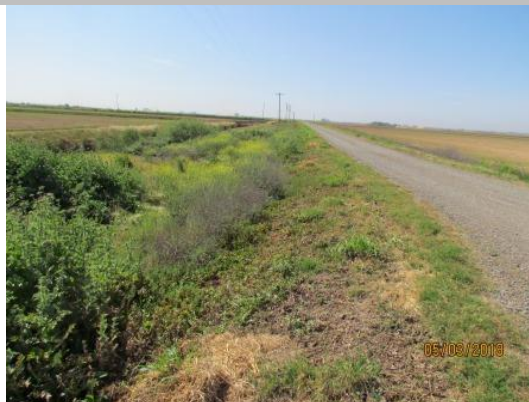
Photo 1 of 1 : SP_2018_NA0006_252_13_20180503_00034.jpg

LM Start	0.66	Rating **	U	Issue No.	13
LM End	1.45	Issue Type +	Ma	Location *	WS
Category	Earthen Levee			GPS Latitude/Longitude	
				Start	End
Item	Vegetation			39.297604 °	39.295250 °
				-121.558325 °	-121.546604 °
DWR ID	DWR_NA0006_01_f_2017_13				
Comment Code					
V1 : Control annual grass and weeds on the levee slopes and easements.					
Inspector Comment					
Annual vegetation needs to be maintained, Spring 2018.

View looking upstream waterside of annual vegetation that needs to be maintained.

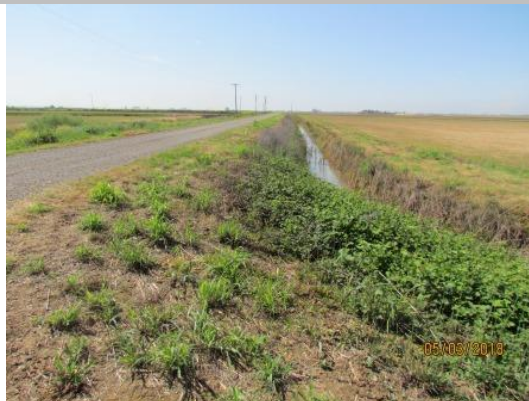
Photo 1 of 1 : SP_2018_NA0006_252_12_20180503_00033.jpg

LM Start	0.67	Rating **	U	Issue No.	12
LM End	1.45	Issue Type +	Ma	Location *	LS
Category	Earthen Levee			GPS Latitude/Longitude	
				Start	End
Item	Vegetation			39.297510 °	39.295259 °
				-121.558330 °	-121.546684 °
DWR ID	DWR_NA0006_01_s_2018_12				
Comment Code					
V1 : Control annual grass and weeds on the levee slopes and easements.					
Inspector Comment					
Annual vegetation needs to be maintained, Spring 2018.

View looking upstream landside of annual vegetation that needs to be maintained.

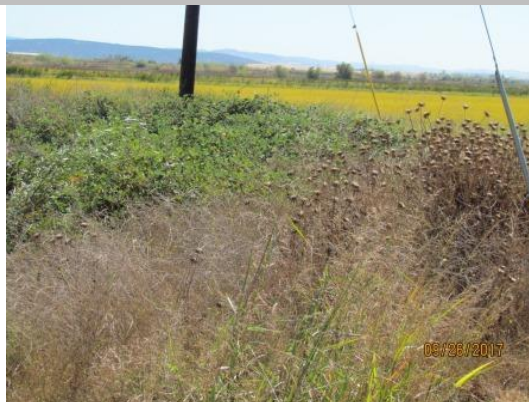
Photo 1 of 1 : SP_2018_NA0006_252_1_20180302_00001.jpg

LM Start	0.85	Rating **	U	Issue No.	1
LM End	0.96	Issue Type +	Ma	Location *	WS
Category	Earthen Levee			GPS Latitude/Longitude	
				Start	End
Item	Vegetation			39.294995 °	39.295021 °
				-121.557823 °	-121.555813 °
DWR ID	DWR_NA0006_01_f_2016_1				
Comment Code					
V2 : Remove the wild growth other than native grasses from the levee slopes.					
Inspector Comment					
Remove Blackberry bushes starting to take over waterside slope. Spring 2017.

View of Blackberry bushes that are starting to cover the waterside slope. Looking upstream waterside, Fall 2017.
