**Flood Control Project Maintenance  
Levee Inspections**

## Maintenance Issue Types Only, Levee Inspection Report By Mile - Spring 2019

### Eastern Honcut Creek

Waterway	Bank	Unit Miles	Inspection Start/End	Inspector
Unit No. 01 Van Tress	Left	1.46	04/24/2019 04/24/2019	Sterling York

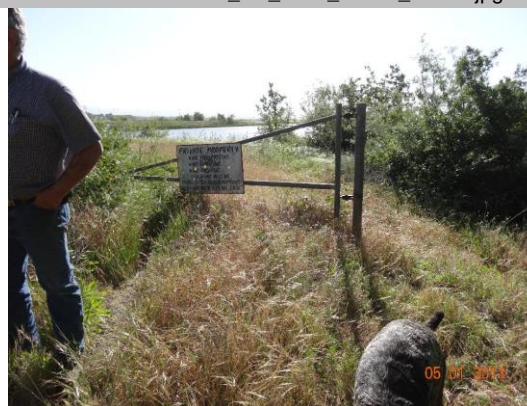
Photo 1 of 3 : UCIP\_SP\_2019\_52800\_24228.jpg

LM Start	0.01	Rating **	M	Issue No.	26
LM End	0.01	Issue Type +	Ma	Location *	
Category	Supplemental			GPS Latitude/Longitude	
				Start	End
Item	DWR UCIP LMA Responsibility			39.298484 °	39.298484 °
				-121.569610 °	-121.569610 °
DWR ID	19167				
Comment Code					
Inspector Comment					
FS_ID:52800 DS_ID:19167 EP_NO: N/A Repair Type: Non-Urgent Crossing Status: Found UCIP Comments: 05/01/2013 Dense vegetation on landward side obstructs inspection. Vegetation needs to be cleared to perform utility crossing inspection. (DWR UCIP - O. Magana) FIELD_STRUCT_DESC: 24-inch corrugated metal drainage pipe through the levee, 12 feet below the crown. Flap gate located on the waterside (WS) end. [Additional Reference(s): DWR Levee Logs, 2005. USACE Sacramento O&M Manual Unit No. 151, November 1953, (Station 0+60)] FS Date: 5/1/2013

View of crown looking east.

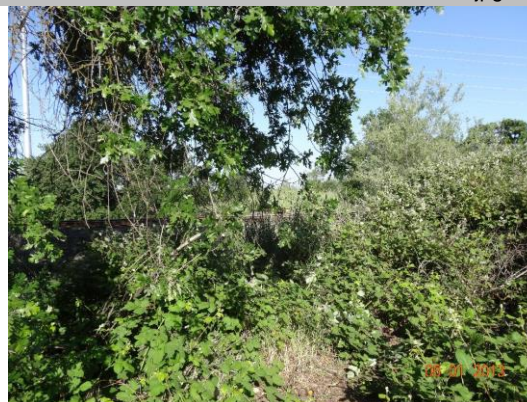
Photo 2 of 3 : UCIP\_SP\_2019\_52800\_24225.jpg

View of railroad looking west of crossing.

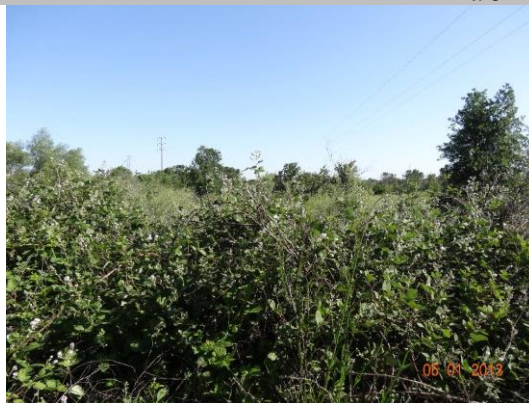
Photo 3 of 3 : UCIP\_SP\_2019\_52800\_24229.jpg

LM Start	0.01	Rating **	M	Issue No.	26 (cont)	
LM End	0.01	Issue Type +	Ma	Location *		
Category	Supplemental			GPS Latitude/Longitude		
				Start		End
Item	DWR UCIP LMA Responsibility			39.298484 °		39.298484 °
				-121.569610 °		-121.569610 °
DWR ID	19167					
Comment Code						
Inspector Comment						
FS_ID:52800 DS_ID:19167 EP_NO: N/A Repair Type: Non-Urgent Crossing Status: Found UCIP Comments: 05/01/2013 Dense vegetation on landward side obstructs inspection. Vegetation needs to be cleared to perform utility crossing inspection. (DWR UCIP - O. Magana) FIELD_STRUCT_DESC: 24-inch corrugated metal drainage pipe through the levee, 12 feet below the crown. Flap gate located on the waterside (WS) end. [Additional Reference(s): DWR Levee Logs, 2005. USACE Sacramento O&M Manual Unit No. 151, November 1953, (Station 0+60)] FS Date: 5/1/2013

Dense vegetation on waterward side obstructing inspection.

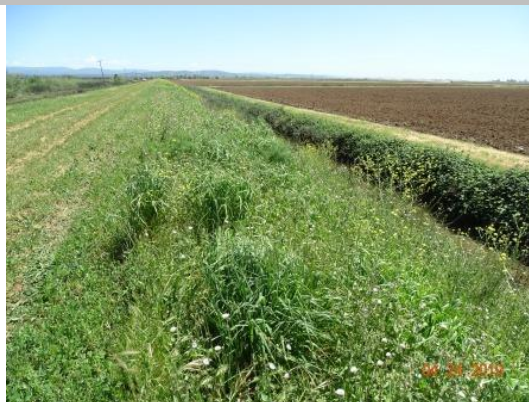
Photo 1 of 1 : SP\_2019\_NA0006\_252\_8\_20190429\_00026.jpg

LM Start	0.02	Rating **	U	Issue No.	8
LM End	0.62	Issue Type +	Ma	Location *	LS
Category	Earthen Levee			GPS Latitude/Longitude	
				Start	End
Item	Vegetation			39.298486 °	39.297887 °
				-121.569504 °	-121.558886 °
DWR ID	DWR_NA0006_01_s_2017_8				
Comment Code					
V2 : Remove the wild growth other than native grasses from the levee slopes.					
Inspector Comment					
Broad leaf thistle and bushes covering landside slope need to be maintained, Spring 2019.

View looking upstream landside at the annual vegetation and wild growth that needs to be maintained, Spring 2019.

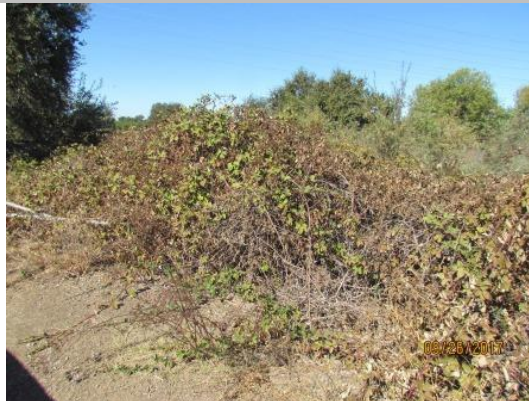
Photo 1 of 1 : SP\_2019\_NA0006\_252\_19\_20190305\_00005.jpg

LM Start	0.02	Rating **	U	Issue No.	19
LM End	0.05	Issue Type +	Ma	Location *	WS
Category	Earthen Levee			GPS Latitude/Longitude	
				Start	End
Item	Vegetation			39.298500 °	39.298995 °
				-121.569508 °	-121.569334 °
DWR ID	DWR_NA0006_01_f_2016_19				
Comment Code					
V2 : Remove the wild growth other than native grasses from the levee slopes.					
Inspector Comment					
Remove blackberry bushes covering waterside levee slope.

View of blackberry bushes covering waterside levee slope, Fall 2017.

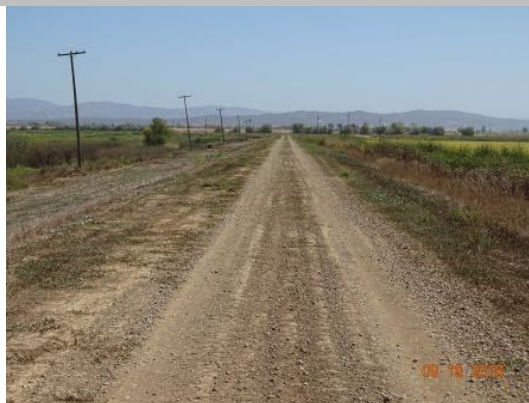
Photo 1 of 1 : SP\_2019\_NA0006\_252\_21\_20190305\_00007.jpg

LM Start	0.02	Rating **	U	Issue No.	21
LM End	0.66	Issue Type +	Ma	Location *	CR
Category	Earthen Levee			GPS Latitude/Longitude	
				Start	End
Item	Crown Surface / Depressions / Rutting			39.298504 °	39.297595 °
				-121.569502 °	-121.558310 °
DWR ID	DWR_NA0006_01_s_2015_21				
Comment Code					
C3 : Add appropriate gravel or road base. Grade and compact.					
Inspector Comment					
Place appropriate gravel on the crown roadway to make it an all weather road.

View of the crown looking upstream of a section of road that needs all weather surface. Fall 2018.

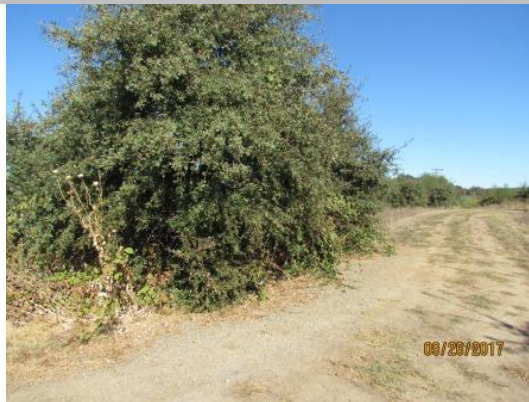
Photo 1 of 1 : SP\_2019\_NA0006\_252\_20\_20190305\_00006.jpg

LM Start	0.02	Rating **	U	Issue No.	20
LM End	0.02	Issue Type +	Ma	Location *	WS
Category	Earthen Levee			GPS Latitude/Longitude	
				Start	End
Item	Trim / Thin Trees			39.298563 °	39.298563 °
				-121.569432 °	-121.569432 °
DWR ID	DWR_NA0006_01_f_2016_20				
Comment Code					
T1 : Trim trees to at least five feet above ground level.					
Inspector Comment					
There is a tree that needs the limbs trimmed up 5' for visibility and access on the waterside.

View of a tree that needs the limbs trimmed up 5' for visibility and access on the waterside looking upstream.

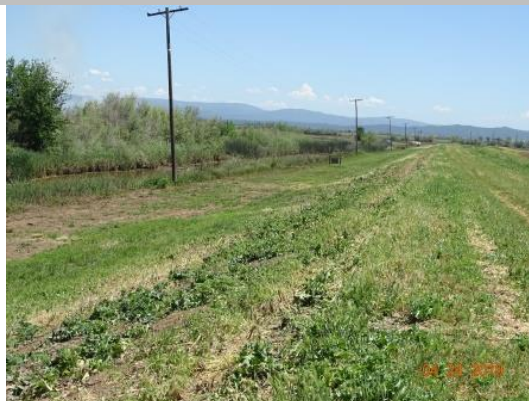
Photo 1 of 1 : SP\_2019\_NA0006\_252\_11\_20190429\_00027.jpg

LM Start	0.06	Rating **	A	Issue No.	11
LM End	0.67	Issue Type +	Ma	Location *	WS
Category	Earthen Levee			GPS Latitude/Longitude	
				Start	End
Item	Vegetation			39.299081 °	39.297468 °
				-121.569246 °	-121.558305 °
DWR ID	DWR_NA0006_01_s_2019_11				
Comment Code					
V1 : Control annual grass and weeds on the levee slopes and easements.					
Inspector Comment					
The annual vegetation is well maintained in this section, Spring 2019.

View looking upstream waterside at the annual vegetation and wild growth that is well maintained in this section, Spring 2019.

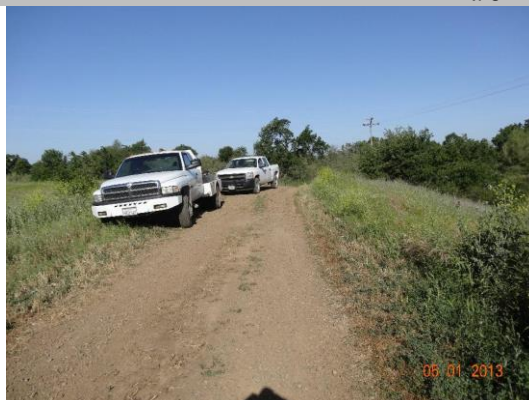
Photo 1 of 3 : UCIP\_SP\_2019\_52801\_24241.jpg

LM Start	0.09	Rating **	M	Issue No.	27	
LM End	0.09	Issue Type +	Ma	Location *		
Category	Supplemental			GPS Latitude/Longitude		
				Start		End
Item	DWR UCIP LMA Responsibility			39.299106 °		39.299106 °
				-121.568749 °		-121.568749 °
DWR ID	19168					
Comment Code						
Inspector Comment						
FS_ID:52801 DS_ID:19168 EP_NO: N/A Repair Type: Non-Urgent Crossing Status: Found UCIP Comments: 05/01/2013 Dense vegetation on waterward side and landward side obstructs inspection. Need to clear vegetation on slopes to conduct proper crossing evaluation. (DWR UCIP - O. Magana) FIELD_STRUCT_DESC: 24-inch corrugated metal drainage pipe through the levee, 10 feet below the crown. Flap gate located on the waterside (WS) end. [Additional Reference(s): DWR Levee Logs, 2005. USACE Sacramento O&M Manual Unit No. 151, November 1953, (Station 5+65)] FS Date: 5/1/2013

Overview of levee crown at crossing looking upstream.

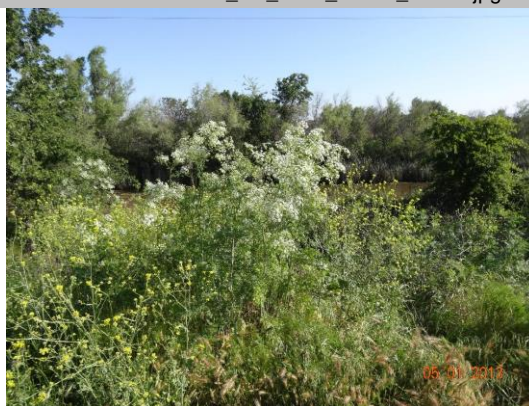
Photo 2 of 3 : UCIP\_SP\_2019\_52801\_24236.jpg

LM Start	0.09	Rating **	M	Issue No.	27 (cont)	
LM End	0.09	Issue Type +	Ma	Location *		
Category	Supplemental			GPS Latitude/Longitude		
				Start		End
Item	DWR UCIP LMA Responsibility			39.299106 °		39.299106 °
				-121.568749 °		-121.568749 °
DWR ID	19168					
Comment Code						
Inspector Comment						
FS_ID:52801 DS_ID:19168 EP_NO: N/A Repair Type: Non-Urgent Crossing Status: Found UCIP Comments: 05/01/2013 Dense vegetation on waterward side and landward side obstructs inspection. Need to clear vegetation on slopes to conduct proper crossing evaluation. (DWR UCIP - O. Magana) FIELD_STRUCT_DESC: 24-inch corrugated metal drainage pipe through the levee, 10 feet below the crown. Flap gate located on the waterside (WS) end. [Additional Reference(s): DWR Levee Logs, 2005. USACE Sacramento O&M Manual Unit No. 151, November 1953, (Station 5+65)] FS Date: 5/1/2013

Dense vegetation obstructing waterward slope.

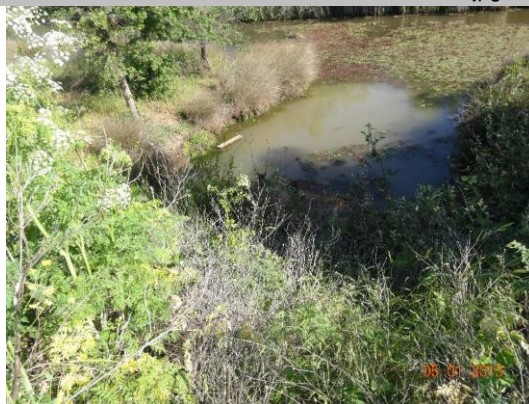
Photo 3 of 3 : UCIP\_SP\_2019\_52801\_24238.jpg

Overview of waterward side (outlet).

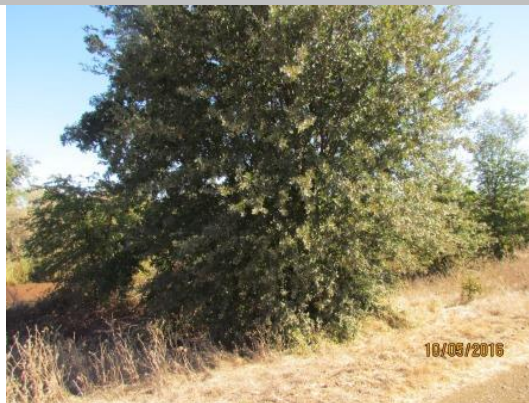
Photo 1 of 1 : SP\_2019\_NA0006\_252\_22\_20190305\_00008.jpg

LM Start	0.10	Rating **	M	Issue No.	22
LM End	0.10	Issue Type +	Ma	Location *	WS
Category	Earthen Levee			GPS Latitude/Longitude	
				Start	End
Item	Trim / Thin Trees			39.299078 °	39.299078 °
				-121.568633 °	-121.568633 °
DWR ID	DWR_NA0006_01_f_2016_22				
Comment Code					
T1 : Trim trees to at least five feet above ground level.					
Inspector Comment					
There is a tree that needs the limbs trimmed up 5' for visibility and access on the waterside.

View of a tree that needs the limbs trimmed up 5' for visibility and access on the waterside.

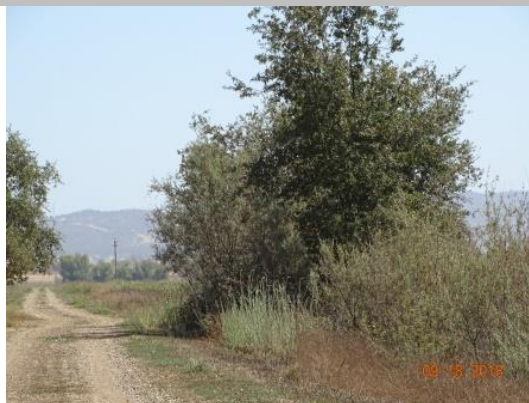
Photo 1 of 1 : SP\_2019\_NA0006\_252\_23\_20190305\_00009.jpg

LM Start	0.21	Rating **	U	Issue No.	23
LM End	0.21	Issue Type +	Ma	Location *	LS
Category	Earthen Levee			GPS Latitude/Longitude	
				Start	End
Item	Trim / Thin Trees			39.298816 °	39.298816 °
				-121.566529 °	-121.566529 °
DWR ID	DWR_NA0006_01_f_2016_23				
Comment Code					
T3 : Trim and thin trees to allow visibility of the ground and room to flood fight.					
Inspector Comment					
There are trees that need the limbs trimmed up 5' for visibility and access on the landside.

View looking upstream landside of trees that need the limbs trimmed up 5' for visibility and access on the landside.

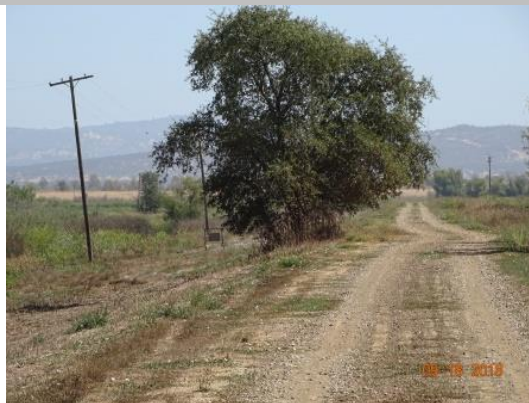
Photo 1 of 1 : SP\_2019\_NA0006\_252\_25\_20190305\_00010.jpg

LM Start	0.23	Rating **	M	Issue No.	25
LM End	0.23	Issue Type +	Ma	Location *	WS
Category	Earthen Levee			GPS Latitude/Longitude	
				Start	End
Item	Trim / Thin Trees			39.298776°	39.298776°
				-121.566158°	-121.566158°
DWR ID	DWR_NA0006_01_f_2016_25				
Comment Code					
T1 : Trim trees to at least five feet above ground level.					
Inspector Comment					
There is a tree that needs the limbs trimmed up 5' for visibility and access on the waterside.

View looking upstream waterside of a tree that needs the limbs trimmed up 5' for visibility and access on the waterside.

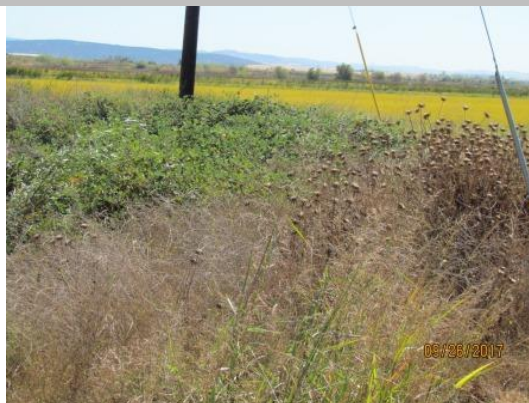
Photo 1 of 1 : SP\_2019\_NA0006\_252\_1\_20190305\_00001.jpg

LM Start	0.85	Rating **	U	Issue No.	1
LM End	0.96	Issue Type +	Ma	Location *	WS
Category	Earthen Levee			GPS Latitude/Longitude	
				Start	End
Item	Vegetation			39.294995 °	39.295021 °
				-121.557823 °	-121.555813 °
DWR ID	DWR_NA0006_01_f_2016_1				
Comment Code					
V2 : Remove the wild growth other than native grasses from the levee slopes.					
Inspector Comment					
Remove blackberry bushes that are starting to take over the waterside slope. Spring 2019.

View of blackberry bushes that are starting to cover the waterside slope. Looking upstream waterside.
