**Flood Control Project Maintenance
Levee Inspections**

Maintenance Issue Types Only, Levee Inspection Report By Mile - Spring 2020

Eastern Honcut Creek

Waterway	Bank	Unit Miles	Inspection Start/End	Inspector
Unit No. 01 Van Tress	Left	1.46	03/24/2020 03/24/2020	Sterling York

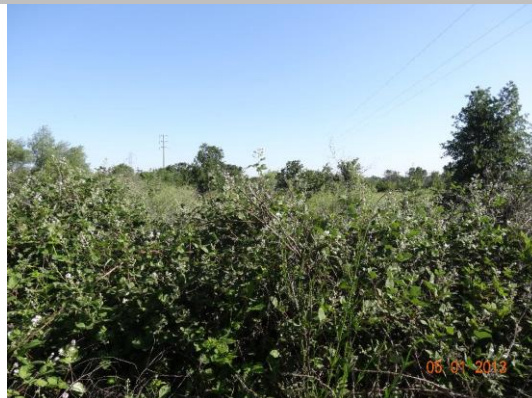
Photo 3 of 3 : UCIP_SP_2020_52800_24229.jpg

LM Start	0.01	Rating **	M	Issue No.	26
LM End	0.01	Issue Type +	Ma	Location *	
Category	Supplemental			GPS Latitude/Longitude	
				Start	End
Item	DWR UCIP LMA Responsibility			39.298484 °	39.298484 °
				-121.569610 °	-121.569610 °
DWR ID	19167				
Comment Code					
Inspector Comment					
DS_ID:19167 FS_ID:52800 EP_NO: N/A Repair Type: Non-Urgent Crossing Status: Found UCIP Comments: 05/01/2013 Dense vegetation on landward side obstructs inspection. Vegetation needs to be cleared to perform utility crossing inspection. (DWR UCIP - O. Magana) FIELD_STRUCT_DESC: 24-inch corrugated metal drainage pipe through the levee, 12 feet below the crown. Flap gate located on the waterside (WS) end. [Additional Reference(s): DWR Levee Logs, 2005. USACE Sacramento O&M Manual Unit No. 151, November 1953, (Station 0+60)] FS Date: 5/1/2013

Dense vegetation on waterward side obstructing inspection.

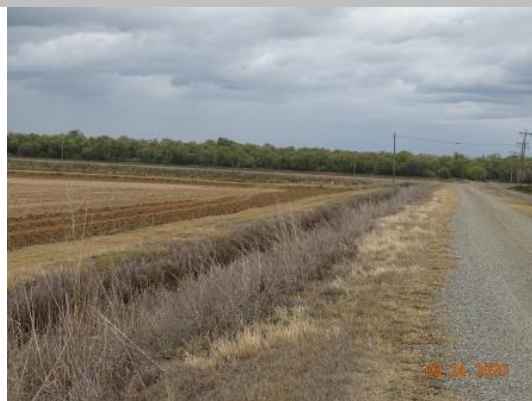
Photo 1 of 1 : SP_2020_NA0006_252_11_20200401_00027.jpg

LM Start	0.02	Rating **	M	Issue No.	11
LM End	1.44	Issue Type +	Ma	Location *	LS
Category	Earthen Levee			GPS Latitude/Longitude	
				Start	End
Item	Vegetation			39.298495 °	39.295257 °
				-121.569508 °	-121.546742 °
DWR ID	DWR_NA0006_01_f_2019_11				
Comment Code					
V1 : Control annual grass and weeds on the levee slopes and easements.					
Inspector Comment					
The annual vegetation on the landside has not been maintained this season, Spring 2020.

View looking downstream landside at the unmaintained annual vegetation, Spring 2020.

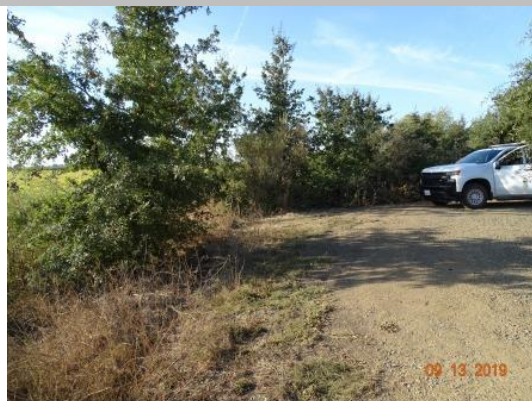
Photo 1 of 1 : SP_2020_NA0006_252_13_20200227_00004.jpg

LM Start	0.02	Rating **	U	Issue No.	13
LM End	0.02	Issue Type +	Ma	Location *	LS
Category	Earthen Levee			GPS Latitude/Longitude	
				Start	End
Item	Trim / Thin Trees			39.298493 °	39.298493 °
				-121.569506 °	-121.569506 °
DWR ID	DWR_NA0006_01_f_2019_13				
Comment Code					
T2 : Thin trees to allow visibility of the ground and room to flood fight.					
Inspector Comment					
There are trees that need the limbs trimmed up 5' for visibility and access on the landside, Spring 2020.

View looking downstream of trees that need the limbs trimmed up 5' for visibility and access on the landside.

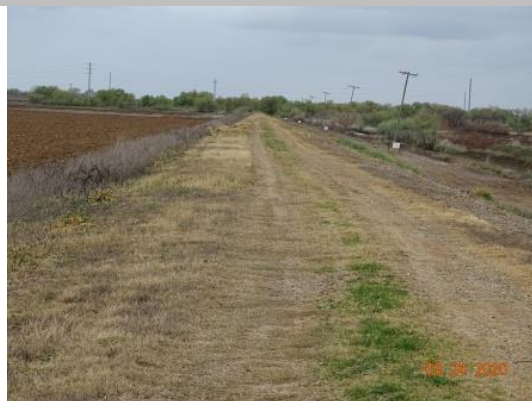
Photo 1 of 1 : SP_2020_NA0006_252_21_20200401_00028.jpg

LM Start	0.02	Rating **	U	Issue No.	21
LM End	0.66	Issue Type +	Ma	Location *	CR
Category	Earthen Levee			GPS Latitude/Longitude	
				Start	End
Item	Crown Surface / Depressions / Rutting			39.298504 °	39.297595 °
				-121.569502 °	-121.558310 °
DWR ID	DWR_NA0006_01_s_2015_21				
Comment Code					
C3 : Add appropriate gravel or road base. Grade and compact.					
Inspector Comment					
Place appropriate gravel on the crown roadway to make it an all weather road, Spring 2020.

View of the crown looking downstream at a section of road that needs all weather surface, Spring 2020.

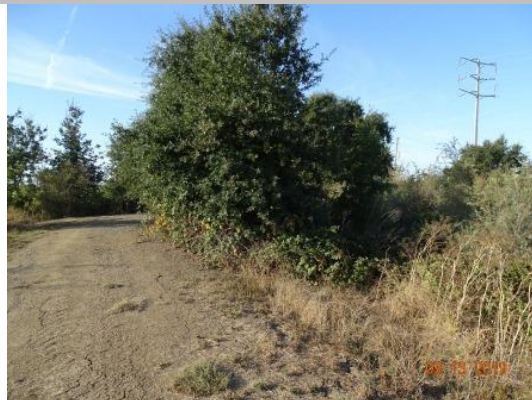
Photo 1 of 1 : SP_2020_NA0006_252_20_20200227_00007.jpg

LM Start	0.02	Rating **	U	Issue No.	20
LM End	0.02	Issue Type +	Ma	Location *	WS
Category	Earthen Levee			GPS Latitude/Longitude	
				Start	End
Item	Trim / Thin Trees			39.298563 °	39.298563 °
				-121.569432 °	-121.569432 °
DWR ID	DWR_NA0006_01_f_2016_20				
Comment Code					
T1 : Trim trees to at least five feet above ground level.					
Inspector Comment					
There is a tree that needs the limbs trimmed up 5' for visibility and access on the waterside, Spring 2020.

View of a tree that needs the limbs trimmed up 5' for visibility and access on the waterside looking downstream.

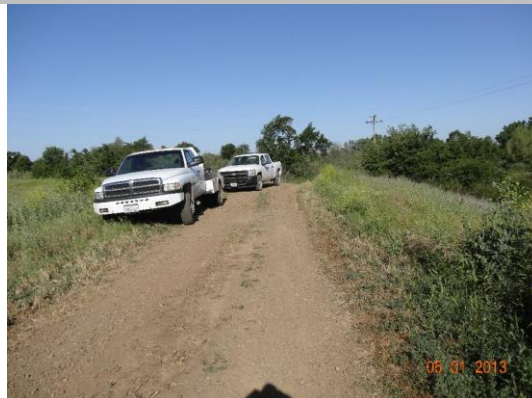
Photo 1 of 3 : UCIP_SP_2020_52801_24241.jpg

Overview of levee crown at crossing looking upstream.

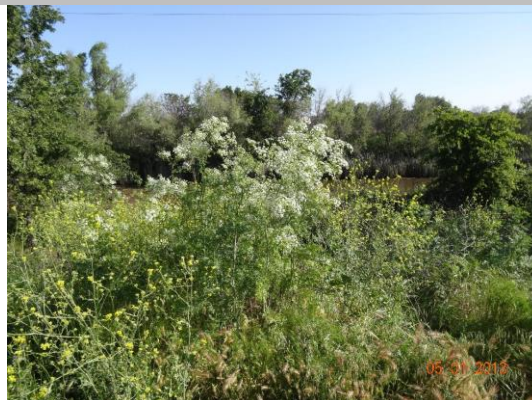
Photo 2 of 3 : UCIP_SP_2020_52801_24236.jpg

LM Start	0.09	Rating **	M	Issue No.	27
LM End	0.09	Issue Type +	Ma	Location *	
Category	Supplemental			GPS Latitude/Longitude	
				Start	End
Item	DWR UCIP LMA Responsibility			39.299106 °	39.299106 °
				-121.568749 °	-121.568749 °
DWR ID	19168				
Comment Code					
Inspector Comment					
DS_ID:19168 FS_ID:52801 EP_NO: N/A Repair Type: Non-Urgent Crossing Status: Found UCIP Comments: 05/01/2013 Dense vegetation on waterward side and landward side obstructs inspection. Need to clear vegetation on slopes to conduct proper crossing evaluation. (DWR UCIP - O. Magana) FIELD_STRUCT_DESC: 24-inch corrugated metal drainage pipe through the levee, 10 feet below the crown. Flap gate located on the waterside (WS) end. [Additional Reference(s): DWR Levee Logs, 2005. USACE Sacramento O&M Manual Unit No. 151, November 1953, (Station 5+65)] FS Date: 5/1/2013

Dense vegetation obstructing waterward slope.

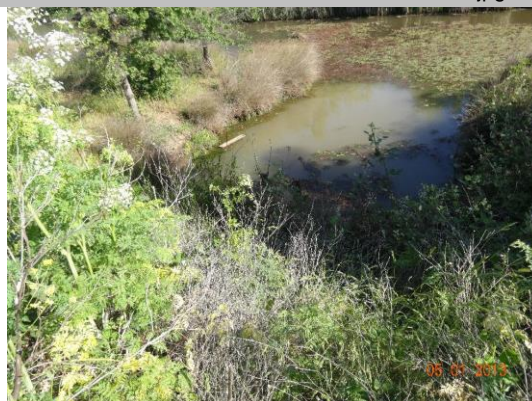
Photo 3 of 3 : UCIP_SP_2020_52801_24238.jpg

Overview of waterward side (outlet).

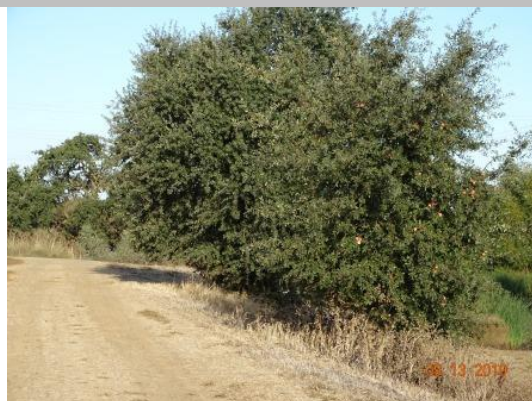
Photo 1 of 1 : SP_2020_NA0006_252_22_20200227_00009.jpg

LM Start	0.10	Rating **	M	Issue No.	22
LM End	0.10	Issue Type +	Ma	Location *	WS
Category	Earthen Levee			GPS Latitude/Longitude	
				Start	End
Item	Trim / Thin Trees			39.299078 °	39.299078 °
				-121.568633 °	-121.568633 °
DWR ID	DWR_NA0006_01_f_2016_22				
Comment Code					
T1 : Trim trees to at least five feet above ground level.					
Inspector Comment					
There is a tree that needs the limbs trimmed up 5' for visibility and access on the waterside, Spring 2020.

View looking downstream waterside of a tree that needs the limbs trimmed up 5' for visibility and access.

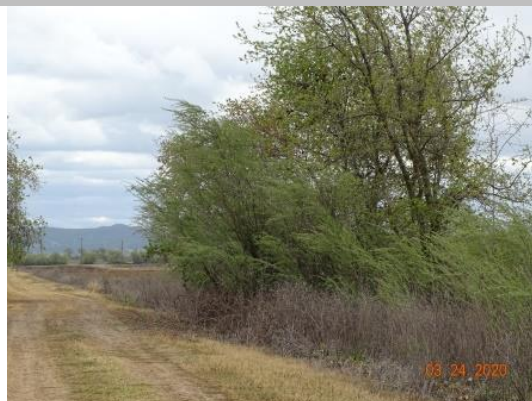
Photo 1 of 1 : SP_2020_NA0006_252_23_20200401_00029.jpg

LM Start	0.21	Rating **	U	Issue No.	23
LM End	0.21	Issue Type +	Ma	Location *	LS
Category	Earthen Levee			GPS Latitude/Longitude	
				Start	End
Item	Trim / Thin Trees			39.298816 °	39.298816 °
				-121.566529 °	-121.566529 °
DWR ID	DWR_NA0006_01_f_2016_23				
Comment Code					
T3 : Trim and thin trees to allow visibility of the ground and room to flood fight.					
Inspector Comment					
There are trees that need the limbs trimmed up 5' for visibility and access on the landside, Spring 2020.

View looking upstream landside of trees that need the limbs trimmed up 5' for visibility and access on the landside, Spring 2020.

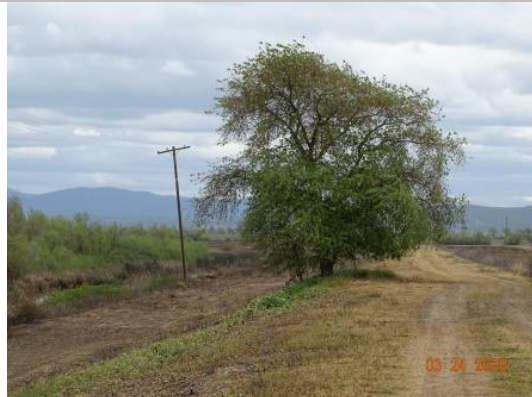
Photo 1 of 1 : SP_2020_NA0006_252_25_20200401_00030.jpg

LM Start	0.23	Rating **	M	Issue No.	25
LM End	0.23	Issue Type +	Ma	Location *	WS
Category	Earthen Levee			GPS Latitude/Longitude	
				Start	End
Item	Trim / Thin Trees			39.298776 °	39.298776 °
				-121.566158 °	-121.566158 °
DWR ID	DWR_NA0006_01_f_2016_25				
Comment Code					
T1 : Trim trees to at least five feet above ground level.					
Inspector Comment					
There is a tree that needs the limbs trimmed up 5' for visibility and access on the waterside, Spring 2020.

View looking upstream waterside of a tree that needs the limbs trimmed up 5' for visibility and access on the waterside, Spring 2020.

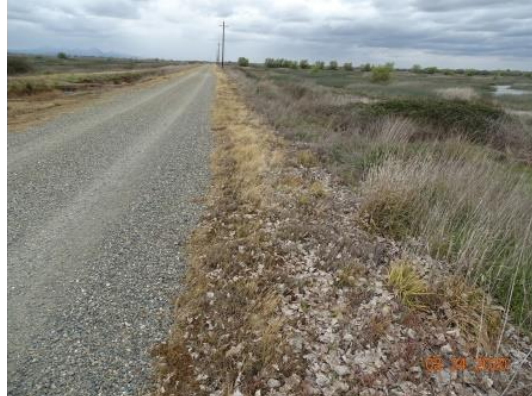
Photo 1 of 1 : SP_2020_NA0006_252_12_20200401_00031.jpg

LM Start	0.66	Rating **	M	Issue No.	12
LM End	0.85	Issue Type +	Ma	Location *	WS
Category	Earthen Levee			GPS Latitude/Longitude	
				Start	End
Item	Vegetation			39.297589 °	39.294995 °
				-121.558342 °	-121.557823 °
DWR ID	DWR_NA0006_01_f_2019_12				
Comment Code					
V1 : Control annual grass and weeds on the levee slopes and easements.					
Inspector Comment					
The annual vegetation on the waterside in this section has not been maintained this season, Spring 2020.

View looking downstream waterside at the section of unmaintained annual vegetation, Spring 2020.

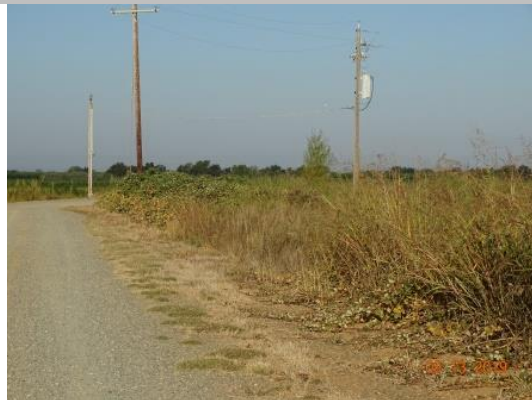
Photo 1 of 1 : SP_2020_NA0006_252_1_20200227_00001.jpg

LM Start	0.85	Rating **	U	Issue No.	1
LM End	0.96	Issue Type +	Ma	Location *	WS
Category	Earthen Levee			GPS Latitude/Longitude	
				Start	End
Item	Vegetation			39.294995 °	39.295021 °
				-121.557823 °	-121.555813 °
DWR ID	DWR_NA0006_01_f_2016_1				
Comment Code					
V2 : Remove the wild growth other than native grasses from the levee slopes.					
Inspector Comment					
Remove blackberry bushes that are taking over the waterside slope, Spring 2020.

View of blackberry bushes that are covering the waterside slope.
Looking downstream waterside.
