**Flood Control Project Maintenance
Levee Inspections**

Maintenance Issue Types Only, Levee Inspection Report By Mile - Spring 2021

Eastern Honcut Creek

Waterway	Bank	Unit Miles	Inspection Start/End	Inspector
Unit No. 01 Van Tress	Left	1.46	03/03/2021 03/03/2021	Brooks Weisser

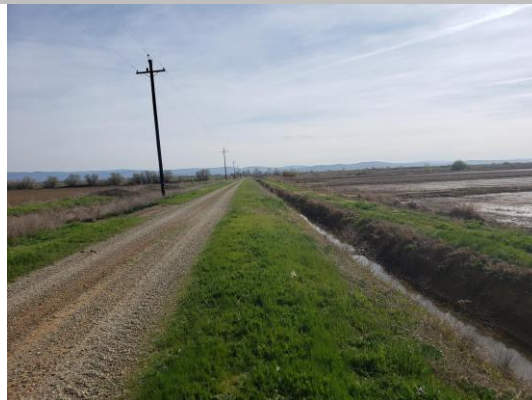
Photo 1 of 1 : SP_2021_NA0006_252_8_20210309_00039.jpg

LM Start	0.00	Rating **	U	Issue No.	8
LM End	1.45	Issue Type +	Ma	Location *	LS
Category	Earthen Levee			GPS Latitude/Longitude	
				Start	End
Item	Vegetation			39.295247 °	39.298504 °
				-121.546537 °	-121.569812 °
DWR ID	DWR_NA0006_01_f_2020_8				
Comment Code					
V1 : Control annual grass and weeds on the levee slopes and easements.					
Inspector Comment					
Annual vegetation needs to be removed, Spring 2021.

View looking upstream landside of annual vegetation that needs to be maintained, Spring 2021

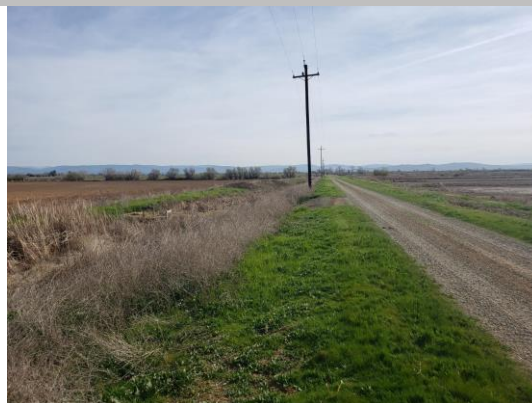
Photo 1 of 1 : SP_2021_NA0006_252_11_20210309_00040.jpg

LM Start	0.00	Rating **	U	Issue No.	11
LM End	1.45	Issue Type +	Ma	Location *	WS
Category	Earthen Levee			GPS Latitude/Longitude	
				Start	End
Item	Vegetation			39.295247 °	39.298504 °
				-121.546537 °	-121.569812 °
DWR ID	DWR_NA0006_01_f_2020_11				
Comment Code					
V1 : Control annual grass and weeds on the levee slopes and easements.					
Inspector Comment					
Annual vegetation needs to be removed, Spring 2021.

View looking upstream waterside of annual vegetation that needs to be maintained, Spring 2021.

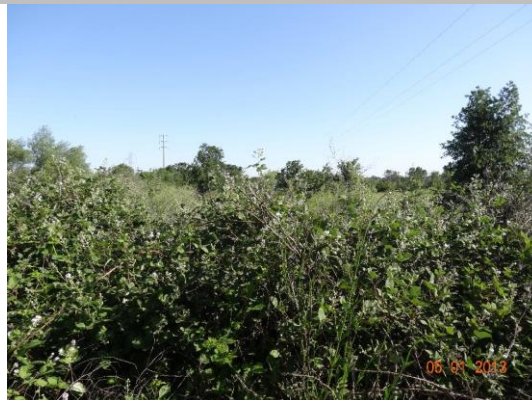
Photo 3 of 3 : UCIP_SP_2021_52800_24229.jpg

Dense vegetation on waterward side obstructing inspection.

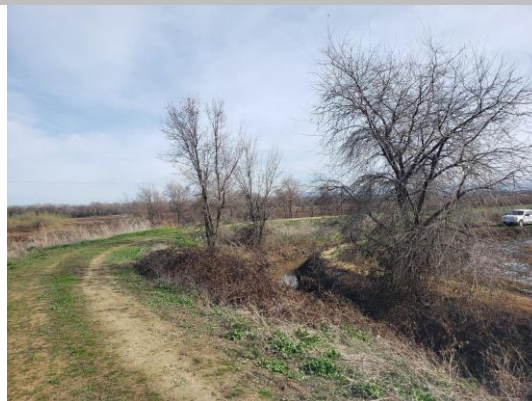
Photo 1 of 1 : SP_2021_NA0006_252_13_20210309_00029.jpg

View looking upstream of trees that need the limbs trimmed up 5' for visibility and access on the landside, Spring 2021.

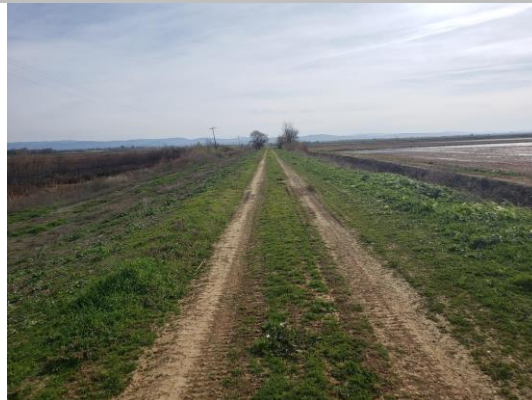
Photo 1 of 1 : SP_2021_NA0006_252_21_20210309_00033.jpg

View of the crown looking upstream of a section of road that needs all weather surface, Spring 2021.

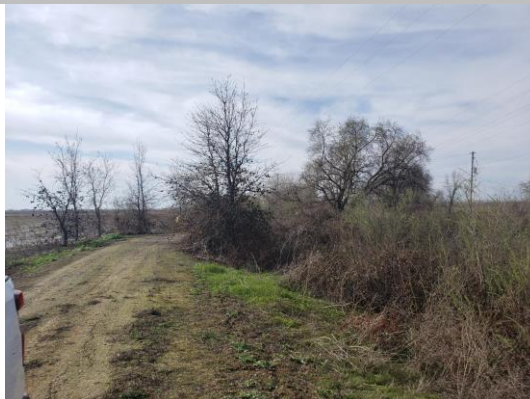
Photo 1 of 1 : SP_2021_NA0006_252_20_20210309_00030.jpg

LM Start	0.02	Rating **	U	Issue No.	20
LM End	0.02	Issue Type +	Ma	Location *	WS
Category	Earthen Levee			GPS Latitude/Longitude	
				Start	End
Item	Trim / Thin Trees			39.298563 °	39.298563 °
				-121.569432 °	-121.569432 °
DWR ID	DWR_NA0006_01_f_2016_20				
Comment Code					
T1 : Trim trees to at least five feet above ground level.					
Inspector Comment					
There is a tree that needs the limbs trimmed up 5' for visibility and access on the waterside, Spring 2021.

View of a tree that needs the limbs trimmed up 5' for visibility and access on the waterside looking down stream, Spring 2021.

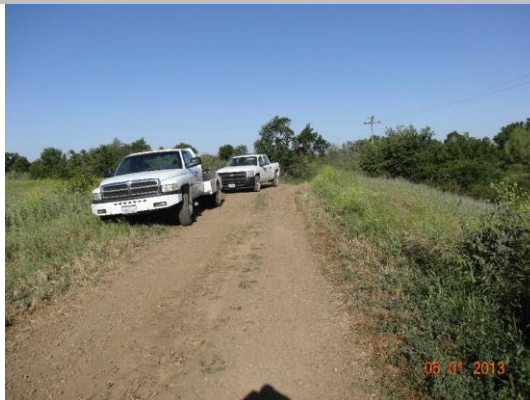
Photo 1 of 3 : UCIP_SP_2021_52801_24241.jpg

LM Start	0.09	Rating **	M	Issue No.	3	
LM End	0.09	Issue Type +	Ma	Location *		
Category	Supplemental			GPS Latitude/Longitude		
				Start		End
Item	DWR UCIP LMA Responsibility			39.299106 °		39.299106 °
				-121.568749 °		-121.568749 °
DWR ID	19168					
Comment Code						
Inspector Comment						
FS_ID:52801 DS_ID:19168 EP_NO: N/A Repair Type: Non-Urgent Crossing Status: Found UCIP Comments: 05/01/2013 Dense vegetation on waterward side and landward side obstructs inspection. Need to clear vegetation on slopes to conduct proper crossing evaluation. (DWR UCIP - O. Magana) FIELD_STRUCT_DESC: 24-inch corrugated metal drainage pipe through the levee, 10 feet below the crown. Flap gate located on the waterside (WS) end. [Additional Reference(s): DWR Levee Logs, 2005. USACE Sacramento O&M Manual Unit No. 151, November 1953, (Station 5+65)] FS Date: 5/1/2013

Overview of levee crown at crossing looking upstream.

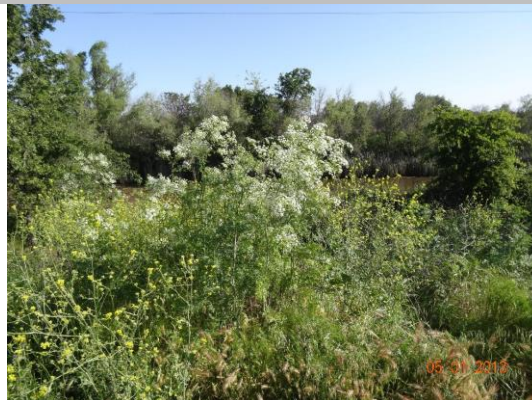
Photo 2 of 3 : UCIP_SP_2021_52801_24236.jpg

Dense vegetation obstructing waterward slope.

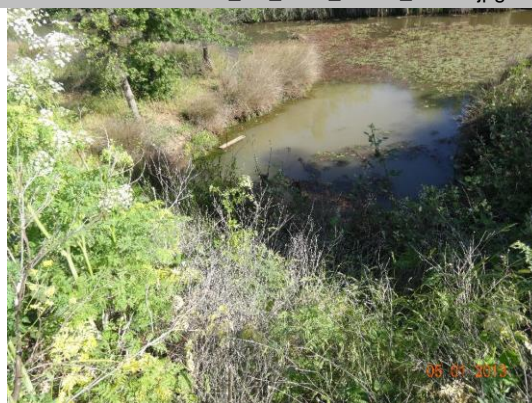
Photo 3 of 3 : UCIP_SP_2021_52801_24238.jpg

Overview of waterward side (outlet).

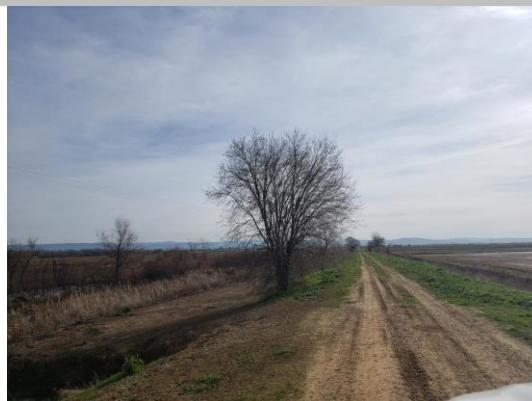
Photo 1 of 1 : SP_2021_NA0006_252_22_20210309_00031.jpg

LM Start	0.10	Rating **	M	Issue No.	22
LM End	0.10	Issue Type +	Ma	Location *	WS
Category	Earthen Levee			GPS Latitude/Longitude	
				Start	End
Item	Trim / Thin Trees			39.299078 °	39.299078 °
				-121.568633 °	-121.568633 °
DWR ID	DWR_NA0006_01_f_2016_22				
Comment Code					
T1 : Trim trees to at least five feet above ground level.					
Inspector Comment					
There is a tree that needs the limbs trimmed up 5' for visibility and access on the waterside, Spring 2021.

View looking upstream waterside of a tree that needs the limbs trimmed up 5' for visibility and access, Spring 2021.

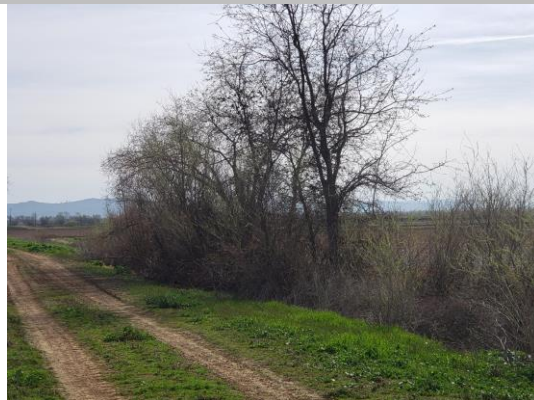
Photo 1 of 1 : SP_2021_NA0006_252_23_20210309_00032.jpg

LM Start	0.21	Rating **	U	Issue No.	23
LM End	0.21	Issue Type +	Ma	Location *	LS
Category	Earthen Levee			GPS Latitude/Longitude	
				Start	End
Item	Trim / Thin Trees			39.298816 °	39.298816 °
				-121.566529 °	-121.566529 °
DWR ID	DWR_NA0006_01_f_2016_23				
Comment Code					
T3 : Trim and thin trees to allow visibility of the ground and room to flood fight.					
Inspector Comment					
There are trees that need the limbs trimmed up 5' for visibility and access on the landside, Spring 2021.

View looking upstream landside of trees that need the limbs trimmed up 5' for visibility and access on the landside, Spring 2021.

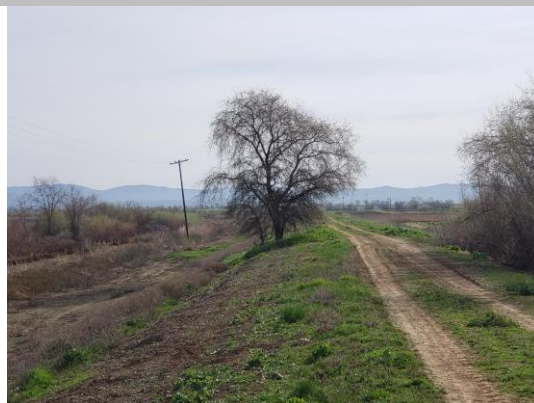
Photo 1 of 1 : SP_2021_NA0006_252_25_20210309_00034.jpg

LM Start	0.23	Rating **	M	Issue No.	25
LM End	0.23	Issue Type +	Ma	Location *	WS
Category	Earthen Levee			GPS Latitude/Longitude	
				Start	End
Item	Trim / Thin Trees			39.298776 °	39.298776 °
				-121.566158 °	-121.566158 °
DWR ID	DWR_NA0006_01_f_2016_25				
Comment Code					
T1 : Trim trees to at least five feet above ground level.					
Inspector Comment					
There is a tree that needs the limbs trimmed up 5' for visibility and access on the waterside, Spring 2021.

View looking downstream waterside of a tree that needs the limbs trimmed up 5' for visibility and access on the waterside, Spring 2021.

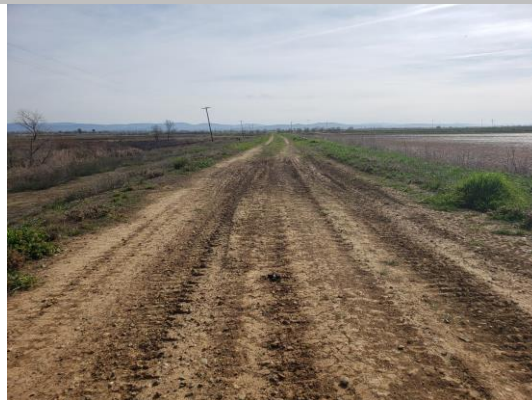
Photo 1 of 1 : SP_2021_NA0006_252_12_20210309_00035.jpg

LM Start	0.43	Rating **	M	Issue No.	12
LM End	0.43	Issue Type +	Ma	Location *	CR
Category	Earthen Levee			GPS Latitude/Longitude	
				Start	End
Item	Crown Surface / Depressions / Rutting			39.298322 °	39.298322 °
				-121.562439 °	-121.562439 °
DWR ID	DWR_NA0006_01_s_2021_12				
Comment Code					
C2 : Repair depressions or ruts in the crown or slope.					
Inspector Comment					
Depressions and ruts in levee crown need to be repaired, Spring 2021

View looking upstream of rutting on the levee crown that should be repaired, Spring 2021.

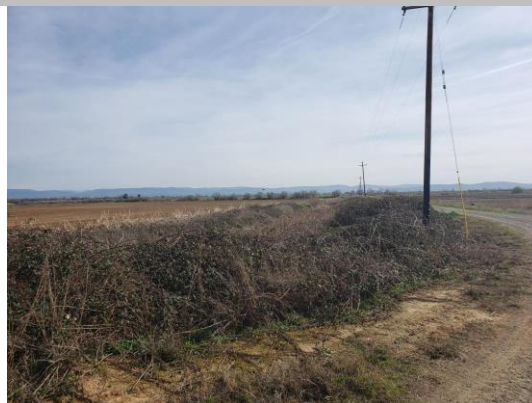
Photo 1 of 1 : SP_2021_NA0006_252_1_20210309_00038.jpg

LM Start	0.85	Rating **	U	Issue No.	1
LM End	0.96	Issue Type +	Ma	Location *	WS
Category	Earthen Levee			GPS Latitude/Longitude	
				Start	End
Item	Vegetation			39.294995 °	39.295021 °
				-121.557823 °	-121.555813 °
DWR ID	DWR_NA0006_01_f_2016_1				
Comment Code					
V2 : Remove the wild growth other than native grasses from the levee slopes.					
Inspector Comment					
Remove blackberry bushes that are taking over the waterside slope, Fall 2020.

View of blackberry bushes that are covering the waterside slope. Looking upstream waterside, Spring 2021
