**Flood Control Project Maintenance
Levee Inspections**

Maintenance Issue Types Only, Levee Inspection Report By Mile - Spring 2022

Eastern Honcut Creek

Waterway	Bank	Unit Miles	Inspection Start/End	Inspector
Unit No. 01 Van Tress	Left	1.46	03/17/2022 03/17/2022	Brooks Weisser

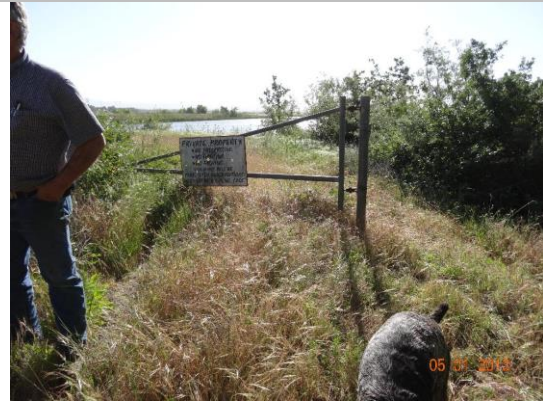
Photo 1 of 3 : UCIP_SP_2022_52800_24228.jpg

LM Start	0.01	Rating **	M	Issue No.	2	
LM End	0.01	Issue Type +	Ma	Location *		
Category	Supplemental			GPS Latitude/Longitude		
				Start	End	
Item	DWR UCIP LMA Responsibility			39.298484 °	39.298484 °	
				-121.569610 °	-121.569610 °	
DWR ID	19167					
Comment Code						
Inspector Comment						
FS_ID:52800 DS_ID:19167 EP_NO: N/A Repair Type: Non-Urgent Crossing Status: Found UCIP Comments: 05/01/2013 Dense vegetation on landward side obstructs inspection. Vegetation needs to be cleared to perform utility crossing inspection. (DWR UCIP - O. Magana) FIELD_STRUCT_DESC: 24-inch corrugated metal drainage pipe through the levee, 12 feet below the crown. Flap gate located on the waterside (WS) end. [Additional Reference(s): DWR Levee Logs, 2005. USACE Sacramento O&M Manual Unit No. 151, November 1953, (Station 0+60)] FS Date: 5/1/2013

View of crown looking east.

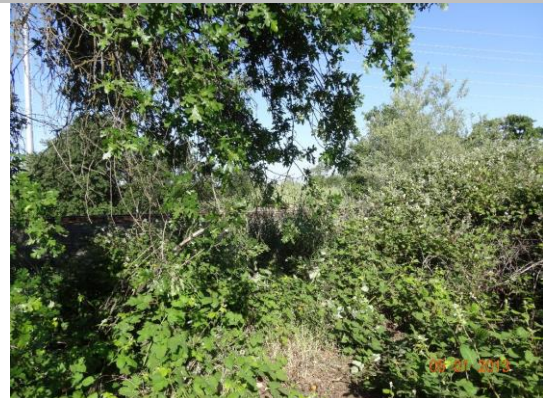
Photo 2 of 3 : UCIP_SP_2022_52800_24225.jpg

View of railroad looking west of crossing.

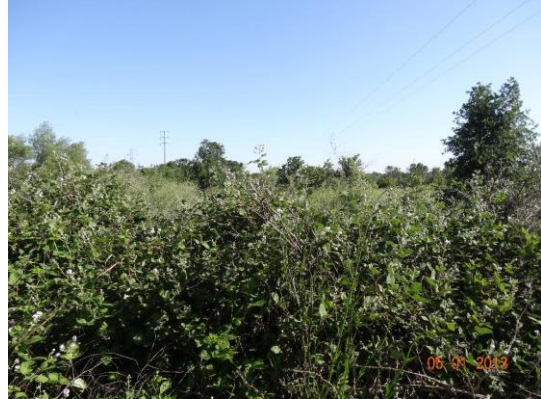
Photo 3 of 3 : UCIP_SP_2022_52800_24229.jpg

Dense vegetation on waterward side obstructing inspection.

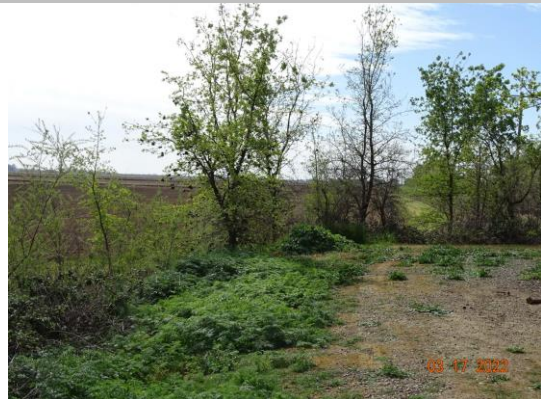
Photo 1 of 1 : SP_2022_NA0006_252_13_20220318_00027.jpg

LM Start	0.02	Rating **	U	Issue No.	13
LM End	0.02	Issue Type +	Ma	Location *	LS
Category	Earthen Levee			GPS Latitude/Longitude	
				Start	End
Item	Trim / Thin Trees			39.298493 °	39.298493 °
				-121.569506 °	-121.569506 °
DWR ID	DWR_NA0006_01_f_2019_13				
Comment Code					
T1 : Trim and thin trees to at least five feet above ground level to allow visibility of the ground and room to flood fight.					
Inspector Comment					
There are trees that need the limbs trimmed up 5' for visibility and access on the landside, Spring 2022.

View looking downstream of trees that need the limbs trimmed up 5' for visibility and access on the landside, Spring 2022.

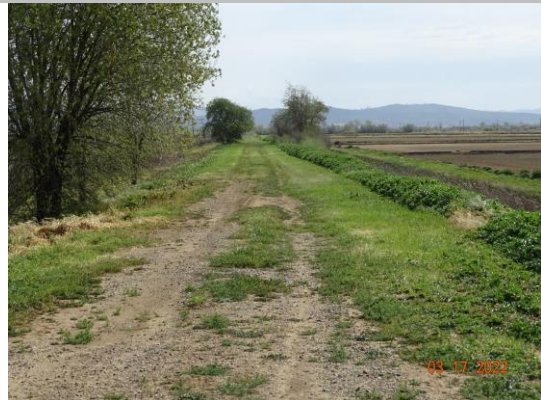
Photo 1 of 1 : SP_2022_NA0006_252_21_20220318_00029.jpg

LM Start	0.02	Rating **	U	Issue No.	21
LM End	0.66	Issue Type +	Ma	Location *	CR
Category	Earthen Levee			GPS Latitude/Longitude	
				Start	End
Item	Crown Surface / Depressions / Rutting			39.298504 °	39.297595 °
				-121.569502 °	-121.558310 °
DWR ID	DWR_NA0006_01_s_2015_21				
Comment Code					
C3 : Add appropriate gravel or road base. Grade and compact.					
Inspector Comment					
Place appropriate gravel on the crown roadway to make it an all weather road, Spring 2022.

View of the crown looking upstream of a section of road that needs all weather surface, Spring 2022.

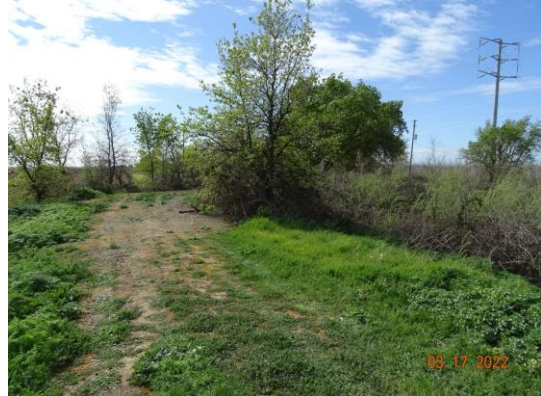
Photo 1 of 1 : SP_2022_NA0006_252_20_20220318_00028.jpg

LM Start	0.02	Rating **	U	Issue No.	20
LM End	0.02	Issue Type +	Ma	Location *	WS
Category	Earthen Levee			GPS Latitude/Longitude	
				Start	End
Item	Trim / Thin Trees			39.298563 °	39.298563 °
				-121.569432 °	-121.569432 °
DWR ID	DWR_NA0006_01_f _ 2016_20				
Comment Code					
T1 : Trim and thin trees to at least five feet above ground level to allow visibility of the ground and room to flood fight.					
Inspector Comment					
There is a tree that needs the limbs trimmed up 5' for visibility and access on the waterside, Spring 2022.

View of a tree that needs the limbs trimmed up 5' for visibility and access on the waterside looking down stream, Spring 2022.

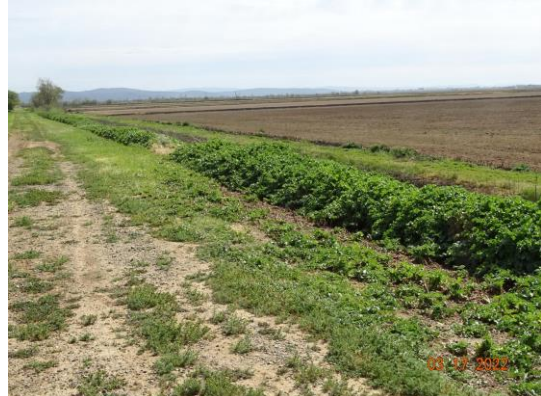
Photo 1 of 1 : SP_2022_NA0006_252_11_20220318_00030.jpg

LM Start	0.07	Rating **	M	Issue No.	11
LM End	0.75	Issue Type +	Ma	Location *	LS
Category	Earthen Levee			GPS Latitude/Longitude	
				Start	End
Item	Vegetation			39.299138 °	39.296292 °
				-121.569096 °	-121.558178 °
DWR ID	DWR_NA0006_01_s_2022_11				
Comment Code					
V1 : Control annual grass and weeds on the levee slopes and easements.					
Inspector Comment					
Annual vegetation needs to be maintained, Spring 2022.

View of annual vegetation on the landside slope that needs to be maintained, Spring 2022.

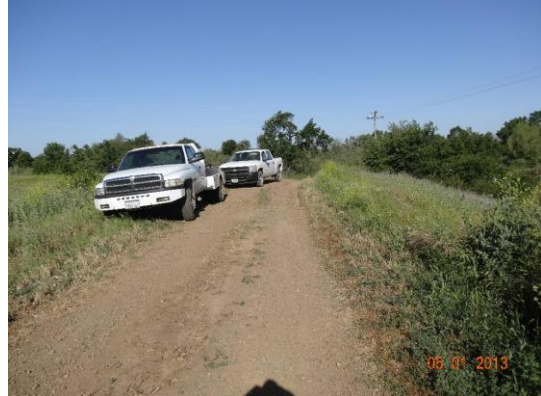
Photo 1 of 3 : UCIP_SP_2022_52801_24241.jpg

LM Start	0.09	Rating **	M	Issue No.	3	
LM End	0.09	Issue Type +	Ma	Location *		
Category	Supplemental			GPS Latitude/Longitude		
				Start		End
Item	DWR UCIP LMA Responsibility			39.299106 °	39.299106 °	
				-121.568749 °	-121.568749 °	
DWR ID	19168					
Comment Code						
Inspector Comment						
FS_ID:52801 DS_ID:19168 EP_NO: N/A Repair Type: Non-Urgent Crossing Status: Found UCIP Comments: 05/01/2013 Dense vegetation on waterward side and landward side obstructs inspection. Need to clear vegetation on slopes to conduct proper crossing evaluation. (DWR UCIP - O. Magana) FIELD_STRUCT_DESC: 24-inch corrugated metal drainage pipe through the levee, 10 feet below the crown. Flap gate located on the waterside (WS) end. [Additional Reference(s): DWR Levee Logs, 2005. USACE Sacramento O&M Manual Unit No. 151, November 1953, (Station 5+65)] FS Date: 5/1/2013

Overview of levee crown at crossing looking upstream.

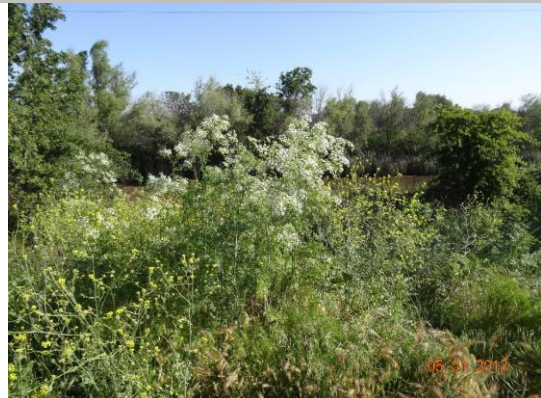
Photo 2 of 3 : UCIP_SP_2022_52801_24236.jpg

Dense vegetation obstructing waterward slope.

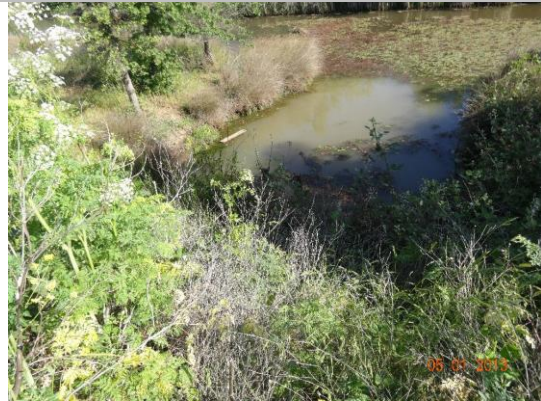
Photo 3 of 3 : UCIP_SP_2022_52801_24238.jpg

Overview of waterward side (outlet).

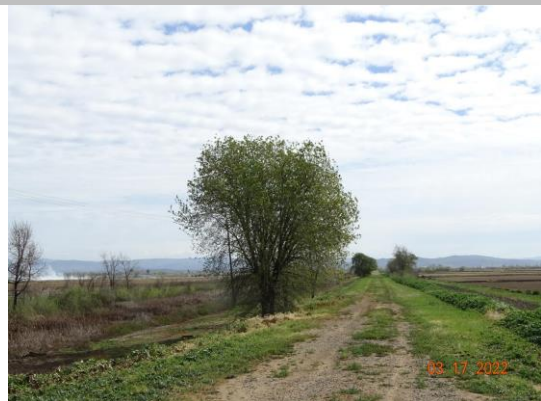
Photo 1 of 1 : SP_2022_NA0006_252_22_20220318_00031.jpg

LM Start	0.10	Rating **	M	Issue No.	22
LM End	0.10	Issue Type +	Ma	Location *	WS
Category	Earthen Levee			GPS Latitude/Longitude	
				Start	End
Item	Trim / Thin Trees			39.299078 °	39.299078 °
				-121.568633 °	-121.568633 °
DWR ID	DWR_NA0006_01_f _ 2016_22				
Comment Code					
T1 : Trim and thin trees to at least five feet above ground level to allow visibility of the ground and room to flood fight.					
Inspector Comment					
There is a tree that needs the limbs trimmed up 5' for visibility and access on the waterside, Spring 2022.

View looking upstream waterside of a tree that needs the limbs trimmed up 5' for visibility and access, Spring 2022.

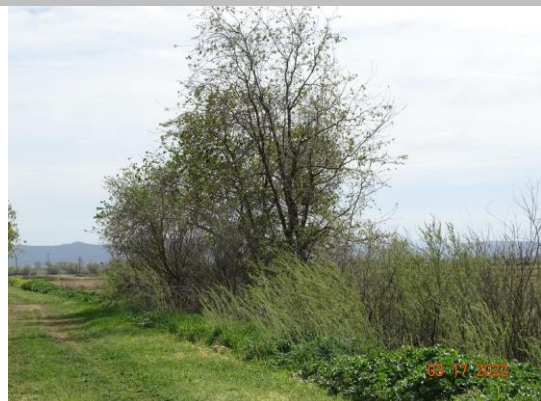
Photo 1 of 1 : SP_2022_NA0006_252_23_20220318_00032.jpg

LM Start	0.21	Rating **	U	Issue No.	23
LM End	0.21	Issue Type +	Ma	Location *	LS
Category	Earthen Levee			GPS Latitude/Longitude	
				Start	End
Item	Trim / Thin Trees			39.298816 °	39.298816 °
				-121.566529 °	-121.566529 °
DWR ID	DWR_NA0006_01_f_2016_23				
Comment Code					
T1 : Trim and thin trees to at least five feet above ground level to allow visibility of the ground and room to flood fight.					
Inspector Comment					
There are trees that need the limbs trimmed up 5' for visibility and access on the landside, Spring 2022.

View looking upstream landside of trees that need the limbs trimmed up 5' for visibility and access on the landside, Spring 2022.

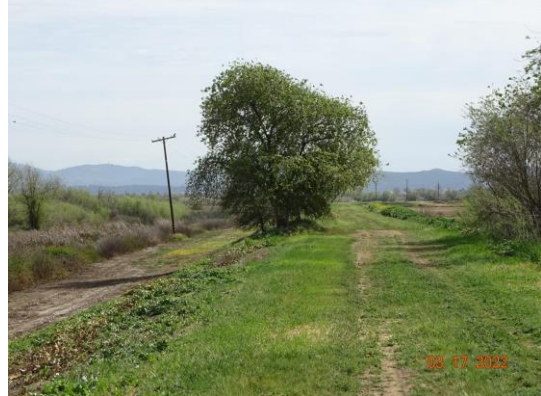
Photo 1 of 1 : SP_2022_NA0006_252_25_20220318_00033.jpg

LM Start	0.23	Rating **	M	Issue No.	25
LM End	0.23	Issue Type +	Ma	Location *	WS
Category	Earthen Levee			GPS Latitude/Longitude	
				Start	End
Item	Trim / Thin Trees			39.298776 °	39.298776 °
				-121.566158 °	-121.566158 °
DWR ID	DWR_NA0006_01_f _ 2016_25				
Comment Code					
T1 : Trim and thin trees to at least five feet above ground level to allow visibility of the ground and room to flood fight.					
Inspector Comment					
There is a tree that needs the limbs trimmed up 5' for visibility and access on the waterside, Spring 2022.

View looking downstream waterside of a tree that needs the limbs trimmed up 5' for visibility and access on the waterside, Spring 2022.

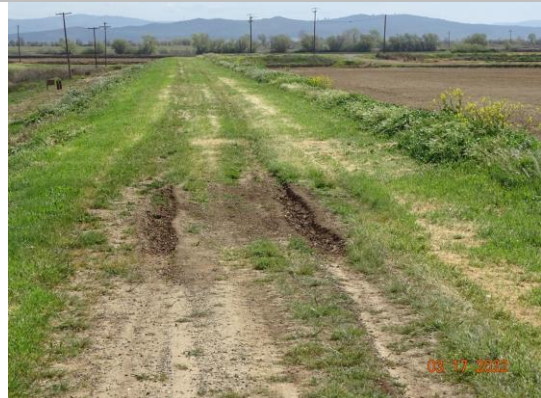
Photo 1 of 1 : SP_2022_NA0006_252_12_20220318_00034.jpg

LM Start	0.43	Rating **	M	Issue No.	12
LM End	0.43	Issue Type +	Ma	Location *	CR
Category	Earthen Levee			GPS Latitude/Longitude	
				Start	End
Item	Crown Surface / Depressions / Rutting			39.298322 °	39.298322 °
				-121.562439 °	-121.562439 °
DWR ID	DWR_NA0006_01_s_2021_12				
Comment Code					
C2 : Repair depressions or ruts in the crown or slope.					
Inspector Comment					
Depressions and ruts in levee crown need to be repaired, Spring 2022.

View looking upstream of rutting on the levee crown that should be repaired, Spring 2022.

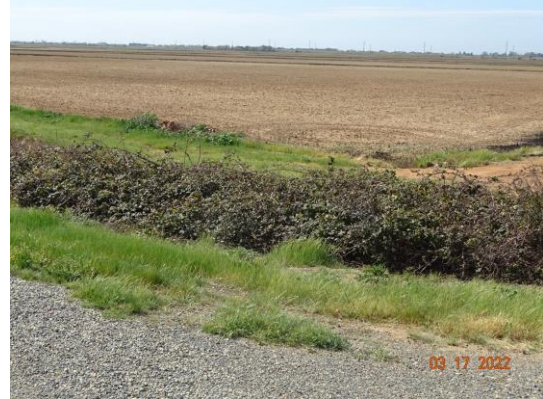
Photo 1 of 1 : SP_2022_NA0006_252_8_20220318_00037.jpg

LM Start	0.68	Rating **	U	Issue No.	8
LM End	0.68	Issue Type +	Ma	Location *	LS
Category	Earthen Levee			GPS Latitude/Longitude	
				Start	End
Item	Vegetation			39.297338 °	39.297338 °
				-121.558318 °	-121.558318 °
DWR ID	DWR_NA0006_01_f_2021_8				
Comment Code					
V2 : Remove the wild growth and woody vegetation other than native grasses from the levee slopes.					
Inspector Comment					
Blackberry bushes need to be removed, Spring 2022.

Blackberry bushes on the landside slope that need to be removed, Spring 2022.

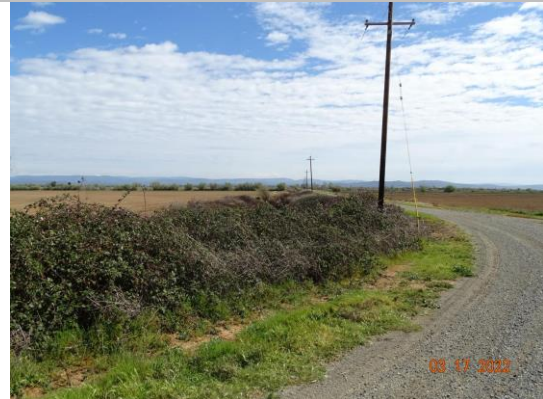
Photo 1 of 1 : SP_2022_NA0006_252_1_20220318_00038.jpg

LM Start	0.85	Rating **	U	Issue No.	1
LM End	0.96	Issue Type +	Ma	Location *	WS
Category	Earthen Levee			GPS Latitude/Longitude	
				Start	End
Item	Vegetation			39.294995 °	39.295021 °
				-121.557823 °	-121.555813 °
DWR ID	DWR_NA0006_01_f_2016_1				
Comment Code					
V2 : Remove the wild growth and woody vegetation other than native grasses from the levee slopes.					
Inspector Comment					
Remove blackberry bushes that are taking over the waterside slope, Spring 2022.

View of blackberry bushes that are covering the waterside slope. Looking upstream waterside, Spring 2022.
