**Flood Control Project Maintenance  
Levee Inspections**

## Maintenance Issue Types Only, Levee Inspection Report By Mile - Spring 2023

### Eastern Honcut Creek

Waterway	Bank	Unit Miles	Inspection Start/End	Inspector
Unit No. 01 Van Tress	Left	1.46	04/03/2023 04/03/2023	Brooks Weisser

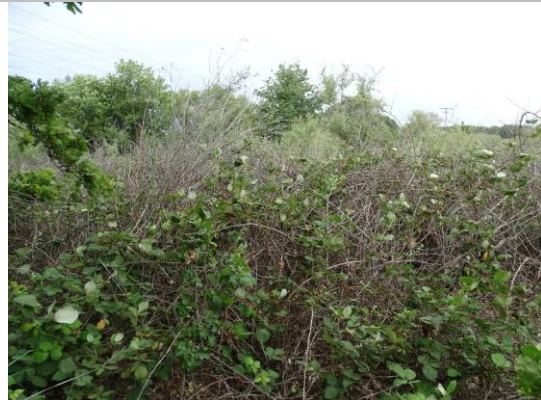
Photo 2 of 2 : UCIP\_SP\_2023\_77403\_111841.jpg

WS view: Looking from crown; dense vegetation.

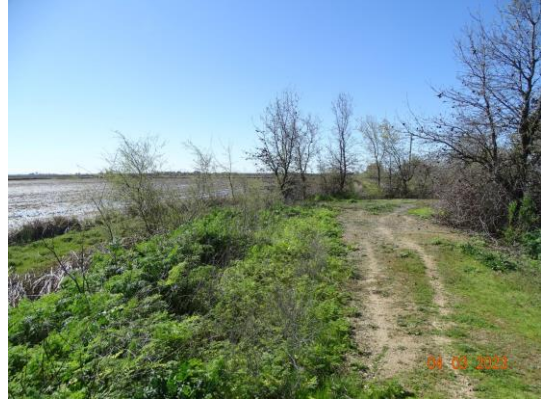
Photo 1 of 1 : SP\_2023\_NA0006\_252\_13\_20230407\_00025.jpg

LM Start	0.02	Rating **	U	Issue No.	13
LM End	0.02	Issue Type +	Ma	Location *	LS
Category	Earthen Levee			GPS Latitude/Longitude	
				Start	End
Item	Trim / Thin Trees			39.298493°	39.298493°
				-121.569506°	-121.569506°
DWR ID	DWR_NA0006_01_f_2019_13				
Comment Code					
T1 : Trim and thin trees to at least five feet above ground level to allow visibility of the ground and room to flood fight.					
Inspector Comment					
There are trees that need the limbs trimmed up 5' for visibility and access on the landside, Spring 2023.

View looking downstream of trees that need the limbs trimmed up 5' for visibility and access on the landside, Spring 2023.

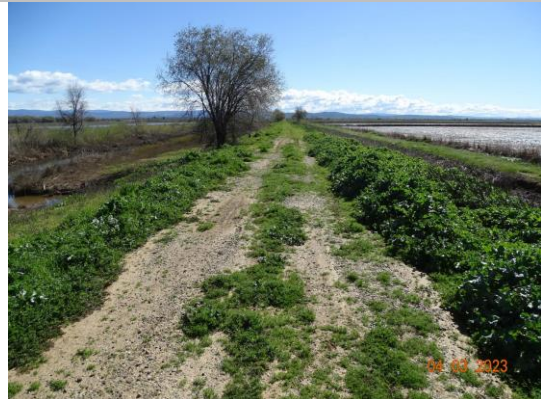
Photo 1 of 1 : SP\_2023\_NA0006\_252\_21\_20230407\_00029.jpg

LM Start	0.02	Rating **	U	Issue No.	21
LM End	0.66	Issue Type +	Ma	Location *	CR
Category	Earthen Levee			GPS Latitude/Longitude	
				Start	End
Item	Crown Surface / Depressions / Rutting			39.298504°	39.297595°
				-121.569502°	-121.558310°
DWR ID	DWR_NA0006_01_s_2015_21				
Comment Code					
C3 : Add appropriate gravel or road base. Grade and compact.					
Inspector Comment					
Place appropriate gravel on the crown roadway to make it an all weather road, Spring 2023.

View of the crown looking downstream of a section of road that needs all weather surface, Spring 2023

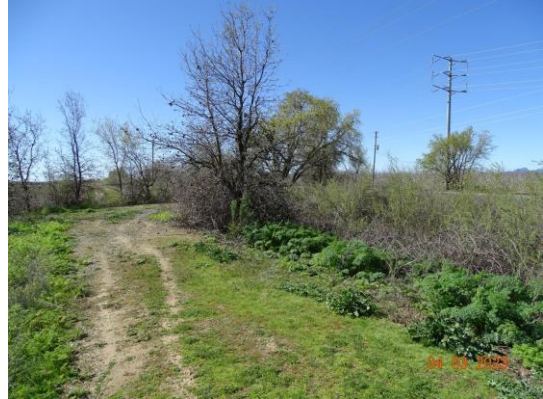
Photo 1 of 1 : SP\_2023\_NA0006\_252\_20\_20230407\_00026.jpg

LM Start	0.02	Rating **	U	Issue No.	20
LM End	0.02	Issue Type +	Ma	Location *	WS
Category	Earthen Levee			GPS Latitude/Longitude	
				Start	End
Item	Trim / Thin Trees			39.298563°	39.298563°
				-121.569432°	-121.569432°
DWR ID	DWR_NA0006_01_f_2016_20				
Comment Code					
T1 : Trim and thin trees to at least five feet above ground level to allow visibility of the ground and room to flood fight.					
Inspector Comment					
There is a tree that needs the limbs trimmed up 5' for visibility and access on the waterside, Spring 2023.

View of a tree that needs the limbs trimmed up 5' for visibility and access on the waterside looking downstream, Spring 2023.

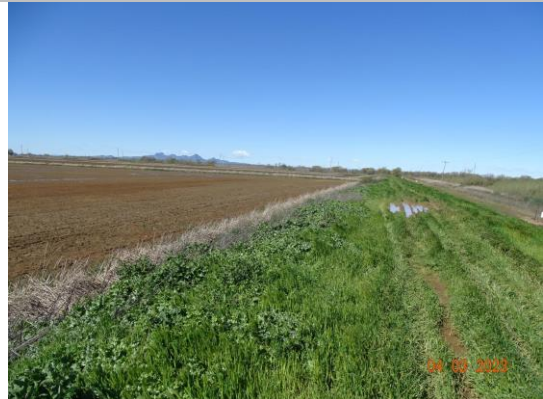
Photo 1 of 1 : SP\_2023\_NA0006\_252\_18\_20230407\_00024.jpg

LM Start	0.09	Rating **	U	Issue No.	18
LM End	0.94	Issue Type +	Ma	Location *	LS
Category	Earthen Levee			GPS Latitude/Longitude	
				Start	End
Item	Vegetation			39.299111°	39.295000°
				-121.568808°	-121.556204°
DWR ID	DWR_NA0006_01_f_2022_18				
Comment Code					
V1 : Control annual grass and weeds on the levee slopes and easements.					
Inspector Comment					
Annual vegetation on the landside slope needs to be maintained, Spring 2023.

View of annual vegetation on the landside slope, Spring 2023.

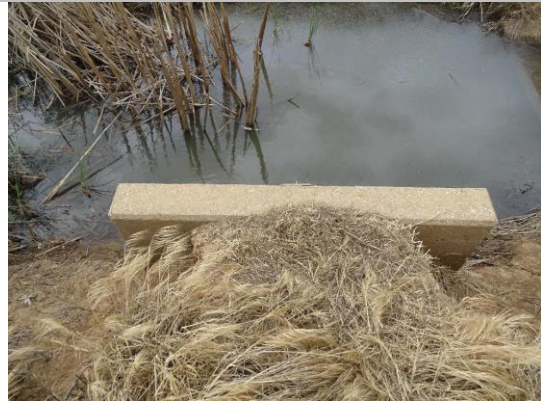
Photo 1 of 2 : UCIP\_SP\_2023\_77404\_111834.jpg

LM Start	0.09	Rating **	U	Issue No.	3
LM End	0.09	Issue Type +	Ma	Location *	
Category	Supplemental			GPS Latitude/Longitude	
				Start	End
Item	DWR UCIP LMA Responsibility			39.299106°	39.299106°
				-121.568749°	-121.568749°
DWR ID	19168

Comment Code					
Inspector Comment					
DS_ID:19168 FS_ID:77404 EP_NO: N/A Repair Type: Urgent EVAL Issue: 2b, Levee Integrity Crossing Status: Found UCIP Comments: 05/05/2022 Record updated from Non-Urgent to Urgent. Erosion of more than 1/2 foot into the levee is present behind the LS headwall and WS concrete saddle. The previous comment regarding dense vegetation was addressed. (M.Thao - DWR UCIP) 05/01/2013 Dense vegetation on waterward side and landward side obstructs inspection. Need to clear vegetation on slopes to conduct proper crossing evaluation. (DWR UCIP - O. Magana) FIELD_STRUCT_DESC: 24-inch corrugated metal drainage pipe through the levee, 10 feet below the crown. Flap gate located on the waterside (WS) end. [Additional Reference(s): DWR Levee Logs, 2005 (HLM 0.09). USACE Sacramento O&M Manual Unit No. 151, May 1953, (Station 5+65)] FS Date: 5/5/2022

LS view: Erosion on backside of headwall.

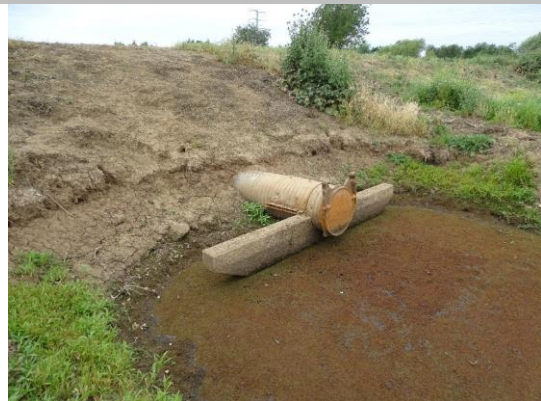
Photo 2 of 2 : UCIP\_SP\_2023\_77404\_111829.jpg

WS view: CMP pipe on toe; erosion cutting into levee behind concrete pipe saddle.

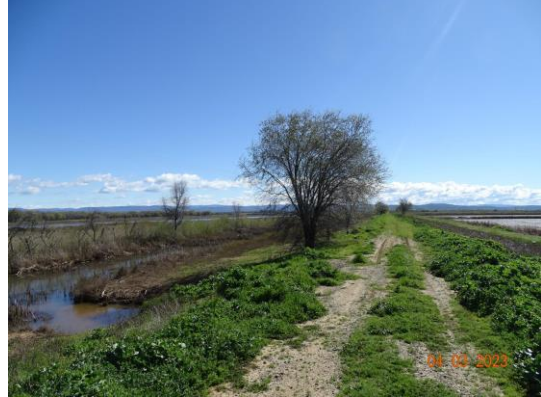
Photo 1 of 1 : SP\_2023\_NA0006\_252\_22\_20230407\_00028.jpg

LM Start	0.10	Rating **	M	Issue No.	22
LM End	0.10	Issue Type +	Ma	Location *	WS
Category	Earthen Levee			GPS Latitude/Longitude	
				Start	End
Item	Trim / Thin Trees			39.299078°	39.299078°
				-121.568633°	-121.568633°
DWR ID	DWR_NA0006_01_f_2016_22				
Comment Code					
T1 : Trim and thin trees to at least five feet above ground level to allow visibility of the ground and room to flood fight.					
Inspector Comment					
There is a tree that needs the limbs trimmed up 5' for visibility and access on the waterside, Spring 2023.

View looking upstream waterside of a tree that needs the limbs trimmed up 5' for visibility and access, Spring 2023.

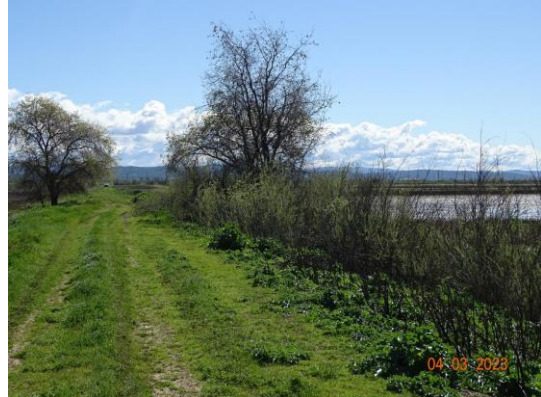
Photo 1 of 1 : SP\_2023\_NA0006\_252\_23\_20230407\_00030.jpg

LM Start	0.21	Rating **	U	Issue No.	23
LM End	0.21	Issue Type +	Ma	Location *	LS
Category	Earthen Levee			GPS Latitude/Longitude	
				Start	End
Item	Trim / Thin Trees			39.298816°	39.298816°
				-121.566529°	-121.566529°
DWR ID	DWR_NA0006_01_f_2016_23				
Comment Code					
T1 : Trim and thin trees to at least five feet above ground level to allow visibility of the ground and room to flood fight.					
Inspector Comment					
There are trees that need the limbs trimmed up 5' for visibility and access on the landside, Spring 2023.

View looking upstream landside of trees that need the limbs trimmed up 5' for visibility and access on the landside, Spring 2023.

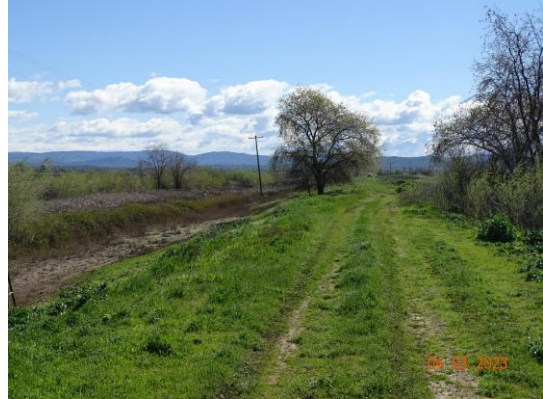
Photo 1 of 1 : SP\_2023\_NA0006\_252\_25\_20230407\_00031.jpg

LM Start	0.23	Rating **	M	Issue No.	25
LM End	0.23	Issue Type +	Ma	Location *	WS
Category	Earthen Levee			GPS Latitude/Longitude	
				Start	End
Item	Trim / Thin Trees			39.298776°	39.298776°
				-121.566158°	-121.566158°
DWR ID	DWR_NA0006_01_f_2016_25				
Comment Code					
T1 : Trim and thin trees to at least five feet above ground level to allow visibility of the ground and room to flood fight.					
Inspector Comment					
There is a tree that needs the limbs trimmed up 5' for visibility and access on the waterside, Spring 2023.

View looking downstream waterside of a tree that needs the limbs trimmed up 5' for visibility and access on the waterside, Spring 2023.

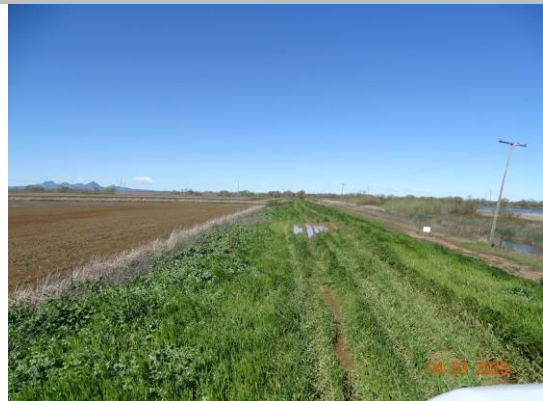
Photo 1 of 1 : SP\_2023\_NA0006\_252\_12\_20230407\_00032.jpg

LM Start	0.43	Rating **	M	Issue No.	12
LM End	0.43	Issue Type +	Ma	Location *	CR
Category	Earthen Levee			GPS Latitude/Longitude	
				Start	End
Item	Crown Surface / Depressions / Rutting			39.298322°	39.298322°
				-121.562439°	-121.562439°
DWR ID	DWR_NA0006_01_s_2021_12				
Comment Code					
C2 : Repair depressions or ruts in the crown or slope.					
Inspector Comment					
Depressions and ruts in levee crown need to be repaired, Spring 2023.

View looking downstream of rutting on the levee crown that should be repaired, Spring 2023.

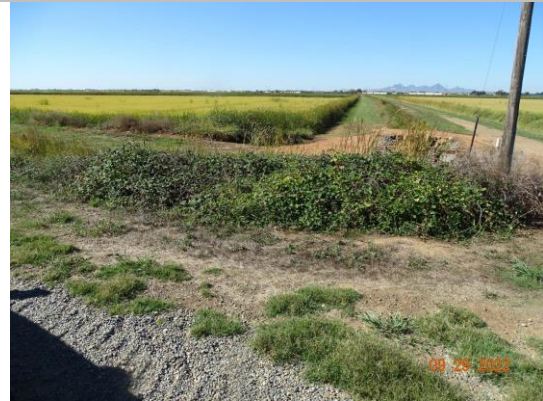
Photo 1 of 1 : SP\_2023\_NA0006\_252\_8\_20230403\_00002.jpg

LM Start	0.68	Rating **	U	Issue No.	8
LM End	0.68	Issue Type +	Ma	Location *	LS
Category	Earthen Levee			GPS Latitude/Longitude	
				Start	End
Item	Vegetation			39.297338°	39.297338°
				-121.558318°	-121.558318°
DWR ID	DWR_NA0006_01_f_2021_8				
Comment Code					
V2 : Remove the wild growth and woody vegetation other than native grasses from the levee slopes.					
Inspector Comment					
Blackberry bushes need to be removed, Spring 2023.

Blackberry bushes on the landside slope that need to be removed, Fall 2022.

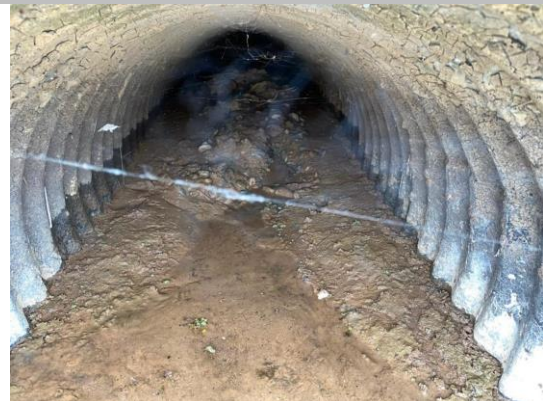
Photo 1 of 2 : UCIP\_SP\_2023\_77408\_111821.jpg

LM Start	0.84	Rating **	M	Issue No.	4
LM End	0.84	Issue Type +	Ma	Location *	
Category	Supplemental			GPS Latitude/Longitude	
				Start	End
Item	DWR UCIP LMA Responsibility			39.295058°	39.295058°
				-121.557965°	-121.557965°
DWR ID	19171

Comment Code					
Inspector Comment					
DS_ID:19171 FS_ID:77408 EP_NO: N/A Repair Type: Non-Urgent EVAL Issue: 11, Maintenance Compliance Issue Crossing Status: Found UCIP Comments: 05/05/2022 Record has been updated to Non-Urgent. Crossing was partially filled with sediment when looking into it from LS. Crossing should be abandoned properly. Overgrown vegetation on WS limits inspection of levee at this crossing; recommend removal of vegetation. Coordinates have been updated from 39.294998, -121.557801 to 39.295058, -121.557965; CLM has been updated from 0.85 to 0.84. (M.Thao - DWR UCIP) FIELD_STRUCT_DESC: *ABANDONED* 24-inch corrugated pipe through the crown, 6 feet below the crown. (24-inch was filled with concrete (abandoned) under Permit No. 9610, 1974-Honcut Creek Ranch). [Additional Reference(s): USACE Sacramento O&M Manual Unit No. 151, May 1953, (Station 36+00)] FS Date: 5/5/2022

LS view: Looking into CMP inlet; filled with sediment and aggregate.

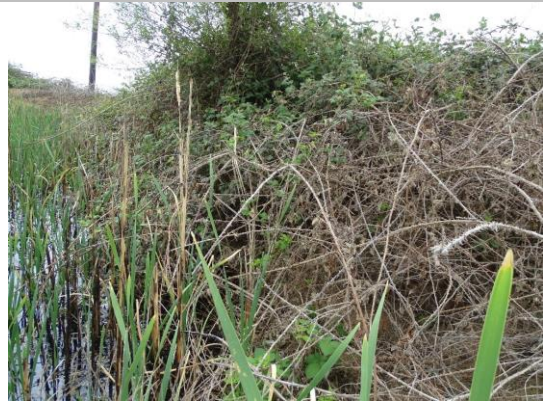
Photo 2 of 2 : UCIP\_SP\_2023\_77408\_111825.jpg

WS view: Dense vegetation on toe and slope.

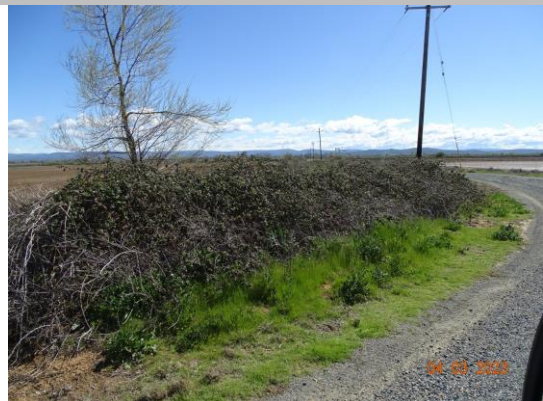
Photo 1 of 1 : SP\_2023\_NA0006\_252\_1\_20230407\_00035.jpg

LM Start	0.85	Rating **	U	Issue No.	1
LM End	0.96	Issue Type +	Ma	Location *	WS
Category	Earthen Levee			GPS Latitude/Longitude	
				Start	End
Item	Vegetation			39.294995°	39.295021°
				-121.557823°	-121.555813°
DWR ID	DWR_NA0006_01_f_2016_1				
Comment Code					
V2 : Remove the wild growth and woody vegetation other than native grasses from the levee slopes.					
Inspector Comment					
Remove blackberry bushes that are taking over the waterside slope, Spring 2023.

View of blackberry bushes that are covering the waterside slope.  
Looking upstream waterside, Spring 2023.
