**Flood Control Project Maintenance  
Levee Inspections**

## Maintenance Issue Types Only, Levee Inspection Report By Mile - Spring 2024

### Eastern Honcut Creek

Waterway	Bank	Unit Miles	Inspection Start/End	Inspector
Unit No. 01 Van Tress	Left	1.46	04/03/2024 04/03/2024	Brooks Weisser

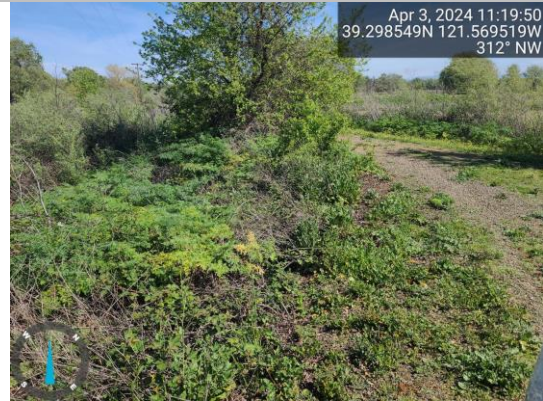
Photo 1 of 1 : SP\_2024\_NA0006\_252\_16\_20240405\_00025.jpg

LM Start	0.00	Rating **	M	Issue No.	16
LM End	1.44	Issue Type +	Ma	Location *	WS
Category	Earthen Levee			GPS Latitude/Longitude	
				Start	End
Item	Vegetation			39.298500°	39.295265°
				-121.569810°	-121.546743°
DWR ID	DWR_NA0006_01_f_2023_16				
Comment Code					
V1 : Control annual grass and weeds on the levee slopes and easements.					
Inspector Comment					
Annual vegetation on the waterside slope needs to be maintained, Spring 2024.

View of vegetation on the waterside slope, Spring 2024.

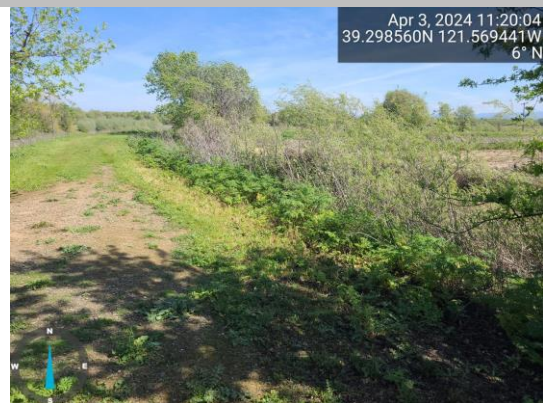
Photo 1 of 1 : SP\_2024\_NA0006\_252\_14\_20240405\_00026.jpg

LM Start	0.00	Rating **	M	Issue No.	14
LM End	1.44	Issue Type +	Ma	Location *	LS
Category	Earthen Levee			GPS Latitude/Longitude	
				Start	End
Item	Vegetation			39.298500°	39.295264°
				-121.569810°	-121.546741°
DWR ID	DWR_NA0006_01_f_2023_14				
Comment Code					
V1 : Control annual grass and weeds on the levee slopes and easements.					
Inspector Comment					
Annual vegetation on the landside slope needs to be maintained, Spring 2024.

View of vegetation on the landside slope, Spring 2024.

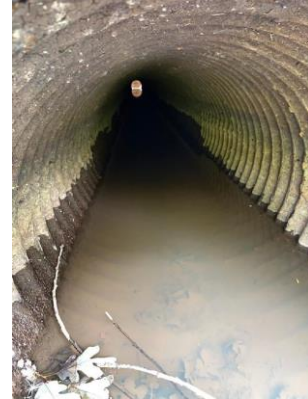
Photo 1 of 2 : UCIP\_SP\_2024\_77403\_111840.jpg

Comment Code						
Inspector Comment						
DS_ID:19167 FS_ID:77403 EP_NO: N/A Repair Type: Urgent EVAL Issue: 3a, Flood Risk Crossing Status: Found UCIP Comments: 05/05/2022 Record updated from Non-Urgent to Urgent. The crossing is open on both ends. Dense vegetation on WS prevents access to close flap gate during high-water events; recommend vegetation be removed. Overgrown vegetation limits inspection of WS at this crossing. (M.Thao - DWR UCIP) 05/01/2013 Dense vegetation on landward side obstructs inspection. Vegetation needs to be cleared to perform utility crossing inspection. (DWR UCIP - O. Magana) FIELD_STRUCT_DESC: 24-inch corrugated metal drainage pipe through the levee, 12 feet below the crown. Flap gate located on the waterside (WS) end. [Additional Reference(s): DWR Levee Logs, 2005 (HLM 0.01). USACE Sacramento O&M Manual Unit No. 151, May 1953, (Station 0+60)] FS Date: 5/5/2022

LS view: Looking inside pipe from inlet; outlet end is open to WS.

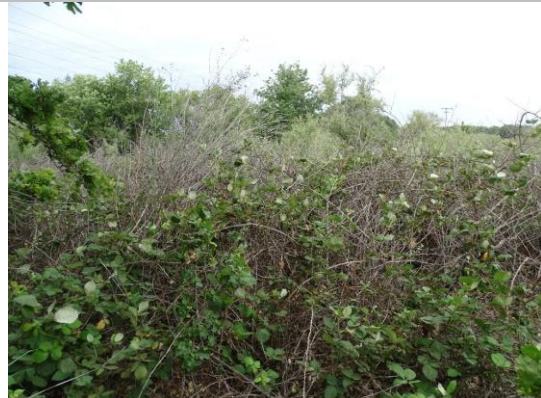
Photo 2 of 2 : UCIP\_SP\_2024\_77403\_111841.jpg

WS view: Looking from crown; dense vegetation.

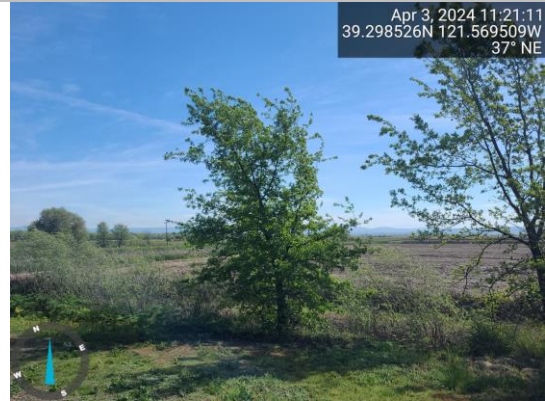
Photo 1 of 1 : SP\_2024\_NA0006\_252\_13\_20240405\_00027.jpg

LM Start	0.02	Rating **	U	Issue No.	13
LM End	0.02	Issue Type +	Ma	Location *	LS
Category	Earthen Levee			GPS Latitude/Longitude	
				Start	End
Item	Trim / Thin Trees			39.298493°	39.298493°
				-121.569506°	-121.569506°
DWR ID	DWR_NA0006_01_f_2019_13				
Comment Code					
T1 : Trim and thin trees to at least five feet above ground level to allow visibility of the ground and room to flood fight.					
Inspector Comment					
There are trees that need the limbs trimmed up 5' for visibility and access on the landside, Spring 2024.

View looking downstream of trees that need the limbs trimmed up 5' for visibility and access on the landside, Spring 2024.

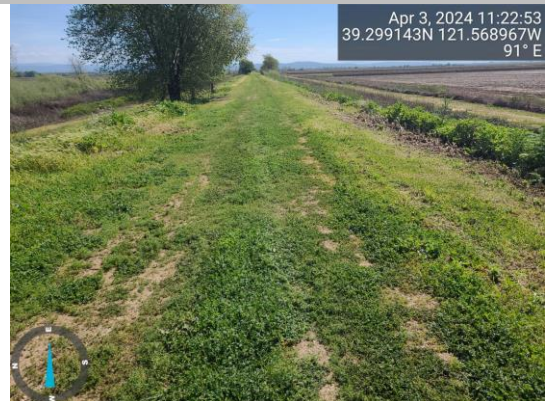
Photo 1 of 1 : SP\_2024\_NA0006\_252\_21\_20240405\_00029.jpg

LM Start	0.02	Rating **	U	Issue No.	21
LM End	0.66	Issue Type +	Ma	Location *	CR
Category	Earthen Levee			GPS Latitude/Longitude	
				Start	End
Item	Crown Surface / Depressions / Rutting			39.298504°	39.297595°
				-121.569502°	-121.558310°
DWR ID	DWR_NA0006_01_s_2015_21				
Comment Code					
C3 : Add appropriate gravel or road base. Grade and compact.					
Inspector Comment					
Place appropriate gravel on the crown roadway to make it an all weather road, Spring 2024.

View of the crown looking upstream of a section of road that needs all weather surface, Spring 2024.

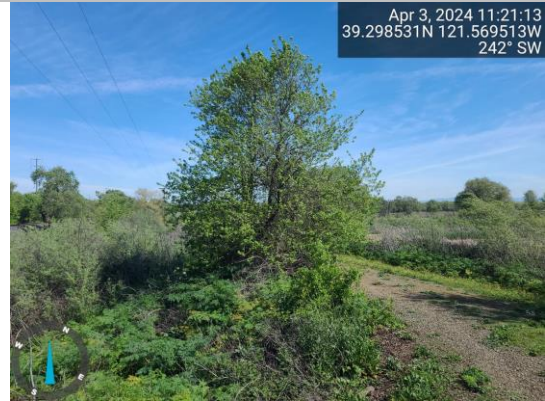
Photo 1 of 1 : SP\_2024\_NA0006\_252\_20\_20240405\_00028.jpg

LM Start	0.02	Rating **	U	Issue No.	20
LM End	0.02	Issue Type +	Ma	Location *	WS
Category	Earthen Levee			GPS Latitude/Longitude	
				Start	End
Item	Trim / Thin Trees			39.298563°	39.298563°
				-121.569432°	-121.569432°
DWR ID	DWR_NA0006_01_f_2016_20				
Comment Code					
T1 : Trim and thin trees to at least five feet above ground level to allow visibility of the ground and room to flood fight.					
Inspector Comment					
There is a tree that needs the limbs trimmed up 5' for visibility and access on the waterside, Spring 2024.

View of a tree that needs the limbs trimmed up 5' for visibility and access on the waterside looking downstream, Spring 2024.

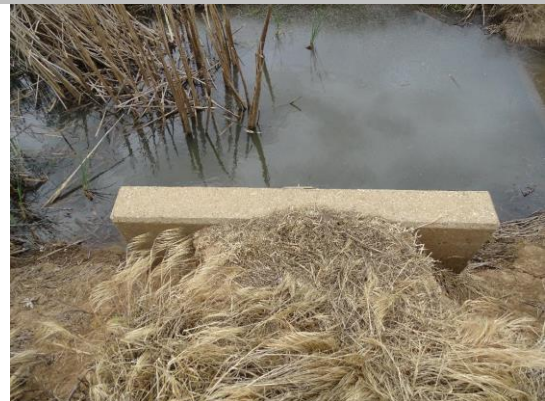
Photo 1 of 2 : UCIP\_SP\_2024\_77404\_111834.jpg

Comment Code					
Inspector Comment					
DS_ID:19168 FS_ID:77404 EP_NO: N/A Repair Type: Urgent EVAL Issue: 2b, Levee Integrity Crossing Status: Found UCIP Comments: 05/05/2022 Record updated from Non-Urgent to Urgent. Erosion of more than 1/2 foot into the levee is present behind the LS headwall and WS concrete saddle. The previous comment regarding dense vegetation was addressed. (M.Thao - DWR UCIP) 05/01/2013 Dense vegetation on waterward side and landward side obstructs inspection. Need to clear vegetation on slopes to conduct proper crossing evaluation. (DWR UCIP - O. Magana) FIELD_STRUCT_DESC: 24-inch corrugated metal drainage pipe through the levee, 10 feet below the crown. Flap gate located on the waterside (WS) end. [Additional Reference(s): DWR Levee Logs, 2005 (HLM 0.09). USACE Sacramento O&M Manual Unit No. 151, May 1953, (Station 5+65)] FS Date: 5/5/2022

LS view: Erosion on backside of headwall.

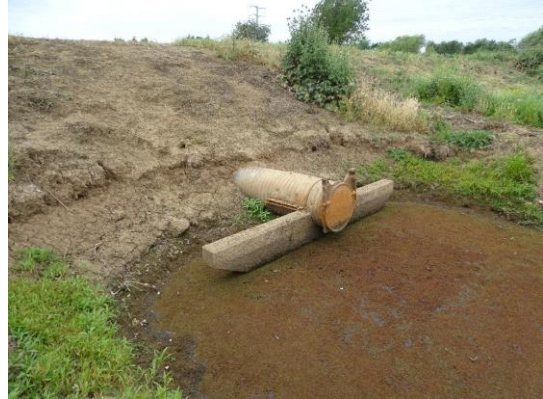
Photo 2 of 2 : UCIP\_SP\_2024\_77404\_111829.jpg

WS view: CMP pipe on toe; erosion cutting into levee behind concrete pipe saddle.

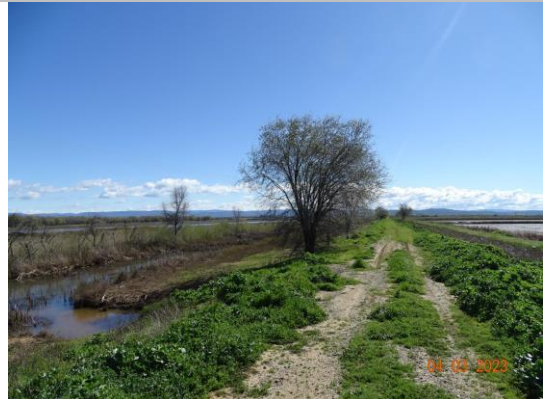
Photo 1 of 1 : SP\_2024\_NA0006\_252\_22\_20240326\_00011.jpg

LM Start	0.10	Rating **	M	Issue No.	22
LM End	0.10	Issue Type +	Ma	Location *	WS
Category	Earthen Levee			GPS Latitude/Longitude	
				Start	End
Item	Trim / Thin Trees			39.299078°	39.299078°
				-121.568633°	-121.568633°
DWR ID	DWR_NA0006_01_f_2016_22				
Comment Code					
T1 : Trim and thin trees to at least five feet above ground level to allow visibility of the ground and room to flood fight.					
Inspector Comment					
There is a tree that needs the limbs trimmed up 5' for visibility and access on the waterside, Spring 2024.

View looking upstream waterside of a tree that needs the limbs trimmed up 5' for visibility and access, Spring 2023.

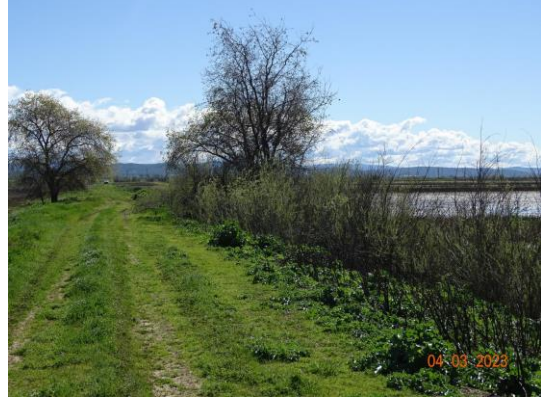
Photo 1 of 1 : SP\_2024\_NA0006\_252\_23\_20240326\_00012.jpg

LM Start	0.21	Rating **	U	Issue No.	23
LM End	0.21	Issue Type +	Ma	Location *	LS
Category	Earthen Levee			GPS Latitude/Longitude	
				Start	End
Item	Trim / Thin Trees			39.298816°	39.298816°
				-121.566529°	-121.566529°
DWR ID	DWR_NA0006_01_f _ 2016_23				
Comment Code					
T1 : Trim and thin trees to at least five feet above ground level to allow visibility of the ground and room to flood fight.					
Inspector Comment					
There are trees that need the limbs trimmed up 5' for visibility and access on the landside, Spring 2024.

View looking upstream landside of trees that need the limbs trimmed up 5' for visibility and access on the landside, Spring 2023.

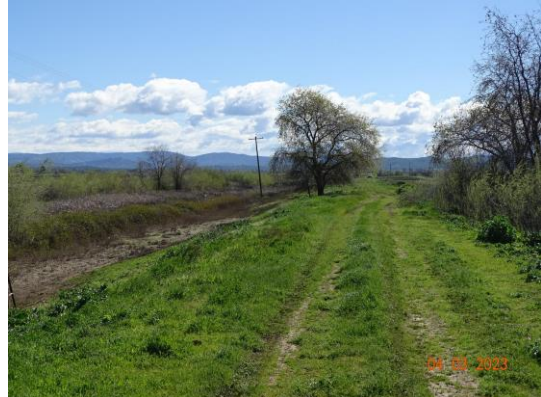
Photo 1 of 1 : SP\_2024\_NA0006\_252\_25\_20240326\_00013.jpg

LM Start	0.23	Rating **	M	Issue No.	25
LM End	0.23	Issue Type +	Ma	Location *	WS
Category	Earthen Levee			GPS Latitude/Longitude	
				Start	End
Item	Trim / Thin Trees			39.298776°	39.298776°
				-121.566158°	-121.566158°
DWR ID	DWR_NA0006_01_f_2016_25				
Comment Code					
T1 : Trim and thin trees to at least five feet above ground level to allow visibility of the ground and room to flood fight.					
Inspector Comment					
There is a tree that needs the limbs trimmed up 5' for visibility and access on the waterside, Spring 2024.

View looking downstream waterside of a tree that needs the limbs trimmed up 5' for visibility and access on the waterside, Spring 2023.

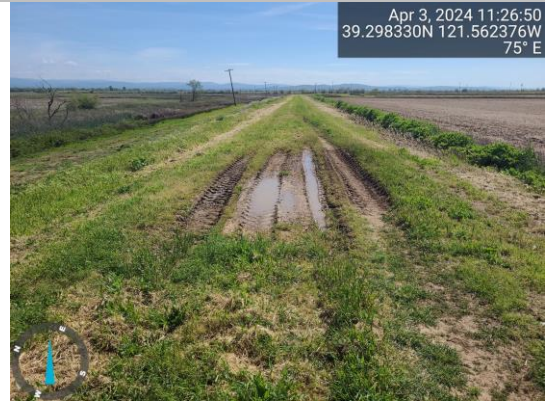
Photo 1 of 1 : SP\_2024\_NA0006\_252\_12\_20240405\_00030.jpg

LM Start	0.43	Rating **	M	Issue No.	12
LM End	0.43	Issue Type +	Ma	Location *	CR
Category	Earthen Levee			GPS Latitude/Longitude	
				Start	End
Item	Crown Surface / Depressions / Rutting			39.298322°	39.298322°
				-121.562439°	-121.562439°
DWR ID	DWR_NA0006_01_s_2021_12				
Comment Code					
C2 : Repair depressions or ruts in the crown or slope.					
Inspector Comment					
Depressions and ruts in levee crown need to be repaired, Spring 2024.

View looking upstream of rutting on the levee crown that should be repaired, Spring 2024.

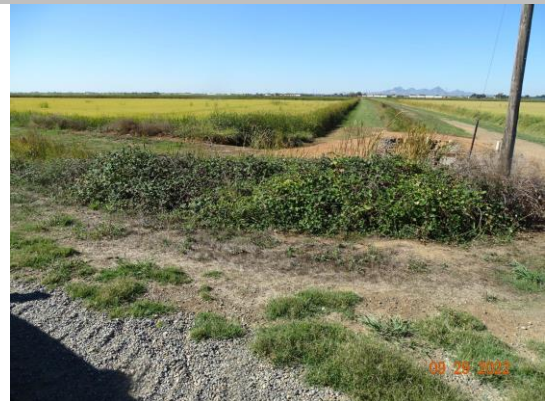
Photo 1 of 1 : SP\_2024\_NA0006\_252\_8\_20240326\_00002.jpg

LM Start	0.68	Rating **	U	Issue No.	8
LM End	0.68	Issue Type +	Ma	Location *	LS
Category	Earthen Levee			GPS Latitude/Longitude	
				Start	End
Item	Vegetation			39.297338°	39.297338°
				-121.558318°	-121.558318°
DWR ID	DWR_NA0006_01_f_2021_8				
Comment Code					
V2 : Remove the wild growth and woody vegetation other than native grasses from the levee slopes.					
Inspector Comment					
Blackberry bushes need to be removed, Spring 2024.

Blackberry bushes on the landside slope that need to be removed, Fall 2022.

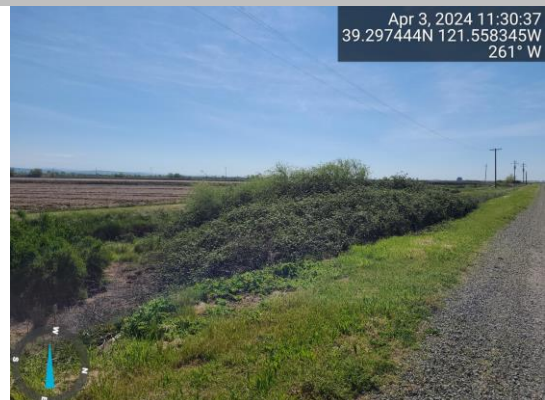
Photo 1 of 1 : SP\_2024\_NA0006\_252\_18\_20240405\_00031.jpg

LM Start	0.69	Rating **	U	Issue No.	18
LM End	0.69	Issue Type +	Ma	Location *	WS
Category	Earthen Levee			GPS Latitude/Longitude	
				Start	End
Item	Vegetation			39.297164°	39.297164°
				-121.558301°	-121.558301°
DWR ID	DWR_NA0006_01_s_2024_18				
Comment Code					
V2 : Remove the wild growth and woody vegetation other than native grasses from the levee slopes.					
Inspector Comment					
Blackberry bushes need to be removed, Spring 2024.

View of blackberry bushes growing on the waterside slope, Spring 2024.

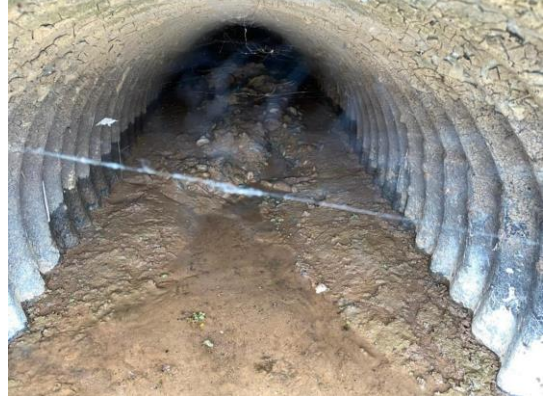
Photo 1 of 2 : UCIP\_SP\_2024\_77408\_111821.jpg

Comment Code						
Inspector Comment						
DS_ID:19171 FS_ID:77408 EP_NO: N/A Repair Type: Non-Urgent EVAL Issue: 11, Maintenance Compliance Issue Crossing Status: Found UCIP Comments: 05/05/2022 Record has been updated to Non-Urgent. Crossing was partially filled with sediment when looking into it from LS. Crossing should be abandoned properly. Overgrown vegetation on WS limits inspection of levee at this crossing; recommend removal of vegetation. Coordinates have been updated from 39.294998, - 121.557801 to 39.295058, -121.557965; CLM has been updated from 0.85 to 0.84. (M.Thao - DWR UCIP) FIELD_STRUCT_DESC: *ABANDONED* 24-inch corrugated pipe through the crown, 6 feet below the crown. (24-inch was filled with concrete (abandoned) under Permit No. 9610, 1974-Honcut Creek Ranch). [Additional Reference(s): USACE Sacramento O&M Manual Unit No. 151, May 1953, (Station 36+00)] FS Date: 5/5/2022

LS view: Looking into CMP inlet; filled with sediment and aggregate.

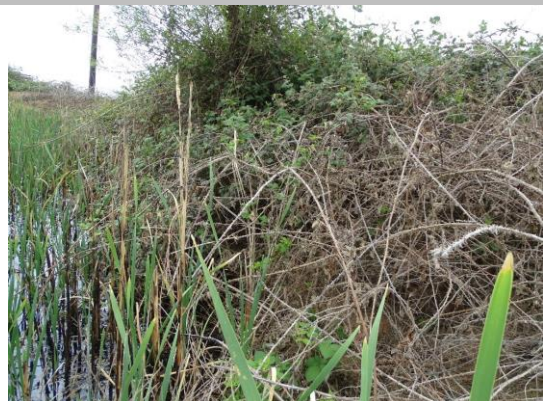
Photo 2 of 2 : UCIP\_SP\_2024\_77408\_111825.jpg

WS view: Dense vegetation on toe and slope.

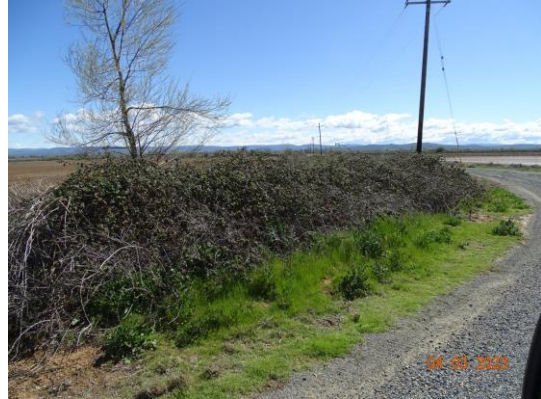
Photo 1 of 1 : SP\_2024\_NA0006\_252\_1\_20240326\_00001.jpg

LM Start	0.85	Rating **	U	Issue No.	1
LM End	0.96	Issue Type +	Ma	Location *	WS
Category	Earthen Levee			GPS Latitude/Longitude	
				Start	End
Item	Vegetation			39.294995°	39.295021°
				-121.557823°	-121.555813°
DWR ID	DWR_NA0006_01_f_2016_1				
Comment Code					
V2 : Remove the wild growth and woody vegetation other than native grasses from the levee slopes.					
Inspector Comment					
Remove blackberry bushes that are taking over the waterside slope, Spring 2024.

View of blackberry bushes that are covering the waterside slope.  
Looking upstream waterside, Spring 2023.
