**Flood Control Project Maintenance
Levee Inspections**
LMA District Cover Sheet
Spring 2012 Levee Inspection Results
Eastern Honcut Creek

**Flood Control Project Maintenance
Levee Inspections
Unit Cover Sheet
Spring 2012 Levee Inspection Results
Eastern Honcut Creek**

Levee Inspection Report By Mile - Spring 2012

Eastern Honcut Creek

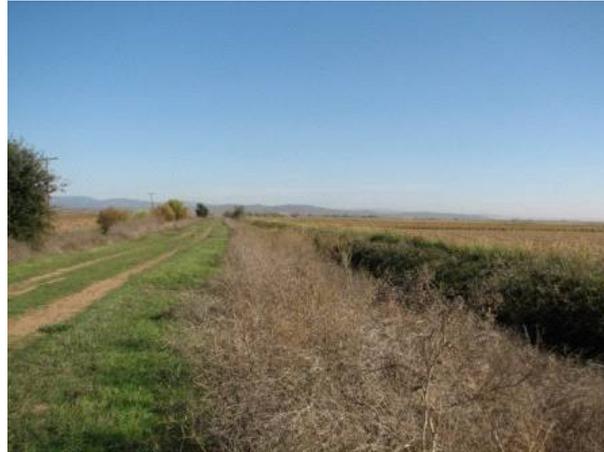
Levee Mile Report Line	4
Start Levee Mile	0.01
End Levee Mile	1.50
Location	Land Side
Category	Earthen Levee
Item	Vegetation
<p>This photo shows the landside vegetation at levee mile 0.10.</p>	
<p>rburnett_s_20120508_001.jpg</p>

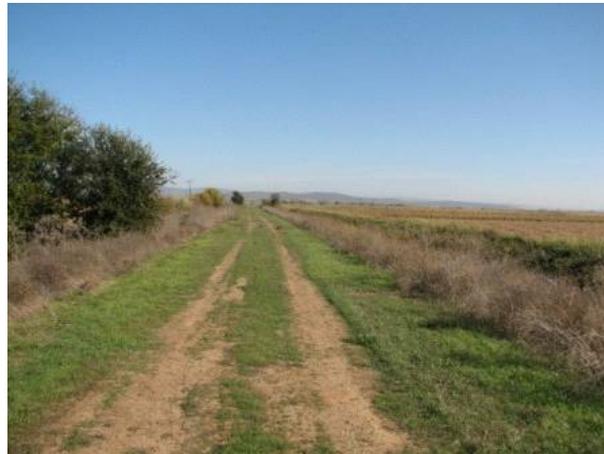
Levee Mile Report Line	5
Start Levee Mile	0.02
End Levee Mile	0.69
Location	Crown
Category	Earthen Levee
Item	Crown Surface / Depressions / Rutting
<p>This photo shows the crown roadway at levee mile 0.10.</p>	
<p>rburnett_s_20120508_003.jpg</p>

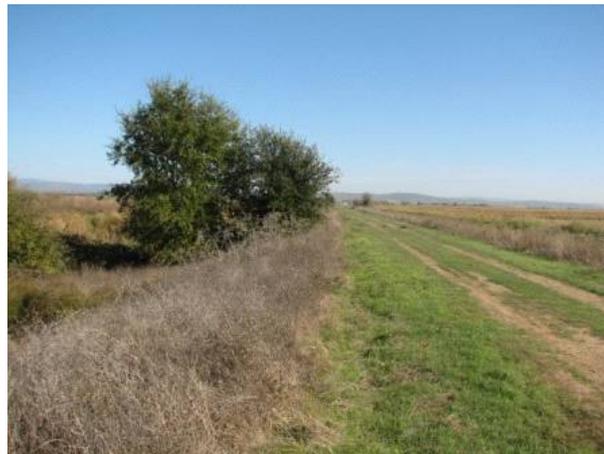
Levee Mile Report Line	6
Start Levee Mile	0.05
End Levee Mile	1.50
Location	Water Side
Category	Earthen Levee
Item	Vegetation
<p>This photo shows the waterside vegetation at levee mile 0.10.</p>	
<p>rburnett_s_20120508_002.jpg</p>

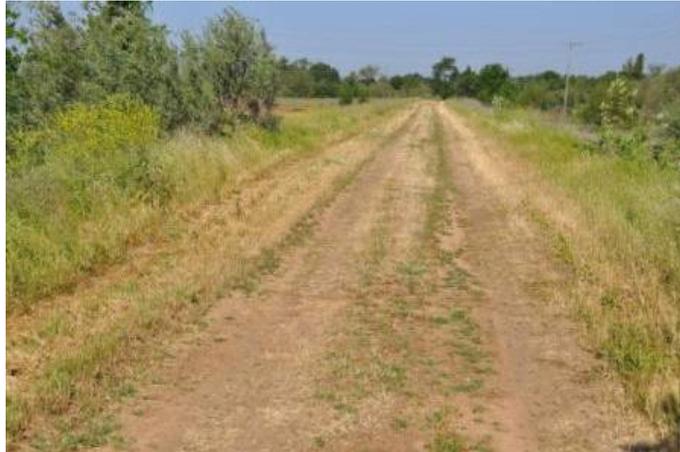
Levee Mile Report Line	7
Start Levee Mile	0.25
End Levee Mile	0.25
Location	Land Side
Category	Earthen Levee
Item	Vegetation
Looking west, Towards RR tracks, typical vegetation.	
rburnett_s_20120514_351.JPG

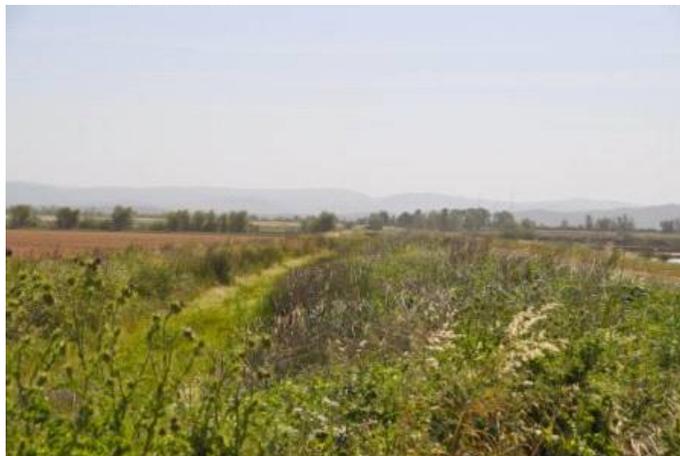
Levee Mile Report Line	8
Start Levee Mile	0.66
End Levee Mile	1.19
Location	Water Side
Category	Earthen Levee
Item	Encroachments
Toe Ditch parallel to levee @ w/s toe. Heavy vegetation in ditch.	
rburnett_s_20120514_352.JPG

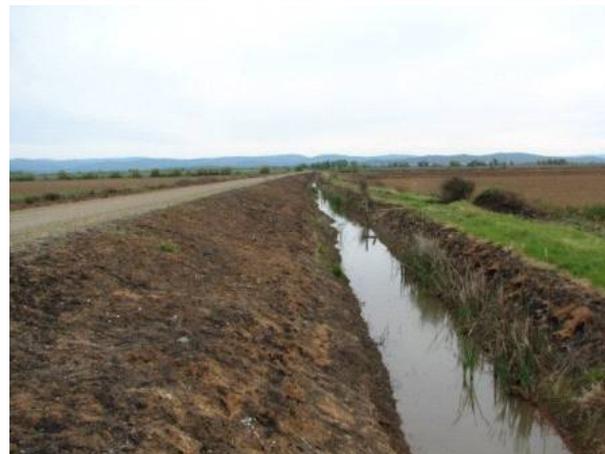
Levee Mile Report Line	9
Start Levee Mile	0.68
End Levee Mile	1.46
Location	Land Side
Category	Earthen Levee
Item	Encroachments
Levee mile 0.85, this photo is looking upstream at a ditch on the landside toe.	
rburnett_s_20120508_004.jpg
