**Flood Control Project Maintenance  
Levee Inspections**

**Fall 2010 Levee Maintenance Deficiency Summary Report**

**Knights Landing Ridge Drainage District**

**Levee Inspection Report By Mile - Fall 2010**

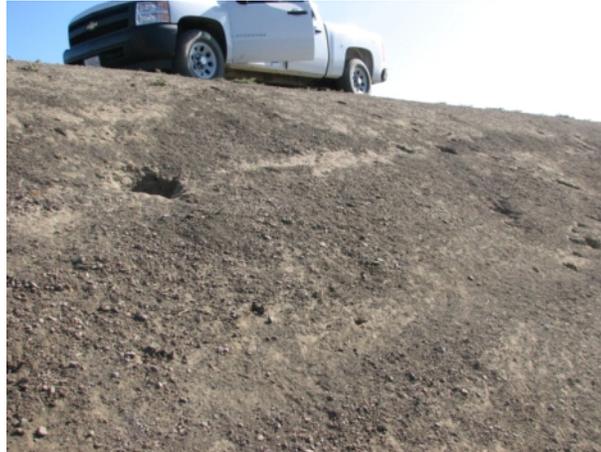
Levee Mile Report Line	3
Start Levee Mile	0.69
End Levee Mile	0.69
Location	Land Side
Category	Earthen Levee
Item	Animal Control
squirrel holes landside	
johngw_f_20101012_061.jpg

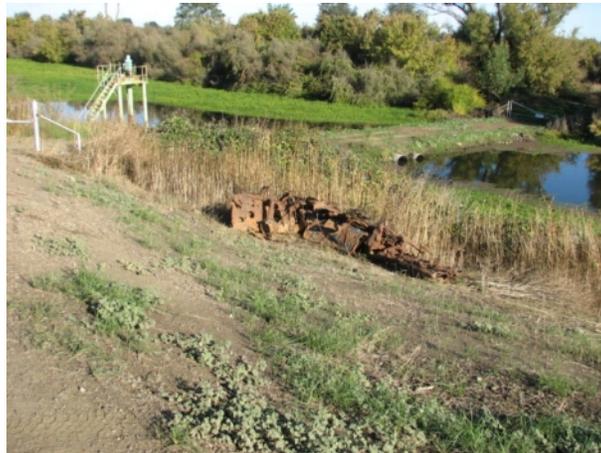
Levee Mile Report Line	5
Start Levee Mile	0.86
End Levee Mile	0.86
Location	Water Side
Category	Earthen Levee
Item	Encroachments
Rusted old car parts left on the levee slope.	
johngw_f_20101101_278.jpg

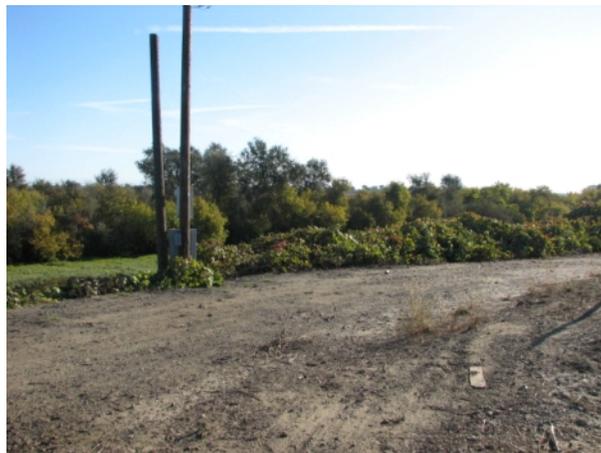
Levee Mile Report Line	6
Start Levee Mile	1.16
End Levee Mile	1.16
Location	Water Side
Category	Earthen Levee
Item	Vegetation
Wild grapes are growing on the levee slope and up to the shoulder.	
johngw_f_20101101_279.jpg

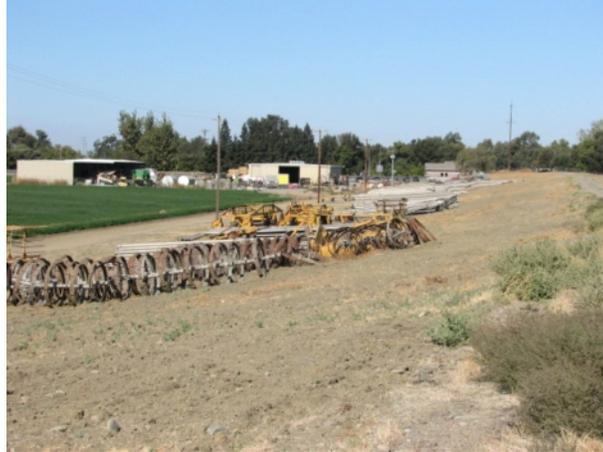
Levee Mile Report Line	14
Start Levee Mile	6.17
End Levee Mile	6.41
Location	Land Side
Category	Earthen Levee
Item	Encroachments
equipment on levee slope	
johngw_f_20101012_060.jpg

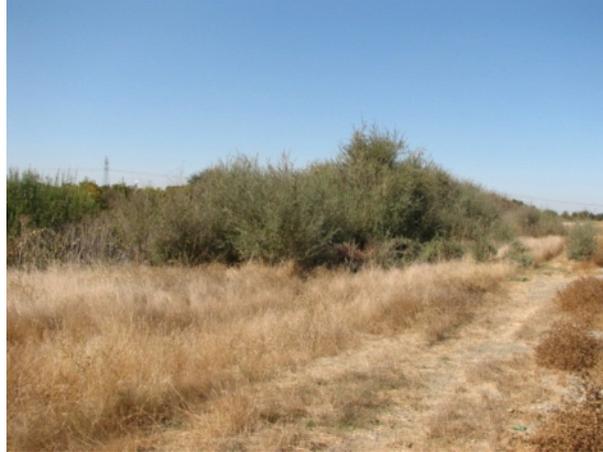
Levee Mile Report Line	1
Start Levee Mile	0.69
End Levee Mile	0.75
Location	Water Side
Category	Earthen Levee
Item	Vegetation
remove willows	
johngw_f_20101012_063.jpg

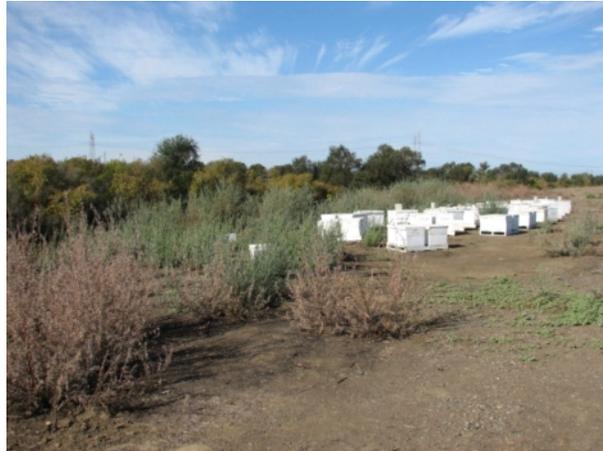
Levee Mile Report Line	1
Start Levee Mile	0.69
End Levee Mile	0.75
Location	Water Side
Category	Earthen Levee
Item	Vegetation
The district has made great progress to eliminate the willows.	
johngw_f_20101101_283.jpg

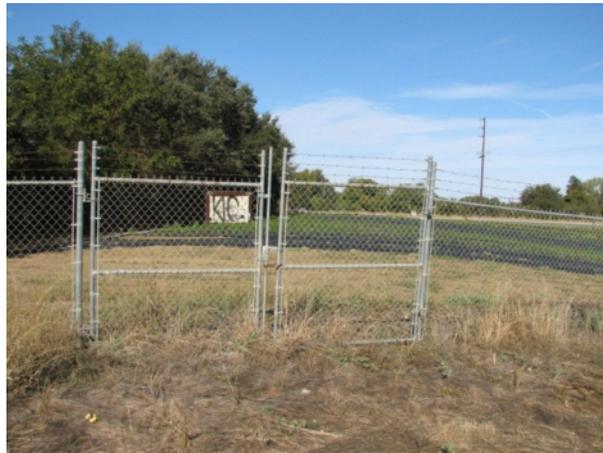
Levee Mile Report Line	9
Start Levee Mile	6.05
End Levee Mile	6.12
Location	Land Side
Category	Earthen Levee
Item	Encroachments
The fence and the well established strawberry crop are an encroachment at the end of unit 2.	
johngw_f_20101101_280.jpg
