**Flood Control Project Maintenance
Levee Inspections**

Fall 2011 Levee Maintenance Deficiency Summary Report

Knights Landing Ridge Drainage District

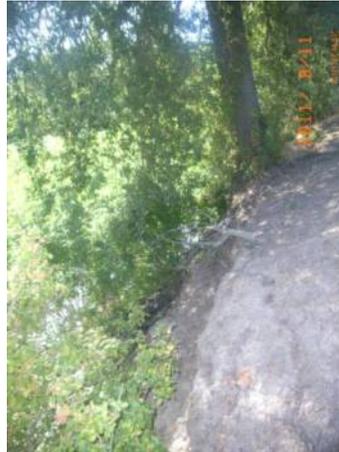
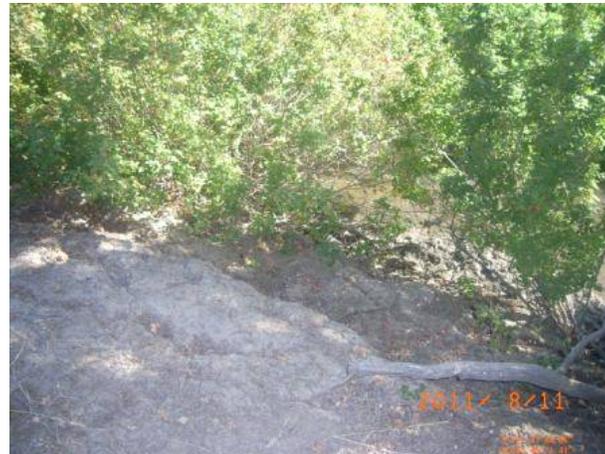
LMIR No.	Levee Mile		Category	Item	* Location	** Rating	Action/Comment	GPS Latitude/Longitude		Issue No. Photo
	Start	End						Start	End	
1	3.26	3.26	Supplemental	USACE Erosion Survey	WS	M	Inspector Comments: 2011: Toe scour and bank slumping. [2011 Site ID: KLR_3-5_R]	38.758432 ° -121.695158 °	38.759332 ° -121.696063 °	1 Y
2	3.86	3.86	Supplemental	USACE Erosion Survey	WS	M	Inspector Comments: 2011: Toe erosion and erosion pockets from tree popouts. More tree popouts are expected due to the eroding toe. [2011 Site ID: KLR_3-9_R]	38.764037 ° -121.701434 °	38.764905 ° -121.702074 °	2 Y
3	6.17	6.41	Earthen Levee	Encroachments	LS	M	Equipment	38.790007 ° -121.723308 °	38.792433 ° -121.726463 °	7 Y

Levee Mile Report Line	1
Start Levee Mile	3.26
End Levee Mile	3.26
Location	Water Side
Category	Supplemental
Item	USACE Erosion Survey
USACE 2011 Photo #1	
USACE2011_KLR_3-5_R_1.jpg

Levee Mile Report Line	1
Start Levee Mile	3.26
End Levee Mile	3.26
Location	Water Side
Category	Supplemental
Item	USACE Erosion Survey
USACE 2011 Photo #2	
USACE2011_KLR_3-5_R_2.jpg

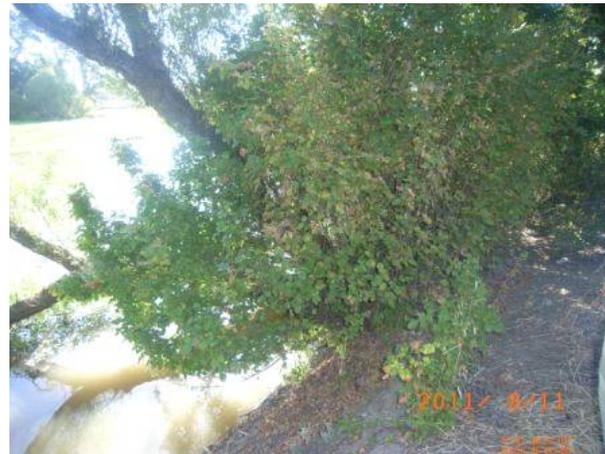
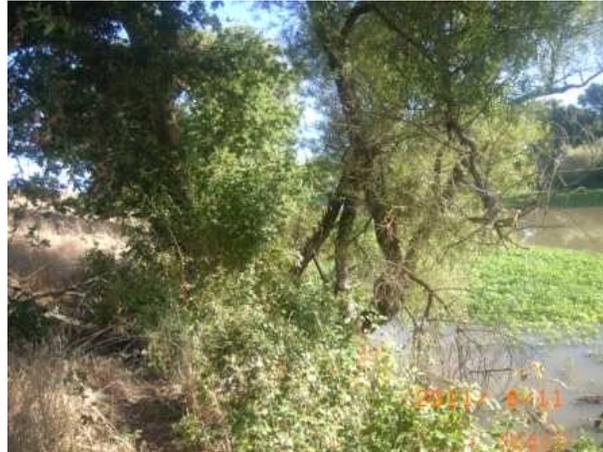
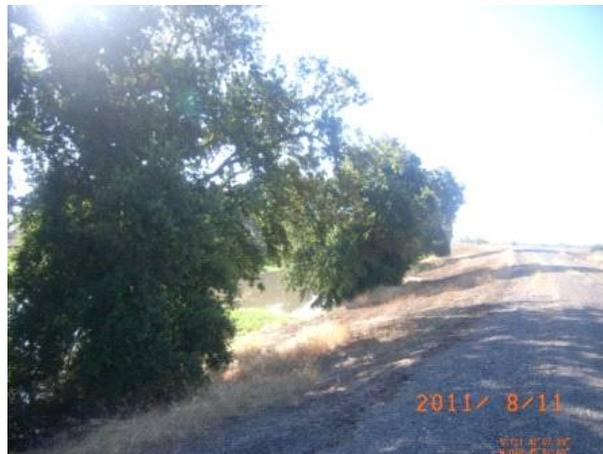
Levee Mile Report Line	2
Start Levee Mile	3.86
End Levee Mile	3.86
Location	Water Side
Category	Supplemental
Item	USACE Erosion Survey
USACE 2011 Photo #1	
USACE2011_KLR_3-9_R_1.jpg

Levee Mile Report Line	2
Start Levee Mile	3.86
End Levee Mile	3.86
Location	Water Side
Category	Supplemental
Item	USACE Erosion Survey
USACE 2011 Photo #2	
USACE2011_KLR_3-9_R_2.jpg

Levee Mile Report Line	2
Start Levee Mile	3.86
End Levee Mile	3.86
Location	Water Side
Category	Supplemental
Item	USACE Erosion Survey
USACE 2011 Photo #3	
USACE2011_KLR_3-9_R_3.jpg

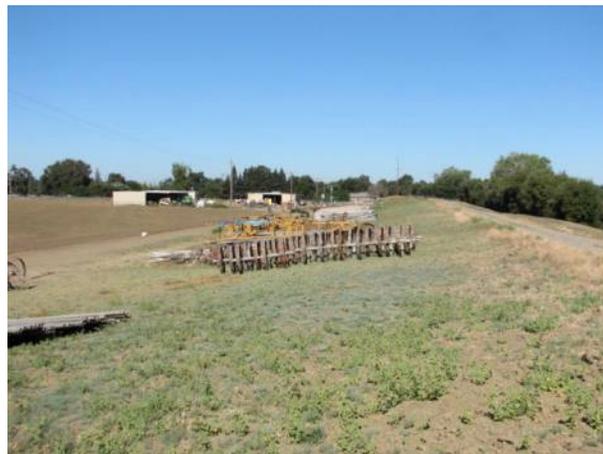
Levee Mile Report Line	3
Start Levee Mile	6.17
End Levee Mile	6.41
Location	Land Side
Category	Earthen Levee
Item	Encroachments
The equipment and irrigation pipe is on the slope of the levee. Photo taken fall 2011.	
johngw_f_20111024_003.jpg

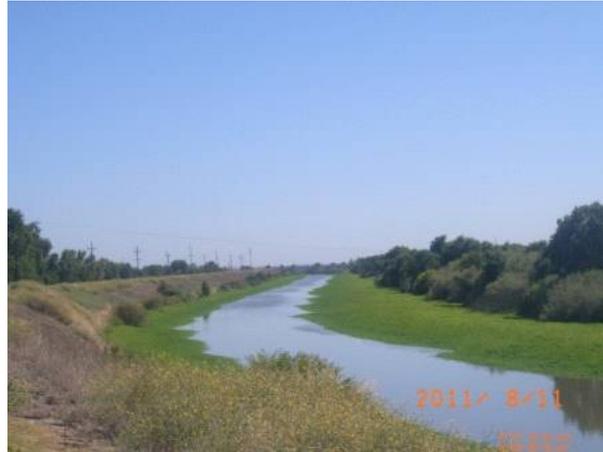
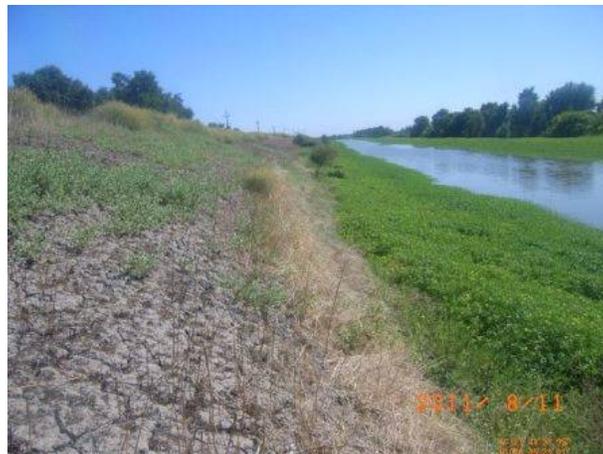
LMIR No.	Levee Mile		Category	Item	Location *	Rating **	Action/Comment	GPS Latitude/Longitude		Issue No.
	Start	End						Start	End	
1	2.66	2.66	Supplemental	USACE Erosion Survey	WS	M	Inspector Comments: 2006 - The whole levee toe area is slowly slumping into the channel (creep) due to dewatering and poor slope soils. Occasional piping in the levee slope evident as well. Pistol-butted trees at the levee toe indicate slow retreat. 2011: Multiple scallops throughout the site and slumping of the toe. [2011 Site ID: KLR_3-0_L]	38.754899 ° -121.692653 °	38.757925 ° -121.693048 °	2 Y
2	2.90	2.90	Supplemental	USACE Erosion Survey	WS	M	Inspector Comments: 2006 - The whole levee toe area is slowly slumping into the channel (creep) due to dewatering and poor slope soils. Occasional piping in the levee slope evident as well. Pistol-butted trees at the levee toe indicate slow retreat. 2011: Slumping of the levee toe. [2011 Site ID: KLR_3-1_L]	38.758587 ° -121.693359 °	38.760053 ° -121.694686 °	3 Y

Levee Mile Report Line	1
Start Levee Mile	2.66
End Levee Mile	2.66
Location	Water Side
Category	Supplemental
Item	USACE Erosion Survey
USACE 2011 Photo #1	
USACE2011_KLR_3-0_L_1.jpg

Levee Mile Report Line	1
Start Levee Mile	2.66
End Levee Mile	2.66
Location	Water Side
Category	Supplemental
Item	USACE Erosion Survey
USACE 2011 Photo #2	
USACE2011_KLR_3-0_L_2.jpg

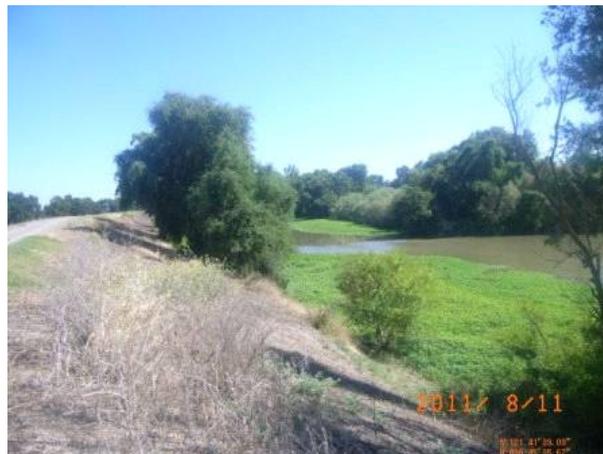
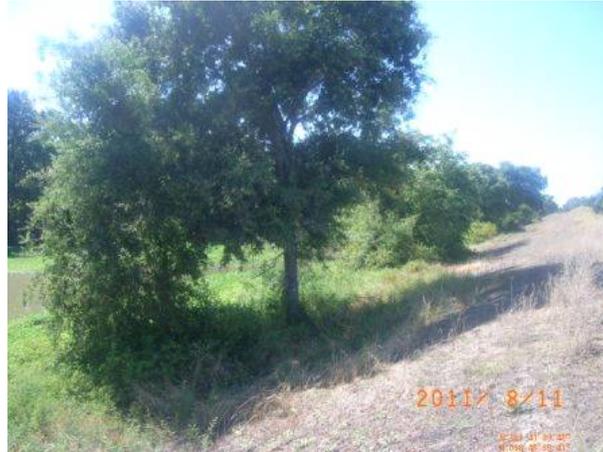
Levee Mile Report Line	2
Start Levee Mile	2.90
End Levee Mile	2.90
Location	Water Side
Category	Supplemental
Item	USACE Erosion Survey
USACE 2011 Photo #1	
USACE2011_KLR_3-1_L_1.jpg

Levee Mile Report Line	2
Start Levee Mile	2.90
End Levee Mile	2.90
Location	Water Side
Category	Supplemental
Item	USACE Erosion Survey
USACE 2011 Photo #2	
USACE2011_KLR_3-1_L_2.jpg

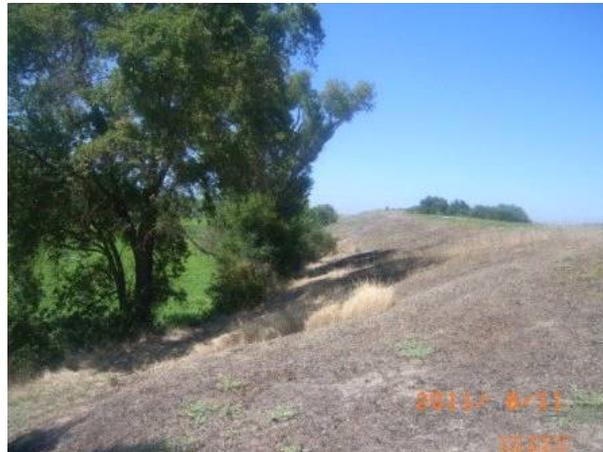
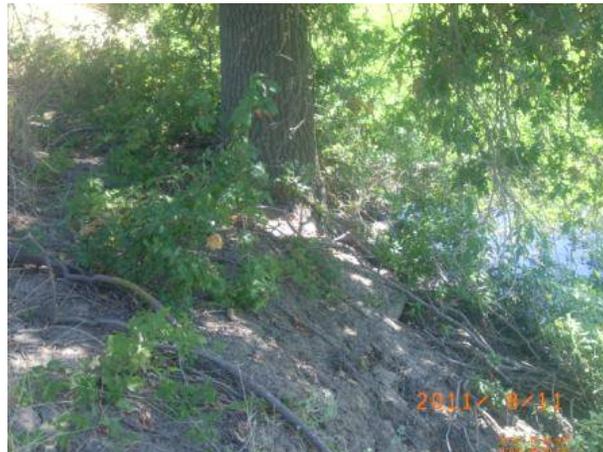
3	3.51	3.51	Supplemental	USACE Erosion Survey	WS	M	Inspector Comments: 2011: The toe has eroded away and there are a few scallops from bank slumping. [2011 Site ID: KLR_3-7_L]	38.765522 ° -121.700608 °	38.767336 ° -121.701023 °	4 Y
4	4.27	4.27	Supplemental	USACE Erosion Survey	WS	M	Inspector Comments: 2011: This site is the downstream section of the old KLR 5.3L site. Levee toe is slowly retreating. Cracking on top of the levee may indicate potential mass movement. [2011 Site ID: KLR_4-7_L]	38.775271 ° -121.703685 °	38.778115 ° -121.706195 °	5 Y
5	4.91	4.91	Earthen Levee	Cracking	LS	M	Schedule repair of subsidence prior to the next inspection.	38.781465 ° -121.709842 °	38.781465 ° -121.709842 °	17 Y
6	5.40	5.40	Supplemental	USACE Erosion Survey	WS	M	Inspector Comments: 2011: This site is the upstream section of the old KLR 5.3L site. Levee toe is slowly retreating. Cracking on top of the levee may indicate potential mass movement. [2011 Site ID: KLR_5-8_L]	38.786566 ° -121.716724 °	38.792395 ° -121.724091 °	6 Y

Levee Mile Report Line	3
Start Levee Mile	3.51
End Levee Mile	3.51
Location	Water Side
Category	Supplemental
Item	USACE Erosion Survey
USACE 2011 Photo #1	
USACE2011_KLR_3-7_L_1.jpg

Levee Mile Report Line	3
Start Levee Mile	3.51
End Levee Mile	3.51
Location	Water Side
Category	Supplemental
Item	USACE Erosion Survey
USACE 2011 Photo #2	
USACE2011_KLR_3-7_L_2.jpg

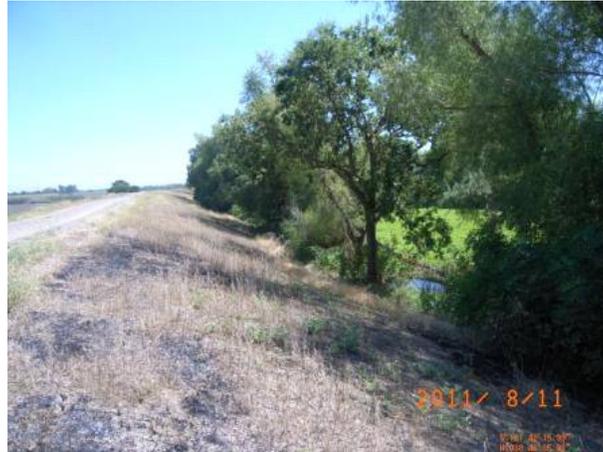
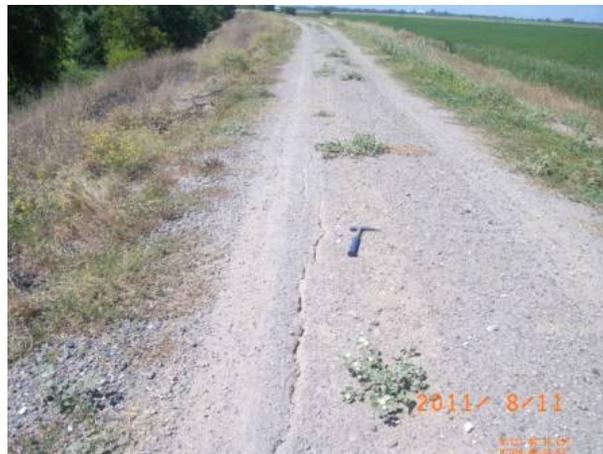
Levee Mile Report Line	4
Start Levee Mile	4.27
End Levee Mile	4.27
Location	Water Side
Category	Supplemental
Item	USACE Erosion Survey
USACE 2011 Photo #1	
USACE2011_KLR_4-7_L_1.jpg

Levee Mile Report Line	4
Start Levee Mile	4.27
End Levee Mile	4.27
Location	Water Side
Category	Supplemental
Item	USACE Erosion Survey
USACE 2011 Photo #2	
USACE2011_KLR_4-7_L_2.jpg

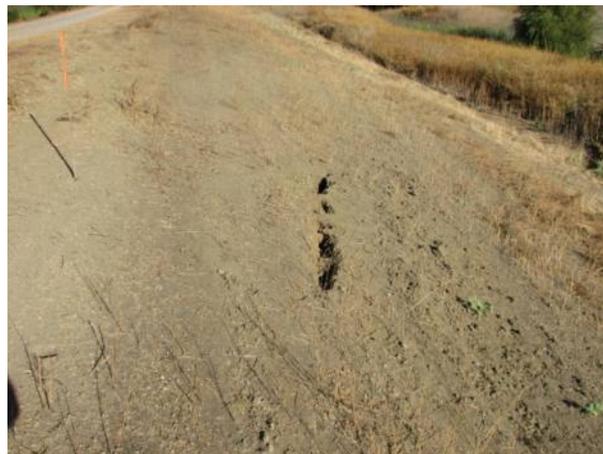
Levee Mile Report Line	5
Start Levee Mile	4.91
End Levee Mile	4.91
Location	Land Side
Category	Earthen Levee
Item	Cracking
A crack on the landside levee slope tree. Photo taken fall 2011.	
johngw_f_20111011_001.jpg

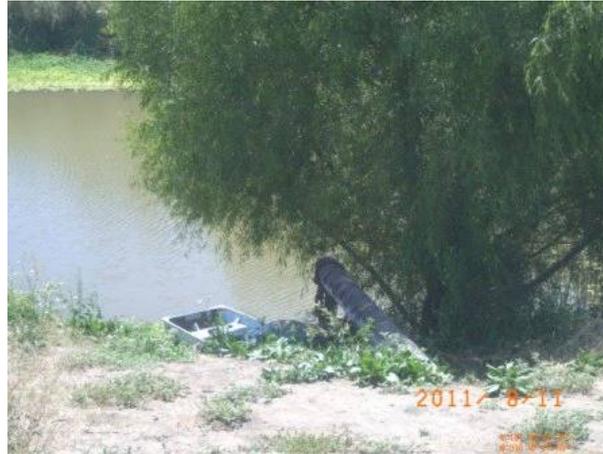
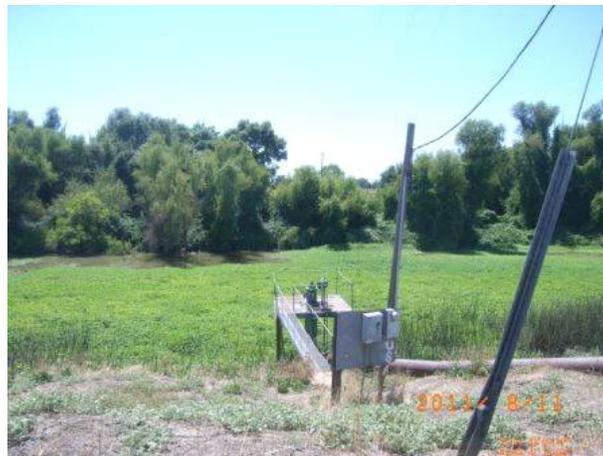
USACE 2011 Photo #1

Levee Mile Report Line	6
Start Levee Mile	5.40
End Levee Mile	5.40
Location	Water Side
Category	Supplemental
Item	USACE Erosion Survey

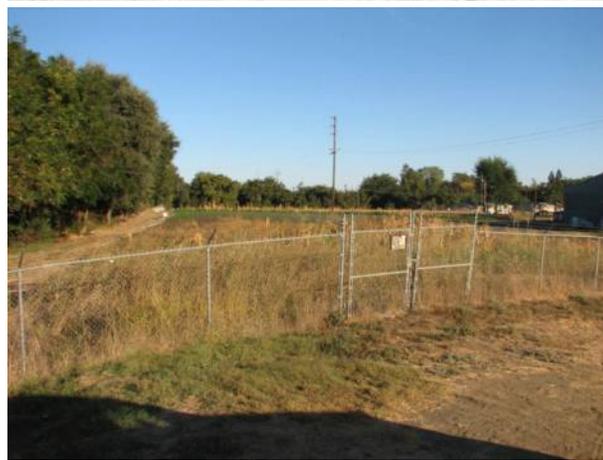
johngw_f_20111011_002.jpg

7	6.05	6.12	Earthen Levee	Encroachments	LS	CO	Crops Inspector Comments: No access; strawberries are being grown landside levee slope and crown	38.792735 ° -121.724092 °	38.792735 ° -121.724092 °	1 Y

Levee Mile Report Line	7
Start Levee Mile	6.05
End Levee Mile	6.12
Location	Land Side
Category	Earthen Levee
Item	Encroachments

A current photo of strawberry patch on the levee. Photo taken fall 2011.
