**Flood Control Project Maintenance
Levee Inspections**

Fall 2013 Levee Maintenance Deficiency Summary Report

Knights Landing Ridge Drainage District

Waterway	Bank	Unit Miles
Unit No. 01 Knights Landing Ridge Cut	Right	6.43

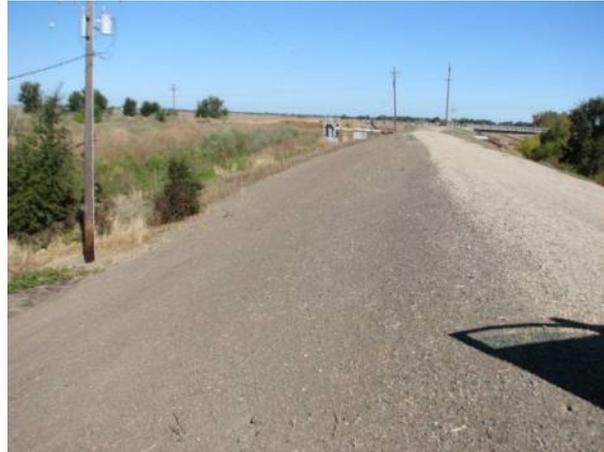
Levee Mile Report Line	4
Start Levee Mile	0.25
End Levee Mile	6.41
Location	Land Side
Category	Earthen Levee
Item	Vegetation
Landside of the levee has been burned and dragged. Fall 2013	
johngw_f_20130930_931.JPG

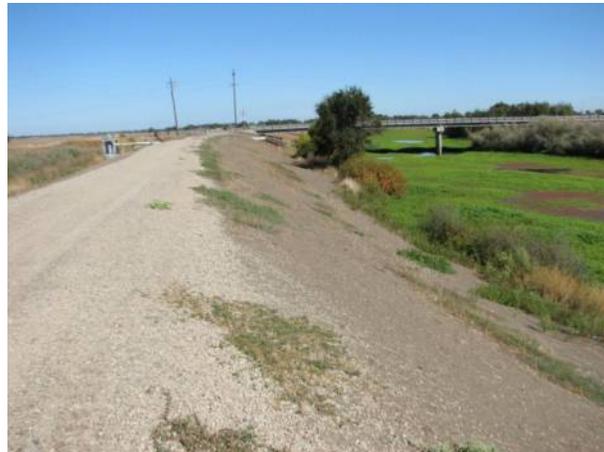
Levee Mile Report Line	5
Start Levee Mile	0.25
End Levee Mile	6.41
Location	Water Side
Category	Earthen Levee
Item	Vegetation
Waterside of the levee has been burned and dragged with little vegetation. Fall 2013	
johngw_f_20130930_932.JPG

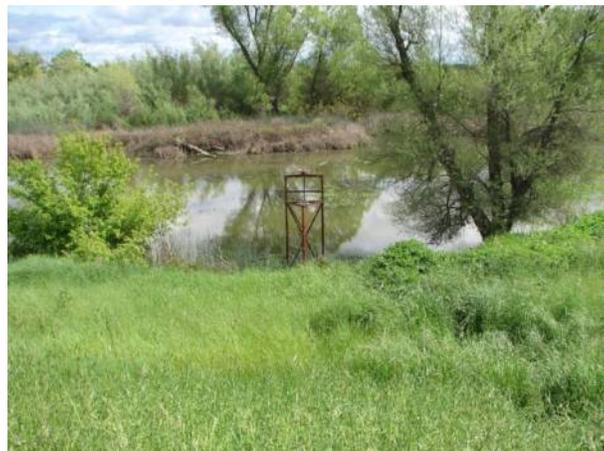
Levee Mile Report Line	6
Start Levee Mile	0.25
End Levee Mile	0.25
Location	Water Side
Category	Supplemental
Item	DWR UCIP Field Study
Slide gate on metal stand on WS toe. Pipe opening not visible.	
UCIP_6248.jpg

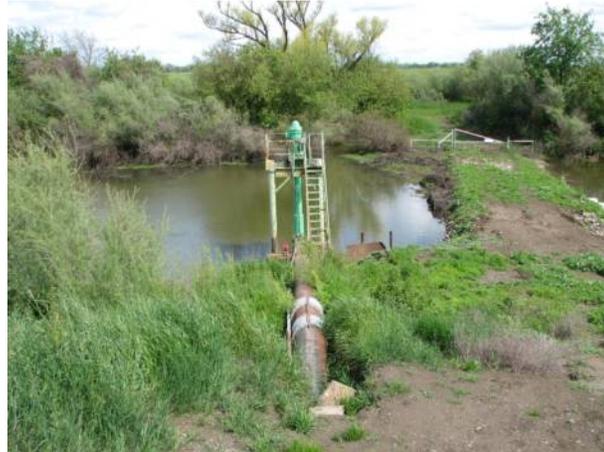
8	0.88	0.88	Supplemental	DWR UCIP Field Study	WS	M En	Inspector Comments: FS_ID:11064 EP_NO: 9302 Repair Type: Non-Urgent Crossing Status: Found UCIP Comments: Pipe exposed on WS slope in trench may need to be backfilled to prevent erosion under pipe. FIELD_STRUCT_DESC: 20-inch steel irrigation pipe through the levee, 8.8 feet below the crown. Pump on steel pile structure at WS toe. Siphon breaker in 12-inch steel riser on LS slope. Possible butterfly valve at LS toe. (Permit No. 9302-Elliott 1974), Originally included in O+M manual (1953). FS Date: 4/5/2013	38.727869 ° 38.727869 °	-121.674875 ° -121.674875 °	6 Y
---	------	------	--------------	-------------------------	----	---------	--	----------------------------	--------------------------------	--------

Levee Mile Report Line	8
Start Levee Mile	0.88
End Levee Mile	0.88
Location	Water Side
Category	Supplemental
Item	DWR UCIP Field Study
Pump on pile at WS toe with pipe in open trench on LS slope.	
UCIP_6253.jpg

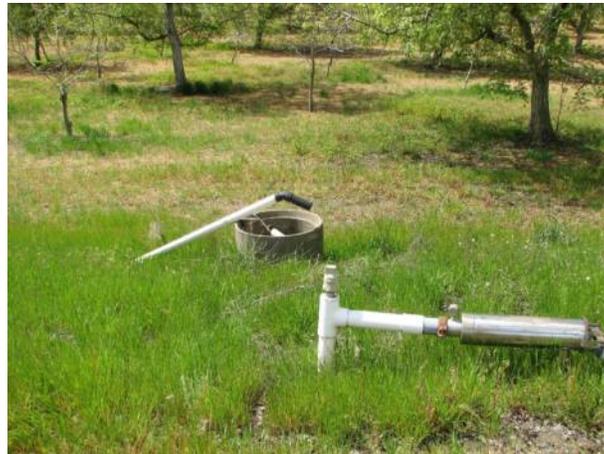
9	1.16	1.16	Supplemental	DWR UCIP Field Study	WS	M En	Inspector Comments: FS_ID:11065 EP_NO: 9305 Repair Type: Non-Urgent Crossing Status: Found UCIP Comments: Slope on WS shoulder appears to be eroding at pipes exit from levee. 36-inch conc riser on LS is filled with mud. FIELD_STRUCT_DESC: 10-inch pipe through the levee, 5.8-feet below the crown. Pump at the waterward toe. 36-inch Concrete standpipe at the landward toe (Permit No. 9305-Bacchini). 5-inch steel-pipe sleeved through 10-inch pipe. Annular space Grouted. (Permit No. 6076-Bacchini). Originally included in O+M manual (1953). FS Date: 4/5/2013	38.730275 ° 38.730275 °	-121.678975 ° -121.678975 °	10 Y
---	------	------	--------------	-------------------------	----	---------	---	----------------------------	--------------------------------	---------

Levee Mile Report Line	9
Start Levee Mile	1.16
End Levee Mile	1.16
Location	Water Side
Category	Supplemental
Item	DWR UCIP Field Study
36-inch Concrete standpipe at LS toe	
UCIP_6254.jpg

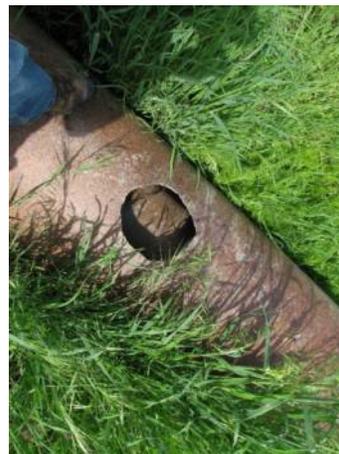
10	1.61	1.61	Supplemental	DWR UCIP Field Study	WS	M En	Inspector Comments: FS_ID:11066 EP_NO: 9302 Repair Type: Non-Urgent Crossing Status: Found UCIP Comments: Space between 16-inch and 24-inch pipe should be grouted. There is no pump on stand at WS toe. FIELD_STRUCT_DESC: 24-inch steel pipe through the levee, 5.9-feet below the crown. 16-inch steel pipe sleeved through this pipe. No visible control valves. Pump on pile structure in stream. Siphon breaker on the landward slope. Discharges into concrete irrigation ditch off the landward toe (Permit No. 9302-Elliott). Originally included in O+M manual (1953). FS Date: 4/5/2013	38.735399 ° 38.735399 °	-121.684058 ° -121.684058 °	11 Y
----	------	------	--------------	-------------------------	----	---------	--	----------------------------	--------------------------------	---------

Levee Mile Report Line	10
Start Levee Mile	1.61
End Levee Mile	1.61
Location	Water Side
Category	Supplemental
Item	DWR UCIP Field Study
16-inch pipe sleeved through 24-inch pipe on WS slope.	
UCIP_6257.jpg

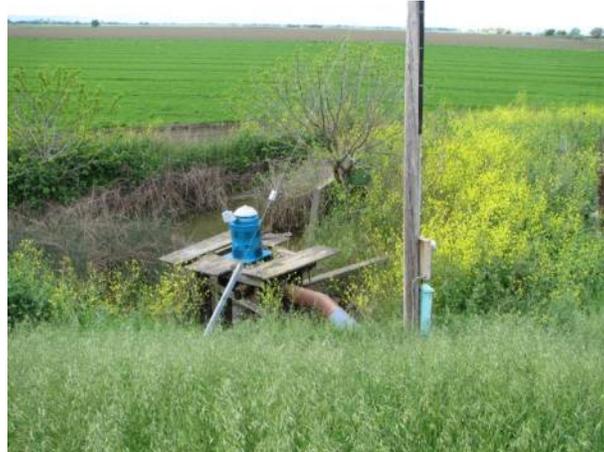
Levee Mile Report Line	12
Start Levee Mile	2.61
End Levee Mile	2.61
Location	Water Side
Category	Supplemental
Item	DWR UCIP Field Study
Pump and pipe on LS toe.	
UCIP_6258.jpg

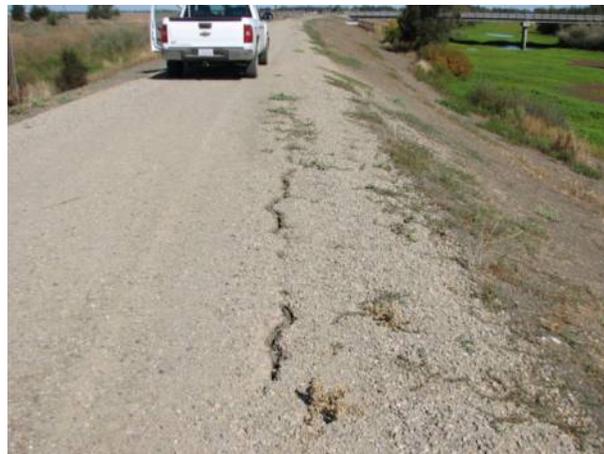
Levee Mile Report Line	15
Start Levee Mile	2.61
End Levee Mile	2.61
Location	Water Side
Category	Earthen Levee
Item	Cracking
Cracking along the waterside shoulder of the crown the length of 20 feet. Fall 2013	
johngw_f_20130930_933.JPG

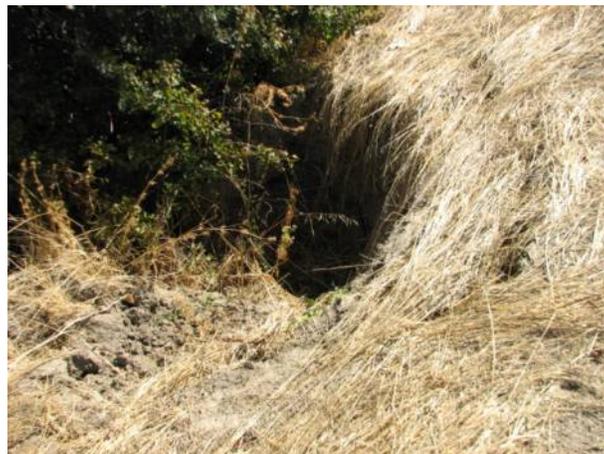
Levee Mile Report Line	17
Start Levee Mile	3.54
End Levee Mile	3.54
Location	Water Side
Category	Earthen Levee
Item	Erosion / Bank Caving
Deep erosion at the bottom of the waterside slope 3-4 foot cut. Fall 2013	
johngw_f_20130930_934.JPG

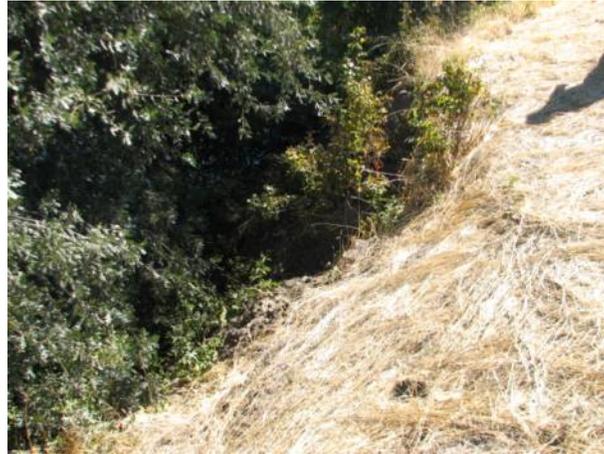
Levee Mile Report Line	17
Start Levee Mile	3.54
End Levee Mile	3.54
Location	Water Side
Category	Earthen Levee
Item	Erosion / Bank Caving

Another view of the erosion cutting into the slope. Fall 2013

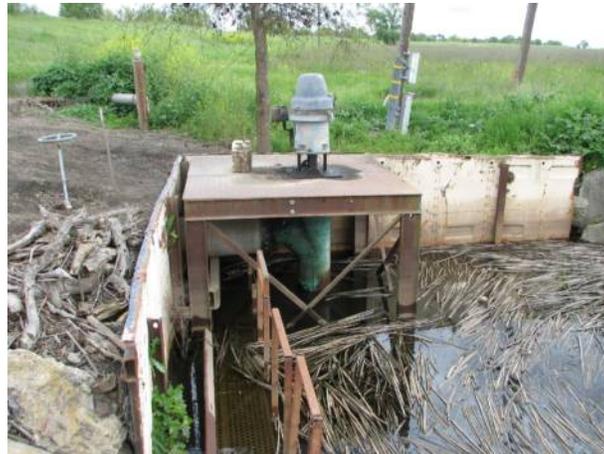
Levee Mile Report Line	19
Start Levee Mile	4.95
End Levee Mile	4.95
Location	Water Side
Category	Supplemental
Item	DWR UCIP Field Study

DWR ID:		
19	4.95	4.95	Supplemental	DWR UCIP Field Study	WS	M En	Inspector Comments: FS_ID:11264 EP_NO: 4443 Repair Type: Non-Urgent Crossing Status: Found UCIP Comments: Pipe does not have adequate cover at crown. FIELD_STRUCT_DESC: 16-inch drainage pipe through the levee 0.5-feet below the crown. Pad constructed over pipe for vehicular crossing. Pump on metal structure on the landward side, flap gate on the waterside end, Siphon breaker on the pipe on the waterside. Slide gate located on LS toe. (Permit No. 4443-RD 730). Design drawings available in permit. FS Date: 4/5/2013	38.777566 °	-121.707591 °	16

Pump on Steel pile structure with slide gate at LS toe.

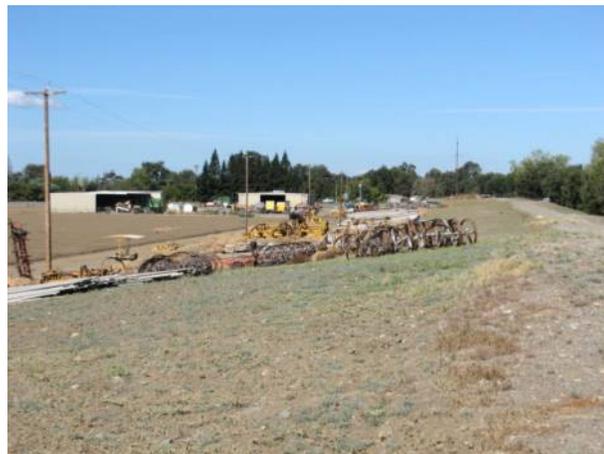
Levee Mile Report Line	20
Start Levee Mile	6.17
End Levee Mile	6.41
Location	Land Side
Category	Earthen Levee
Item	Encroachments

Equipment and irrigation pipe lays on the landside levee slope. Fall 2013

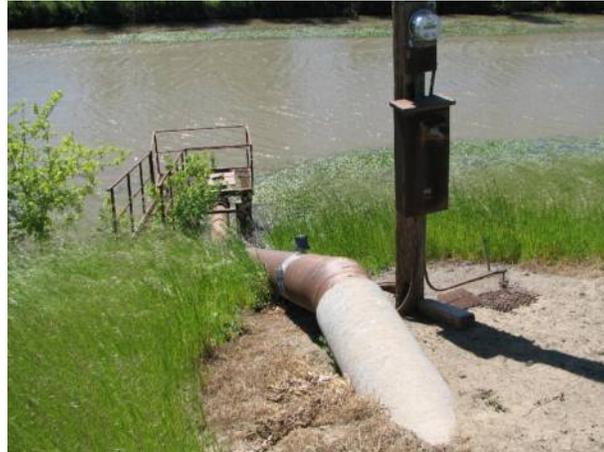
Levee Mile Report Line	1
Start Levee Mile	1.00
End Levee Mile	1.00
Location	Water Side
Category	Supplemental
Item	DWR UCIP Field Study
Pump platform and walkway on WS toe.	
UCIP_6279.jpg

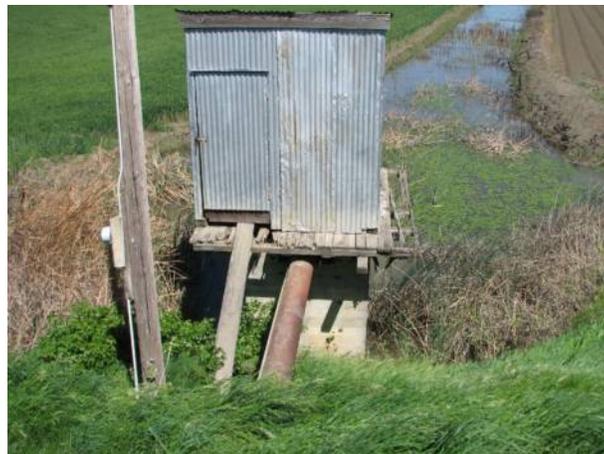
Levee Mile Report Line	2
Start Levee Mile	1.91
End Levee Mile	1.91
Location	Water Side
Category	Supplemental
Item	DWR UCIP Field Study
Pumphouse on concrete platform on LS toe with JP.	
UCIP_6276.jpg

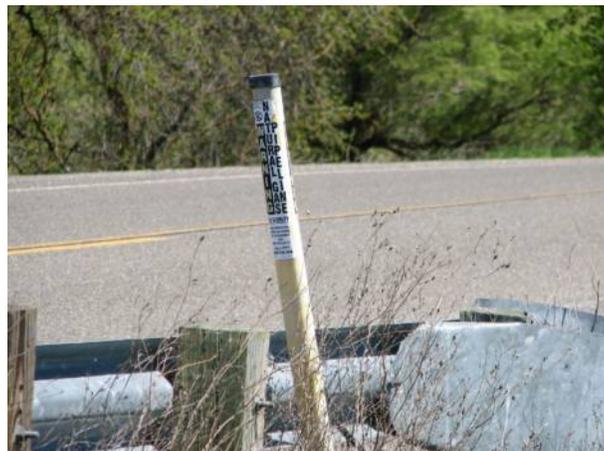
Levee Mile Report Line	4
Start Levee Mile	2.30
End Levee Mile	2.30
Location	Water Side
Category	Supplemental
Item	DWR UCIP Field Study
Sign on LS shoulder may indicate location of pipe, or it may indicate where pipe crosses approach ramp to bridge.	
UCIP_6275.jpg

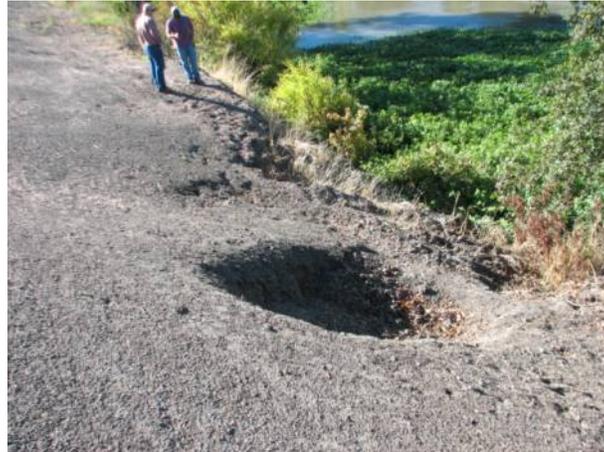
Levee Mile Report Line	7
Start Levee Mile	3.05
End Levee Mile	3.05
Location	Water Side
Category	Earthen Levee
Item	Erosion / Bank Caving
Erosion at the bottom of the slope. It appears that a fallen tree has caused a sink hole. Fall 2013	
johngw_f_20130930_930.JPG

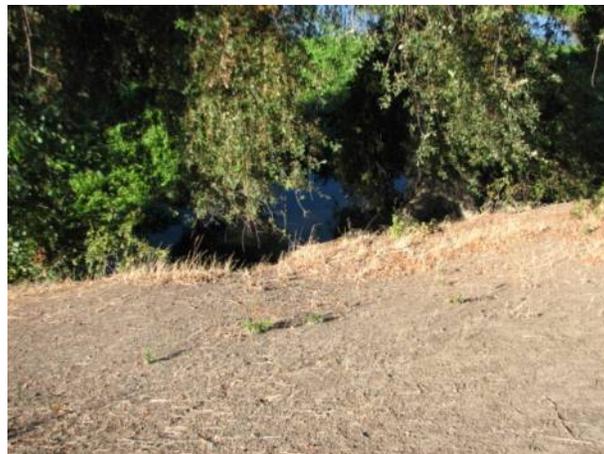
Levee Mile Report Line	8
Start Levee Mile	3.08
End Levee Mile	3.08
Location	Water Side
Category	Earthen Levee
Item	Erosion / Bank Caving
Waterside eroision vertical cut at bottom of slope. Fall 2013	
johngw_f_20130930_928.JPG

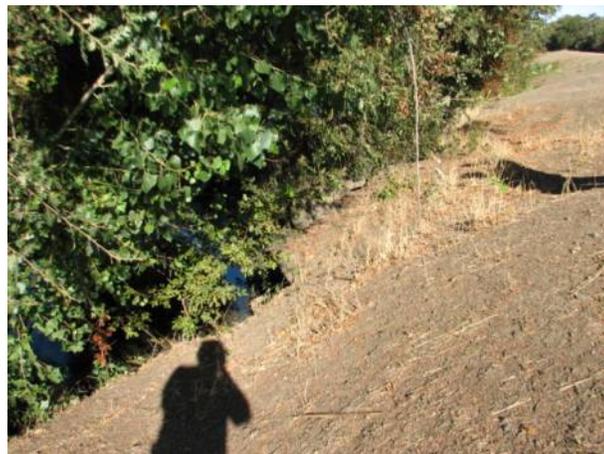
Levee Mile Report Line	8
Start Levee Mile	3.08
End Levee Mile	3.08
Location	Water Side
Category	Earthen Levee
Item	Erosion / Bank Caving
Another view of the vertical cut at the bottom of the slope. Fall 2013	
johngw_f_20130930_929.JPG

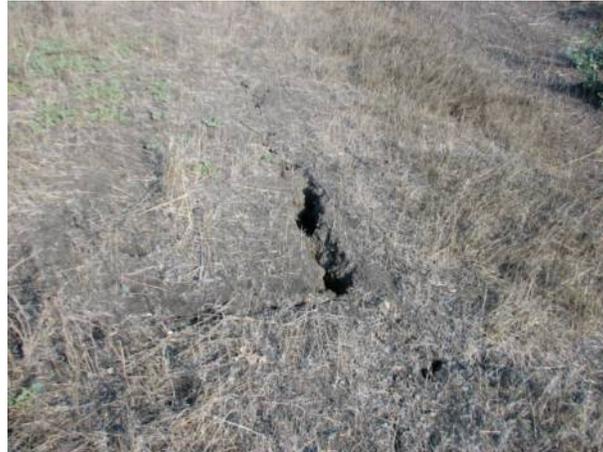
Levee Mile Report Line	12
Start Levee Mile	4.86
End Levee Mile	4.88
Location	Land Side
Category	Earthen Levee
Item	Cracking
Cracking on the landside is 3-4 inches wide and 12 inches deep. Fall 2013	
johngw_f_20130930_925.JPG

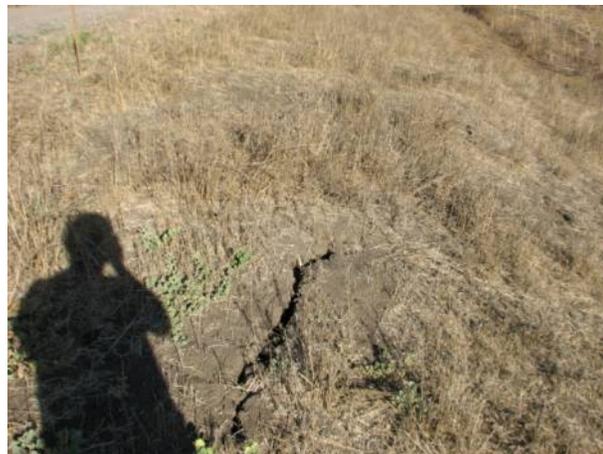
Levee Mile Report Line	13
Start Levee Mile	4.86
End Levee Mile	4.86
Location	Water Side
Category	Earthen Levee
Item	Cracking
Cracking on levee slope 1-2 inches wide and 6 inches deep. Fall 2013	
johngw_f_20130930_926.JPG

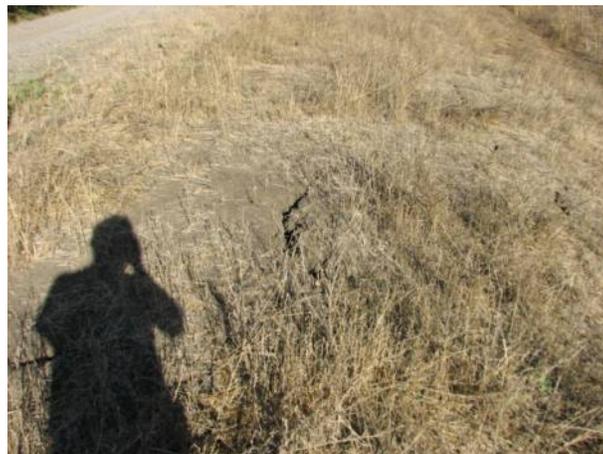
Levee Mile Report Line	13
Start Levee Mile	4.86
End Levee Mile	4.86
Location	Water Side
Category	Earthen Levee
Item	Cracking
Another view of the cracking on the levee slope. Fall 2013	
johngw_f_20130930_927.JPG

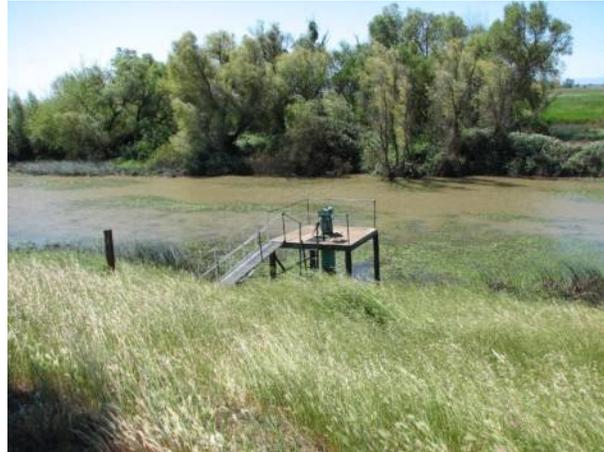
Levee Mile Report Line	15
Start Levee Mile	5.64
End Levee Mile	5.64
Location	Land Side
Category	Supplemental
Item	DWR UCIP Field Study
Pump on pile structure on WS toe. UCIP_6273.jpg

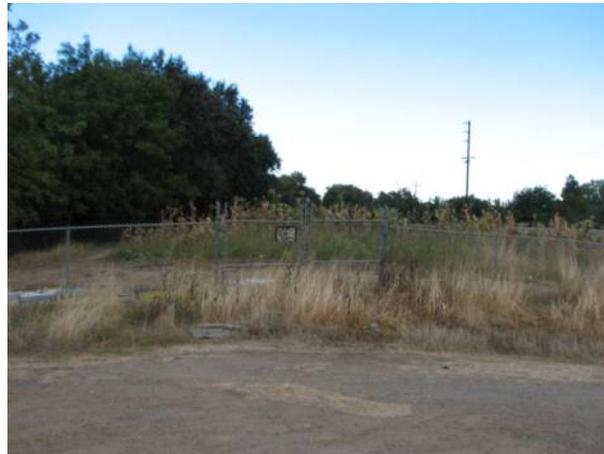
Levee Mile Report Line	16
Start Levee Mile	6.05
End Levee Mile	6.12
Location	Land Side
Category	Earthen Levee
Item	Encroachments
Strawberry patch on the levee crown has added other crops on the crown. Fall 2013 johngw_f_20130930_924.JPG
