**Flood Control Project Maintenance
Levee Inspections
LMA District Cover Sheet
Spring 2012 Levee Inspection Results**

Knights Landing Ridge Drainage District

Spring 2012 Levee Inspection Results

Levee Inspection Report By Mile - Spring 2012

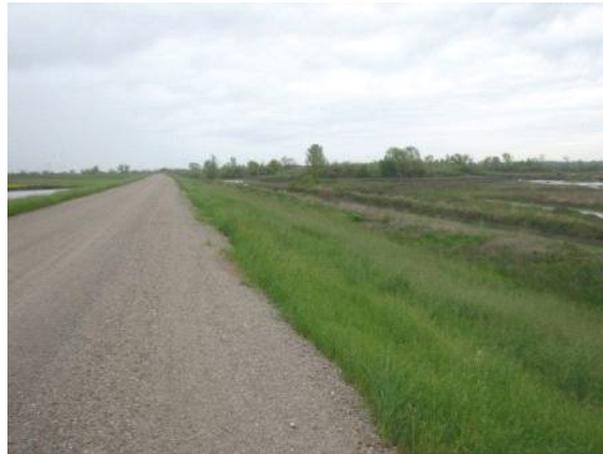
Levee Mile Report Line	4
Start Levee Mile	0.03
End Levee Mile	6.41
Location	Water Side
Category	Earthen Levee
Item	Vegetation
The grasses are taller that 12", photo taken spring 2012.	
johngw_s_20120411_685.jpg

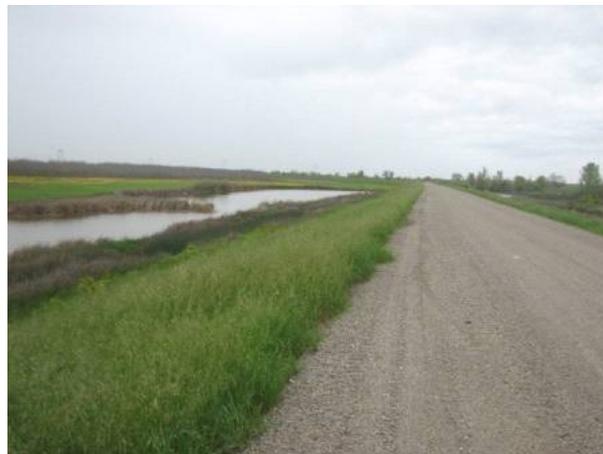
Levee Mile Report Line	5
Start Levee Mile	0.03
End Levee Mile	6.41
Location	Land Side
Category	Earthen Levee
Item	Vegetation
The grasses are taller than 12" in height, photo taken spring 2012.	
johngw_s_20120411_684.jpg

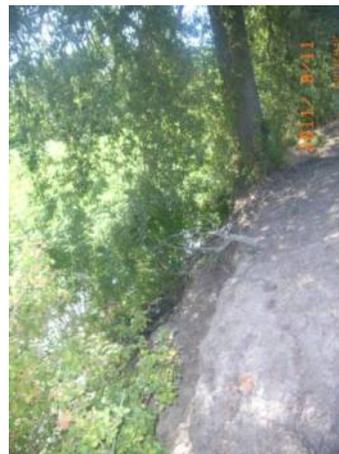
Levee Mile Report Line	6
Start Levee Mile	3.26
End Levee Mile	3.26
Location	Water Side
Category	Supplemental
Item	USACE Erosion Survey
USACE 2011 Photo #1	
johngw_s_20120313_157.jpg

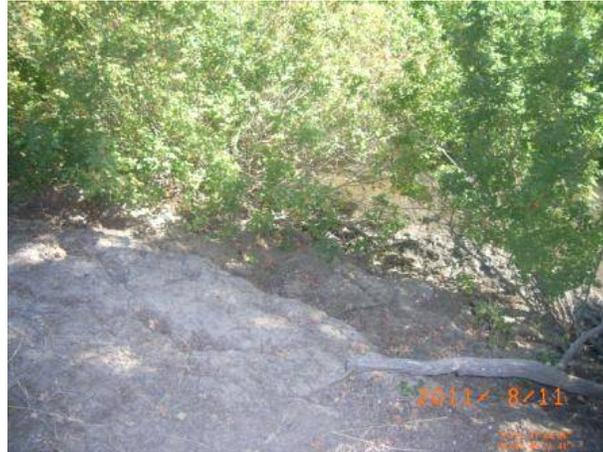
Levee Mile Report Line	6
Start Levee Mile	3.26
End Levee Mile	3.26
Location	Water Side
Category	Supplemental
Item	USACE Erosion Survey
USACE 2011 Photo #2	
johngw_s_20120313_158.jpg

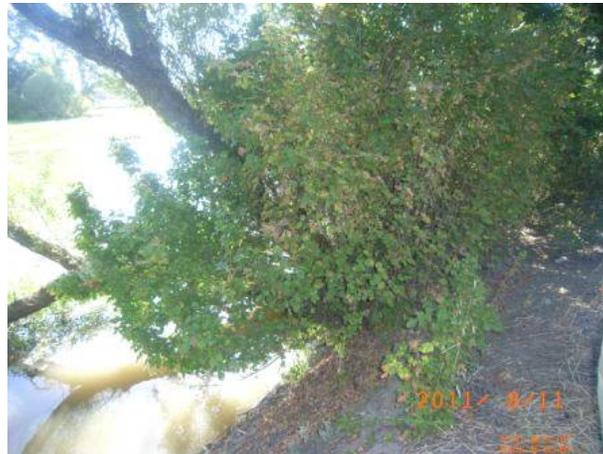
DWR ID: DWR_NA0008_01_s_2012_1										
7	3.86	3.86	Supplemental	USACE Erosion Survey	WS	M Ma	Inspector Comments: 2011: Toe erosion and erosion pockets from tree popouts. More tree popouts are expected due to the eroding toe. [2011 Site ID: KLR_3-9_R]	38.764037 ° -121.701434 °	38.764905 ° -121.702074 °	2 Y
DWR ID: DWR_NA0008_01_s_2012_2										
8	6.17	6.41	Earthen Levee	Encroachments	LS	M Ma	EQ : Equipment	38.790007 ° -121.723308 °	38.792433 ° -121.726463 °	7 Y
DWR ID: DWR_NA0008_01_s_2012_7

Levee Mile Report Line	7
Start Levee Mile	3.86
End Levee Mile	3.86
Location	Water Side
Category	Supplemental
Item	USACE Erosion Survey
USACE 2011 Photo #1	
johngw_s_20120313_159.jpg

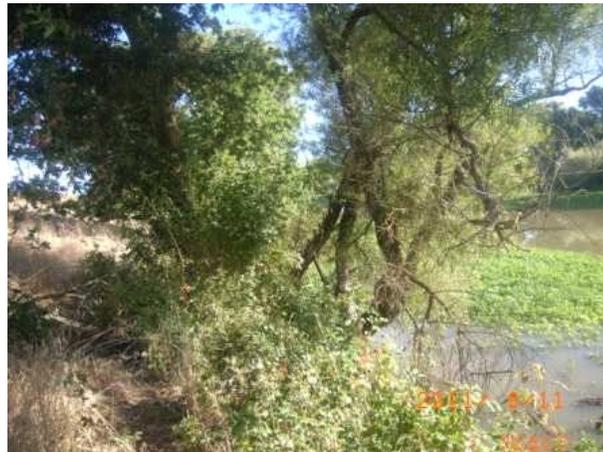
Levee Mile Report Line	7
Start Levee Mile	3.86
End Levee Mile	3.86
Location	Water Side
Category	Supplemental
Item	USACE Erosion Survey
USACE 2011 Photo #2	
johngw_s_20120313_160.jpg

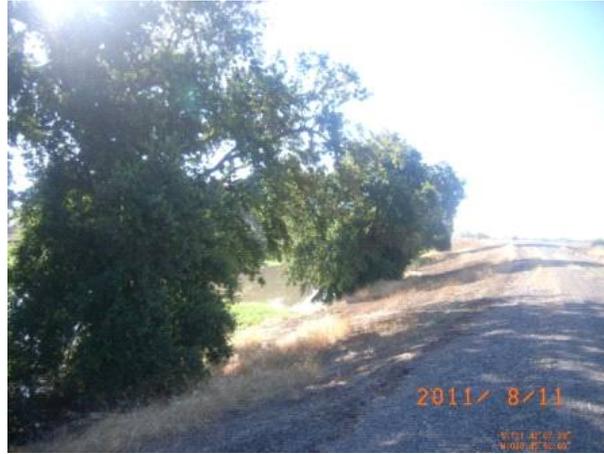
USACE 2011 Photo #3

Levee Mile Report Line	7
Start Levee Mile	3.86
End Levee Mile	3.86
Location	Water Side
Category	Supplemental
Item	USACE Erosion Survey

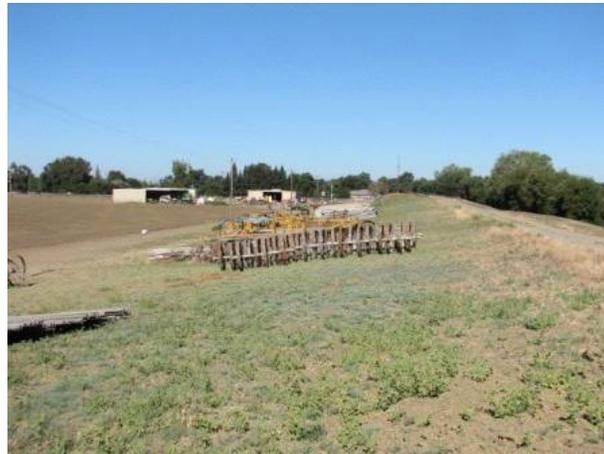
johnngw_s_20120313_162.jpg

Levee Mile Report Line	8
Start Levee Mile	6.17
End Levee Mile	6.41
Location	Land Side
Category	Earthen Levee
Item	Encroachments

The equipment and irrigation pipe is on the slope of the levee. Photo taken fall 2011.

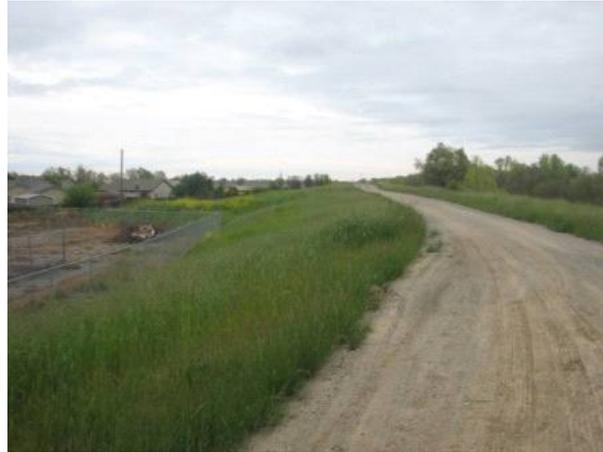
Levee Mile Report Line	1
Start Levee Mile	0.02
End Levee Mile	6.04
Location	Land Side
Category	Earthen Levee
Item	Vegetation
The grasses are taller than 12", photo taken spring 2012	
johngw_s_20120411_686.jpg

LMIR No.	Levee Mile		Category	Item	Location	Rating	Action/Comment	GPS Latitude/Longitude		Issue No. Photo
	Start	End						Start	End	
1	0.02	6.04	Earthen Levee	Vegetation	LS	M Ma	V1 : Control annual grass and weeds on the levee slopes and easements.	38.724485 ° -121.665513 °	38.792672 ° -121.724090 °	7 Y
DWR ID: DWR_NA0008_02_s_2012_7										
2	0.02	6.04	Earthen Levee	Vegetation	WS	M Ma	V1 : Control annual grass and weeds on the levee slopes and easements.	38.724485 ° -121.665512 °	38.792667 ° -121.724087 °	8 Y
DWR ID: DWR_NA0008_02_s_2012_8										
3	2.66	2.66	Supplemental Levee	USACE Erosion Survey	WS	M Ma	Inspector Comments: 2006 - The whole levee toe area is slowly slumping into the channel (creep) due to dewatering and poor slope soils. Occasional piping in the levee slope evident as well. Pistol-butted trees at the levee toe indicate slow retreat. 2011: Multiple scallops throughout the site and slumping of the toe. [2011 Site ID: KLR_3-0_L]	38.754899 ° -121.692653 °	38.757925 ° -121.693048 °	2 Y

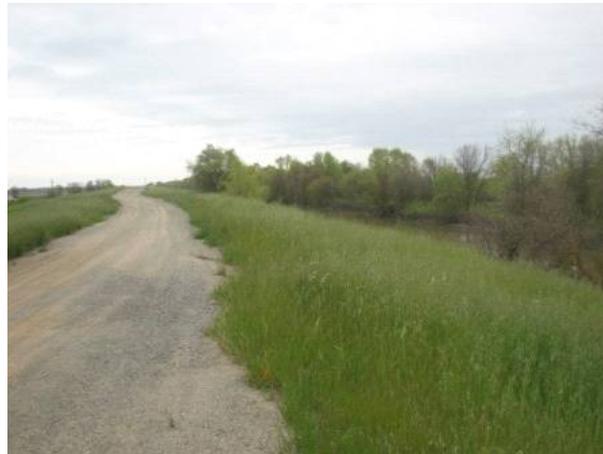
Levee Mile Report Line	2
Start Levee Mile	0.02
End Levee Mile	6.04
Location	Water Side
Category	Earthen Levee
Item	Vegetation
The grasses are taller than 12", photo taken spring 2012.	
johngw_s_20120411_687.jpg

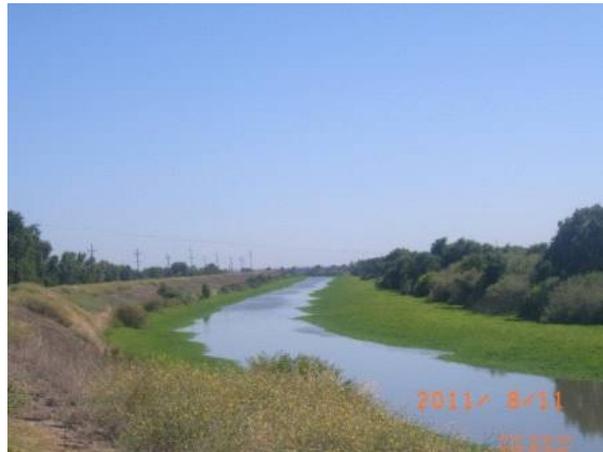
Levee Mile Report Line	3
Start Levee Mile	2.66
End Levee Mile	2.66
Location	Water Side
Category	Supplemental
Item	USACE Erosion Survey
USACE 2011 Photo #1	
johngw_s_20120313_164.jpg

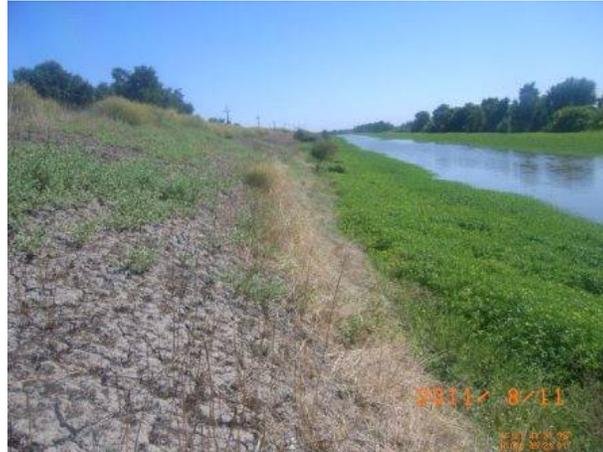
Levee Mile Report Line	3
Start Levee Mile	2.66
End Levee Mile	2.66
Location	Water Side
Category	Supplemental
Item	USACE Erosion Survey
USACE 2011 Photo #2	
johngw_s_20120313_165.jpg

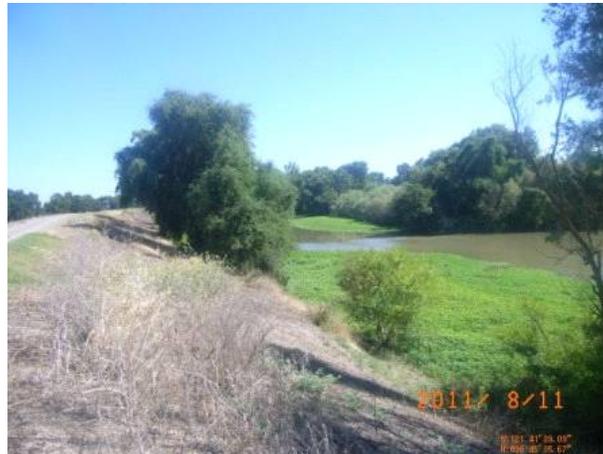
DWR ID: DWR_NA0008_02_s_2012_2										
4	2.90	2.90	Supplemental Levee	USACE Erosion Survey	WS	M Ma	Inspector Comments: 2006 - The whole levee toe area is slowly slumping into the channel (creep) due to dewatering and poor slope soils. Occasional piping in the levee slope evident as well. Pistol-butted trees at the levee toe indicate slow retreat. 2011: Slumping of the levee toe. [2011 Site ID: KLR_3-1_L]	38.758587 ° -121.693359 °	38.760053 ° -121.694686 °	3 Y
DWR ID: DWR_NA0008_02_s_2012_3										
5	3.51	3.51	Supplemental Levee	USACE Erosion Survey	WS	M Ma	Inspector Comments: 2011: The toe has eroded away and there are a few scallops from bank slumping. [2011 Site ID: KLR_3-7_L]	38.765522 ° -121.700608 °	38.767336 ° -121.701023 °	4 Y
DWR ID: DWR_NA0008_02_s_2012_4										
6	4.27	4.27	Supplemental Levee	USACE Erosion Survey	WS	M Ma	Inspector Comments: 2011: This site is the downstream section of the old KLR 5.3L site. Levee toe is slowly retreating. Cracking on top of the levee may indicate potential mass movement. [2011 Site ID: KLR_4-7_L]	38.775271 ° -121.703685 °	38.778115 ° -121.706195 °	5 Y

Levee Mile Report Line	4
Start Levee Mile	2.90
End Levee Mile	2.90
Location	Water Side
Category	Supplemental
Item	USACE Erosion Survey
USACE 2011 Photo #1	
johngw_s_20120313_166.jpg

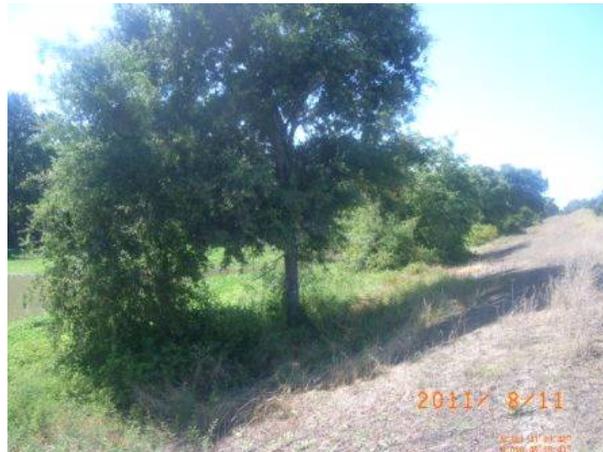
Levee Mile Report Line	4
Start Levee Mile	2.90
End Levee Mile	2.90
Location	Water Side
Category	Supplemental
Item	USACE Erosion Survey
USACE 2011 Photo #2	
johngw_s_20120313_167.jpg

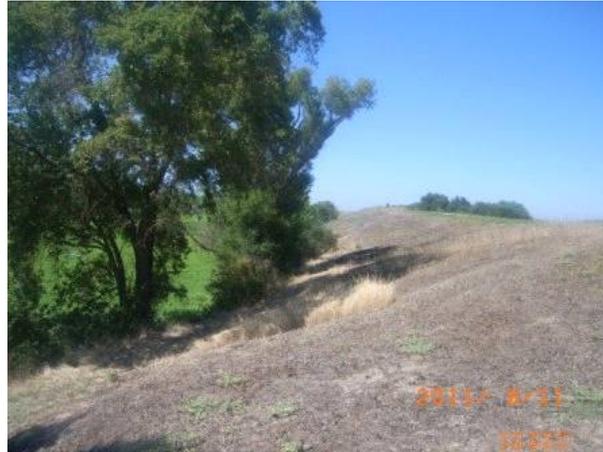
Levee Mile Report Line	5
Start Levee Mile	3.51
End Levee Mile	3.51
Location	Water Side
Category	Supplemental
Item	USACE Erosion Survey
USACE 2011 Photo #1	
johngw_s_20120313_168.jpg

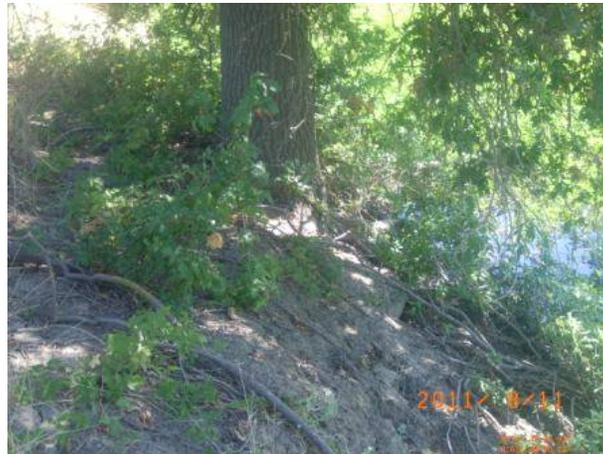
Levee Mile Report Line	5
Start Levee Mile	3.51
End Levee Mile	3.51
Location	Water Side
Category	Supplemental
Item	USACE Erosion Survey
USACE 2011 Photo #2	
johngw_s_20120313_169.jpg

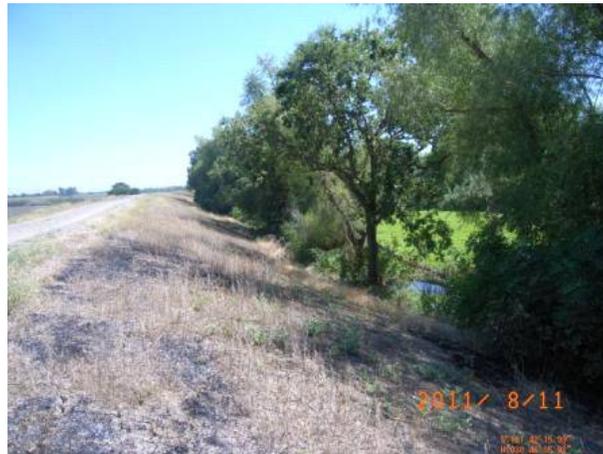
Levee Mile Report Line	6
Start Levee Mile	4.27
End Levee Mile	4.27
Location	Water Side
Category	Supplemental
Item	USACE Erosion Survey
USACE 2011 Photo #1	
johngw_s_20120313_170.jpg

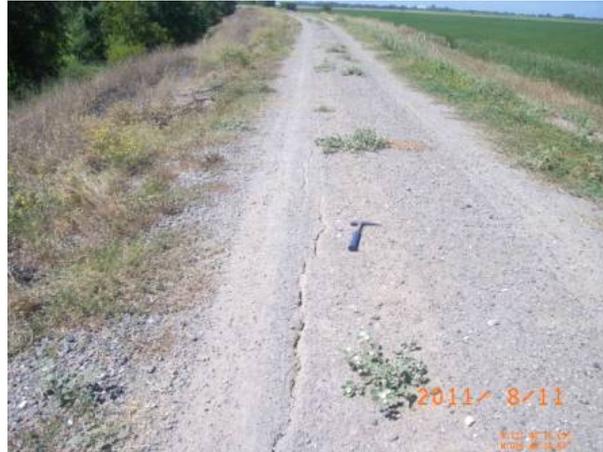
Levee Mile Report Line	6
Start Levee Mile	4.27
End Levee Mile	4.27
Location	Water Side
Category	Supplemental
Item	USACE Erosion Survey
USACE 2011 Photo #2	
johngw_s_20120313_171.jpg

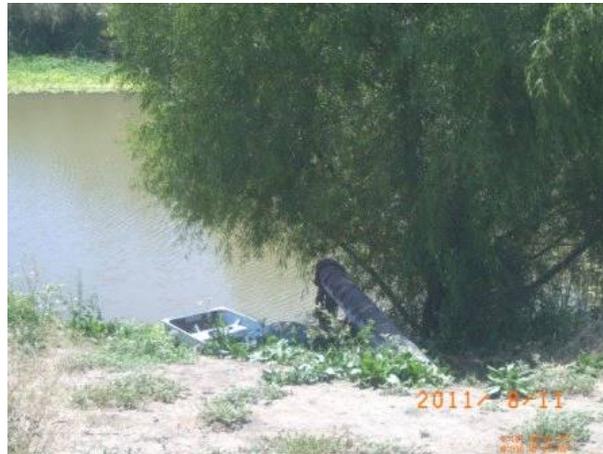
Levee Mile Report Line	8
Start Levee Mile	5.40
End Levee Mile	5.40
Location	Water Side
Category	Supplemental
Item	USACE Erosion Survey
USACE 2011 Photo #1	
johngw_s_20120313_172.jpg

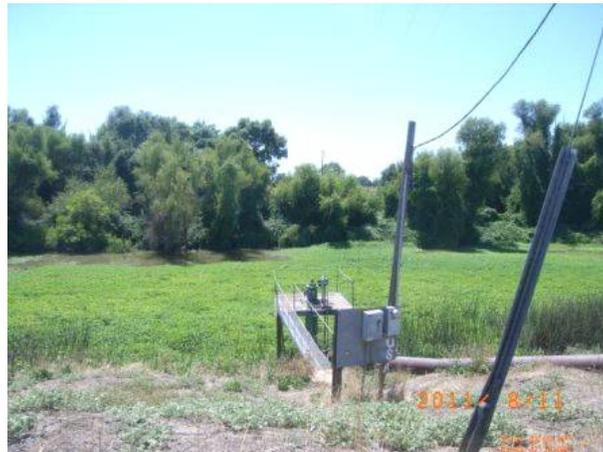
Levee Mile Report Line	8
Start Levee Mile	5.40
End Levee Mile	5.40
Location	Water Side
Category	Supplemental
Item	USACE Erosion Survey
USACE 2011 Photo #2	
johngw_s_20120313_173.jpg

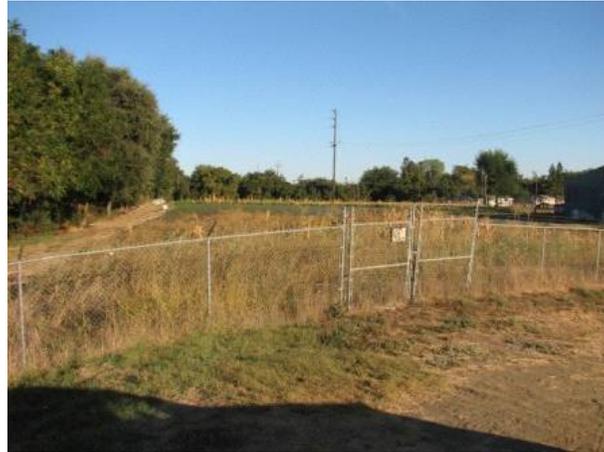
johngw_s_20120313_163.jpg

Levee Mile Report Line	9
Start Levee Mile	6.05
End Levee Mile	6.12
Location	Land Side
Category	Earthen Levee
Item	Encroachments

A current photo of strawberry patch on the levee. Photo taken fall 2011.

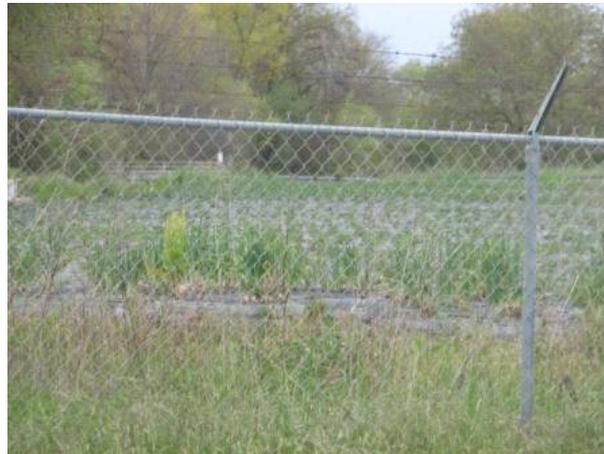
johngw_s_20120411_688.jpg

Levee Mile Report Line	9
Start Levee Mile	6.05
End Levee Mile	6.12
Location	Land Side
Category	Earthen Levee
Item	Encroachments

Photo of the strawberry patch in the spring of 2012.
