**Flood Control Project Maintenance
Levee Inspections
LMA District Cover Sheet
Spring 2014 Levee Inspection Results**

Knights Landing Ridge Drainage District

Spring 2014 Levee Inspection Results

Waterway	Bank	Unit Miles
Unit No. 01 Knights Landing Ridge Cut	Right	6.43

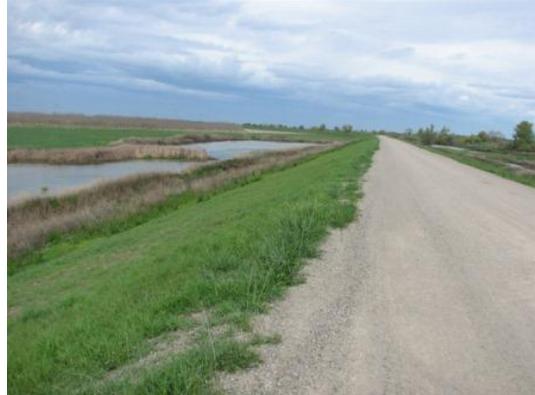
Photo 1 of 1 : johngw_s_20140401_681.jpg

LM Start	0.02	Rating **	A	Issue No.	14
LM End	6.41	Issue Type +	Ma	Location *	LS
Category	Earthen Levee		GPS Latitude/Longitude		
			Start	End	
Item	Vegetation		38.719254 °	38.792352 °	
			-121.664234 °	-121.726516 °	
DWR ID	DWR_NA0008_01_s_2014_14				
Action/Comments					
Control annual grass and weeds on the levee slopes and easements.

The vegetation complies with standards. Spring 2014

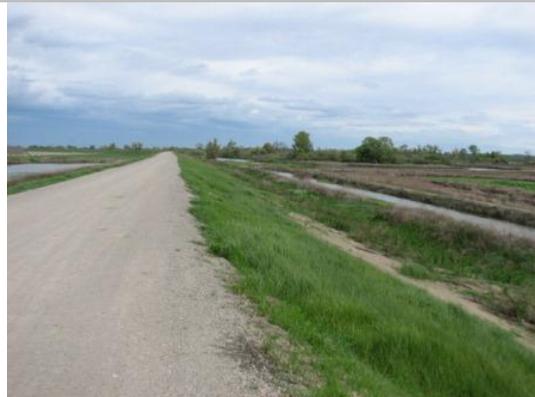
Photo 1 of 1 : johngw_s_20140401_682.jpg

LM Start	0.02	Rating **	A	Issue No.	15
LM End	6.41	Issue Type +	Ma	Location *	WS
Category	Earthen Levee		GPS Latitude/Longitude		
			Start	End	
Item	Vegetation		38.719254 °	38.792353 °	
			-121.664234 °	-121.726516 °	
DWR ID	DWR_NA0008_01_s_2014_15				
Action/Comments					
Control annual grass and weeds on the levee slopes and easements.

The vegetation complies with standards. Spring 2014

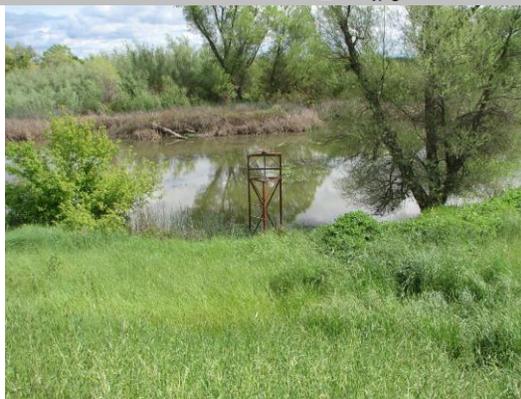
Photo 1 of 1 : UCIP_802.jpg

LM Start	0.25	Rating **	M	Issue No.	4
LM End	0.25	Issue Type +	En	Location *	WS
Category	Supplemental			GPS Latitude/Longitude	
				Start	End
Item	DWR UCIP Field Study			38.722222 °	38.722222 °
				-121.666357 °	-121.666357 °
DWR ID	DWR_NA0008_01_s_2014_4				
Action/Comments					
Inspector Comments: FS_ID:13203 EP_NO: 9302 Repair Type: Crossing Status: UCIP Comments: Pipe completely rusted through on LS slope of levee at toe/headwall of concrete distribution box. Pipe needs replacement or proper abandonment. Pipe not visible at outlet. FIELD_STRUCT_DESC: 36-inch pipe through the levee, 24.0 feet below the crown. Slide gate on the waterward end. 12'X6' Concrete box on the landward end (Permit No. 9302-Elliott). Originally included in O+M manual (1953). FS Date: 4/5/2013

Slide gate on metal stand on WS toe. Pipe opening not visible.

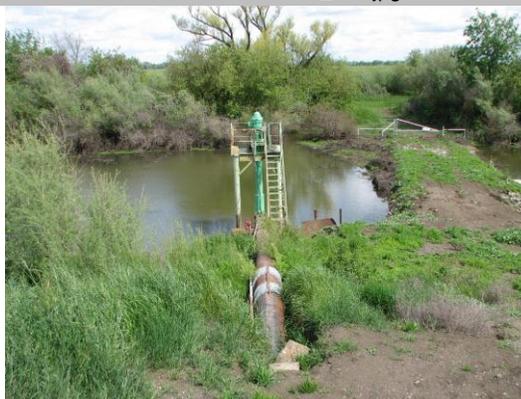
Photo 1 of 1 : UCIP_436.jpg

LM Start	0.88	Rating **	M	Issue No.	5
LM End	0.88	Issue Type +	En	Location *	WS
Category	Supplemental			GPS Latitude/Longitude	
				Start	End
Item	DWR UCIP Field Study			38.727869 °	38.727869 °
				-121.674875 °	-121.674875 °
DWR ID	DWR_NA0008_01_s_2014_5				
Action/Comments					
Inspector Comments: FS_ID:11064 EP_NO: 9302 Repair Type: Crossing Status: UCIP Comments: Pipe exposed on WS slope in trench may need to be backfilled to prevent erosion under pipe. FIELD_STRUCT_DESC: 20-inch steel irrigation pipe through the levee, 8.8 feet below the crown. Pump on steel pile structure at WS toe. Siphon breaker in 12-inch steel riser on LS slope. Possible butterfly valve at LS toe. (Permit No. 9302-Elliott 1974), Originally included in O+M manual (1953). FS Date: 4/5/2013

Pump on pile at WS toe with pipe in open trench on LS slope.

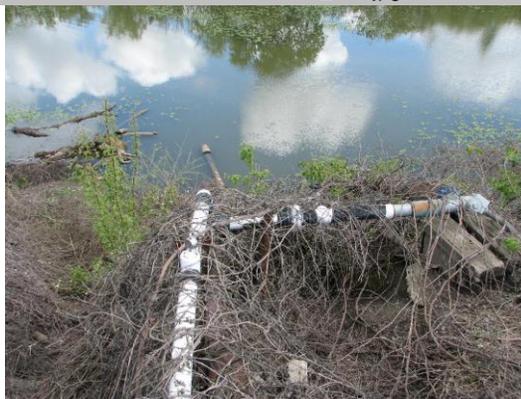
Photo 1 of 1 : UCIP_439.jpg

LM Start	1.16	Rating **	M	Issue No.	6
LM End	1.16	Issue Type +	En	Location *	WS
Category	Supplemental			GPS Latitude/Longitude	
				Start	End
Item	DWR UCIP Field Study			38.730275 °	38.730275 °
				-121.678975 °	-121.678975 °
DWR ID	DWR_NA0008_01_s_2014_6				
Action/Comments					
Inspector Comments: FS_ID:11065 EP_NO: 9305 Repair Type: Crossing Status: UCIP Comments: Slope on WS shoulder appears to be eroding at pipes exit from levee. 36-inch conc riser on LS is filled with mud. FIELD_STRUCT_DESC: 10-inch pipe through the levee, 5.8-feet below the crown. Pump at the waterward toe. 36-inch Concrete standpipe at the landward toe (Permit No. 9305-Bacchini). 5-inch steel-pipe sleeved through 10-inch pipe. Annular space Grouted. (Permit No. 6076-Bacchini). Originally included in O+M manual (1953). FS Date: 4/5/2013

Pump on WS shoulder overgrown and may be abandoned.

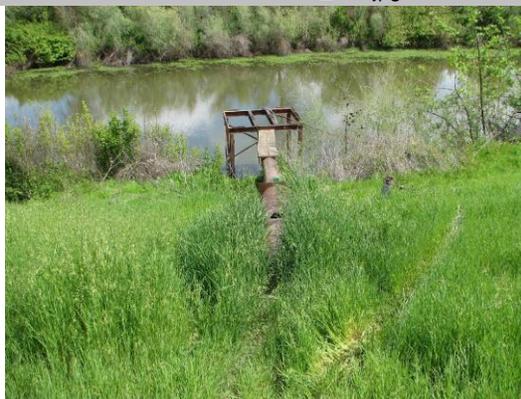
Photo 1 of 1 : UCIP_806.jpg

LM Start	1.61	Rating **	M	Issue No.	10
LM End	1.61	Issue Type +	En	Location *	WS
Category	Supplemental			GPS Latitude/Longitude	
				Start	End
Item	DWR UCIP Field Study			38.735399 °	38.735399 °
				-121.684058 °	-121.684058 °
DWR ID	DWR_NA0008_01_s_2014_10				
Action/Comments					
Inspector Comments: FS_ID:13204 EP_NO: 9302 Repair Type: Crossing Status: UCIP Comments: Space between 16-inch and 24-inch pipe should be grouted. There is no pump on stand at WS toe. FIELD_STRUCT_DESC: 24-inch steel pipe through the levee, 5.9-feet below the crown. 16-inch steel pipe sleeved through this pipe. No visible control valves. Pump on pile structure in stream. Siphon breaker on the landward slope. Discharges into concrete irrigation ditch off the landward toe (Permit No. 9302-Elliott). Originally included in O+M manual (1953). FS Date: 4/5/2013

Pipe and pier on WS toe.

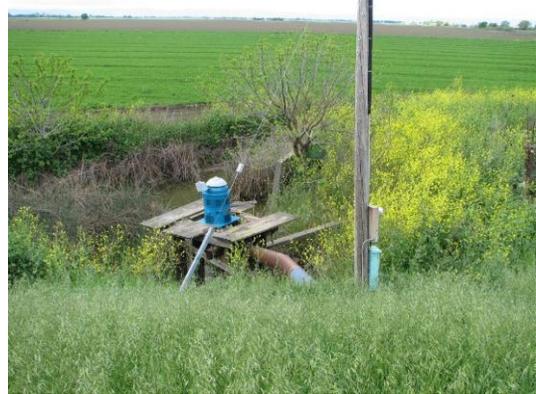
Photo 1 of 1 : UCIP_440.jpg

LM Start	2.61	Rating **	M	Issue No.	11
LM End	2.61	Issue Type +	En	Location *	WS
Category	Supplemental			GPS Latitude/Longitude	
				Start	End
Item	DWR UCIP Field Study			38.747110 °	38.747110 °
				-121.694415 °	-121.694415 °
DWR ID	DWR_NA0008_01_s_2014_11				
Action/Comments					
Inspector Comments: FS_ID:11067 EP_NO: 9307 Repair Type: Crossing Status: UCIP Comments: Siphon breaker on LS burried or broken off and missing. FIELD_STRUCT_DESC: 1 of 2: 14-inch pipe through the levee, 5.4-feet below crown. Pump house on pile structure at the landward toe Siphon breaker on the landward slope. Service pole and anchor at landward toe (Permit No. 9307- Lowe). Originally included in O+M manual (1953). FS Date: 4/5/2013

Pump and pipe on LS toe.

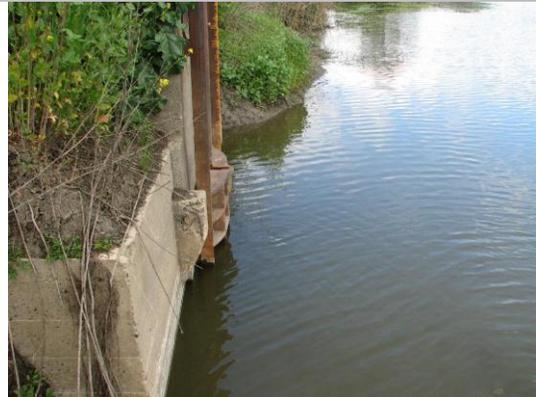
Photo 1 of 1 : UCIP_811.jpg

LM Start	2.61	Rating **	M	Issue No.	12
LM End	2.61	Issue Type +	En	Location *	WS
Category	Supplemental			GPS Latitude/Longitude	
				Start	End
Item	DWR UCIP Field Study			38.747204 °	38.747204 °
				-121.694440 °	-121.694440 °
DWR ID	DWR_NA0008_01_s_2014_12				
Action/Comments					
Inspector Comments: FS_ID:13205 EP_NO: 9307 Repair Type: Crossing Status: UCIP Comments: Walkway to actuator slide gate is missing. No method of actuating slide gate. FIELD_STRUCT_DESC: 2 of 2: 4-foot x 4-foot concrete box culvert through the levee, 23 feet below the crown. Walkway to slide gate on the waterside end, concrete headwalls on both ends. Service pole and anchor at landward toe. Concrete headwalls on both ends (Permit No. 9307- Lowe). FS Date: 4/5/2013

Slide gate and concrete headwall on WS toe.

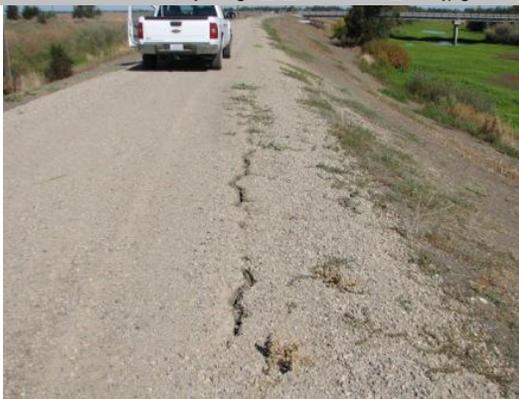
Photo 1 of 1 : johngw_s_20140306_667.jpg

LM Start	2.61	Rating **	A/W	Issue No.	19
LM End	2.61	Issue Type +	Ma	Location *	WS
Category	Earthen Levee			GPS Latitude/Longitude	
				Start	End
Item	Cracking			38.747218 °	38.747218 °
				-121.694450 °	-121.694450 °
DWR ID	DWR_NA0008_01_f_2013_19				
Action/Comments					
Monitor and have inspected by geotechnical engineer. Inspector Comments: Cracks along crown and down waterside slope.

Cracking along the waterside shoulder of the crown the length of 20 feet.
Fall 2013

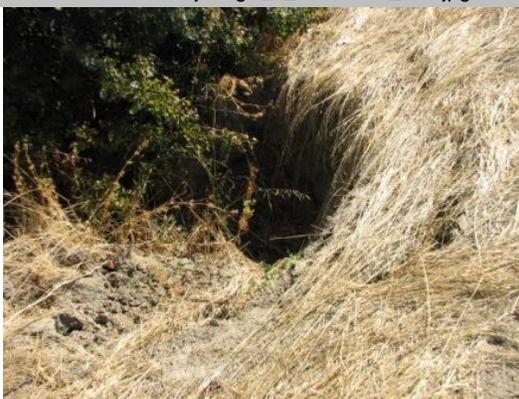
Photo 1 of 2 : johngw_s_20140306_668.jpg

LM Start	3.54	Rating **	M	Issue No.	20
LM End	3.54	Issue Type +	Ma	Location *	WS
Category	Earthen Levee			GPS Latitude/Longitude	
				Start	End
Item	Erosion / Bank Caving			38.759910 °	38.759910 °
				-121.696920 °	-121.696920 °
DWR ID	DWR_NA0008_01_f_2013_20				
Action/Comments					
Note and monitor erosion site.

Deep erosion at the bottom of the waterside slope 3-4 foot cut. Fall 2013

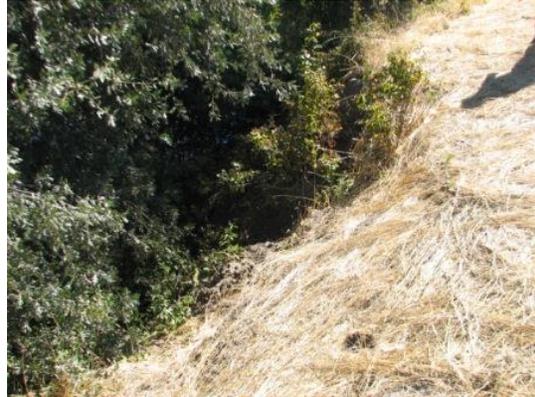
Photo 2 of 2 : johngw_s_20140306_669.jpg

LM Start	3.54	Rating **	M	Issue No.	20 (cont)
LM End	3.54	Issue Type +	Ma	Location *	WS
Category	Earthen Levee			GPS Latitude/Longitude	
				Start	End
Item	Erosion / Bank Caving			38.759910 °	38.759910 °
				-121.696920 °	-121.696920 °
DWR ID	DWR_NA0008_01_f_2013_20				
Action/Comments					
Note and monitor erosion site.

Another view of the erosion cutting into the slope. Fall 2013

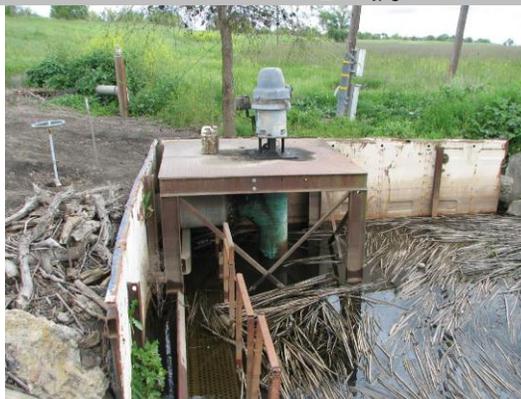
Photo 1 of 1 : UCIP_441.jpg

LM Start	4.95	Rating **	M	Issue No.	13
LM End	4.95	Issue Type +	En	Location *	WS
Category	Supplemental			GPS Latitude/Longitude	
				Start	End
Item	DWR UCIP Field Study			38.777566 °	38.777566 °
				-121.707591 °	-121.707591 °
DWR ID	DWR_NA0008_01_s_2014_13				
Action/Comments					
Inspector Comments: FS_ID:11264 EP_NO: 4443 Repair Type: Crossing Status: UCIP Comments: Pipe does not have adequate cover at crown. FIELD_STRUCT_DESC: 16-inch drainage pipe through the levee 0.5-feet below the crown. Pad constructed over pipe for vehicular crossing. Pump on metal structure on the landward side, flap gate on the waterside end, Siphon breaker on the pipe on the waterside. Slide gate located on LS toe. (Permit No. 4443-RD 730). Design drawings available in permit. FS Date: 4/5/2013

Pump on Steel pile structure with slide gate at LS toe.

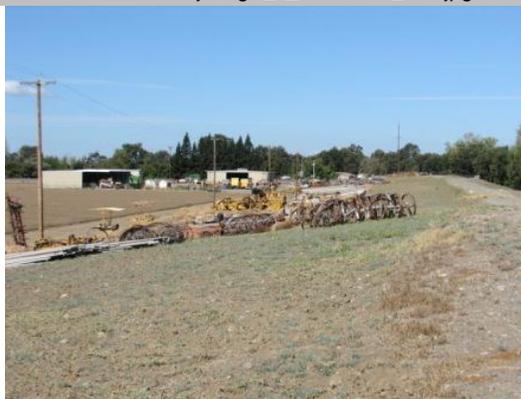
Photo 1 of 2 : johngw_s_20140306_666.jpg

LM Start	6.17	Rating **	M	Issue No.	7
LM End	6.41	Issue Type +	Ma	Location *	LS
Category	Earthen Levee			GPS Latitude/Longitude	
				Start	End
Item	Encroachments			38.790007 °	38.792433 °
				-121.723308 °	-121.726463 °
DWR ID	DWR_NA0008_01_s_2012_7				
Action/Comments					
Equipment

Equipment and irrigation pipe lays on the landside levee slope. Fall 2013

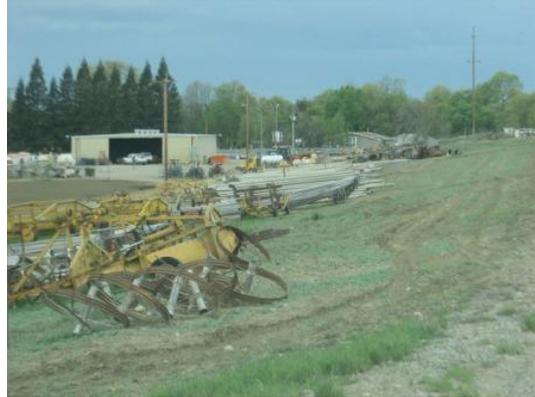
Photo 2 of 2 : johngw_s_20140401_683.jpg

LM Start	6.17	Rating **	M	Issue No.	7 (cont)
LM End	6.41	Issue Type +	Ma	Location *	LS
Category	Earthen Levee			GPS Latitude/Longitude	
				Start	End
Item	Encroachments			38.790007 °	38.792433 °
				-121.723308 °	-121.726463 °
DWR ID	DWR_NA0008_01_s_2012_7				
Action/Comments					
Equipment

A current view of the equipment on the levee slope. Spring 2014

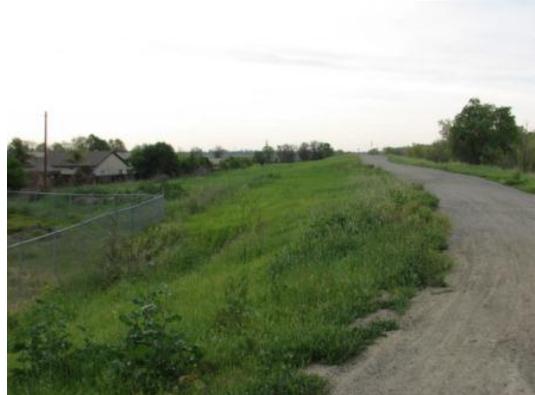
Photo 1 of 1 : johngw_s_20140401_675.jpg

Tall grasses, weeds partially blocks visibility. Spring 2014

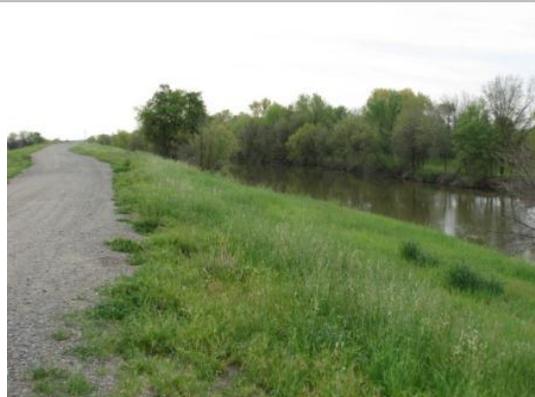
Photo 1 of 1 : johngw_s_20140401_676.jpg

LM Start	0.02	Rating **	M	Issue No.	14
LM End	6.04	Issue Type +	Ma	Location *	WS
Category	Earthen Levee		GPS Latitude/Longitude		
			Start	End	
Item	Vegetation		38.724519 °	38.792660 °	
			-121.665520 °	-121.724050 °	
DWR ID	DWR_NA0008_02_s_2014_14				
Action/Comments					
Control annual grass and weeds on the levee slopes and easements.

Tall grasses, weeds partially blocks visibility. Spring 2014

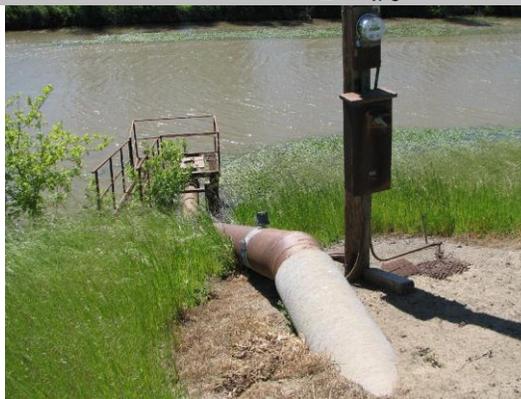
Photo 1 of 1 : UCIP_452.jpg

LM Start	1.00	Rating **	M	Issue No.	7
LM End	1.00	Issue Type +	En	Location *	WS
Category	Supplemental			GPS Latitude/Longitude	
				Start	End
Item	DWR UCIP Field Study			38.733119 °	38.733119 °
				-121.679383 °	-121.679383 °
DWR ID	DWR_NA0008_02_s_2014_7				
Action/Comments					
Inspector Comments: FS_ID:11307 EP_NO: 9320 Repair Type: Crossing Status: UCIP Comments: Appears abandoned as pump is missing from platform. FIELD_STRUCT_DESC: 16-inch steel pipe through the levee 2.8-feet below the crown. Discharges into 36-inch concrete standpipe at levee toe. Pump on steel pile structure in stream with metal walkway. Two service poles on the waterward slope. (Permit No. 9320-Pollock) Originally included in O+M manual 1953. FS Date: 4/9/2013

Pump platform and walkway on WS toe.

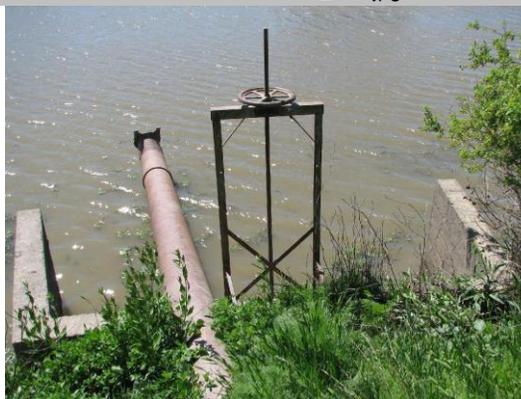
Photo 1 of 1 : UCIP_451.jpg

LM Start	1.91	Rating **	M	Issue No.	8
LM End	1.91	Issue Type +	En	Location *	WS
Category	Supplemental			GPS Latitude/Longitude	
				Start	End
Item	DWR UCIP Field Study			38.743767 °	38.743767 °
				-121.689184 °	-121.689184 °
DWR ID	DWR_NA0008_02_s_2014_8				
Action/Comments					
Inspector Comments: FS_ID:11306 EP_NO: 9320 Repair Type: Crossing Status: UCIP Comments: Pipe at flap gate rusted through at WS toe. Flap gate does not function properly. FIELD_STRUCT_DESC: 1 of 2: 12-inch pipe through the levee, 4-feet below the crown. Flap gate on waterward end at concrete headwall, siphon breaker in 2-inch CM pipe riser on the landward shoulder. Vertical pump unit on concrete foundation in irrigation ditch at the LS toe. (Permit No. 9320-Pollock) Originally included in O+M manual 1953. FS Date: 4/9/2013

12-inch pipe at concrete headwall on WS toe.

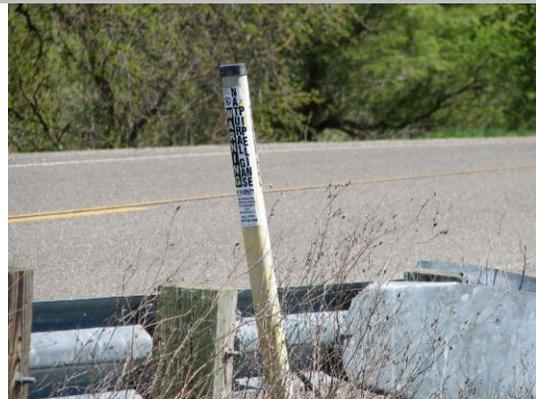
Photo 1 of 1 : UCIP_448.jpg

LM Start	2.30	Rating **	M	Issue No.	10
LM End	2.30	Issue Type +	En	Location *	WS
Category	Supplemental			GPS Latitude/Longitude	
				Start	End
Item	DWR UCIP Field Study			38.748504 °	38.748504 °
				-121.692697 °	-121.692697 °
DWR ID	DWR_NA0008_02_s_2014_10				
Action/Comments					
Inspector Comments: FS_ID:11303 EP_NO: 13164 Repair Type: Crossing Status: UCIP Comments: Need to have pipe located and marked properly if still in use. FIELD_STRUCT_DESC: 4-inch steel natural gas collection pipe through the levee 3.2-feet below the crown. (Permit No. 13164, 1981). Design drawings available in permit. FS Date: 4/9/2013

Sign on LS shoulder may indicate location of pipe, or it may indicate where pipe crosses approach ramp to bridge.

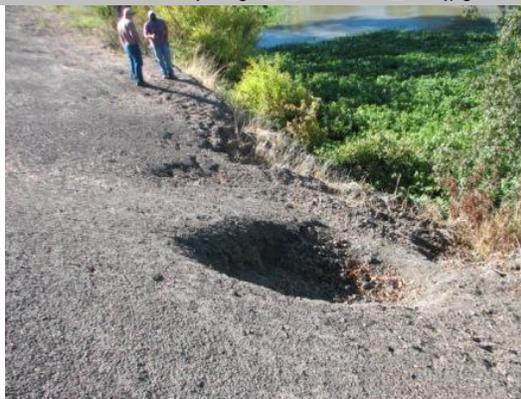
Photo 1 of 1 : johngw_s_20140306_683.jpg

Erosion at the bottom of the slope. It appears that a fallen tree has caused a sink hole. Fall 2013

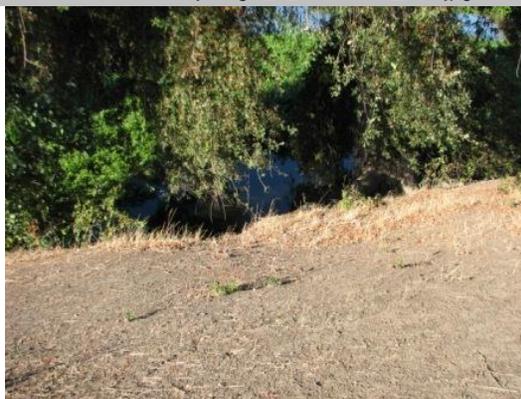
Photo 1 of 2 : johngw_s_20140306_681.jpg

LM Start	3.08	Rating **	U	Issue No.	229
LM End	3.08	Issue Type +	Ma	Location *	WS
Category	Earthen Levee		GPS Latitude/Longitude		
			Start	End	
Item	Erosion / Bank Caving		38.759542 °	38.759542 °	
			-121.694007 °	-121.694007 °	
DWR ID	DWR_NA0008_02_f_2013_229				
Action/Comments					
Note and monitor erosion site. Inspector Comments: Erosion is undermining large oak tree and is growing.

Waterside eroison vertical cut at bottom of slope. Fall 2013

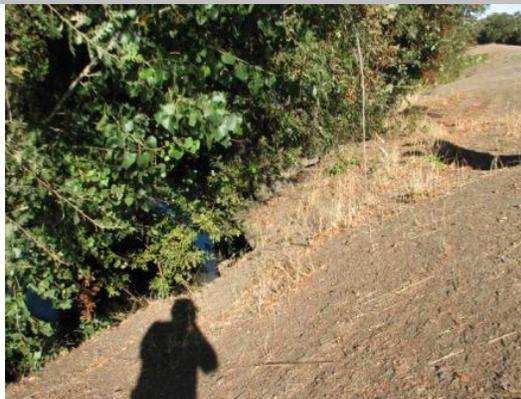
Photo 2 of 2 : johngw_s_20140306_682.jpg

LM Start	3.08	Rating **	U	Issue No.	229 (cont)
LM End	3.08	Issue Type +	Ma	Location *	WS

Another view of the vertical cut at the bottom of the slope. Fall 2013

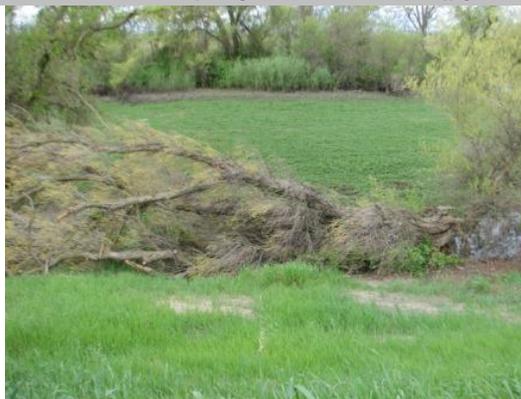
Photo 1 of 1 : johngw_s_20140401_680.jpg

A cottonwood tree has fallen across the levee slope. Spring 2014

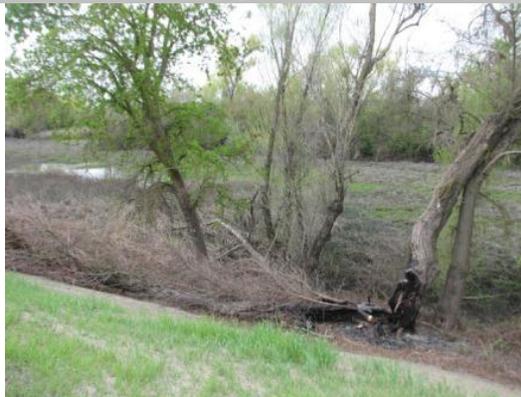
Photo 1 of 1 : johngw_s_20140401_679.jpg

A cottonwood tree may have been struck by lightning. The tree is split into tree parts. Spring 2014

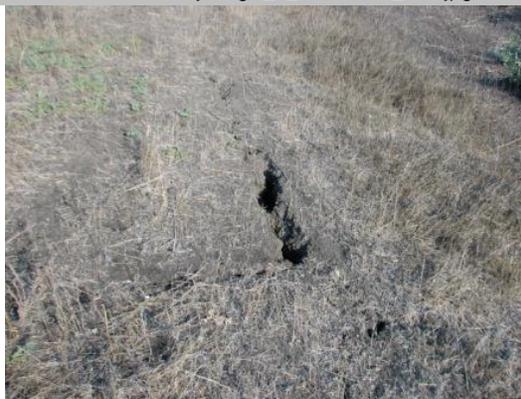
Photo 1 of 1 : johngw_s_20140306_678.jpg

LM Start	4.86	Rating **	A/W	Issue No.	226
LM End	4.88	Issue Type +	Ma	Location *	LS
Category	Earthen Levee		GPS Latitude/Longitude		
			Start	End	
Item	Cracking		38.780858 °	38.781102 °	
			-121.709093 °	-121.709385 °	
DWR ID	DWR_NA0008_02_f_2013_226				
Action/Comments					
Monitor and have inspected by geotechnical engineer.

Cracking on the landside is 3-4 inches wide and 12 inches deep. Fall 2013

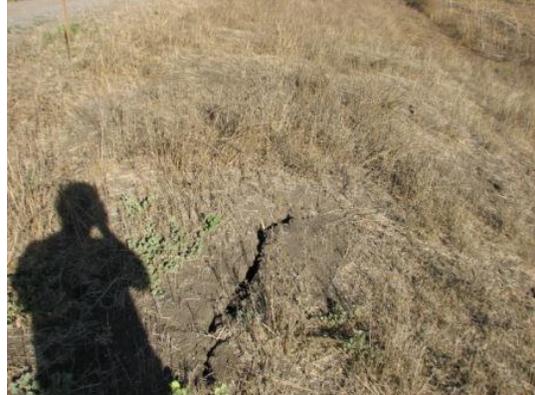
Photo 1 of 2 : johngw_s_20140306_679.jpg

LM Start	4.86	Rating **	A/W	Issue No.	227
LM End	4.86	Issue Type +	Ma	Location *	WS
Category	Earthen Levee			GPS Latitude/Longitude	
				Start	End
Item	Cracking			38.780858 °	38.780858 °
				-121.709095 °	-121.709095 °
DWR ID	DWR_NA0008_02_f_2013_227				
Action/Comments					
Monitor and have inspected by geotechnical engineer.

Cracking on levee slope 1-2 inches wide and 6 inches deep. Fall 2013

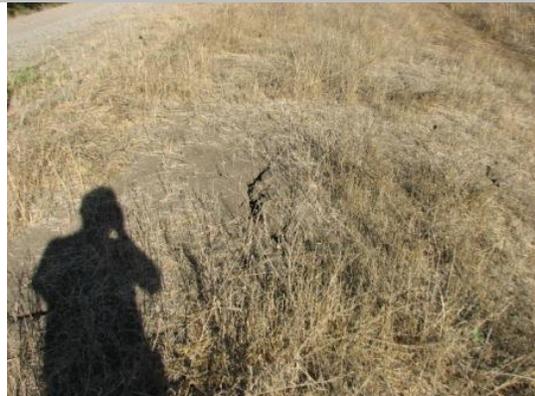
Photo 2 of 2 : johngw_s_20140306_680.jpg

LM Start	4.86	Rating **	A/W	Issue No.	227 (cont)
LM End	4.86	Issue Type +	Ma	Location *	WS

Another view of the cracking on the levee slope. Fall 2013

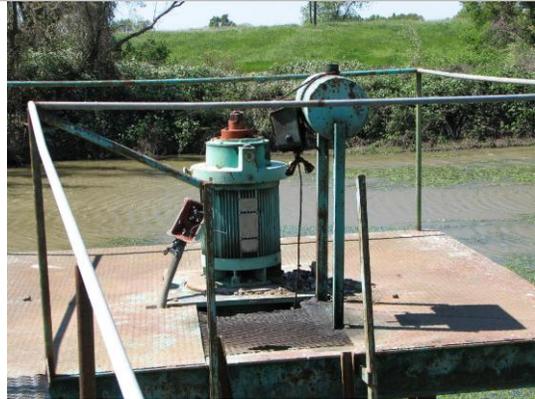
Photo 1 of 1 : UCIP_447.jpg

LM Start	5.64	Rating **	M	Issue No.	11
LM End	5.64	Issue Type +	En	Location *	WS
Category	Supplemental		GPS Latitude/Longitude		
			Start	End	
Item	DWR UCIP Field Study		38.788662 °	38.788662 °	
			-121.718997 °	-121.718997 °	
DWR ID	DWR_NA0008_02_s_2014_11				
Action/Comments					
Inspector Comments: FS_ID:11289 EP_NO: 3671 Repair Type: Crossing Status: UCIP Comments: Electrical panel missing parts. Siphon breaker missing from pipe on LS. Pipe heavily corroded at outlet with holes present. Appears abandoned-should be abandoned properly. FIELD_STRUCT_DESC: 20-inch steel pipe through the levee, 5.5-feet below the crown. Siphon breaker in a steel pipe riser on the landward slope. Metal cutoff wall. Service pole on the waterward slope. (Permit No. 3671-Wallace Replaced 20-inch pipe at same location in 1961) FS Date: 4/9/2013

Pump on pile structure appears to be missing electrical connection.

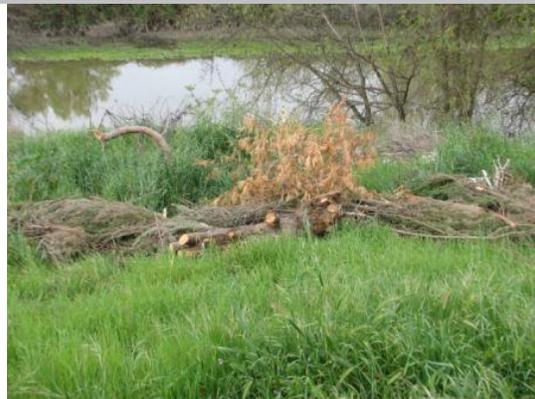
Photo 1 of 1 : johngw_s_20140401_678.jpg

LM Start	6.04	Rating **	M	Issue No.	12
LM End	6.04	Issue Type +	En	Location *	WS
Category	Earthen Levee		GPS Latitude/Longitude		
			Start	End	
Item	Encroachments		38.792661 °	38.792661 °	
			-121.724047 °	-121.724047 °	
DWR ID	DWR_NA0008_02_s_2014_12				
Action/Comments					
Debris

A debris pile is on the waterside levee slope. Spring 2014

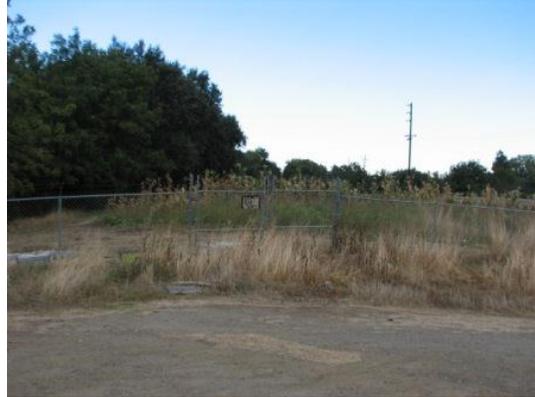
Photo 1 of 2 : johngw_s_20140306_677.jpg

Strawberry patch on the levee crown has added other crops on the crown. Fall 2013

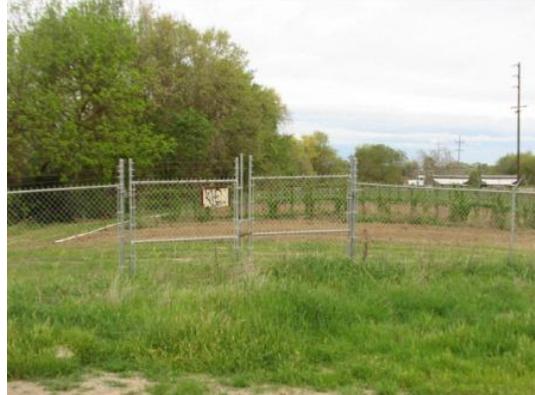
Photo 2 of 2 : johngw_s_20140401_677.jpg

LM Start	6.05	Rating **	M	Issue No.	1 (cont)
LM End	6.12	Issue Type +	En	Location *	LS

Crops (strawberries and berries vines) are planted on the crown with a fence blocking access. Spring 2014
