**Flood Control Project Maintenance
Levee Inspections
LMA District Cover Sheet
Spring 2016 Levee Inspection Results**

Knights Landing Ridge Drainage District

Spring 2016 Levee Inspection Results

Waterway		Bank	Unit Miles
Unit No. 01 Knights Landing Ridge Cut		Right	6.36

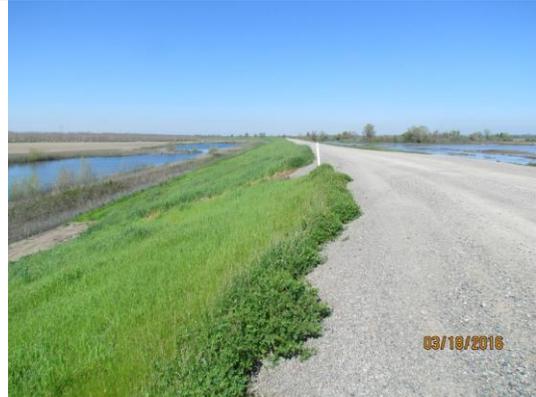
Photo 1 of 1 : SP_2016_NA0008_256_19_20160407_00037.jpg

View of the vegetation on the landward side of the levee looking upstream. Spring 2016.

LM Start	0.00	Rating **	M	Issue No.	26
LM End	6.35	Issue Type +	Ma	Location *	WS
Category	Earthen Levee		GPS Latitude/Longitude		
			Start	End	
Item	Vegetation		38.719047 °	38.792464 °	
			-121.664124 °	-121.726706 °	
DWR ID	DWR_NA0008_01_s_2016_26				
Comment Code					
V1 : Control annual grass and weeds on the levee slopes and easements.					
Inspector Comment

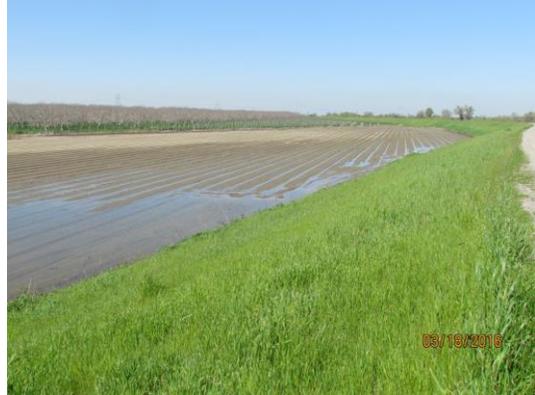
Photo 1 of 1 : SP_2016_NA0008_256_27_20160407_00039.jpg

View of the seepage on the landward side of the levee looking upstream. Spring 2016.

LM Start	0.73	Rating **	C	Issue No.	16
LM End	0.73	Issue Type +	En	Location *	WS
Category	Earthen Levee		GPS Latitude/Longitude		
			Start	End	
Item	Encroachments		38.726906 °	38.726906 °	
			-121.672744 °	-121.672744 °	
DWR ID	DWR_NA0008_01_f_2015_16				
Comment Code					
DE : Debris					
Inspector Comment

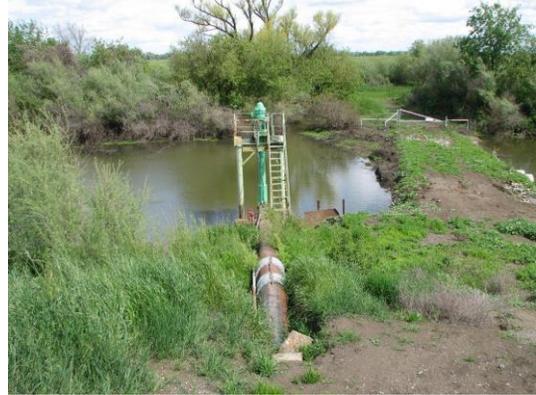
Photo 1 of 2 : UCIP_SP_2016_11064_18426.jpg

LM Start	0.87	Rating **	M	Issue No.	36
LM End	0.87	Issue Type +	En	Location *	WS
Category	Supplemental			GPS Latitude/Longitude	
				Start	End
Item	DWR UCIP Field Study			38.727869 °	38.727869 °
				-121.674875 °	-121.674875 °
DWR ID					
Comment Code					
Inspector Comment					
FS_ID:11064 DS_ID:19361 EP_NO: 9302 Repair Type: Non-Urgent Crossing Status: Found UCIP Comments: Pipe exposed on WS slope in trench may need to be backfilled to prevent erosion under pipe. FIELD_STRUCT_DESC: 20-inch steel irrigation pipe through the levee, 8.8 feet below the crown. Pump on steel pile structure at WS toe. Siphon breaker in 12-inch steel riser on LS slope. Possible butterfly valve at LS toe. (Permit No. 9302-Elliott 1974), Originally included in O+M manual (1953). FS Date: 4/5/2013

Pump on pile at WS toe with pipe in open trench on LS slope.

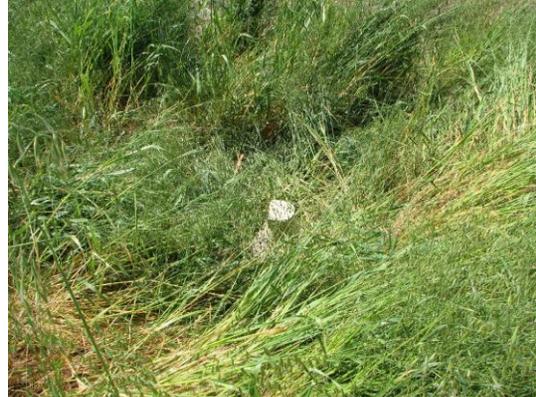
Photo 2 of 2 : UCIP_SP_2016_11064_18425.jpg

Siphon breaker in 12-inch steel riser on LS slope.

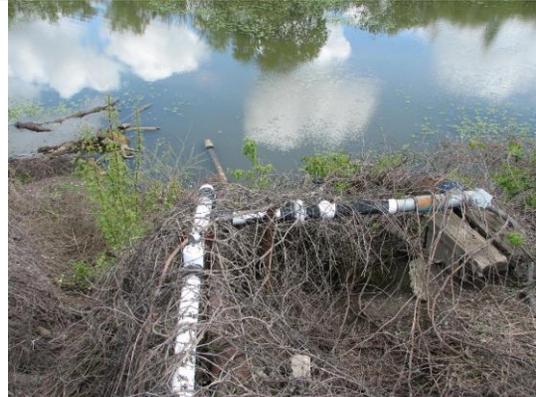
Photo 1 of 2 : UCIP_SP_2016_11065_18429.jpg

LM Start	1.15	Rating **	M	Issue No.	37
LM End	1.15	Issue Type +	En	Location *	WS
Category	Supplemental			GPS Latitude/Longitude	
				Start	End
Item	DWR UCIP Field Study			38.730275 °	38.730275 °
				-121.678975 °	-121.678975 °
DWR ID					
Comment Code					
Inspector Comment					
FS_ID:11065 DS_ID:19362 EP_NO: 9305 Repair Type: Non-Urgent Crossing Status: Found UCIP Comments: Slope on WS shoulder appears to be eroding at pipes exit from levee. 36-inch conc riser on LS is filled with mud. FIELD_STRUCT_DESC: 10-inch pipe through the levee, 5.8-feet below the crown. Pump at the waterward toe. 36-inch Concrete standpipe at the landward toe (Permit No. 9305-Bacchini). 5-inch steel-pipe sleeved through 10-inch pipe. Annular space Grouted. (Permit No. 6076-Bacchini). Originally included in O+M manual (1953). FS Date: 4/5/2013

Pump on WS shoulder overgrown and may be abandoned.

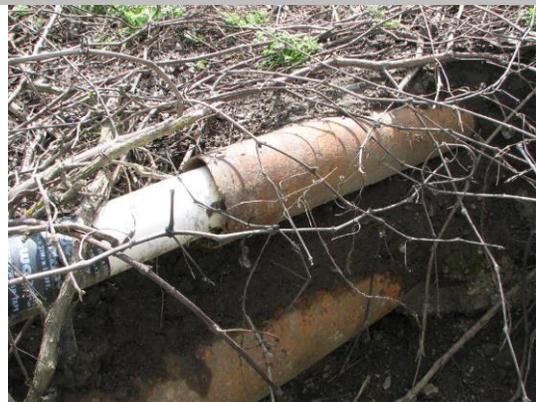
Photo 2 of 2 : UCIP_SP_2016_11065_18428.jpg

Erosion at pipes exit from levee on WS shoulder.

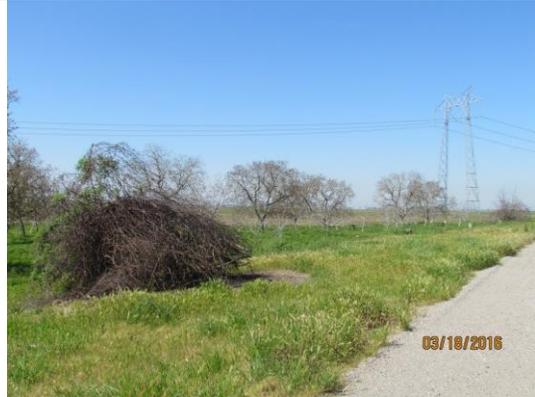
Photo 1 of 1 : SP_2016_NA0008_256_28_20160407_00040.jpg

View of the pruning pile on the landward side of the levee looking upstream. Spring 2016.

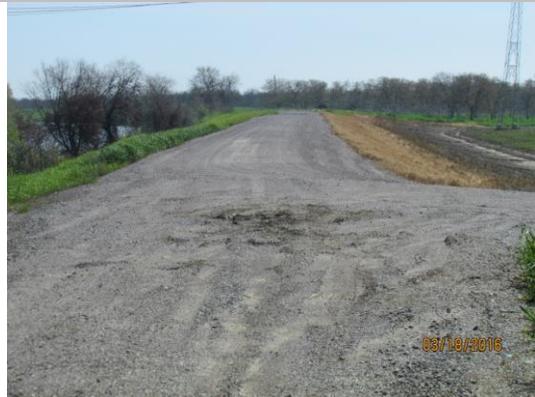
Photo 1 of 1 : SP_2016_NA0008_256_29_20160407_00041.jpg

LM Start	1.57	Rating **	M	Issue No.	29
LM End	1.57	Issue Type +	Ma	Location *	CR
Category	Earthen Levee		GPS Latitude/Longitude		
			Start	End	
Item	Crown Surface / Depressions / Rutting		38.735164 °	38.735164 °	
			-121.683843 °	-121.683843 °	
DWR ID	DWR_NA0008_01_s_2016_29				
Comment Code					
C2 : Repair depressions or ruts in the crown or slope.					
Inspector Comment

View of the ruts on the crown of the levee looking downstream. Spring 2016.

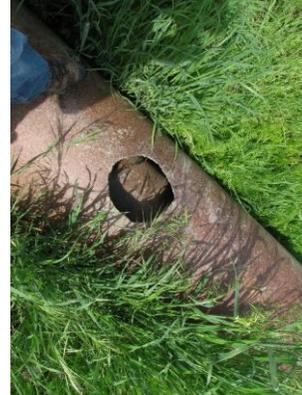
Photo 1 of 2 : UCIP_SP_2016_13204_21588.jpg

LM Start	1.59	Rating **	M	Issue No.	40
LM End	1.59	Issue Type +	En	Location *	CR
Category	Supplemental			GPS Latitude/Longitude	
				Start	End
Item	DWR UCIP Field Study			38.735399 °	38.735399 °
				-121.684058 °	-121.684058 °
DWR ID					
Comment Code					
Inspector Comment					
FS_ID:13204 DS_ID:19363 EP_NO: 9302 Repair Type: Non-Urgent Crossing Status: Found UCIP Comments: Space between 16-inch and 24-inch pipe should be grouted. There is no pump on stand at WS toe. FIELD_STRUCT_DESC: 24-inch steel pipe through the levee, 5.9-feet below the crown. 16-inch steel pipe sleeved through this pipe. No visible control valves. Pump on pile structure in stream. Siphon breaker on the landward slope. Discharges into concrete irrigation ditch off the landward toe (Permit No. 939, 1944). Also included in O+M manual (1953). FS Date: 4/5/2013

16-inch pipe sleeved through 24-inch pipe on WS slope.

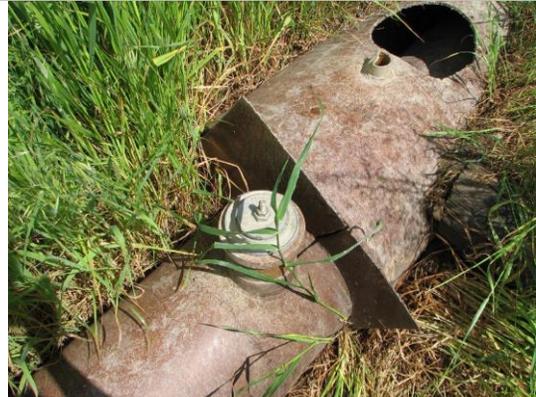
Photo 2 of 2 : UCIP_SP_2016_13204_21590.jpg

Siphon breaker on LS slope.

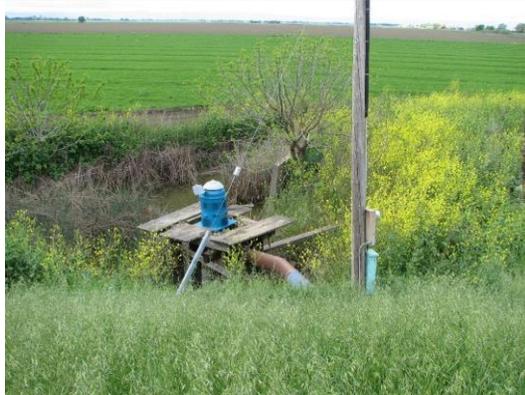
Photo 1 of 1 : UCIP_SP_2016_11067_18431.jpg

LM Start	2.58	Rating **	M	Issue No.	39
LM End	2.58	Issue Type +	En	Location *	LS
Category	Supplemental		GPS Latitude/Longitude		
			Start	End	
Item	DWR UCIP Field Study		38.747110 °	38.747110 °	
			-121.694415 °	-121.694415 °	
DWR ID					
Comment Code					
Inspector Comment					
FS_ID:11067 DS_ID:19364 EP_NO: 9307 Repair Type: Non-Urgent Crossing Status: Found UCIP Comments: Siphon breaker on LS burried or broken off and missing. FIELD_STRUCT_DESC: 1 of 2: 14-inch pipe through the levee, 5.4-feet below crown. Pump house on pile structure at the landward toe Siphon breaker on the landward slope. Service pole and anchor at landward toe (Permit No. 9307- Lowe). Originally included in O+M manual (1953). FS Date: 4/5/2013

Pump and pipe on LS toe.

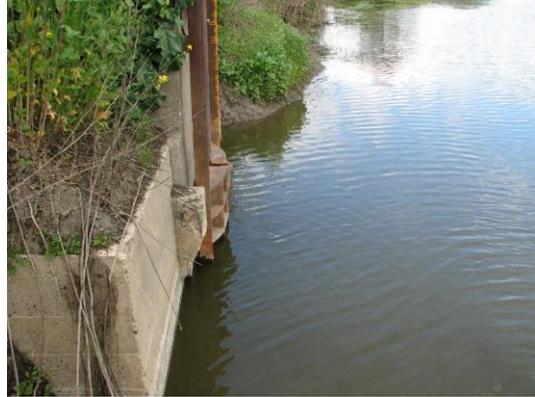
Photo 1 of 2 : UCIP_SP_2016_13205_21602.jpg

LM Start	2.58	Rating **	M	Issue No.	41
LM End	2.58	Issue Type +	En	Location *	LS
Category	Supplemental			GPS Latitude/Longitude	
				Start	End
Item	DWR UCIP Field Study			38.747204 °	38.747204 °
				-121.694440 °	-121.694440 °
DWR ID					
Comment Code					
Inspector Comment					
FS_ID:13205 DS_ID:19391 EP_NO: 9307 Repair Type: Non-Urgent Crossing Status: Found UCIP Comments: Walkway to actuator slide gate is missing. No method of actuating slide gate. FIELD_STRUCT_DESC: 2 of 2: 4-foot x 4-foot concrete box culvert through the levee, 23 feet below the crown. Walkway to slide gate on the waterside end, concrete headwalls on both ends. Service pole and anchor at landward toe. Concrete headwalls on both ends (Permit No. 9307- Lowe). FS Date: 4/5/2013

Slide gate and concrete headwall on WS toe.

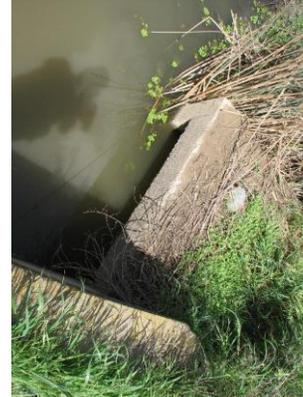
Photo 2 of 2 : UCIP_SP_2016_13205_21601.jpg

Concrete inlet on LS toe.

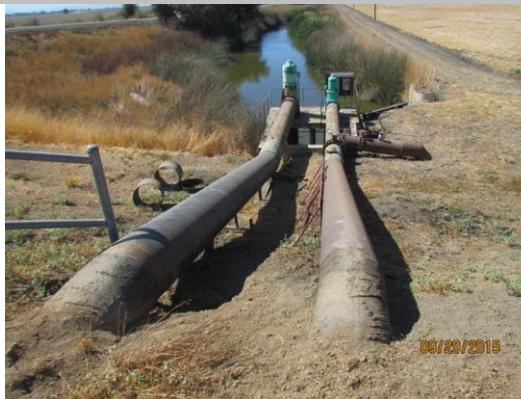
Photo 1 of 2 : SP_2016_NA0008_256_18_20160304_00007.jpg

LM Start	2.70	Rating **	M	Issue No.	18
LM End	2.70	Issue Type +	En	Location *	LS
Category	Earthen Levee			GPS Latitude/Longitude	
				Start	End
Item	Encroachments			38.748837 °	38.748837 °
				-121.694823 °	-121.694823 °
DWR ID	DWR_NA0008_01_f_2015_18				
Comment Code					
PI : Pipe					
Inspector Comment					
Portion of the pipe seems to be replaced and the abandoned pipe is left at the toe of the landward side of the levee.

The dark portion on the left pipe seems to have been replaced with a new pipe. Fall 2015.

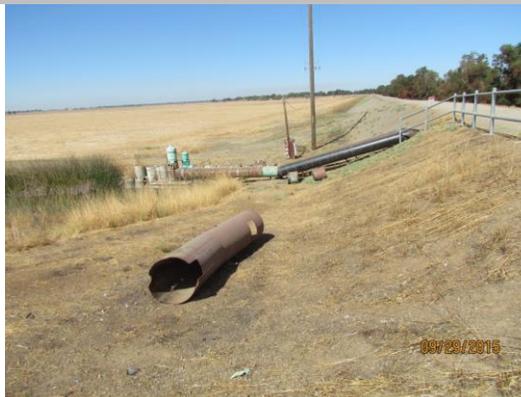
Photo 2 of 2 : SP_2016_NA0008_256_18_20160304_00008.jpg

LM Start	2.70	Rating **	M	Issue No.	18 (cont)
LM End	2.70	Issue Type +	En	Location *	LS
Category	Earthen Levee			GPS Latitude/Longitude	
				Start	End
Item	Encroachments			38.748837 °	38.748837 °
				-121.694823 °	-121.694823 °
DWR ID	DWR_NA0008_01_f_2015_18				
Comment Code					
PI : Pipe					
Inspector Comment					
Portion of the pipe seems to be replaced and the abandoned pipe is left at the toe of the landward side of the levee.

View of the abandoned pipe at the toe of levee on the landward side. Fall 2015.

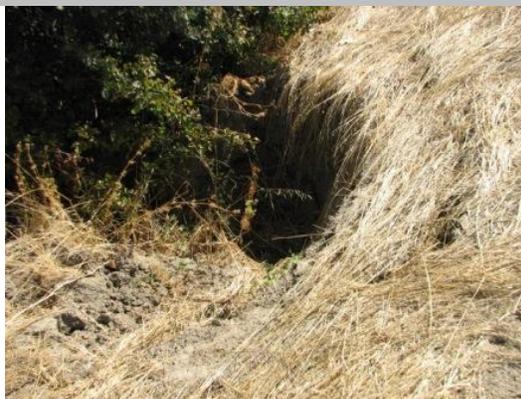
Photo 1 of 2 : SP_2016_NA0008_256_20_20160304_00009.jpg

LM Start	3.36	Rating **	M	Issue No.	2
LM End	3.44	Issue Type +	Ma	Location *	WS
Category	Supplemental			GPS Latitude/Longitude	
				Start	End
Item	2015 USACE Erosion Survey, DRAFT			38.758432 °	38.759332 °
				-121.695158 °	-121.696063 °
DWR ID	DWR_NA0008_01_s_2016_2				
Comment Code					
Inspector Comment					
2011 - Toe scour and bank slumping. 2015: Site is part of the extended inventory, last inspected 2011. [2015 Site ID: KLR_3-5_R]

Deep erosion at the bottom of the waterside slope 3-4 foot cut. Fall 2013

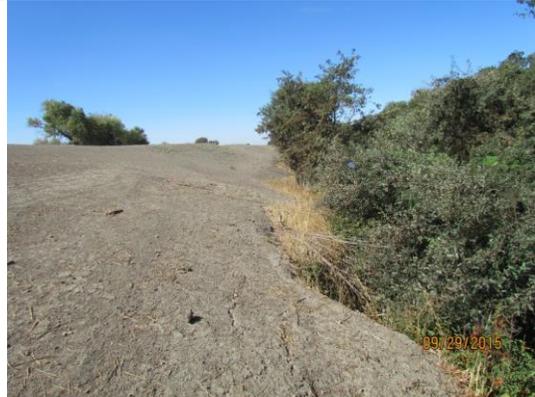
Photo 2 of 2 : SP_2016_NA0008_256_20_20160304_00010.jpg

View of the erosion on the waterward side of the levee looking upstream. Fall 2015.

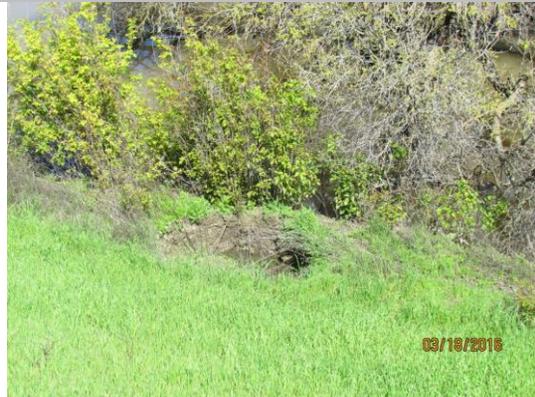
Photo 1 of 1 : SP_2016_NA0008_256_30_20160407_00042.jpg

LM Start	3.78	Rating **	U	Issue No.	30
LM End	3.78	Issue Type +	Ma	Location *	WS
Category	Earthen Levee			GPS Latitude/Longitude	
				Start	End
Item	Erosion / Bank Caving			38.762886 °	38.762886 °
				-121.700406 °	-121.700406 °
DWR ID	DWR_NA0008_01_s_2016_30				
Comment Code					
E1 : Note and monitor erosion site.					
Inspector Comment					
Hole is at the toe of the levee on the waterward side.

View of the erosion at the toe of the levee on the waterward side. Spring 2016.

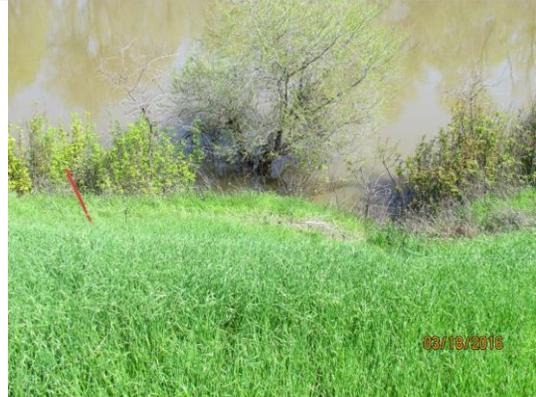
Photo 1 of 1 : SP_2016_NA0008_256_31_20160407_00043.jpg

View of the erosion at the toe of the levee on the waterward side. Spring 2016.

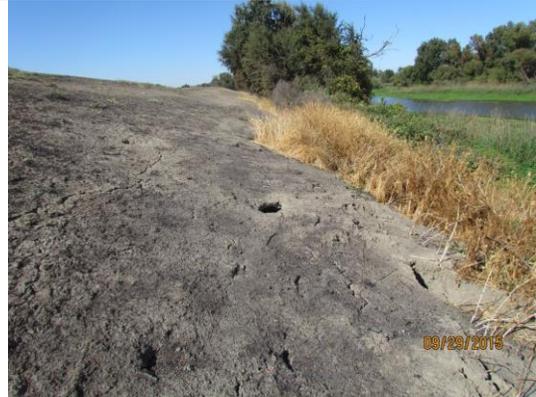
Photo 1 of 1 : SP_2016_NA0008_256_21_20160304_00011.jpg

View of the rodent holes on the waterward side of the levee looking upstream. Fall 2015.

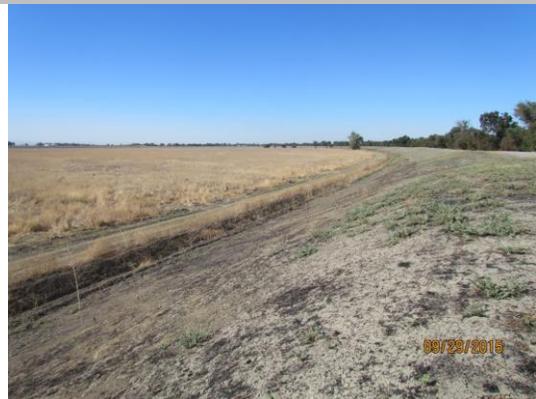
Photo 1 of 1 : SP_2016_NA0008_256_22_20160304_00012.jpg

LM Start	4.38	Rating **	M	Issue No.	22
LM End	4.88	Issue Type +	En	Location *	LS
Category	Earthen Levee		GPS Latitude/Longitude		
			Start	End	
Item	Encroachments		38.771003 °	38.777404 °	
			-121.703413 °	-121.707412 °	
DWR ID	DWR_NA0008_01_f_2015_22				
Comment Code					
DT : Ditch					
Inspector Comment					
Ditch is at the levee toe on the landward side.

View of the ditch on the landward side of the levee looking upstream. Fall 2015.

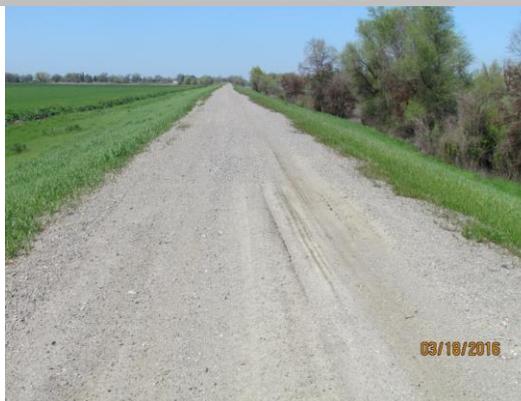
Photo 1 of 1 : SP_2016_NA0008_256_32_20160407_00044.jpg

LM Start	5.29	Rating **	M	Issue No.	32
LM End	5.29	Issue Type +	Ma	Location *	CR
Category	Earthen Levee		GPS Latitude/Longitude		
			Start	End	
Item	Crown Surface / Depressions / Rutting		38.781712°	38.781712°	
			-121.712819°	-121.712819°	
DWR ID	DWR_NA0008_01_s_2016_32				
Comment Code					
C2 : Repair depressions or ruts in the crown or slope.					
Inspector Comment

View of the crown of the levee looking upstream. Spring 2016.

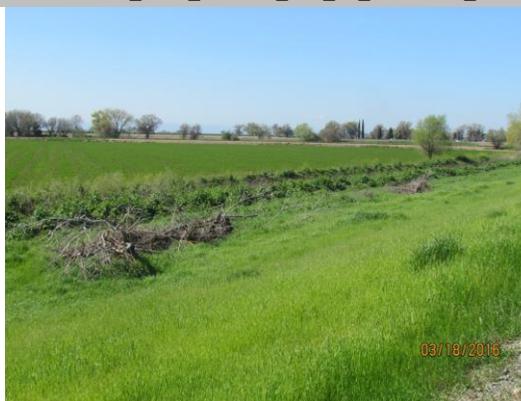
Photo 1 of 1 : SP_2016_NA0008_256_33_20160407_00045.jpg

View of the pruning piles on the landward side of the levee looking upstream. Spring 2016.

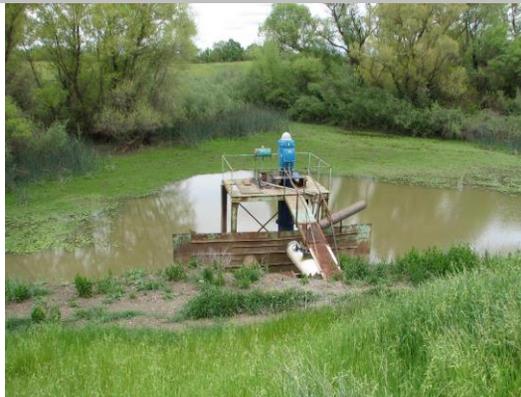
Photo 1 of 2 : UCIP_SP_2016_41068_18643.jpg

LM Start	6.00	Rating **	M	Issue No.	42
LM End	6.00	Issue Type +	En	Location *	LS
Category	Supplemental			GPS Latitude/Longitude	
				Start	End
Item	DWR UCIP Field Study			38.788921 °	38.788921 °
				-121.721985 °	-121.721985 °
DWR ID					
Comment Code					
Inspector Comment					
FS_ID:41068 DS_ID:19397 EP_NO: 5276 Repair Type: Non-Urgent Crossing Status: Found UCIP Comments: Pipe appears abandoned at this time. FIELD_STRUCT_DESC: 2 of 2: 20-inch steel irrigation pipe through the levee 4.9-feet below the crown. Vertical pump unit on pile structure in stream. Siphon breaker on the landward shoulder in 16-inch steel riser. Flap gate on the landward end. Discharges into irrigation ditch at the landward side. (Permit No. 5276-RD 730 replaced an 18-inch at this location). Steel plate welded over end of pipe at pump structure. FS Date: 4/5/2013

Pump on steel structure at WS toe.

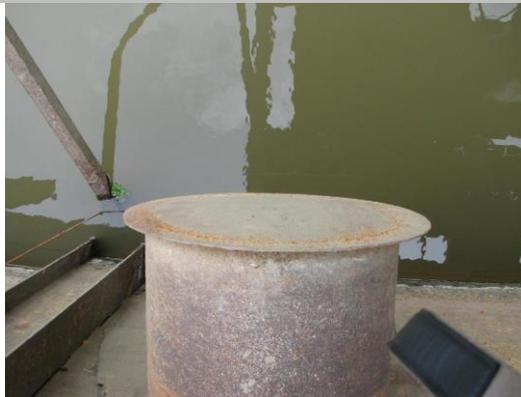
Photo 2 of 2 : UCIP_SP_2016_41068_18642.jpg

Steel plate welded over pipe end at pump platform.

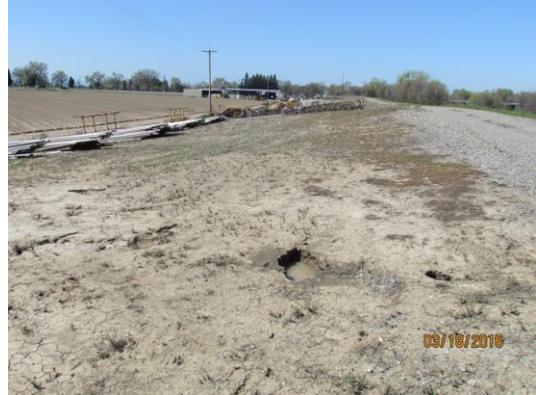
Photo 1 of 1 : SP_2016_NA0008_256_34_20160407_00046.jpg

LM Start	6.06	Rating **	M	Issue No.	34
LM End	6.06	Issue Type +	Ma	Location *	LS
Category	Earthen Levee		GPS Latitude/Longitude		
			Start	End	
Item	Erosion / Bank Caving		38.789539 °	38.789539 °	
			-121.722832 °	-121.722832 °	
DWR ID	DWR_NA0008_01_s_2016_34				
Comment Code					
E2 : Schedule repair of erosion site prior to the next inspection.					
Inspector Comment

View of the erosion on the landward side of the levee looking upstream. Spring 2016.

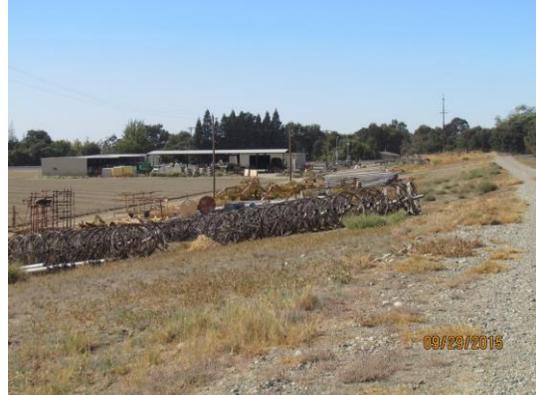
Photo 1 of 2 : SP_2016_NA0008_256_7_20160304_00001.jpg

View of the equipment on the landward side of the levee looking upstream. Fall 2015.

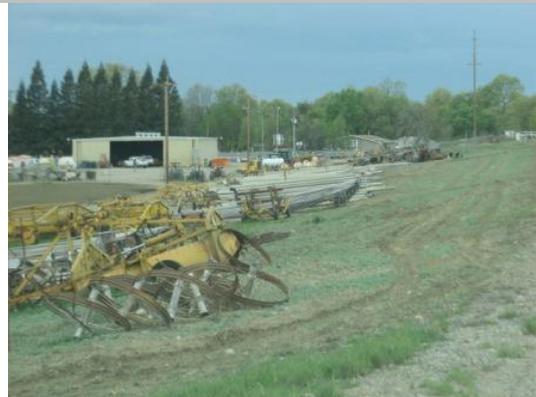
Photo 2 of 2 : SP_2016_NA0008_256_7_20160304_00002.jpg

LM Start	6.07	Rating **	M	Issue No.	7 (cont)
LM End	6.34	Issue Type +	En	Location *	LS

A current view of the equipment on the levee slope. Spring 2014

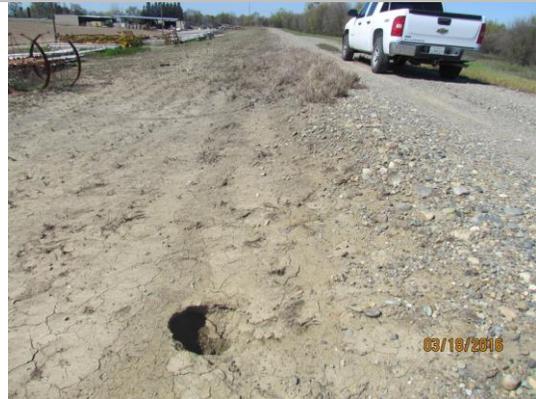
Photo 1 of 3 : SP_2016_NA0008_256_35_20160407_00048.jpg

View of the erosion on the landward side of the levee looking upstream. Spring 2016.

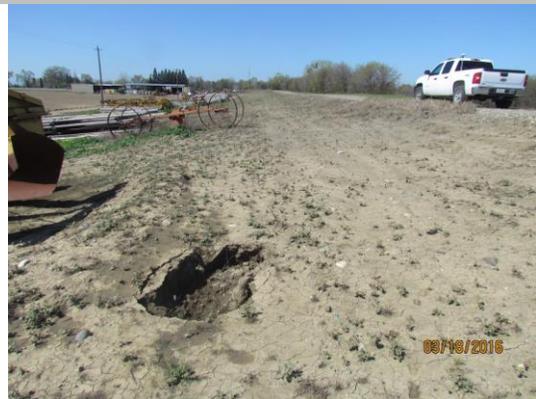
Photo 2 of 3 : SP_2016_NA0008_256_35_20160407_00047.jpg

Erosion is located downstream from first erosion. Spring 2016.

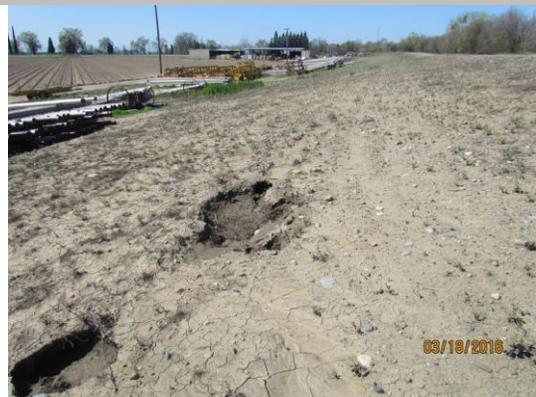
Photo 3 of 3 : SP_2016_NA0008_256_35_20160407_00049.jpg

There are multiple erosions in this area. Spring 2016.

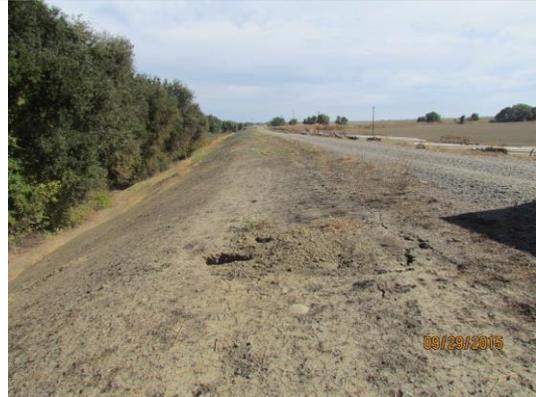
Photo 1 of 1 : SP_2016_NA0008_256_24_20160304_00013.jpg

View of the rodent holes on the waterward side of the levee looking downstream. Fall 2015.

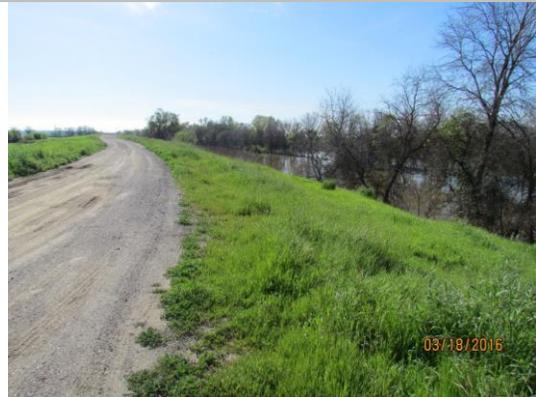
Photo 1 of 1 : SP_2016_NA0008_257_12_20160401_00028.jpg

View of the vegetation on the waterward side of the levee looking downstream. Spring 2016.

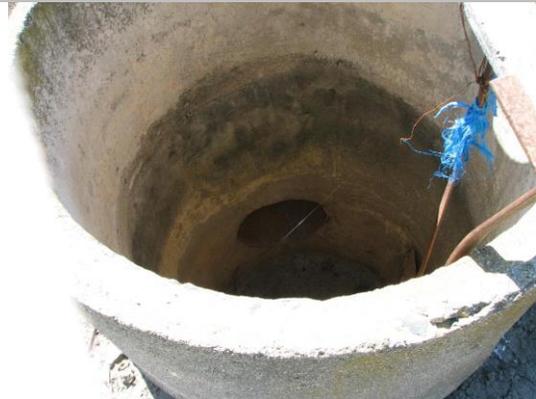
Photo 1 of 2 : UCIP_SP_2016_11307_18708.jpg

LM Start	0.99	Rating **	M	Issue No.	230
LM End	0.99	Issue Type +	En	Location *	WS
Category	Supplemental			GPS Latitude/Longitude	
				Start	End
Item	DWR UCIP Field Study			38.733120 °	38.733120 °
				-121.679383 °	-121.679383 °
DWR ID					
Comment Code					
Inspector Comment					
FS_ID:11307 DS_ID:19370 EP_NO: 9320 Repair Type: Non-Urgent Crossing Status: Found UCIP Comments: Appears abandoned as pump is missing from platform. FIELD_STRUCT_DESC: 16-inch steel pipe through the levee 2.8-feet below the crown. Discharges into 36-inch concrete standpipe at levee toe. Pump on steel pile structure in stream with metal walkway. Two service poles on the waterward slope. (Permit No. 9320-Pollock) Originally included in O+M manual 1953. FS Date: 4/9/2013

Pipe at 36-inch Concrete standpipe on LS toe.

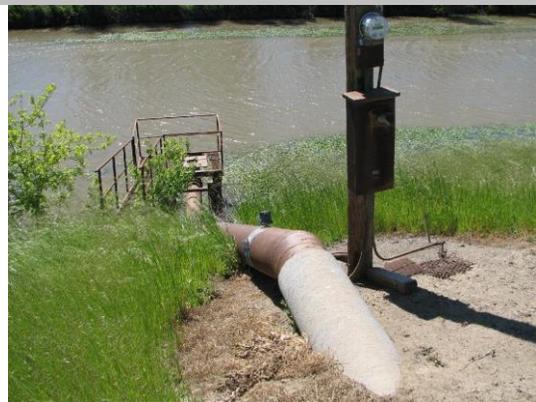
Photo 2 of 2 : UCIP_SP_2016_11307_18707.jpg

Pump platform and walkway on WS toe.

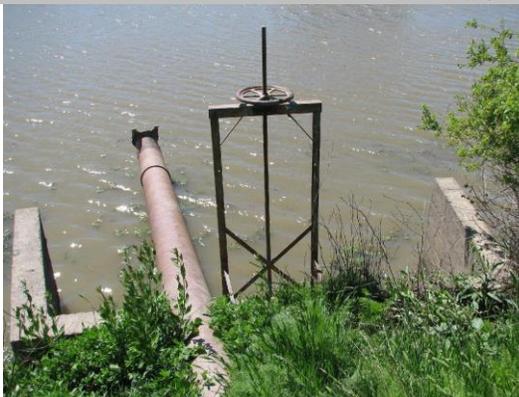
Photo 1 of 2 : UCIP_SP_2016_11306_18706.jpg

LM Start	1.89	Rating **	U	Issue No.	229
LM End	1.89	Issue Type +	En	Location *	WS
Category	Supplemental			GPS Latitude/Longitude	
				Start	End
Item	DWR UCIP Field Study			38.743768 °	38.743768 °
				-121.689185 °	-121.689185 °
DWR ID					
Comment Code					
Inspector Comment					
FS_ID:11306 DS_ID:19371 EP_NO: 9320 Repair Type: Urgent Crossing Status: Found UCIP Comments: Pipe at flap gate rusted through at WS toe. Flap gate does not function properly. FIELD_STRUCT_DESC: 1 of 2: 12-inch pipe through the levee, 4-feet below the crown. Flap gate on waterward end at concrete headwall, siphon breaker in 2-inch CM pipe riser on the landward shoulder. Vertical pump unit on concrete foundation in irrigation ditch at the LS toe. (Permit No. 9320-Pollock) Originally included in O+M manual 1953. FS Date: 4/9/2013

12-inch pipe at concrete headwall on WS toe.

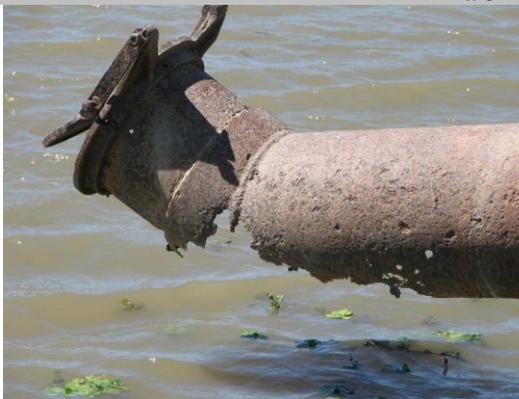
Photo 2 of 2 : UCIP_SP_2016_11306_18705.jpg

Pipe rusted through at flap gate on WS toe.

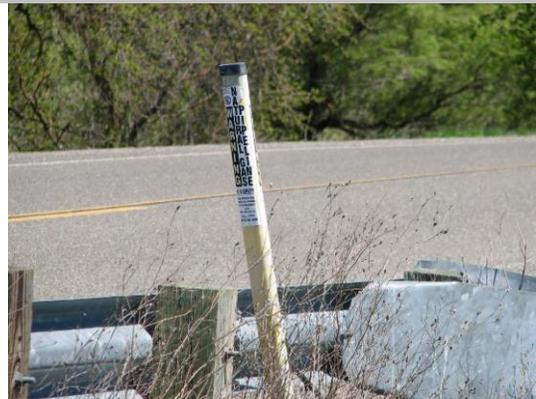
Photo 1 of 1 : UCIP_SP_2016_41832_18700.jpg

LM Start	2.26	Rating **	M	Issue No.	232
LM End	2.26	Issue Type +	En	Location *	WS
Category	Supplemental			GPS Latitude/Longitude	
				Start	End
Item	DWR UCIP Field Study			38.748282 °	38.748282 °
				-121.692652 °	-121.692652 °
DWR ID					
Comment Code					
Inspector Comment					
FS_ID:11304 DS_ID:19388 EP_NO: 15517 Repair Type: Non-Urgent Crossing Status: Indicator Found UCIP Comments: Pipe alignment should be marked at levee crossing. FIELD_STRUCT_DESC: 8-inch natural gas pipeline through the levee 50-feet below the crown. (Permit No. 15517, 1991). Design drawings available in permit. FS Date: 4/9/2013

Sign on LS shoulder may indicate location of pipe, or it may indicate where pipe crosses approach ramp to bridge.

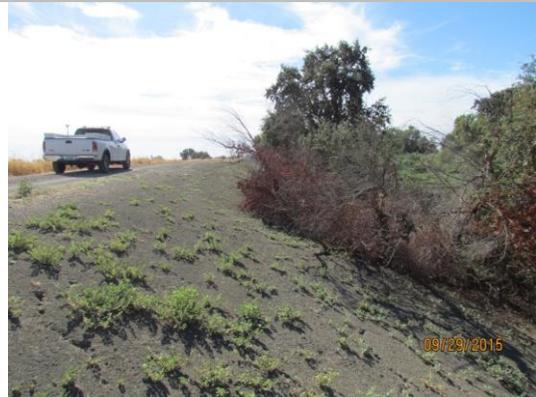
Photo 1 of 1 : SP_2016_NA0008_257_23_20160304_00013.jpg

Perspective view of the fallen tree on the waterward side of the levee looking downstream. Fall 2015.

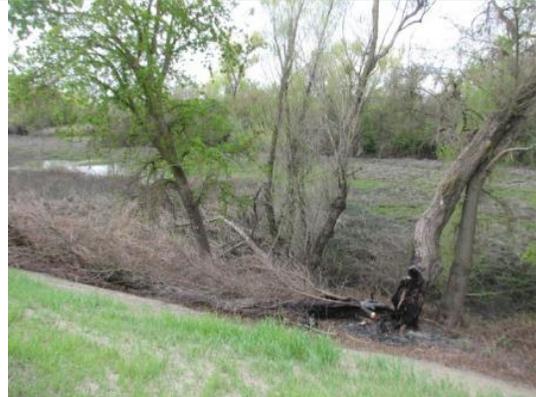
Photo 1 of 2 : SP_2016_NA0008_257_15_20160304_00003.jpg

A cottonwood tree may have been struck by lightning. The tree is split into three parts. Spring 2014

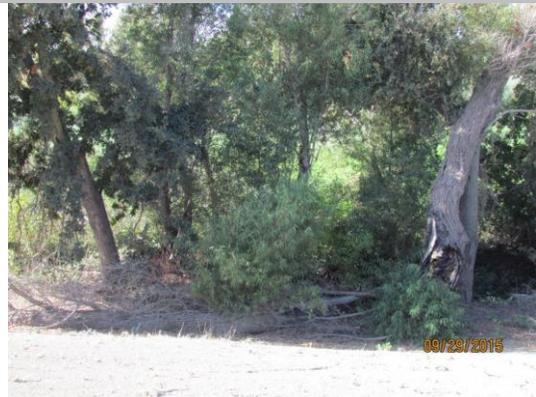
Photo 2 of 2 : SP_2016_NA0008_257_15_20160304_00004.jpg

The cottonwood tree has broken and is on the waterward side of the levee. Fall 2015.

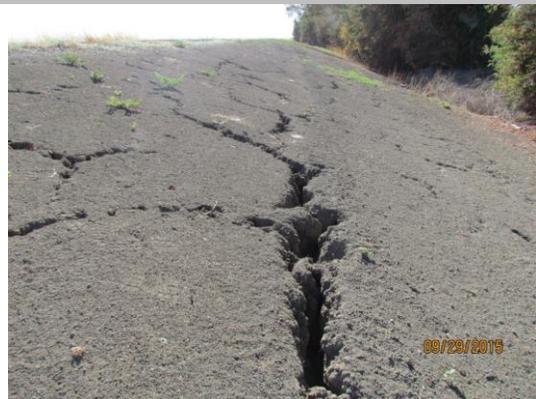
Photo 1 of 1 : SP_2016_NA0008_257_21_20160304_00012.jpg

View of the dessication crack on the waterward side of the levee looking downstream. Fall 2015.

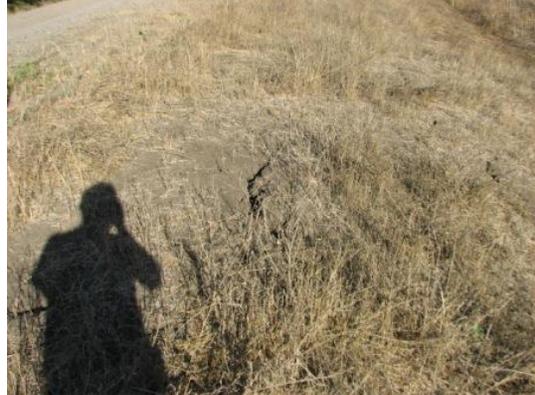
Photo 1 of 2 : SP_2016_NA0008_257_227_20160304_00015.jpg

Another view of the cracking on the levee slope. Fall 2013

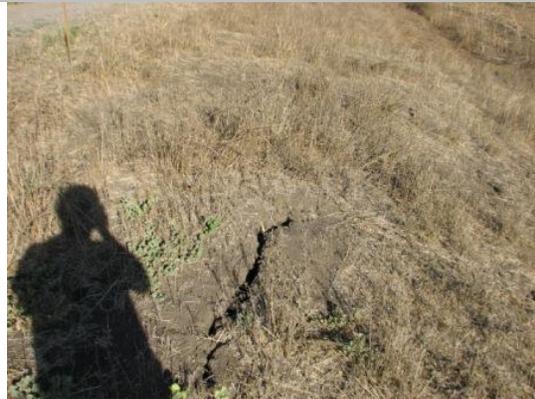
Photo 2 of 2 : SP_2016_NA0008_257_227_20160304_00016.jpg

Cracking on levee slope 1-2 inches wide and 6 inches deep. Fall 2013

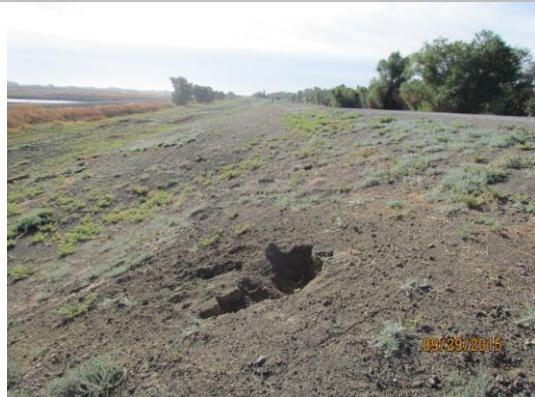
Photo 1 of 2 : SP_2016_NA0008_257_17_20160304_00007.jpg

Perspective view of the slope damaged by rodent burrows on the landward side of the levee looking downstream. Fall 2015.

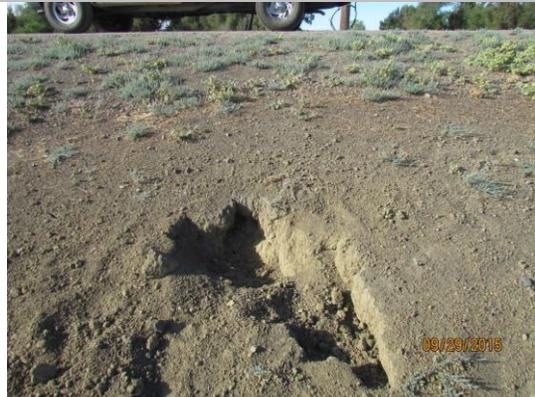
Photo 2 of 2 : SP_2016_NA0008_257_17_20160304_00008.jpg

The rodent hole does not seem to go through the levee. Fall 2015.

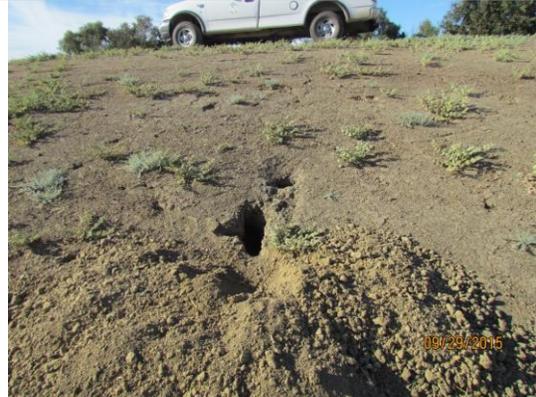
Photo 1 of 2 : SP_2016_NA0008_257_16_20160304_00005.jpg

There seems to be more than 2 cubic feet of material on the landward side of the levee. Fall 2015.

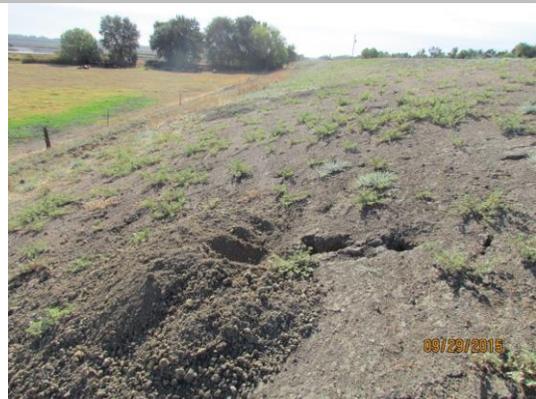
Photo 2 of 2 : SP_2016_NA0008_257_16_20160304_00006.jpg

Perspective view of the animal hole on the landward side of the levee looking downstream. Fall 2015.

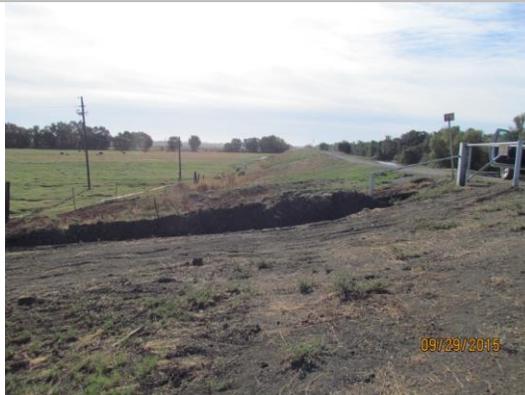
Photo 1 of 3 : SP_2016_NA0008_257_18_20160304_00009.jpg

Perspective view of the ditch on the landward slope of the levee looking downstream. Fall 2015.

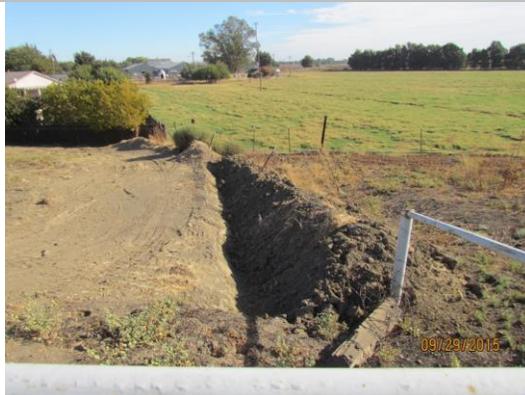
Photo 2 of 3 : SP_2016_NA0008_257_18_20160304_00010.jpg

The ditch is dug onto the landward slope of the levee. Fall 2015.

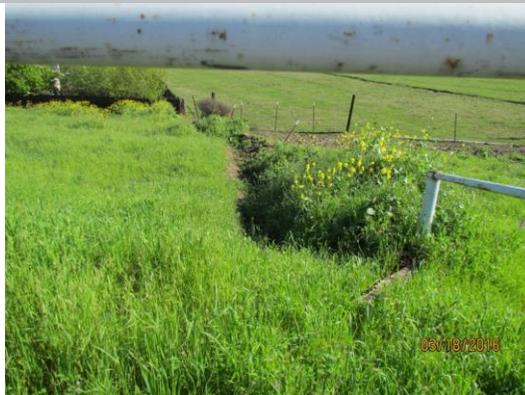
Photo 3 of 3 : SP_2016_NA0008_257_18_20160401_00027.jpg

View of the ditch on the landward slope of the levee. Spring 2016.

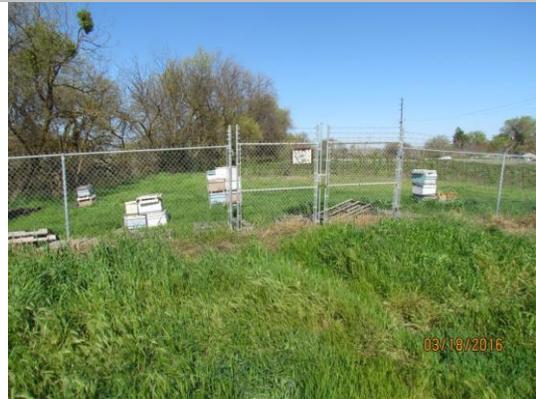
Photo 1 of 1 : SP_2016_NA0008_257_1_20160401_00026.jpg

View of the fence on the crown of the levee looking upstream. Spring 2016.
