**Flood Control Project Maintenance  
Levee Inspections**

**Maintenance Issue Types Only, Levee Inspection Report By Mile - Fall 2014**

**Knights Landing Ridge Drainage District**

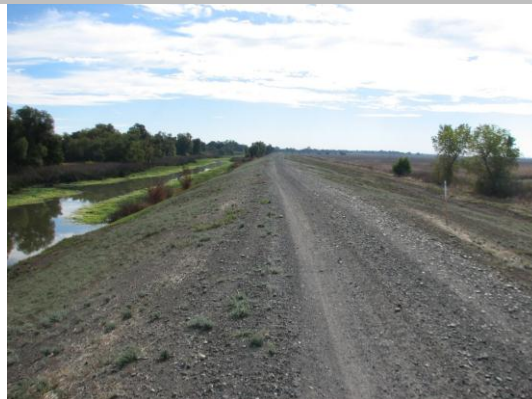
Photo 1 of 1 : FA\_2014\_NA0008\_256\_199\_20141030\_00370.jpg

LM Start	0.00	Rating **	A	Issue No.	199
LM End	6.43	Issue Type +	Ma	Location *	WS
Category	Earthen Levee			GPS Latitude/Longitude	
				Start	End
Item	Vegetation				°
					°
DWR ID	DWR_NA0008_01_f_2014_199				
Action/Comments					
Control annual grass and weeds on the levee slopes and easements.

Levee mile 5.90, vegetation on levee slopes. Fall 2014.

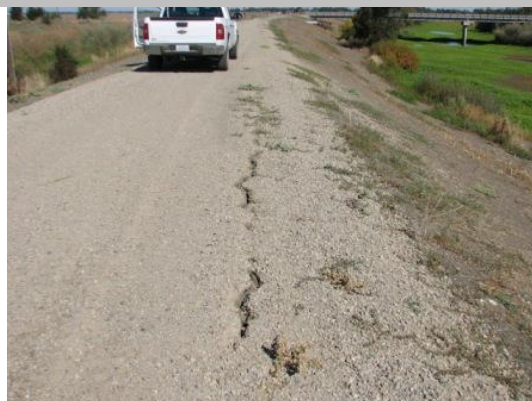
Photo 1 of 1 : FA\_2014\_NA0008\_256\_19\_20141014\_00003.jpg

LM Start	2.61	Rating **	A/W	Issue No.	19
LM End	2.61	Issue Type +	Ma	Location *	WS
Category	Earthen Levee			GPS Latitude/Longitude	
				Start	End
Item	Cracking			38.747218 °	38.747218 °
				-121.694450 °	-121.694450 °
DWR ID	DWR_NA0008_01_f_2013_19				
Action/Comments					
Monitor and have inspected by geotechnical engineer.					
Inspector Comments: Cracks along crown and down waterside slope.

Cracking along the waterside shoulder of the crown the length of 20 feet.  
Fall 2013

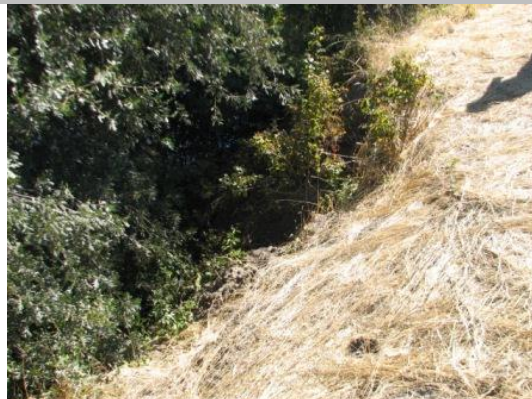
Photo 1 of 2 : FA\_2014\_NA0008\_256\_20\_20141014\_00004.jpg

LM Start	3.54	Rating **	M	Issue No.	20
LM End	3.54	Issue Type +	Ma	Location *	WS
Category	Earthen Levee			GPS Latitude/Longitude	
				Start	End
Item	Erosion / Bank Caving			38.759910 °	38.759910 °
				-121.696920 °	-121.696920 °
DWR ID	DWR_NA0008_01_f_2013_20				
Action/Comments					
Note and monitor erosion site.

Another view of the erosion cutting into the slope. Fall 2013

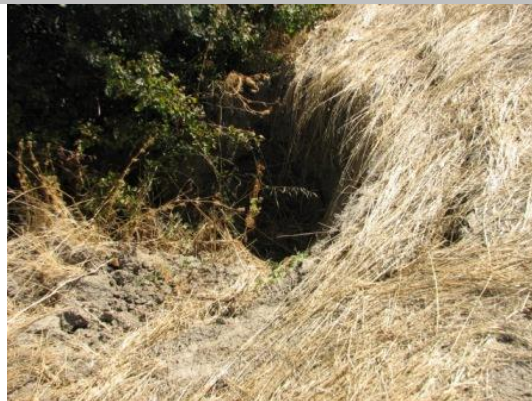
Photo 2 of 2 : FA\_2014\_NA0008\_256\_20\_20141014\_00005.jpg

Deep erosion at the bottom of the waterside slope 3-4 foot cut. Fall 2013

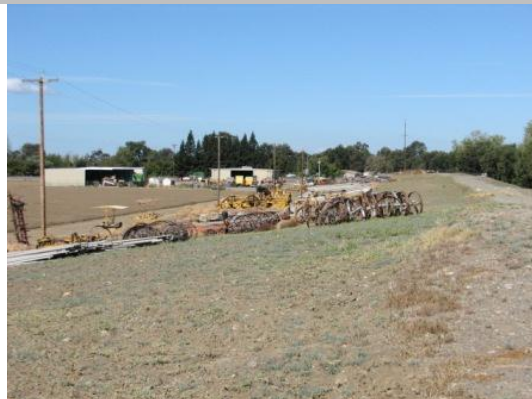
Photo 1 of 2 : FA\_2014\_NA0008\_256\_7\_20141014\_00001.jpg

LM Start	6.17	Rating **	M	Issue No.	7
LM End	6.41	Issue Type +	Ma	Location *	LS
Category	Earthen Levee			GPS Latitude/Longitude	
				Start	End
Item	Encroachments			38.790007 °	38.792433 °
				-121.723308 °	-121.726463 °
DWR ID	DWR_NA0008_01_s_2012_7				
Action/Comments					
Equipment

Equipment and irrigation pipe lays on the landside levee slope. Fall 2013

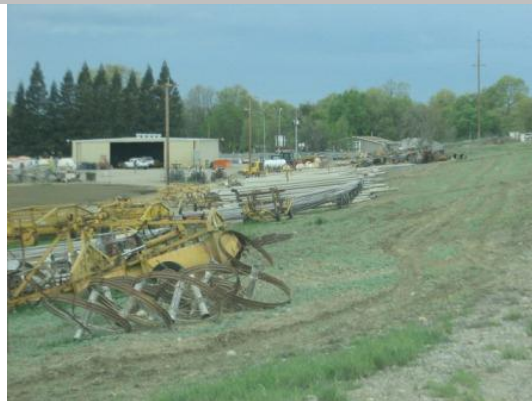
Photo 2 of 2 : FA\_2014\_NA0008\_256\_7\_20141014\_00002.jpg

A current view of the equipment on the levee slope. Spring 2014

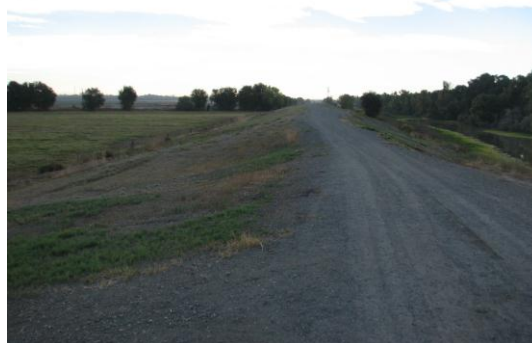
Photo 1 of 1 : FA\_2014\_NA0008\_257\_13\_20141030\_00016.jpg

LM Start	0.00	Rating **	A	Issue No.	13
LM End	5.88	Issue Type +	Ma	Location *	LS
Category	Earthen Levee			GPS Latitude/Longitude	
				Start	End
Item	Vegetation				°
					°
DWR ID	DWR_NA0008_02_f_2014_13				
Action/Comments					
Control annual grass and weeds on the levee slopes and easements.

Levee mile 5.88, vegetation on levee slopes. Fall 2014.

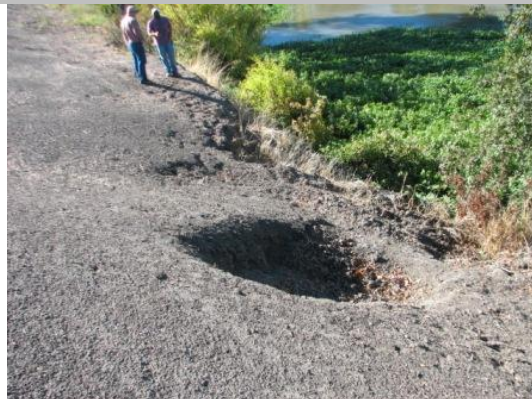
Photo 1 of 1 : FA\_2014\_NA0008\_257\_230\_20141014\_00011.jpg

LM Start	3.05	Rating **	U	Issue No.	230
LM End	3.05	Issue Type +	Ma	Location *	WS
Category	Earthen Levee			GPS Latitude/Longitude	
				Start	End
Item	Erosion / Bank Caving			38.759112 °	38.759112 °
				-121.693638 °	-121.693638 °
DWR ID	DWR_NA0008_02_f_2013_230				
Action/Comments					
Note and monitor erosion site.

Erosion at the bottom of the slope. It appears that a fallen tree has caused a sink hole. Fall 2013

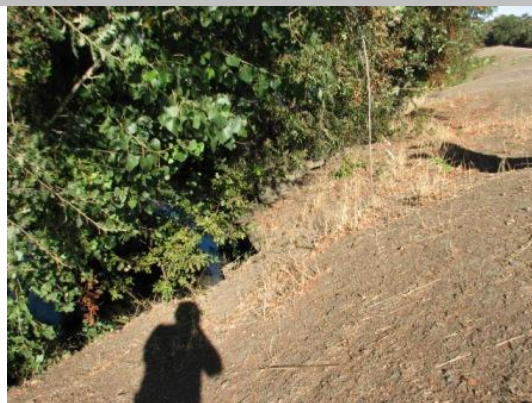
Photo 1 of 2 : FA\_2014\_NA0008\_257\_229\_20141014\_00009.jpg

LM Start	3.08	Rating **	U	Issue No.	229
LM End	3.08	Issue Type +	Ma	Location *	WS
Category	Earthen Levee			GPS Latitude/Longitude	
				Start	End
Item	Erosion / Bank Caving			38.759542 °	38.759542 °
				-121.694007 °	-121.694007 °
DWR ID	DWR_NA0008_02_f_2013_229				
Action/Comments					
Note and monitor erosion site. Inspector Comments: Erosion is undermining large oak tree and is growing.

Another view of the vertical cut at the bottom of the slope. Fall 2013

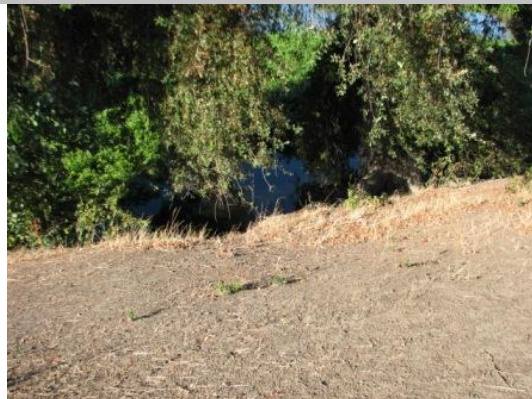
Photo 2 of 2 : FA\_2014\_NA0008\_257\_229\_20141014\_00010.jpg

Waterside eroision vertical cut at bottom of slope. Fall 2013

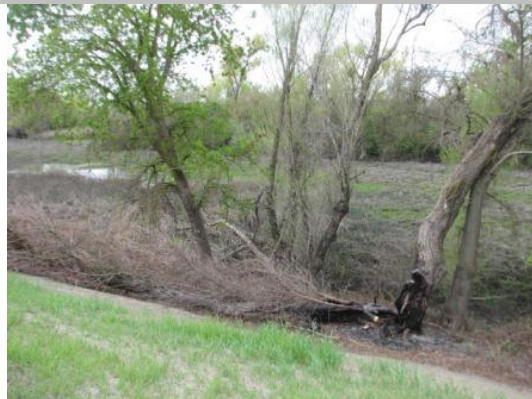
Photo 1 of 1 : FA\_2014\_NA0008\_257\_15\_20141014\_00004.jpg

LM Start	4.65	Rating **	U	Issue No.	15
LM End	4.65	Issue Type +	Ma	Location *	WS
Category	Earthen Levee			GPS Latitude/Longitude	
				Start	End
Item	Vegetation			38.778822 °	38.778822 °
				-121.706515 °	-121.706515 °
DWR ID	DWR_NA0008_02_s_2014_15				
Action/Comments					
Trees / Woody Vegetation

A cottonwood tree may have been struck by lightning. The tree is split into tree parts. Spring 2014

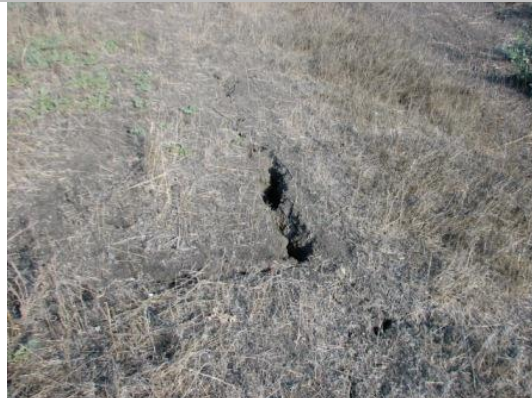
Photo 1 of 1 : FA\_2014\_NA0008\_257\_226\_20141014\_00006.jpg

LM Start	4.86	Rating **	A/W	Issue No.	226
LM End	4.88	Issue Type +	Ma	Location *	LS
Category	Earthen Levee			GPS Latitude/Longitude	
				Start	End
Item	Cracking			38.780858 °	38.781102 °
				-121.709093 °	-121.709385 °
DWR ID	DWR_NA0008_02_f_2013_226				
Action/Comments					
Monitor and have inspected by geotechnical engineer.

Cracking on the landside is 3-4 inches wide and 12 inches deep. Fall 2013

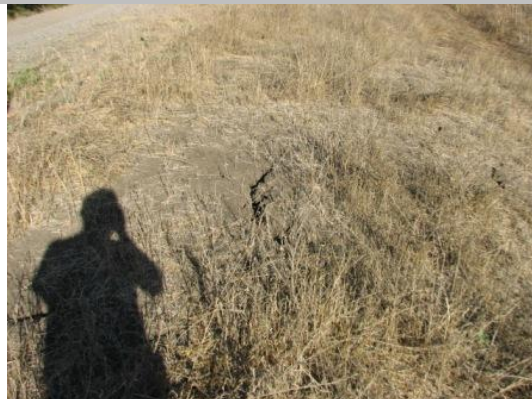
Photo 1 of 2 : FA\_2014\_NA0008\_257\_227\_20141014\_00007.jpg

LM Start	4.86	Rating **	A/W	Issue No.	227
LM End	4.86	Issue Type +	Ma	Location *	WS
Category	Earthen Levee			GPS Latitude/Longitude	
				Start	End
Item	Cracking			38.780858 °	38.780858 °
				-121.709095 °	-121.709095 °
DWR ID	DWR_NA0008_02_f_2013_227				
Action/Comments					
Monitor and have inspected by geotechnical engineer.

Another view of the cracking on the levee slope. Fall 2013

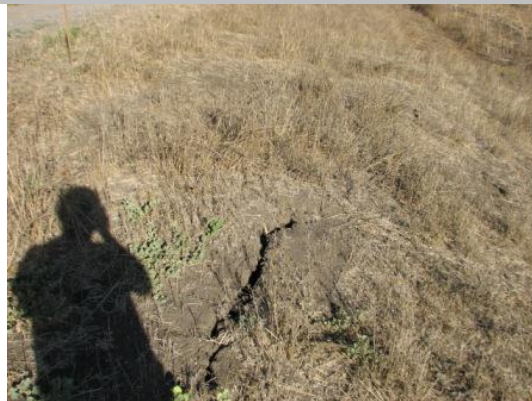
Photo 2 of 2 : FA\_2014\_NA0008\_257\_227\_20141014\_00008.jpg

Cracking on levee slope 1-2 inches wide and 6 inches deep. Fall 2013
