**Flood Control Project Maintenance
Levee Inspections**

Maintenance Issue Types Only, Levee Inspection Report By Mile - Fall 2015

Knights Landing Ridge Drainage District

Waterway	Bank	Unit Miles	Inspection Start/End	Inspector
Unit No. 01 Knights Landing Ridge Cut	Right	6.36	09/29/2015 09/29/2015	Jai Lor

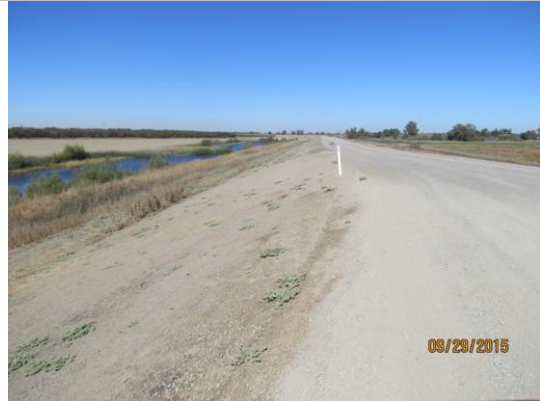
Photo 1 of 1 : FA_2015_NA0008_256_14_20151005_00013.jpg

LM Start	0.00	Rating **	A	Issue No.	14
LM End	6.35	Issue Type +	Ma	Location *	LS
Category	Earthen Levee			GPS Latitude/Longitude	
				Start	End
Item	Vegetation			38.719063 °	38.792438 °
				-121.664139 °	-121.726674 °
DWR ID	DWR_NA0008_01_f _ 2015_14				
Action/Comments					
Control annual grass and weeds on the levee slopes and easements. Inspector Comments: The LMA has maintained the vegetation on the slope.

View of the vegetation on the landward side of the levee looking upstream. Fall 2015.

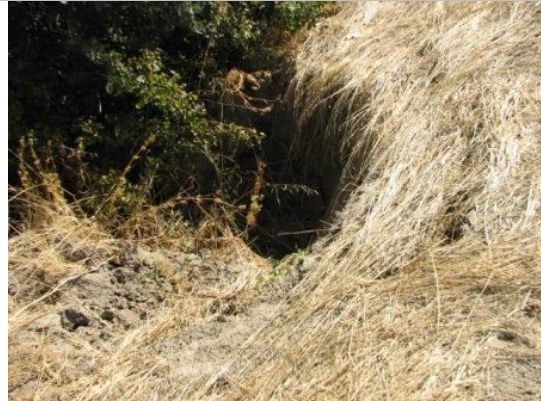
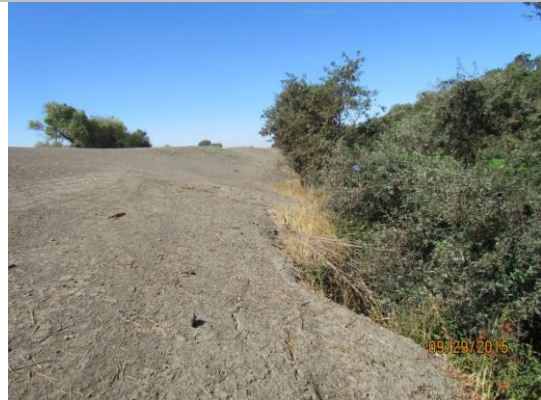
LM Start	3.50	Rating **	U	Issue No.	20
LM End	3.50	Issue Type +	Ma	Location *	WS
Category	Earthen Levee			GPS Latitude/Longitude	
				Start	End
Item	Erosion / Bank Caving			38.759910 °	38.759910 °
				-121.696920 °	-121.696920 °
DWR ID	DWR_NA0008_01_f_2015_20				
Action/Comments					
Note and monitor erosion site.

Deep erosion at the bottom of the waterside slope 3-4 foot cut. Fall 2013

View of the erosion on the waterward side of the levee looking upstream. Fall 2015.

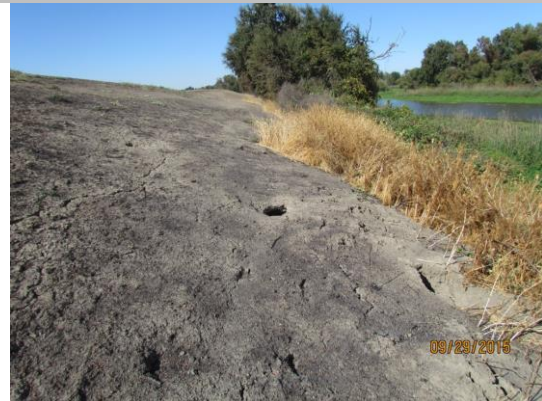
Photo 1 of 1 : FA_2015_NA0008_256_21_20151005_00021.jpg

LM Start	4.28	Rating **	M	Issue No.	21
LM End	4.28	Issue Type +	Ma	Location *	WS
Category	Earthen Levee			GPS Latitude/Longitude	
				Start	End
Item	Animal Control			38.769608 °	38.769608 °
				-121.703076 °	-121.703076 °
DWR ID	DWR_NA0008_01_f_2015_21				
Action/Comments					
No rodents visible, but rodent burrows visible; need to backfill and compact or grout burrows.

View of the rodent holes on the waterward side of the levee looking upstream. Fall 2015.

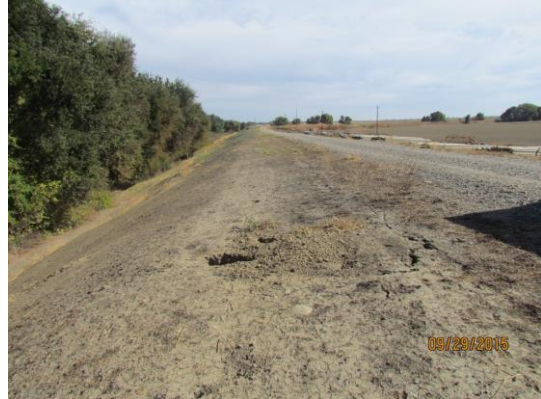
Photo 1 of 1 : FA_2015_NA0008_256_24_20151005_00024.jpg

LM Start	6.23	Rating **	M	Issue No.	24
LM End	6.23	Issue Type +	Ma	Location *	WS
Category	Earthen Levee			GPS Latitude/Longitude	
				Start	End
Item	Animal Control			38.791286 °	38.791286 °
				-121.725034 °	-121.725034 °
DWR ID	DWR_NA0008_01_f_2015_24				
Action/Comments					
Exterminate rodents and backfill and compact or grout burrows.

View of the rodent holes on the waterward side of the levee looking downstream. Fall 2015.

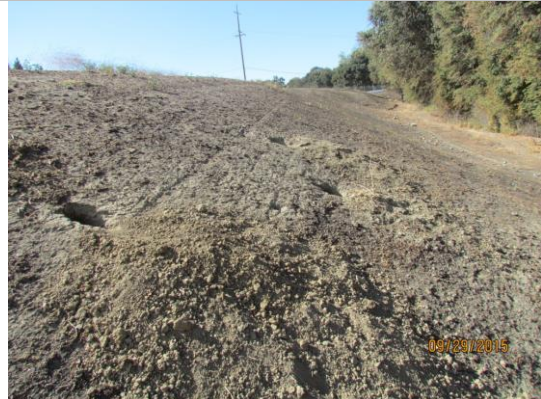
Photo 1 of 1 : FA_2015_NA0008_256_25_20151005_00025.jpg

LM Start	6.29	Rating **	U	Issue No.	25
LM End	6.29	Issue Type +	Ma	Location *	WS
Category	Earthen Levee			GPS Latitude/Longitude	
				Start	End
Item	Animal Control			38.791949 °	38.791949 °
				-121.725921 °	-121.725921 °
DWR ID	DWR_NA0008_01_f_2015_25				
Action/Comments					
Exterminate rodents and backfill and compact or grout burrows.

View of the animal hole on the waterward side of the levee looking upstream. Fall 2015.

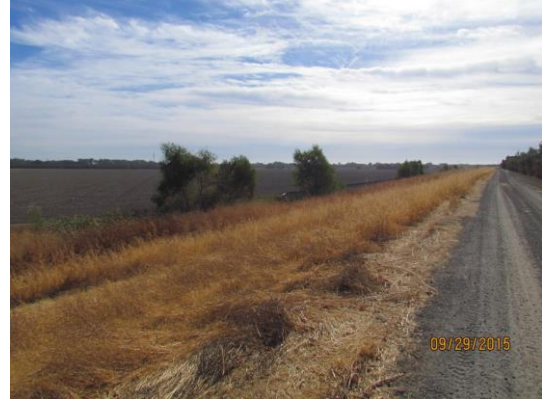
Photo 1 of 1 : FA_2015_NA0008_257_20_20151005_00023.jpg

LM Start	4.17	Rating **	M	Issue No.	20
LM End	4.90	Issue Type +	Ma	Location *	LS
Category	Earthen Levee			GPS Latitude/Longitude	
				Start	End
Item	Vegetation			38.773554 °	38.781930 °
				-121.702435 °	-121.710416 °
DWR ID	DWR_NA0008_02_f _ 2015_20				
Action/Comments					
Control annual grass and weeds on the levee slopes and easements.

View of the vegetation on the landward side of the levee looking downstream. Fall 2015.

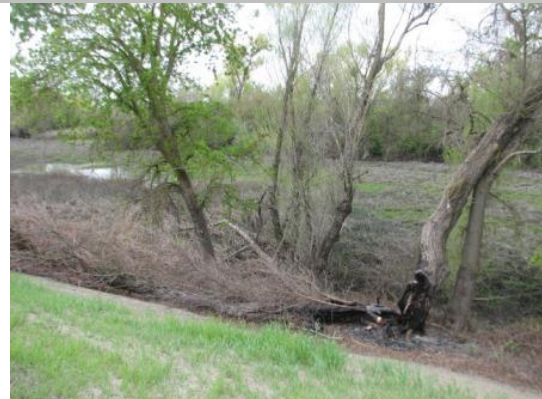
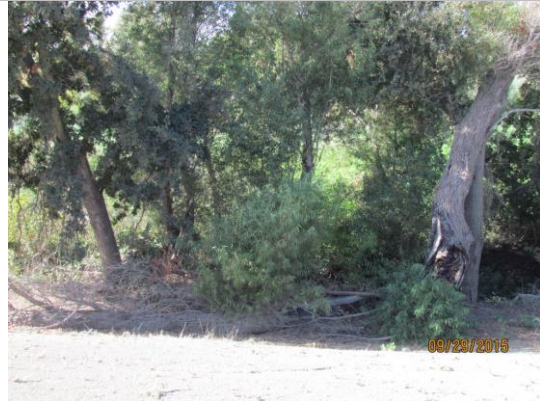
LM Start	4.59	Rating **	U	Issue No.	15
LM End	4.59	Issue Type +	Ma	Location *	WS
Category	Earthen Levee			GPS Latitude/Longitude	
				Start	End
Item	Vegetation			38.778773 °	38.778773 °
				-121.706482 °	-121.706482 °
DWR ID	DWR_NA0008_02_s_2014_15				
Action/Comments					
Trees / Woody Vegetation					
Inspector Comments: Identified trees shall be removed and associated root balls and roots shall be appropriately removed since it threatens the integrity of the levee.

A cottonwood tree may have been struck by lightning. The tree is split into three parts. Spring 2014

The cottonwood tree has broken and is on the waterward side of the levee. Fall 2015.

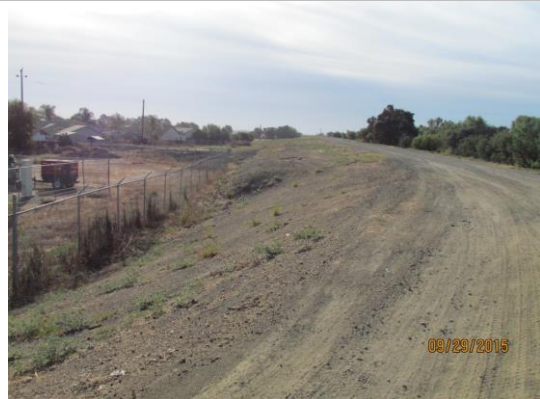
Photo 1 of 1 : FA_2015_NA0008_257_13_20151005_00015.jpg

LM Start	4.90	Rating **	A	Issue No.	13
LM End	5.94	Issue Type +	Ma	Location *	LS
Category	Earthen Levee			GPS Latitude/Longitude	
				Start	End
Item	Vegetation			38.781930 °	38.792721 °
				-121.710416 °	-121.724113 °
DWR ID	DWR_NA0008_02_f _ 2015_13				
Action/Comments					
Control annual grass and weeds on the levee slopes and easements. Inspector Comments: The slope has been mowed and in compliance.

View of the vegetation on the landward side of the levee looking downstream. Fall 2015.

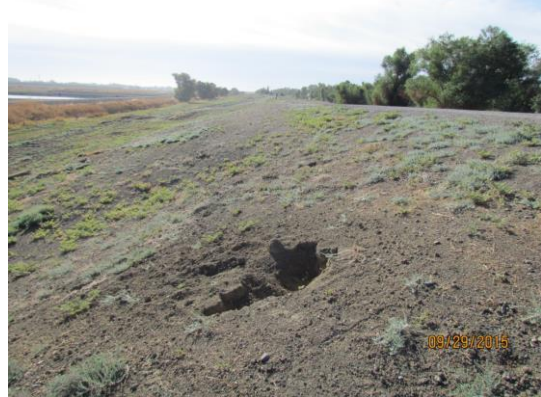
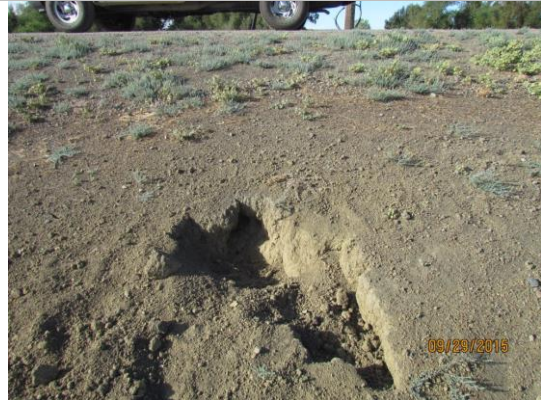
LM Start	5.54	Rating **	M	Issue No.	17
LM End	5.54	Issue Type +	Ma	Location *	LS
Category	Earthen Levee			GPS Latitude/Longitude	
				Start	End
Item	Animal Control			38.788592 °	38.788592 °
				-121.718902 °	-121.718902 °
DWR ID	DWR_NA0008_02_f _ 2015_17				
Action/Comments					
No rodents visible, but rodent burrows visible; need to backfill and compact or grout burrows.

Perspective view of the slope damaged by rodent burrows on the landward side of the levee looking downstream. Fall 2015.

The rodent hole does not seem to go through the levee. Fall 2015.

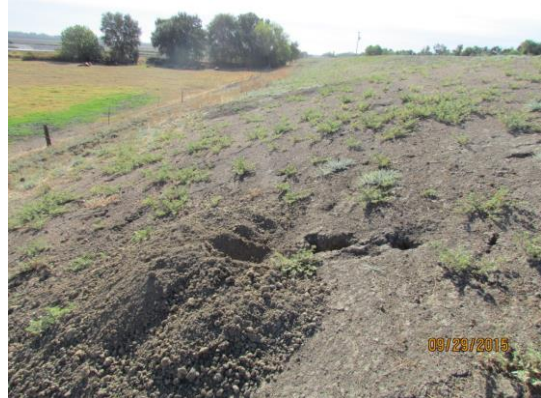
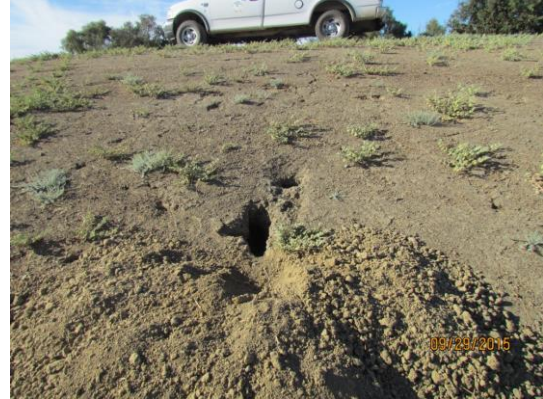
LM Start	5.66	Rating **	U	Issue No.	16
LM End	5.66	Issue Type +	Ma	Location *	LS
Category	Earthen Levee			GPS Latitude/Longitude	
				Start	End
Item	Animal Control			38.789794 °	38.789794 °
				-121.720338 °	-121.720338 °
DWR ID	DWR_NA0008_02_f_2015_16				
Action/Comments					
No rodents visible, but rodent burrows visible; need to backfill and compact or grout burrows.

Perspective view of the animal hole on the landward side of the levee looking downstream. Fall 2015.

There seems to be more than 2 cubic feet of material on the landward side of the levee. Fall 2015.
