**Flood Control Project Maintenance
Levee Inspections**

Maintenance Issue Types Only, Levee Inspection Report By Mile - Fall 2016

Knights Landing Ridge Drainage District

Waterway	Bank	Unit Miles	Inspection Start/End	Inspector
Unit No. 01 Knights Landing Ridge Cut	Right	6.36	10/05/2016 10/05/2016	Oleg Yakimov

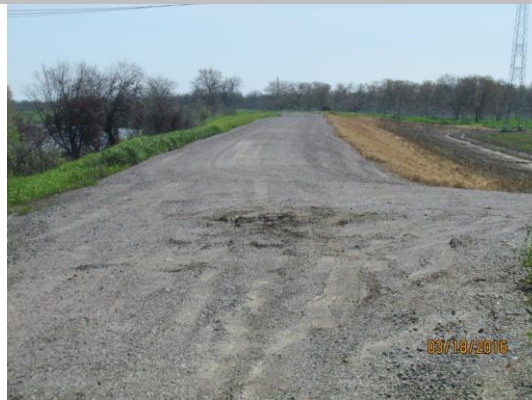
Photo 1 of 1 : FA_2016_NA0008_256_29_20160913_00012.jpg

LM Start	1.57	Rating **	M	Issue No.	29
LM End	1.57	Issue Type +	Ma	Location *	CR
Category	Earthen Levee			GPS Latitude/Longitude	
				Start	End
Item	Crown Surface / Depressions / Rutting			38.735164 °	38.735164 °
				-121.683843 °	-121.683843 °
DWR ID	DWR_NA0008_01_s_2016_29				
Comment Code					
C2 : Repair depressions or ruts in the crown or slope.					
Inspector Comment

View of the ruts on the crown of the levee looking downstream. Spring 2016.

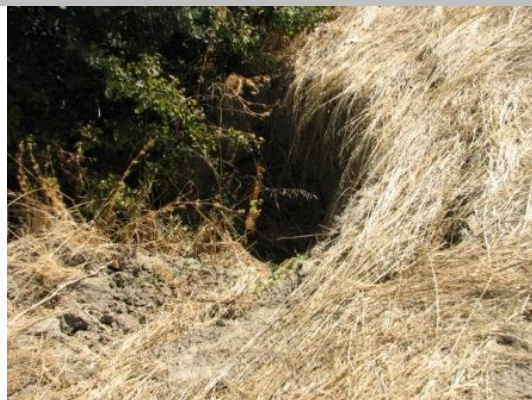
Photo 1 of 2 : FA_2016_NA0008_256_20_20160913_00005.jpg

LM Start	3.50	Rating **	U	Issue No.	20
LM End	3.50	Issue Type +	Ma	Location *	WS
Category	Earthen Levee			GPS Latitude/Longitude	
				Start	End
Item	Erosion / Bank Caving			38.759910 °	38.759910 °
				-121.696920 °	-121.696920 °
DWR ID	DWR_NA0008_01_f_2015_20				
Comment Code					
E1 : Note and monitor erosion site.					
Inspector Comment

Deep erosion at the bottom of the waterside slope 3-4 foot cut. Fall 2013

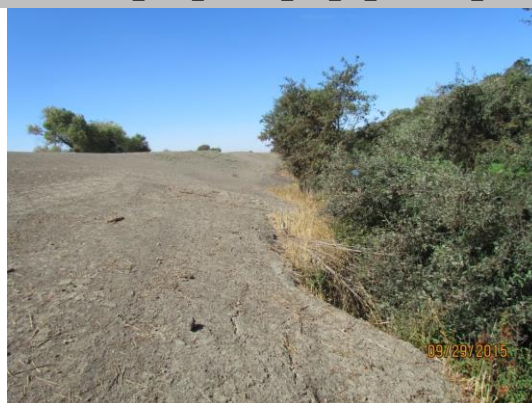
Photo 2 of 2 : FA_2016_NA0008_256_20_20160913_00006.jpg

View of the erosion on the waterward side of the levee looking upstream. Fall 2015.

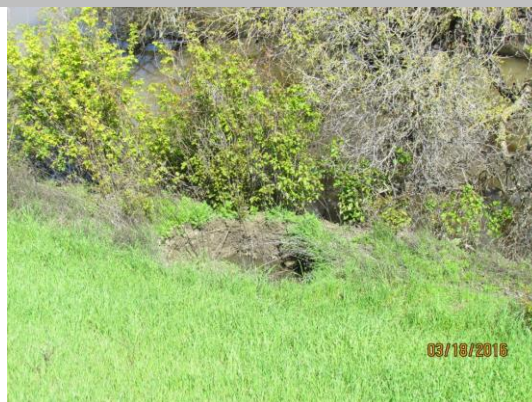
Photo 1 of 1 : FA_2016_NA0008_256_30_20160913_00013.jpg

LM Start	3.78	Rating **	U	Issue No.	30
LM End	3.78	Issue Type +	Ma	Location *	WS
Category	Earthen Levee			GPS Latitude/Longitude	
				Start	End
Item	Erosion / Bank Caving			38.762886 °	38.762886 °
				-121.700406 °	-121.700406 °
DWR ID	DWR_NA0008_01_s_2016_30				
Comment Code					
E1 : Note and monitor erosion site.					
Inspector Comment					
Hole is at the toe of the levee on the waterward side.

View of the erosion at the toe of the levee on the waterward side. Spring 2016.

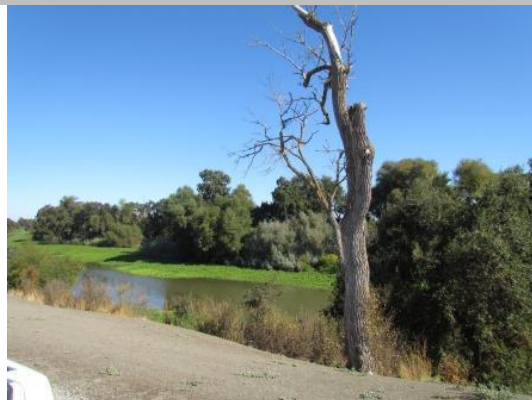
Photo 1 of 1 : FA_2016_NA0008_256_15_20161005_00041.jpg

LM Start	3.84	Rating **	A/W	Issue No.	15
LM End	3.84	Issue Type +	Ma	Location *	WS
Category	Earthen Levee			GPS Latitude/Longitude	
				Start	End
Item	Vegetation			38.763460 °	38.763460 °
				-121.701097 °	-121.701097 °
DWR ID	DWR_NA0008_01_f_2016_15				
Comment Code					
V7 : Trees / Woody Vegetation					
Inspector Comment					
Monitor trees that pose a future threat to the integrity of the levee.

View of an old tree on waterward side of the levee. Subject to monitor. Fall 2016.

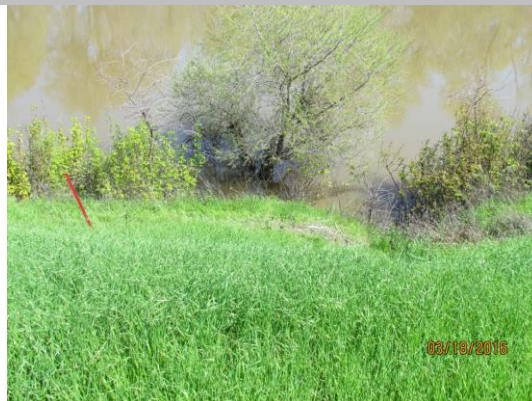
Photo 1 of 1 : FA_2016_NA0008_256_31_20160913_00014.jpg

LM Start	3.86	Rating **	M	Issue No.	31
LM End	3.86	Issue Type +	Ma	Location *	WS
Category	Earthen Levee			GPS Latitude/Longitude	
				Start	End
Item	Erosion / Bank Caving			38.763751°	38.763751°
				-121.701398°	-121.701398°
DWR ID	DWR_NA0008_01_s_2016_31				
Comment Code					
E1 : Note and monitor erosion site.					
Inspector Comment					
Erosion at the toe of the levee. LMA is monitoring erosion with stakes.

View of the erosion at the toe of the levee on the waterward side. Spring 2016.

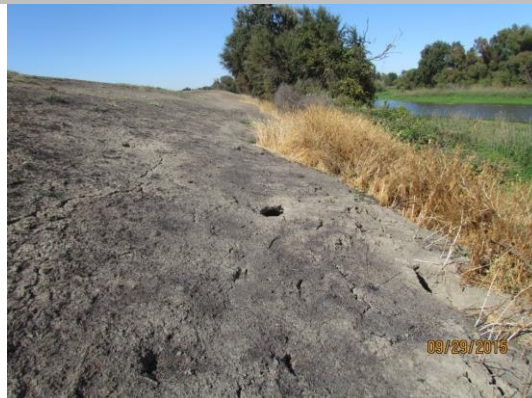
Photo 1 of 1 : FA_2016_NA0008_256_21_20160913_00007.jpg

LM Start	4.28	Rating **	M	Issue No.	21
LM End	4.28	Issue Type +	Ma	Location *	WS
Category	Earthen Levee			GPS Latitude/Longitude	
				Start	End
Item	Animal Control			38.769608 °	38.769608 °
				-121.703076 °	-121.703076 °
DWR ID	DWR_NA0008_01_f_2015_21				
Comment Code					
A3 : No rodents visible, but rodent burrows visible; need to backfill and compact or grout burrows.					
Inspector Comment

View of the rodent holes on the waterward side of the levee looking upstream. Fall 2015.

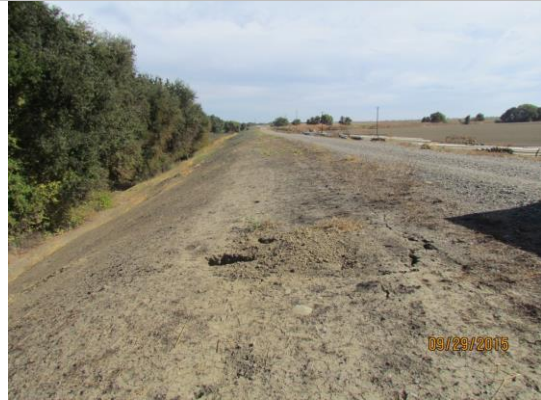
Photo 1 of 1 : FA_2016_NA0008_256_24_20160913_00009.jpg

LM Start	6.23	Rating **	M	Issue No.	24
LM End	6.23	Issue Type +	Ma	Location *	WS
Category	Earthen Levee			GPS Latitude/Longitude	
				Start	End
Item	Animal Control			38.791286 °	38.791286 °
				-121.725034 °	-121.725034 °
DWR ID	DWR_NA0008_01_f_2015_24				
Comment Code					
A1 : Exterminate rodents and backfill and compact or grout burrows.					
Inspector Comment					
Ground squirrels are seen in this area.

View of the rodent holes on the waterward side of the levee looking downstream. Fall 2015.

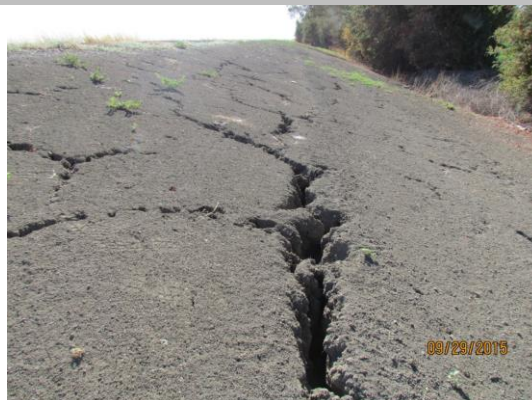
Photo 1 of 1 : FA_2016_NA0008_257_21_20160913_00011.jpg

LM Start	4.76	Rating **	M	Issue No.	21
LM End	4.76	Issue Type +	Ma	Location *	WS
Category	Earthen Levee			GPS Latitude/Longitude	
				Start	End
Item	Cracking			38.780496 °	38.780496 °
				-121.708671 °	-121.708671 °
DWR ID	DWR_NA0008_02_f_2015_21				
Comment Code					
CR1 : Monitor and have inspected by geotechnical engineer.					
Inspector Comment					
Dessication crack is 7 inches wide and 2 feet deep.

View of the dessication crack on the waterward side of the levee looking downstream. Fall 2015.

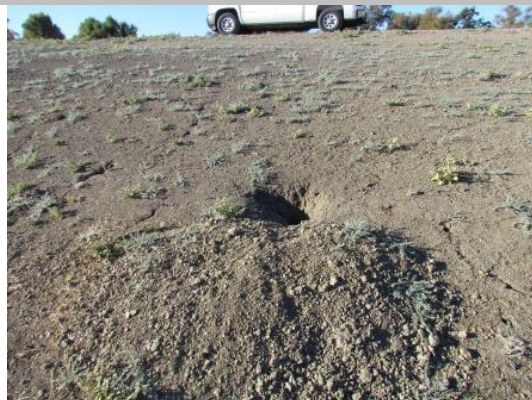
Photo 1 of 1 : FA_2016_NA0008_257_13_20161005_00026.jpg

LM Start	5.34	Rating **	M	Issue No.	13
LM End	5.34	Issue Type +	Ma	Location *	LS
Category	Earthen Levee			GPS Latitude/Longitude	
				Start	End
Item	Animal Control			38.786504°	38.786504°
				-121.716261°	-121.716261°
DWR ID	DWR_NA0008_02_f_2016_13				
Comment Code					
A3 : No rodents visible, but rodent burrows visible; need to backfill and compact or grout burrows.					
Inspector Comment

View of a rodent hole on LS slope. Fall 2016.

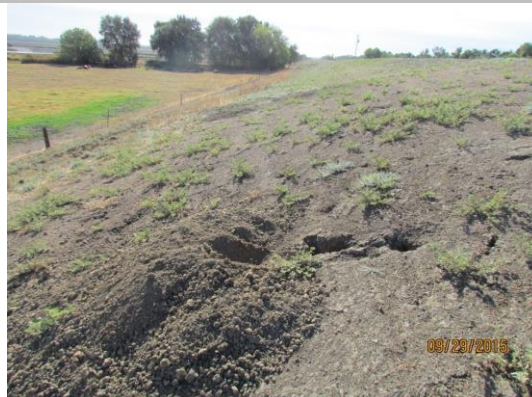
Photo 1 of 2 : FA_2016_NA0008_257_16_20160913_00004.jpg

LM Start	5.66	Rating **	U	Issue No.	16
LM End	5.66	Issue Type +	Ma	Location *	LS
Category	Earthen Levee			GPS Latitude/Longitude	
				Start	End
Item	Animal Control			38.789794°	38.789794°
				-121.720338°	-121.720338°
DWR ID	DWR_NA0008_02_f_2015_16				
Comment Code					
A3 : No rodents visible, but rodent burrows visible; need to backfill and compact or grout burrows.					
Inspector Comment

Perspective view of the animal hole on the landward side of the levee looking downstream. Fall 2015.

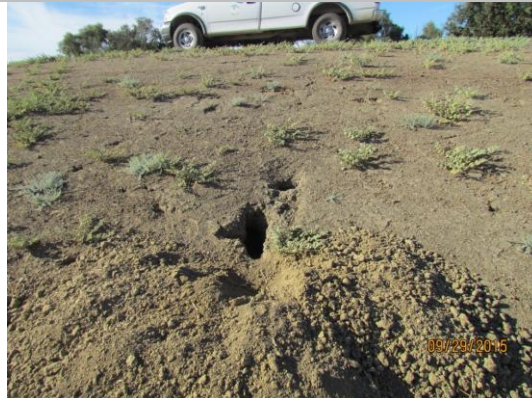
Photo 2 of 2 : FA_2016_NA0008_257_16_20160913_00005.jpg

There seems to be more than 2 cubic feet of material on the landward side of the levee. Fall 2015.
