**Flood Control Project Maintenance
Levee Inspections**

Maintenance Issue Types Only, Levee Inspection Report By Mile - Fall 2017

Knights Landing Ridge Drainage District

Waterway	Bank	Unit Miles	Inspection Start/End	Inspector
Unit No. 01 Knights Landing Ridge Cut	Right	6.36	09/26/2017 09/26/2017	Zach Jojola

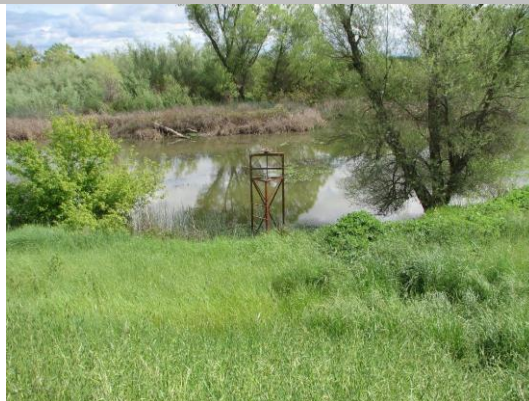
Photo 2 of 3 : UCIP_FA_2017_48010_21581.jpg

FS_ID:48010
DS_ID:19360
EP_NO: 9302
Repair Type: No Action Needed
Crossing Status: Found
UCIP Comments: Pipe has been grouted in place under permit 18987, 2015Pipe completely rusted through on LS slope of levee at toe/headwall of concrete distribution box. Pipe needs replacement or proper abandonment. Pipe not visible at outlet.
FIELD_STRUCT_DESC: *ABANDONED* 36-inch corrugated metal drainage pipe through the levee, 27 feet below the crown. Slide gate on the waterside (WS) end. 12-foot by 6-foot concrete box on the landside (LS) end. (36-inch pipe [HLM 1.62] authorized under Automatic Board Order (ABO) issued as Permit No. 9302, 1974 - Barbara Lowe Elliott; 36-inch pipe abandoned by removing ends and pumping pipe full of concrete under Permit No. 18987, 2016 - Knaggs Ranch, LLC, care of John Brennan). [Additional Reference(s): DWR Levee Log, 1990. USACE Sacramento O&M Manual 127, June 1953, (Station 0+30)].

Slide gate on metal stand on WS toe. Pipe opening not visible.

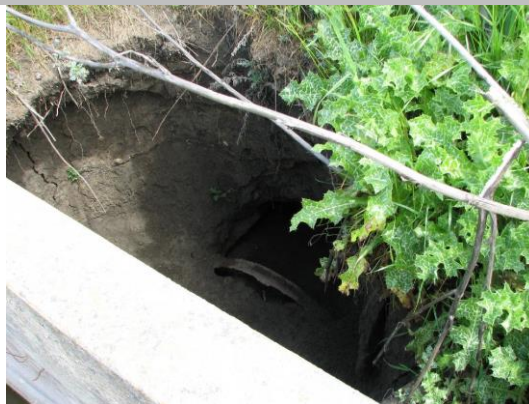
Photo 3 of 3 : UCIP_FA_2017_48010_21580.jpg

Pipe failure at connection to concrete box on LS toe.

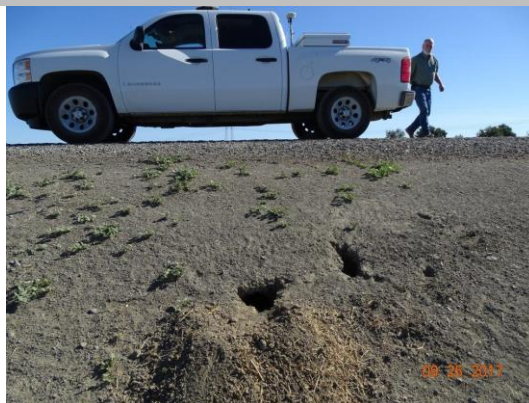
Photo 1 of 2 : FA_2017_NA0008_256_28_20170926_00066.jpg

LM Start	1.74	Rating **	M	Issue No.	28
LM End	1.87	Issue Type +	Ma	Location *	LS
Category	Earthen Levee			GPS Latitude/Longitude	
				Start	End
Item	Animal Control			38.737104 °	38.738684 °
				-121.685624 °	-121.687077 °
DWR ID	DWR_NA0008_01_f_2017_28				
Comment Code					
A3 : No rodents visible, but rodent burrows visible; need to backfill and compact or grout burrows.					
Inspector Comment					
Multiple rodent holes on section of landside slope.

View of rodent holes on the landside slope. Fall 2017.

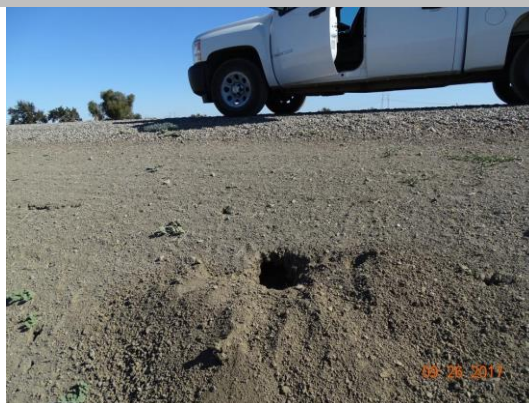
Photo 2 of 2 : FA_2017_NA0008_256_28_20170926_00067.jpg

Additional rodent hole on the landside slope. Fall 2017.

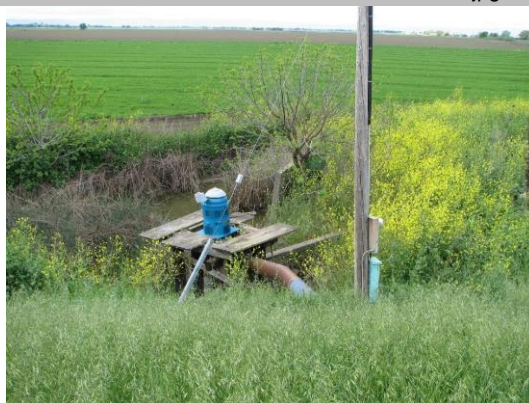
Photo 1 of 1 : UCIP_FA_2017_11067_18431.jpg

FS_ID:11067
DS_ID:19364
EP_NO: 9307
Repair Type: Non-Urgent
Crossing Status: Found
UCIP Comments: Siphon breaker on LS burried or broken off and missing.
FIELD_STRUCT_DESC: 1 of 2: 14-inch steel drainage pipe through the levee, 5.4 feet below the crown. Pump house on a pile structure at the landside (LS) toe. Siphon breaker on the LS slope. Service pole and anchor at the LS toe. (14-inch pipe [HLM 2.62] authorized under Automatic Board Order (ABO) issued as Permit No. 9307, 1974 - Azalene E. Lowe; a 12-foot section of an existing 14-inch pipe on LS replaced and name change under Permit No. 9307-1, 2016 - Ann Grube). [Additional Reference(s): DWR Levee Log, 1990. USACE Sacramento O&M Manual 127, June 1953, (Station 123+25)].
FS Date: 4/5/2013

Pump and pipe on LS toe.

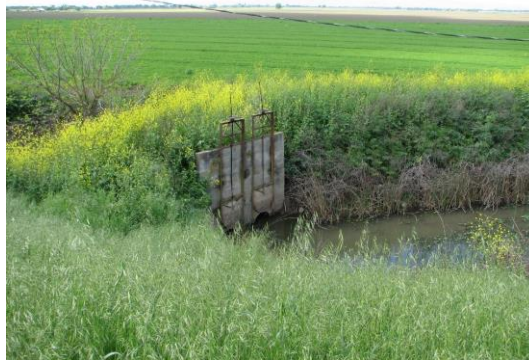
Photo 3 of 3 : UCIP_FA_2017_13205_21605.jpg

Comment Code						
Inspector Comment						
FS_ID:13205						
DS_ID:19391						
EP_NO: 9307						
Repair Type: Non-Urgent						
Crossing Status: Found						
UCIP Comments: Walkway to actuator slide gate is missing. No method of actuating slide gate.						
FIELD_STRUCT_DESC: 2 of 2: 48-inch by 48-inch reinforced concrete box drainage culvert through the levee, 23 feet below the crown.						
Walkway to slide gate on the waterside (WS) end. Concrete headwalls on both ends. Service pole and anchor at the landside (LS) toe.						
Concrete headwalls on both ends. (four foot by four foot culvert [HLM 2.62] authorized under Automatic Board Order (ABO) issued as Permit No. 9307, 1974 - Azalene E. Lowe). [Additional Reference(s): DWR Levee Log, 1990. USACE Sacramento O&M Manual 127, June 1953, (Station 123+55.5)].						
FS Date: 4/5/2013

Inlet located next to concrete headwall on LS toe.

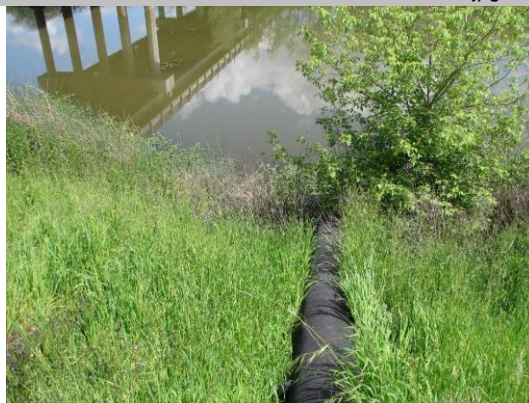
Photo 1 of 3 : UCIP_FA_2017_16105_27207.jpg

FS_ID:16105
DS_ID:19365
EP_NO: 9301
Repair Type: No Action Needed
Crossing Status: Found
UCIP Comments:
FIELD_STRUCT_DESC: 1 of 2: 18-inch steel drainage pipe through the levee, 6.4 feet below the crown. Siphon breaker on the waterside (WS) slope. Pump house mounted on concrete box in irrigation ditch at the landside (LS) toe. (one 18-inch and one 24-inch pipes [HLM 2.7] authorized under Automatic Board Order (ABO) issued as Permit No. 9301, 1974 - Reclamation District No. 730). [Additional Reference(s): DWR Levee Log, 1990. USACE Sacramento O&M Manual 127, June 1953, (Station 128+00)].
FS Date: 4/5/2013

Pipe on WS slope.

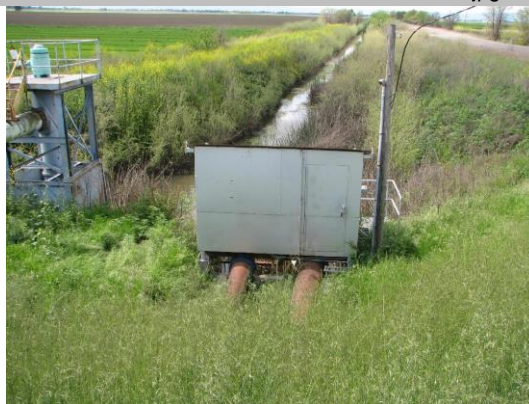
Photo 2 of 3 : UCIP_FA_2017_16105_27209.jpg

Pumphouse and pipe on LS toe.

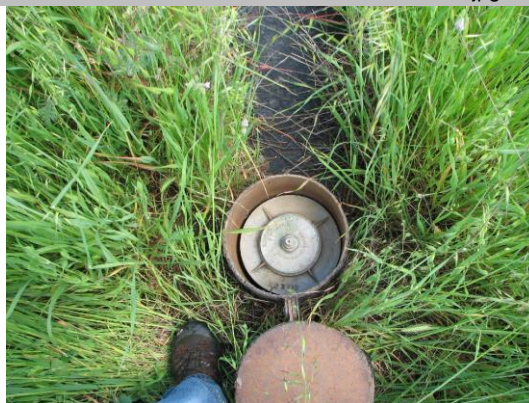
Photo 2 of 3 : UCIP_FA_2017_16106_27212.jpg

FS_ID:16106
DS_ID:19392
EP_NO: 9301
Repair Type: No Action Needed
Crossing Status: Found
UCIP Comments:
FIELD_STRUCT_DESC: 2 of 2: 24-inch steel drainage pipe through the levee, 7.3 feet below the crown. Pump house mounted on concrete box in irrigation ditch at the landside (LS) toe. Siphon breaker in riser on the waterside (WS) slope. (one 24-inch and one 18-inch pipes [HLM 2.7] authorized under Automatic Board Order (ABO) issued as Permit No. 9301, 1974 - Reclamation District No. 730). [Additional Reference(s): DWR Levee Log, 1990. USACE Sacramento O&M Manual 127, June 1953, (Station 128+00)].
FS Date: 4/5/2013

Siphon breaker on WS slope

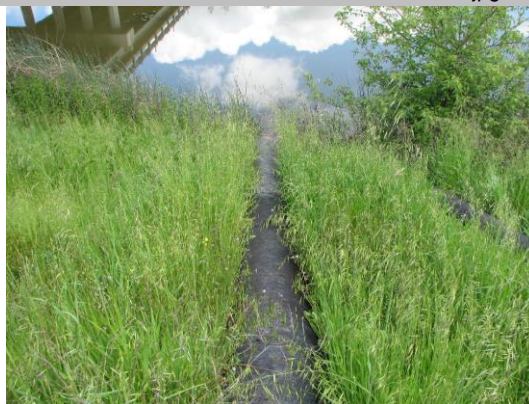
Photo 3 of 3 : UCIP_FA_2017_16106_27214.jpg

Pipe on WS slope.

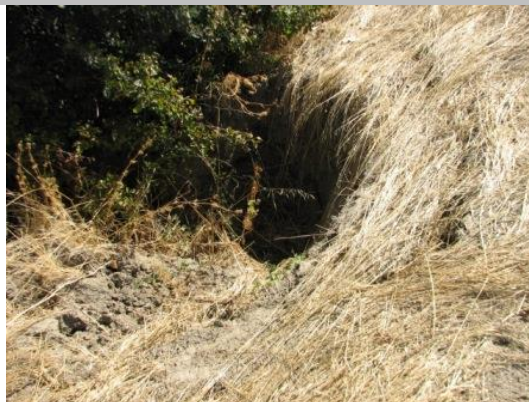
Photo 1 of 2 : FA_2017_NA0008_256_20_20170911_00006.jpg

LM Start	3.50	Rating **	U	Issue No.	20
LM End	3.50	Issue Type +	Ma	Location *	WS
Category	Earthen Levee			GPS Latitude/Longitude	
				Start	End
Item	Erosion / Bank Caving			38.759910 °	38.759910 °
				-121.696920 °	-121.696920 °
DWR ID	DWR_NA0008_01_f_2015_20				
Comment Code					
E2 : Schedule repair of erosion site prior to the next inspection.					
Inspector Comment

Deep erosion at the bottom of the waterside slope 3-4 foot cut. Fall 2013

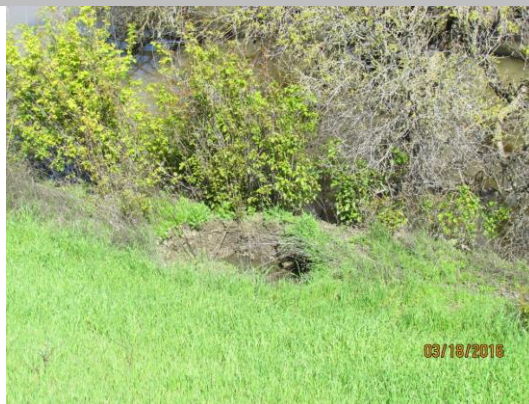
Photo 1 of 1 : FA_2017_NA0008_256_30_20170911_00012.jpg

LM Start	3.78	Rating **	M	Issue No.	30
LM End	3.78	Issue Type +	Ma	Location *	WS
Category	Earthen Levee			GPS Latitude/Longitude	
				Start	End
Item	Erosion / Bank Caving			38.762886 °	38.762886 °
				-121.700406 °	-121.700406 °
DWR ID	DWR_NA0008_01_s_2017_30				
Comment Code					
E2 : Schedule repair of erosion site prior to the next inspection.					
Inspector Comment					
Hole is at the toe of the levee on the waterward side.

View of the erosion at the toe of the levee on the waterward side. Spring 2016.

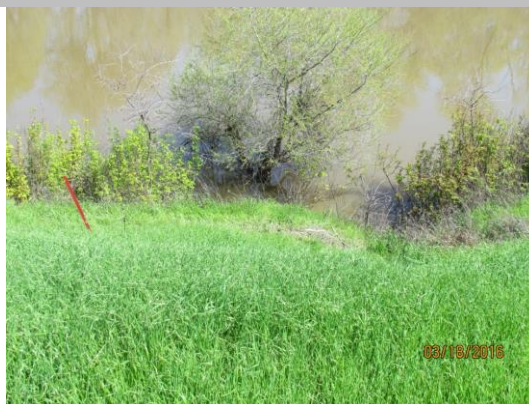
Photo 1 of 1 : FA_2017_NA0008_256_31_20170911_00013.jpg

LM Start	3.86	Rating **	M	Issue No.	31
LM End	3.86	Issue Type +	Ma	Location *	WS
Category	Earthen Levee			GPS Latitude/Longitude	
				Start	End
Item	Erosion / Bank Caving			38.763751 °	38.763751 °
				-121.701398 °	-121.701398 °
DWR ID	DWR_NA0008_01_s_2016_31				
Comment Code					
E1 : Note and monitor erosion site.					
Inspector Comment					
Erosion at the toe of the levee. LMA is monitoring erosion with stakes.

View of the erosion at the toe of the levee on the waterward side. Spring 2016.

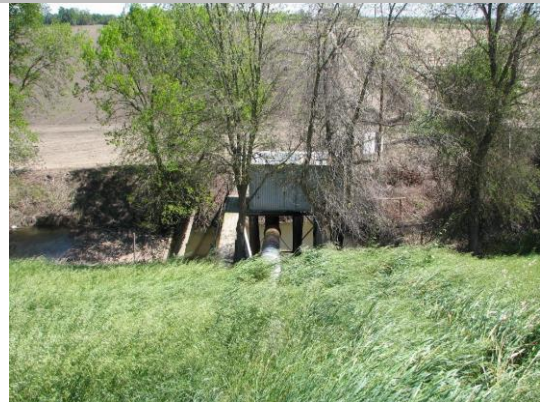
Photo 1 of 3 : UCIP_FA_2017_11293_18675.jpg

Comment Code					
Inspector Comment					
FS_ID:11293 DS_ID:19374 EP_NO: 9317 Repair Type: No Action Needed Crossing Status: Found UCIP Comments: FIELD_STRUCT_DESC: 1 of 2: 16-inch steel discharge pipe through the levee, 3 feet below the crown. Pump house on pile structure in drainage ditch on the landside (LS). Siphon breaker on the pipe on the waterside (WS). Service pole at the pump house. (16-inch pipe [HLM 3.97] authorized under Automatic Board Order (ABO) issued as Permit No. 9317, 1974 - Reclamation District No. 819). [Additional Reference(s): DWR Levee Log, 1990. USACE Sacramento O&M Manual 127, June 1953, (Station 211+05) (15-inch pipe listed)]. FS Date: 4/9/2013

Pump on LS toe.

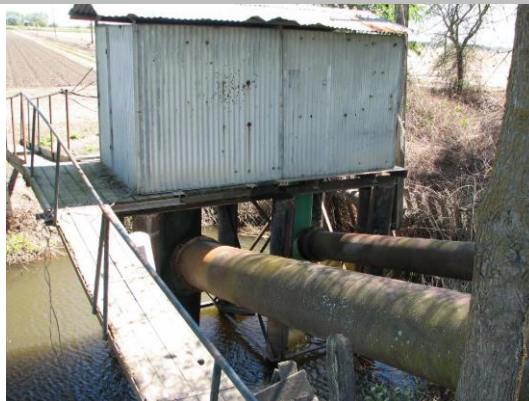
Photo 2 of 3 : UCIP_FA_2017_11293_18674.jpg

FS_ID:11293
DS_ID:19374
EP_NO: 9317
Repair Type: No Action Needed
Crossing Status: Found
UCIP Comments:
FIELD_STRUCT_DESC: 1 of 2: 16-inch steel discharge pipe through the levee, 3 feet below the crown. Pump house on pile structure in drainage ditch on the landside (LS). Siphon breaker on the pipe on the waterside (WS). Service pole at the pump house. (16-inch pipe [HLM 3.97] authorized under Automatic Board Order (ABO) issued as Permit No. 9317, 1974 - Reclamation District No. 819). [Additional Reference(s): DWR Levee Log, 1990. USACE Sacramento O&M Manual 127, June 1953, (Station 211+05) (15-inch pipe listed)].
FS Date: 4/9/2013

Pump and pipes on LS toe.

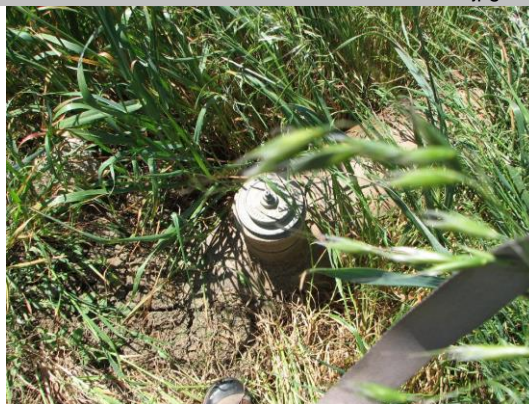
Photo 3 of 3 : UCIP_FA_2017_11293_18673.jpg

16-inch pipe with siphon breaker on WS shoulder.

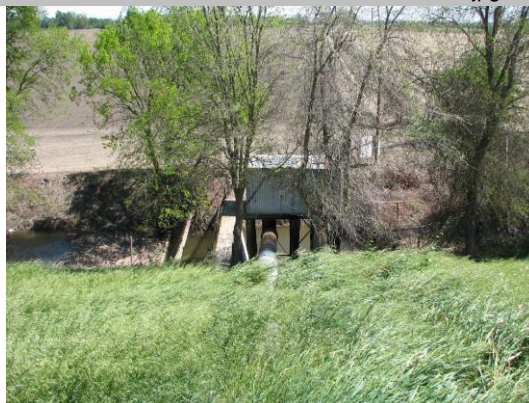
Photo 1 of 3 : UCIP_FA_2017_11291_18669.jpg

LM Start	3.94	Rating **	A/W	Issue No.	30
LM End	3.94	Issue Type +	Ma	Location *	
Category	Supplemental			GPS Latitude/Longitude	
				Start	End
Item	DWR UCIP LMA Responsibility			38.770335 °	38.770335 °
				-121.701286 °	-121.701286 °
DWR ID					
Comment Code					
Inspector Comment					
FS_ID:11291 DS_ID:19401 EP_NO: 9317 Repair Type: No Action Needed Crossing Status: Found UCIP Comments: FIELD_STRUCT_DESC: 2 of 2: 24-inch steel discharge pipe through the levee, 9 feet below the crown. Pump house on pile structure in drainage ditch on the landside (LS). Siphon breaker on the pipe on the waterside (WS) with a butterfly shutoff valve. Service pole at the pump house. (Permit No. 9317, 1974 - Reclamation District No. 819). Pipe replaced in 2012. [Additional Reference(s): DWR Levee Log, 1990. USACE Sacramento O&M Manual 127, June 1953, (Station 210+99)]. FS Date: 4/9/2013

Pumphouse at LS toe.

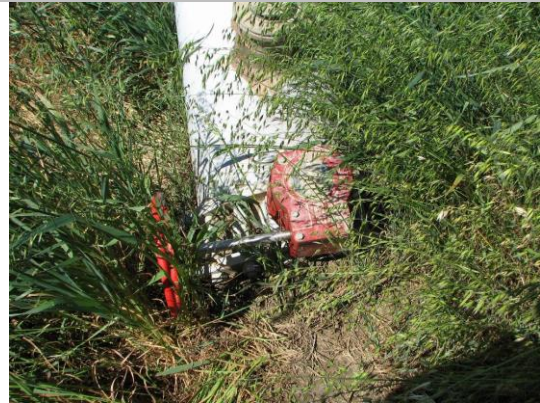
Photo 3 of 3 : UCIP_FA_2017_11291_18667.jpg

LM Start	3.94	Rating **	A/W	Issue No.	30 (cont)	
LM End	3.94	Issue Type +	Ma	Location *		
Category	Supplemental			GPS Latitude/Longitude		
				Start	End	
Item	DWR UCIP LMA Responsibility			38.770335 °	38.770335 °	
				-121.701286 °	-121.701286 °	
DWR ID						
Comment Code						
Inspector Comment						
FS_ID:11291 DS_ID:19401 EP_NO: 9317 Repair Type: No Action Needed Crossing Status: Found UCIP Comments: FIELD_STRUCT_DESC: 2 of 2: 24-inch steel discharge pipe through the levee, 9 feet below the crown. Pump house on pile structure in drainage ditch on the landside (LS). Siphon breaker on the pipe on the waterside (WS) with a butterfly shutoff valve. Service pole at the pump house. (Permit No. 9317, 1974 - Reclamation District No. 819). Pipe replaced in 2012. [Additional Reference(s): DWR Levee Log, 1990. USACE Sacramento O&M Manual 127, June 1953, (Station 210+99)]. FS Date: 4/9/2013

Siphon breaker and butterfly valve on WS shoulder.

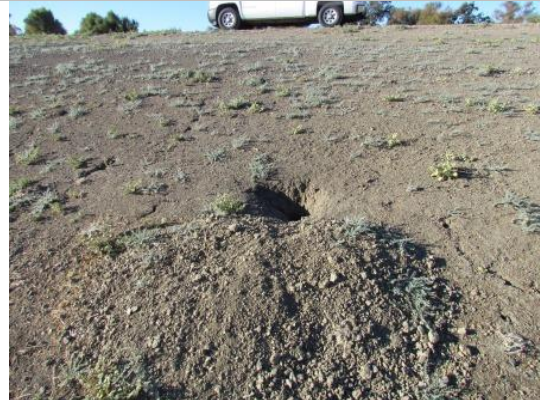
Photo 1 of 1 : FA_2017_NA0008_257_13_20170911_00002.jpg

LM Start	5.34	Rating **	A/W	Issue No.	13
LM End	5.34	Issue Type +	Ma	Location *	LS
Category	Earthen Levee			GPS Latitude/Longitude	
				Start	End
Item	Animal Control			38.786504 °	38.786504 °
				-121.716261 °	-121.716261 °
DWR ID	DWR_NA0008_02_f _ 2017_13				
Comment Code					
A3 : No rodents visible, but rodent burrows visible; need to backfill and compact or grout burrows.					
Inspector Comment

View of a rodent hole on LS slope. Fall 2016.
