**Flood Control Project Maintenance
Levee Inspections**

Maintenance Issue Types Only, Levee Inspection Report By Mile - Fall 2019

Knights Landing Ridge Drainage District

Waterway	Bank	Unit Miles	Inspection Start/End	Inspector
Unit No. 01 Knights Landing Ridge Cut	Right	6.36	10/01/2019 10/01/2019	Zach Jojola

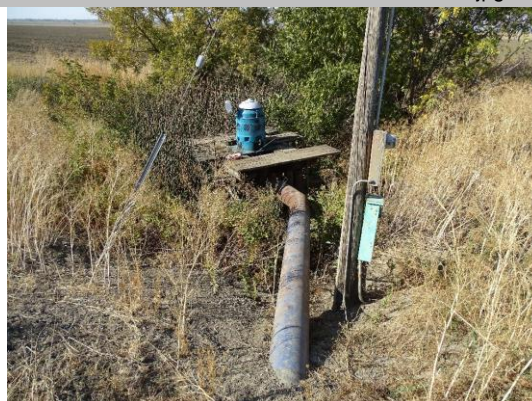
Photo 1 of 3 : UCIP_FA_2019_55698_82444.jpg

DS_ID:19364
FS_ID:55698
EP_NO: 9307
Repair Type: Non-Urgent
Crossing Status: Found
UCIP Comments: 10/08/2019 Siphon breaker not found on LS slope. Pipe outlet not found on WS. Work under permit 9307-1 not started. (O.Yakimov - DWR UCIP)04/05/2013 Siphon breaker on LS buried or broken off and missing.
FIELD_STRUCT_DESC: 1 of 2: 14-inch steel drainage pipe through the levee, 5.4 feet below the crown. Pump house on a pile structure at the landside (LS) toe. Siphon breaker on the LS slope. Service pole and anchor at the LS toe. (14-inch pipe [HLM 2.62] authorized under Automatic Board Order (ABO) issued as Permit No. 9307, 1974 - Azalene E. Lowe; a 12-foot section of an existing 14-inch pipe on LS replaced and name change under Permit No. 9307-1, 2016 - Ann Grube). [Additional Reference(s): DWR Levee Log, 1990. USACE Sacramento O&M Manual 127, June 1953, (Station 123+25)].
FS Date: 10/8/2019 8:30:25 AM

View of LS looking from levee crown

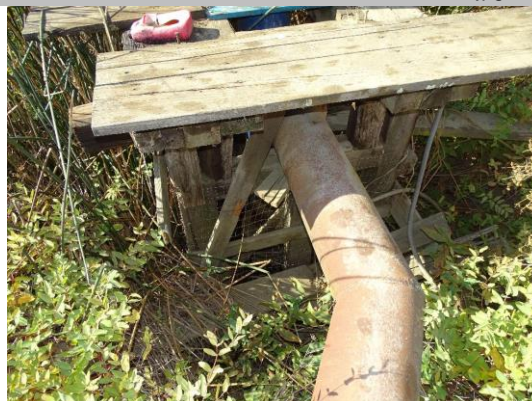
Photo 2 of 3 : UCIP_FA_2019_55698_82445.jpg

Pumping platform on pile structure

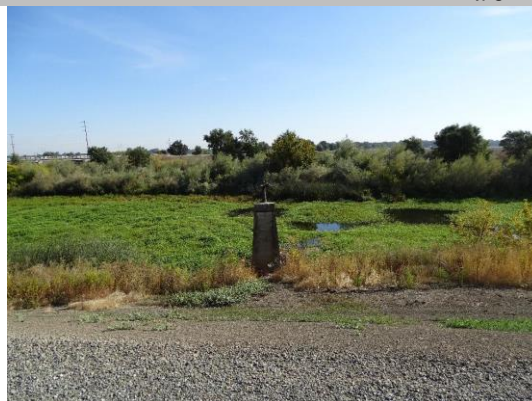
Photo 2 of 3 : UCIP_FA_2019_55708_82488.jpg

Comment Code						
Inspector Comment						
DS_ID:19391						
FS_ID:55708						
EP_NO: 9307						
Repair Type: Non-Urgent						
Crossing Status: Found						
UCIP Comments: 10/08/2019 Slide gate actuator is not accessible without use of equipment. (O.Yakimov - DWR UCIP)04/05/2013						
Walkway to actuator slide gate is missing. No method of actuating slide gate.						
FIELD_STRUCT_DESC: 2 of 2: 48-inch by 48-inch reinforced concrete box drainage culvert through the levee, 23 feet below the crown.						
Walkway to slide gate on the waterside (WS) end. Concrete headwalls on both ends. Service pole and anchor at the landside (LS) toe.						
Concrete headwalls on both ends. (four foot by four foot culvert [HLM 2.62] authorized under Automatic Board Order (ABO) issued as Permit No. 9307, 1974 - Azalene E. Lowe). [Additional Reference(s): DWR Levee Log, 1990. USACE Sacramento O&M Manual 127, June 1953, (Station 123+55.5)].

View of WS looking from levee crown

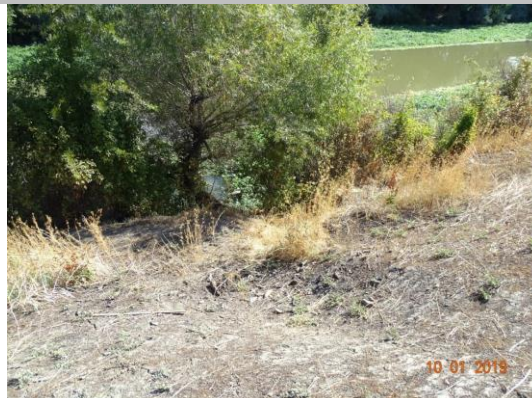
Photo 1 of 2 : FA_2019_NA0008_256_31_20191001_00039.jpg

LM Start	3.86	Rating **	M	Issue No.	31
LM End	3.86	Issue Type +	Ma	Location *	WS
Category	Earthen Levee			GPS Latitude/Longitude	
				Start	End
Item	Erosion / Bank Caving			38.763751°	38.763751°
				-121.701398°	-121.701398°
DWR ID	DWR_NA0008_01_s_2018_31				
Comment Code					
E1 : Note and monitor erosion site.					
Inspector Comment					
The erosion appears to be stable. LMA continues to monitor.

View of the erosion at the waterside toe. Fall 2019.

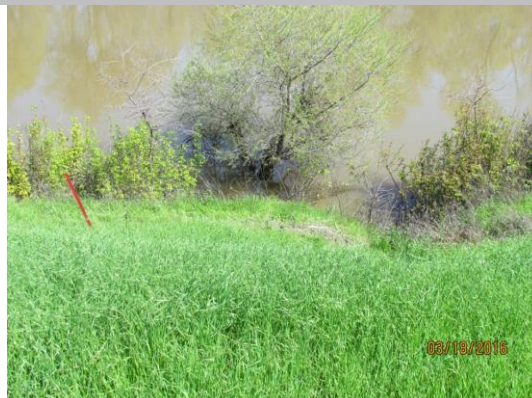
Photo 2 of 2 : FA_2019_NA0008_256_31_20190829_00010.jpg

View of the erosion at the toe of the levee on the waterward side. Spring 2016.

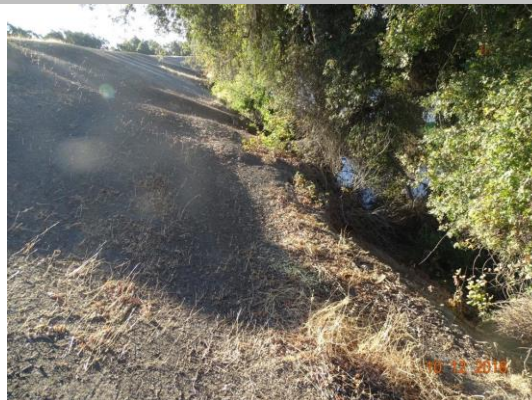
Photo 1 of 2 : FA_2019_NA0008_257_9_20190829_00003.jpg

View of the erosion on the waterside slope. Fall 2018.

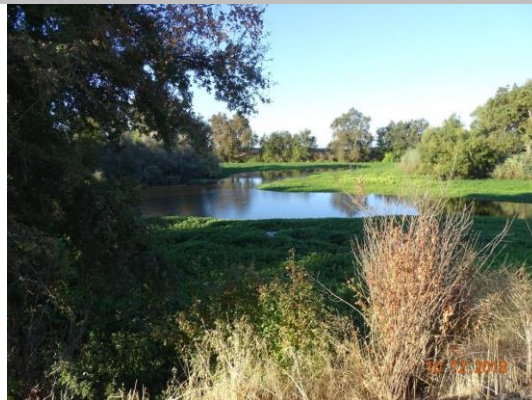
Photo 2 of 2 : FA_2019_NA0008_257_9_20190829_00004.jpg

View of the opening within the center channel. Fall 2018.

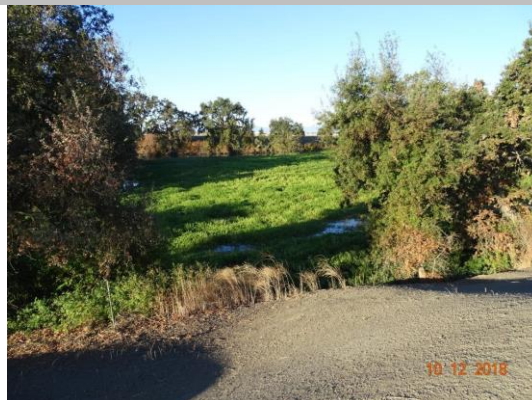
Photo 2 of 2 : FA_2019_NA0008_257_14_20190829_00006.jpg

View of the opening within the main channel, facing upstream. Fall 2018.

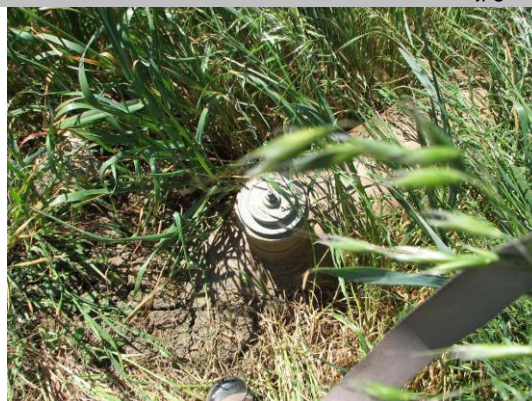
Photo 3 of 3 : UCIP_FA_2019_11293_18673.jpg

Comment Code						
Inspector Comment						
DS_ID:19374 FS_ID:11293 EP_NO: 9317 Repair Type: No Action Needed Crossing Status: Found UCIP Comments: 01/14/2019 Pipe has been replaved with a 16-inch pipe under permit 9317-1; new DS-ID 25571. (O.Yakimov - DWR UCIP) FIELD_STRUCT_DESC: *REMOVED* 1 of 2: 16-inch steel discharge pipe through the levee, 3 feet below the crown. Pump house on pile structure in drainage ditch on the landside (LS). Siphon breaker on the pipe on the waterside (WS). Service pole at the pump house. (16-inch pipe [HLM 3.97] authorized under Automatic Board Order (ABO) issued as Permit No. 9317, 1974 - Reclamation District No. 819). [Additional Reference(s): DWR Levee Log, 1990. USACE Sacramento O&M Manual 127, June 1953, (Station 211+05) (15-inch pipe listed)]. FS Date: 4/9/2013

16-inch pipe with siphon breaker on WS shoulder.
