**Flood Control Project Maintenance  
Levee Inspections**

**Maintenance Issue Types Only, Levee Inspection Report By Mile - Fall 2020**

**Knights Landing Ridge Drainage District**

Waterway	Bank	Unit Miles	Inspection Start/End	Inspector
Unit No. 01 Knights Landing Ridge Cut	Right	6.36	09/17/2020 09/17/2020	Zach Jojola

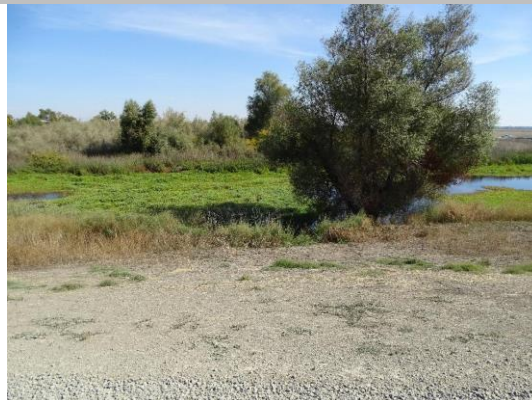
Photo 1 of 3 : UCIP\_FA\_2020\_55381\_81599.jpg

Comment Code					
Inspector Comment					
DS_ID:19360 FS_ID:55381 EP_NO: 9302 Repair Type: Non-Urgent EVAL Issue: Maintenance Compliance Issue Crossing Status: Found UCIP Comments: 10/8/2019 Record updated from No Action Needed to Non-Urgent. Concrete distribution box on LS toe has been removed. Slide gate with its metal stand debris should be removed from the channel. Pipe has been grouted in 2015 under Permit 18987. (O.Yakimov - DWR UCIP) 12/07/2018 Need updated photos to show proper pipe abandonment. Update Part VI, 1. Pipe Section to remove part c and e. If crossing was abandoned properly crossing will need to be removed from the LMA responsibility list. (O. Magana - DWR UCIP)05/16/2016 Pipe has been grouted in place under permit 18987, 2015. (T. Hatch - DWR UCIP)04/05/2013 Pipe completely rusted through on LS slope of levee at toe/headwall of concrete distribution box. Pipe needs replacement or proper abandonment. Pipe not visible at outlet. (W. Wylie - DWR UCIP) FIELD_STRUCT_DESC: *ABANDONED* 36-inch corrugated metal drainage pipe through the levee, 27 feet below the crown. Slide gate on the waterside (WS) end. 12-foot by 6-foot concrete box on the landside (LS) end. (36-inch pipe [HLM 1.62] authorized under Automatic Board Order (ABO) issued as Permit No. 9302, 1974 - Barbara Lowe Elliott; 36-inch pipe abandoned by removing ends and pumping pipe full of concrete under Permit No. 18987, 2016 - Knaggs Ranch, LLC, care of John Brennan). [Additional Reference(s): DWR Levee Log, 1990. USACE Sacramento O&M Manual 127, June 1953, (Station 0+30)]. FS Date: 10/8/2019 2:41:37 PM

View of WS looking from crown

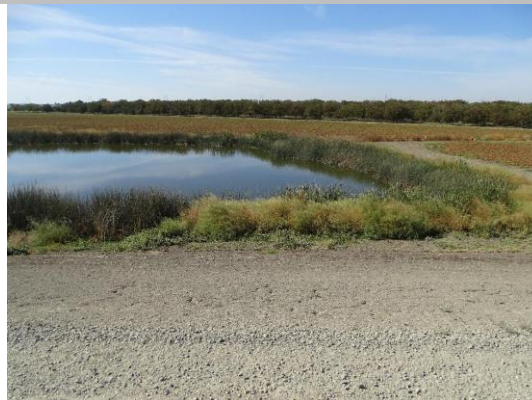
Photo 2 of 3 : UCIP\_FA\_2020\_55381\_81600.jpg

Concrete distribution box on LS toe

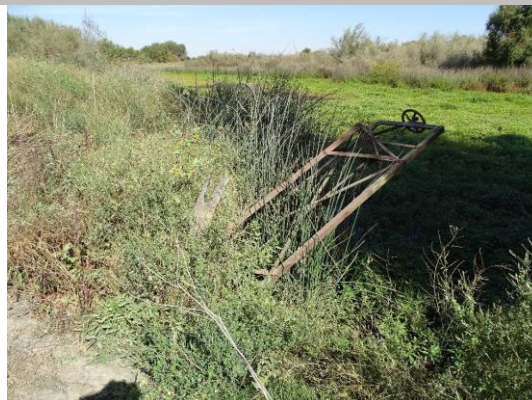
Photo 3 of 3 : UCIP\_FA\_2020\_55381\_81601.jpg

Slide gate on metal stand on WS toe needs removal

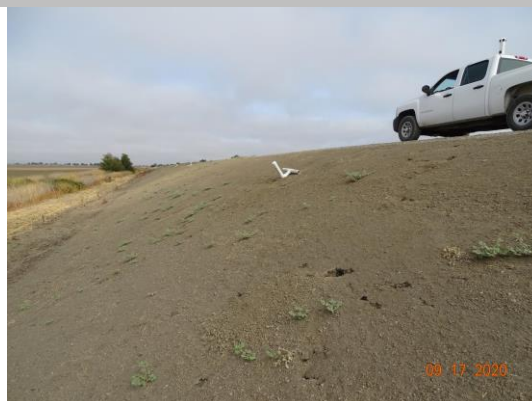
Photo 1 of 1 : FA\_2020\_NA0008\_256\_23\_20200928\_00046.jpg

LM Start	1.70	Rating **	M	Issue No.	23
LM End	1.70	Issue Type +	Ma	Location *	LS
Category	Earthen Levee			GPS Latitude/Longitude	
				Start	End
Item	Animal Control			38.736695 °	-121.685246 °
				-121.685246 °	-121.685246 °
DWR ID	DWR_NA0008_01_f_2020_23				
Comment Code					
A3 : No rodents visible, but rodent burrows visible; need to backfill and compact or grout burrows.					
Inspector Comment					
Rodent holes on the landside slope.

View of rodent holes on the landside slope. Fall 2020.

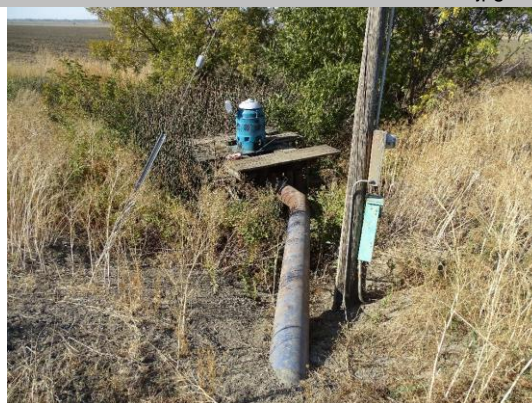
Photo 1 of 3 : UCIP\_FA\_2020\_55698\_82444.jpg

Comment Code						
Inspector Comment						
DS_ID:19364 FS_ID:55698 EP_NO: 9307 Repair Type: Non-Urgent EVAL Issue: Maintenance Compliance Issue Crossing Status: Found UCIP Comments: 0/08/2019 Record remains Non-Urgent, due to maintenance issue. Siphon breaker not found on LS slope: can be burried or broken off. Pipe outlet not found on WS. CVFPB is working with current owner to approve the removal and replacement of existing 14-inch pipe under draft Permit 9307-1. Work under permit 9307-1 not started. (O.Yakimov - DWR UCIP) 04/05/2013 Siphon breaker on LS burried or broken off and missing. (W.Wylie - DWR UCIP) FIELD_STRUCT_DESC: 14-inch steel drainage pipe through the levee, 5.4 feet below the crown. Pump house on a pile structure at the landside (LS) toe. Siphon breaker on the LS slope. Service pole and anchor at the LS toe. (14-inch pipe [HLM 2.62] authorized under Automatic Board Order (ABO) issued as Permit No. 9307, 1974 - Azalene E. Lowe; a 12-foot section of an existing 14-inch pipe on LS scheduled to be replaced and name change under DRAFT Permit No. 9307-1, 2016 - Ann Grube). [Additional Reference(s): DWR Levee Log, 1990. USACE Sacramento O&M Manual 127, June 1953, (Station 123+25)]. FS Date: 10/8/2019 8:30:25 AM

View of LS looking from levee crown

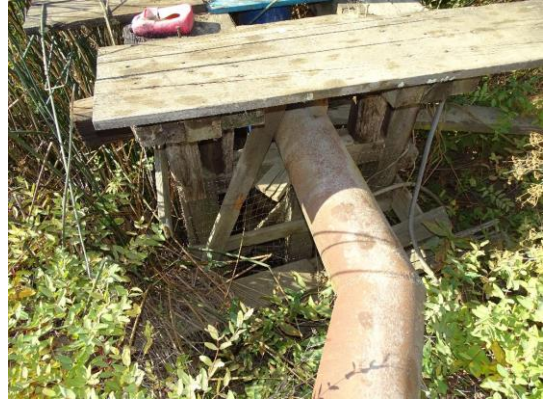
Photo 2 of 3 : UCIP\_FA\_2020\_55698\_82445.jpg

Pumping platform on pile structure

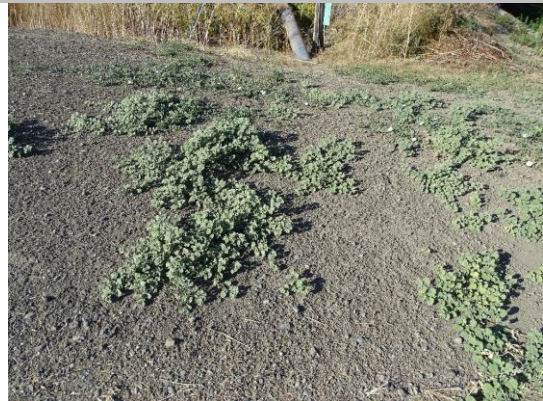
Photo 3 of 3 : UCIP\_FA\_2020\_55698\_82446.jpg

Not found siphon breaker on LS slope

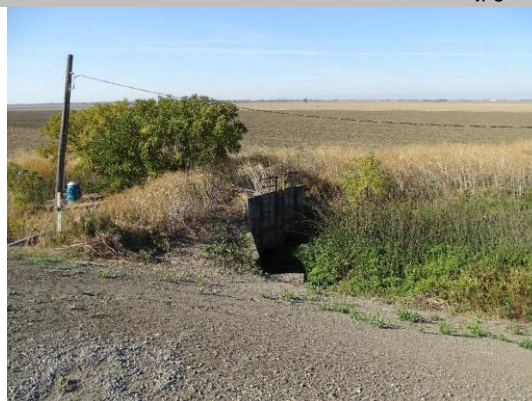
Photo 1 of 3 : UCIP\_FA\_2020\_55708\_82487.jpg

Comment Code					
Inspector Comment					
DS_ID:19391 FS_ID:55708 EP_NO: 9307 Repair Type: Non-Urgent EVAL Issue: Maintenance Compliance Issue Crossing Status: Found UCIP Comments: 10/8/2019 Record remains Non-Urgent. slide gate actuator is not accessible without use of equipment. Need to have CVFPB review ABO and determine current owner. (O.Yakimov - DWR UCIP) 04/05/2013 Walkway to actuator slide gate is missing. No method of actuating slide gate. (W.Wylie - DWR UCIP) FIELD_STRUCT_DESC: 48-inch by 48-inch reinforced concrete box drainage culvert through the levee, 23 feet below the crown. Walkway to slide gate on the waterside (WS) end. Concrete headwalls on both ends. Service pole and anchor at the landside (LS) toe. Concrete headwalls on both ends. (four foot by four foot culvert [HLM 2.62] authorized under Automatic Board Order (ABO) issued as Permit No. 9307, 1974 - Azalene E. Lowe). [Additional Reference(s): DWR Levee Log, 1990. USACE Sacramento O&M Manual 127, June 1953, (Station 123+55.5)]. FS Date: 10/8/2019 10:14:53 AM

View of LS looking from levee crown

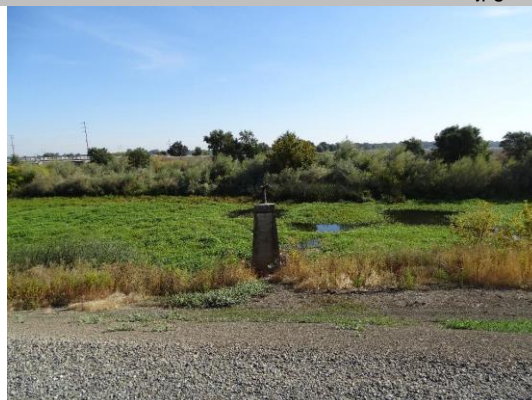
Photo 2 of 3 : UCIP\_FA\_2020\_55708\_82488.jpg

View of WS looking from levee crown

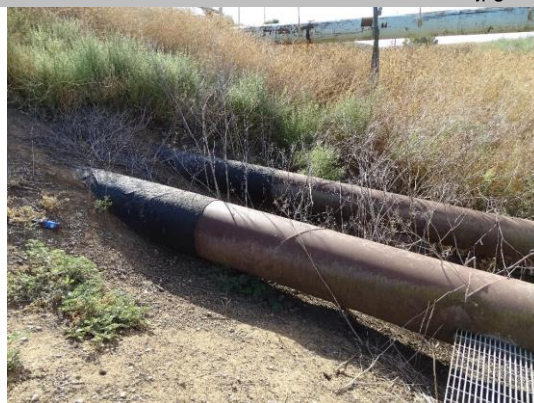
Photo 2 of 3 : UCIP\_FA\_2020\_55711\_82499.jpg

View of pipe on WS slope

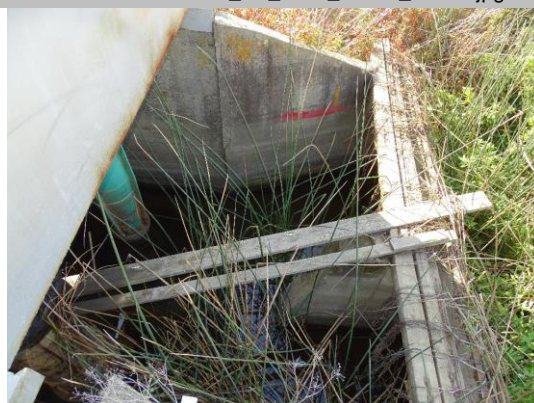
Photo 3 of 3 : UCIP\_FA\_2020\_55711\_82500.jpg

Concrete sump at pumping house

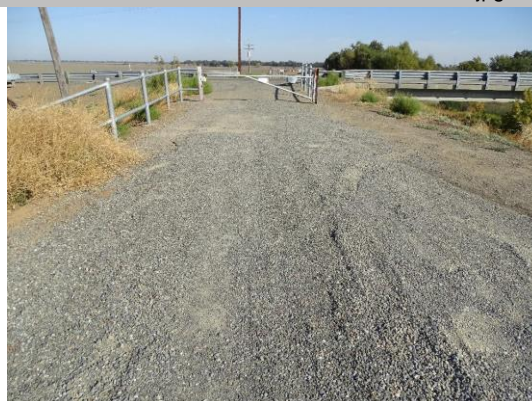
Photo 1 of 3 : UCIP\_FA\_2020\_55712\_82512.jpg

DS\_ID:19392  
 FS\_ID:55712  
 EP\_NO: 9301  
 Repair Type: Non-Urgent  
 EVAL Issue: Unauthorized Encroachment, installed decades prior  
 Crossing Status: Found  
 UCIP Comments: 10/8/2019 Record updated from No Action Needed to Non-Urgent. Need to have CVFPB review ABO and determine current owner. (O.Yakimov - DWR UCIP)  
 FIELD\_STRUCT\_DESC: 2 of 2: 24-inch steel drainage pipe through the levee, 7.3 feet below the crown. Pump house mounted on concrete box in irrigation ditch at the landside (LS) toe. Siphon breaker in riser on the waterside (WS) slope. (one 24-inch and one 18-inch pipes [HLM 2.7] authorized under Automatic Board Order (ABO) issued as Permit No. 9301, 1974 - Reclamation District No. 730). [Additional Reference(s): DWR Levee Log, 1990. USACE Sacramento O&M Manual 127, June 1953, (Station 128+00)].  
 FS Date: 10/8/2019 1:07:27 PM

View of levee crown at the crossing

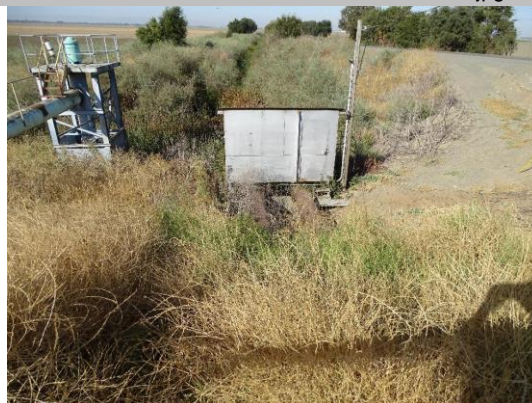
Photo 2 of 3 : UCIP\_FA\_2020\_55712\_82514.jpg

Pumphouse and pipe on LS toe

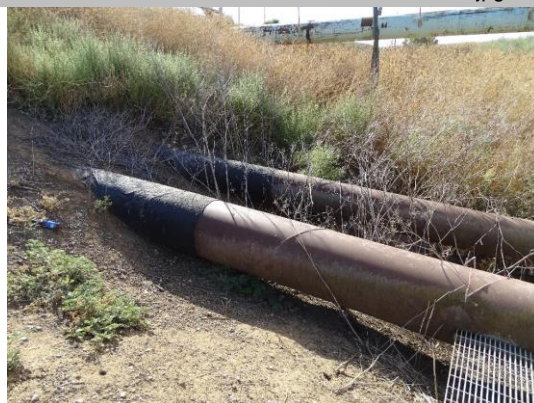
Photo 3 of 3 : UCIP\_FA\_2020\_55712\_82515.jpg

View of pipe on WS slope

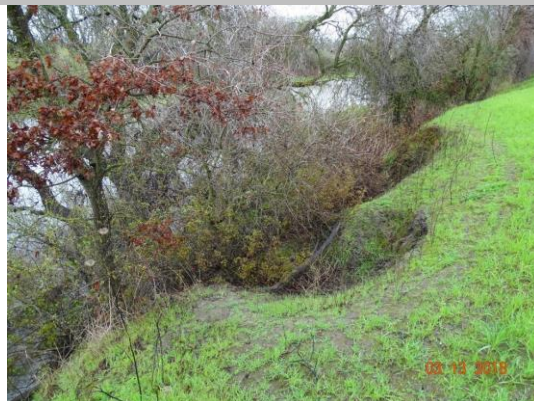
Photo 1 of 1 : FA\_2020\_NA0008\_256\_20\_20200813\_00003.jpg

LM Start	3.50	Rating **	M	Issue No.	20
LM End	3.50	Issue Type +	Ma	Location *	WS
Category	Earthen Levee			GPS Latitude/Longitude	
				Start	End
Item	Erosion / Bank Caving			38.759910 °	38.759910 °
				-121.696920 °	-121.696920 °
DWR ID	DWR_NA0008_01_f_2015_20				
Comment Code					
E2 : Schedule repair of erosion site prior to the next inspection.					
Inspector Comment

View of erosion on the waterside slope. Spring 2018.

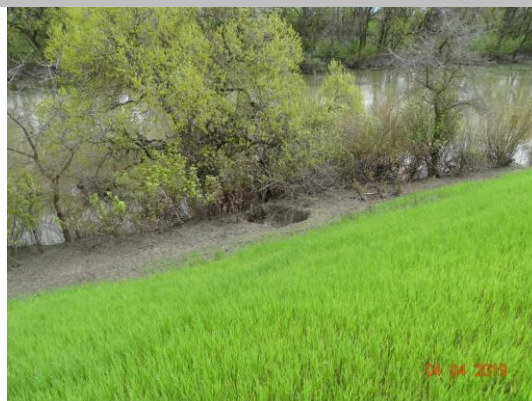
Photo 1 of 1 : FA\_2020\_NA0008\_256\_30\_20200813\_00008.jpg

LM Start	3.78	Rating **	M	Issue No.	30
LM End	3.78	Issue Type +	Ma	Location *	WS
Category	Earthen Levee			GPS Latitude/Longitude	
				Start	End
Item	Erosion / Bank Caving			38.762886 °	38.762886 °
				-121.700406 °	-121.700406 °
DWR ID	DWR_NA0008_01_s_2017_30				
Comment Code					
E2 : Schedule repair of erosion site prior to the next inspection.					
Inspector Comment					
There is a hole from a fallen tree at the waterside toe.

View of hole at the waterside toe. Spring 2019.

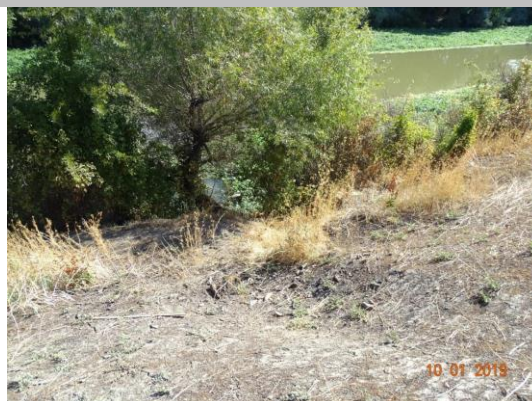
Photo 1 of 2 : FA\_2020\_NA0008\_256\_31\_20200813\_00009.jpg

LM Start	3.86	Rating **	A/W	Issue No.	31
LM End	3.86	Issue Type +	Ma	Location *	WS
Category	Earthen Levee			GPS Latitude/Longitude	
				Start	End
Item	Erosion / Bank Caving			38.763751 °	38.763751 °
				-121.701398 °	-121.701398 °
DWR ID	DWR_NA0008_01_s_2018_31				
Comment Code					
E1 : Note and monitor erosion site.					
Inspector Comment					
The erosion appears to be stable. LMA continues to monitor.

View of the erosion at the waterside toe. Fall 2019.

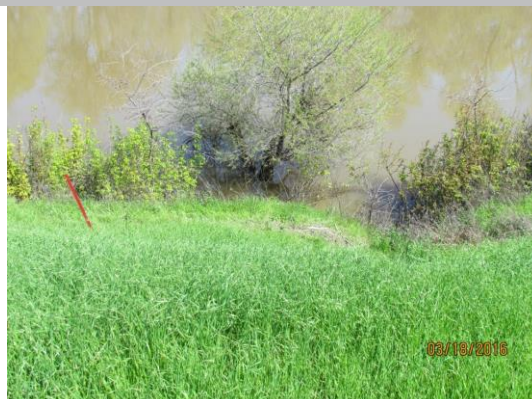
Photo 2 of 2 : FA\_2020\_NA0008\_256\_31\_20200813\_00010.jpg

View of the erosion at the toe of the levee on the waterward side. Spring 2016.

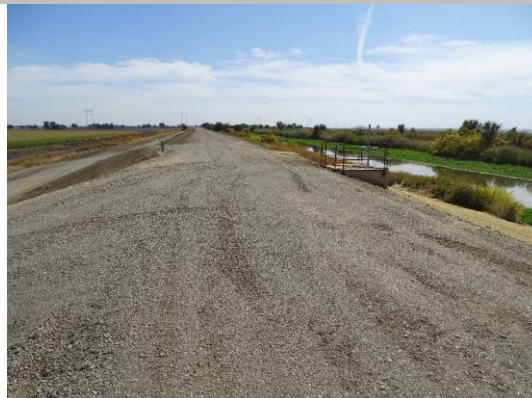
Photo 1 of 3 : UCIP\_FA\_2020\_55761\_82744.jpg

Comment Code						
Inspector Comment						
DS_ID:19399 FS_ID:55761 EP_NO: 9320 Repair Type: Non-Urgent EVAL Issue: Unauthorized Encroachment, installed decades prior Crossing Status: Found UCIP Comments: 10/08/2019 Record updated from No Action Needed to Non-Urgent. Pipe though levee has been replaced as part of the Knights Landing 2015 Levee Repair Project. A concrete box with slide gate was constructed on WS shoulder, a concrete pad with electrical wiring installed at LS toe, pipe inlet on LS is modified and revetted. New flap gate at WS end. Need to have CVFPB review ABO and determine current owner. Encroachment permit is missing. No details provided from Levee Improvement Project. (O.Yakimov - DWR UCIP) FIELD_STRUCT_DESC: *REMOVED & REPLACED with DSID 25597* 24-inch steel drainage pipe through the levee, 21 feet below the crown. Slide gate on the waterside (WS) end. Open on the landside (LS) end. LS toe cobble revetted. Service pole on the LS slope. (24-inch pipe [HLM 1.9] authorized under Automatic Board Order (ABO) issued as Permit No. 9320, 1974 - Ralph W. Pollock). [Additional Reference(s): DWR Levee Log, 1990. USACE Sacramento O&M Manual 127, June 1953, (Station 103+21.8)]. FS Date: 10/8/2019 2:13:30 PM

View of levee crown at the crossing

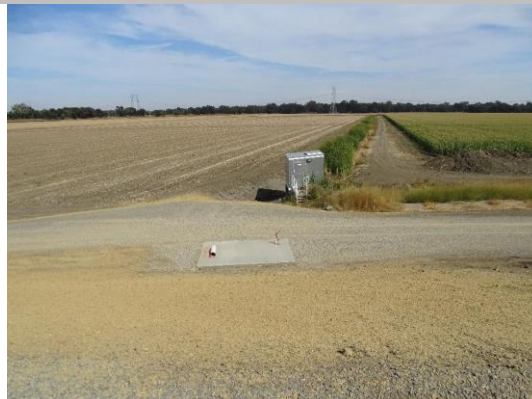
Photo 2 of 3 : UCIP\_FA\_2020\_55761\_82749.jpg

View of LS looking from levee crown

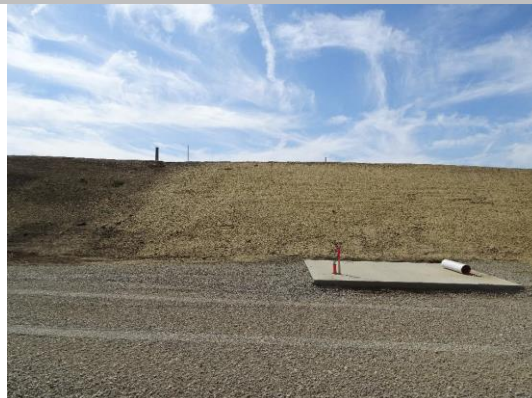
Photo 3 of 3 : UCIP\_FA\_2020\_55761\_82746.jpg

Concrete pad with electrical wiring at LS levee toe

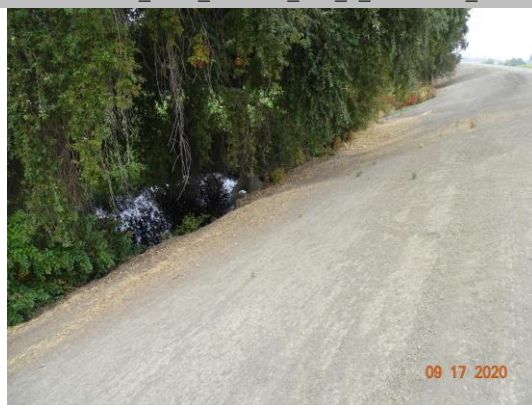
Photo 1 of 1 : FA\_2020\_NA0008\_257\_9\_20200928\_00047.jpg

LM Start	<b>2.72</b>	Rating **	A/W	Issue No.	<b>8</b>
LM End	<b>2.93</b>	Issue Type +	Ma	Location *	WS
Category	Supplemental		GPS Latitude/Longitude		
			Start	End	
Item	2017 USACE Erosion Survey		38.754899 °	38.757925 °	
			-121.692653 °	-121.693048 °	
DWR ID	DWR_NA0008_02_f_2018_8				
Comment Code					
Inspector Comment					
DWR Inspector Comment: Opening in center channel berm causing erosion near waterside toe. Recommend monitoring.					
2017 Site ID: KLR 3.0 L Status: Eroding 2017 Field Notes: Access Issues - Could not observe Site History: 2006 - The whole levee toe area is slowly slumping into the channel (creep) due to dewatering and poor slope soils. Occasional piping in the levee slope evident as well. Pistol-butted trees at the levee toe indicate slow retreat. 2011 - Multiple scallops throughout the site and slumping of the toe.

View of the erosion on the waterside slope. Fall 2020.

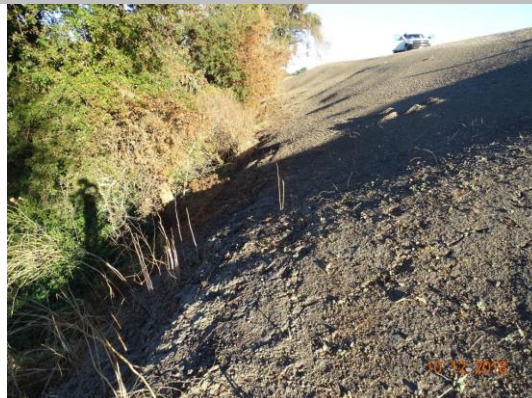
Photo 1 of 2 : FA\_2020\_NA0008\_257\_14\_20200813\_00005.jpg

View of erosion on the waterside slope. Fall 2018.

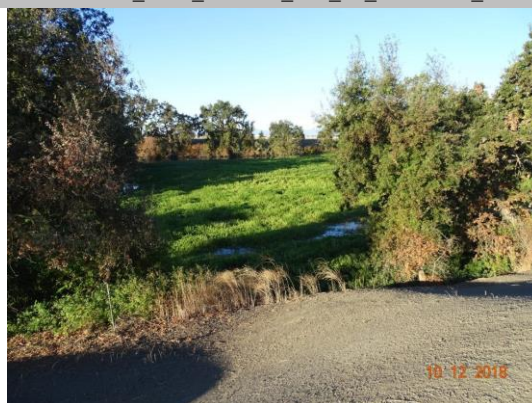
Photo 2 of 2 : FA\_2020\_NA0008\_257\_14\_20200813\_00006.jpg

View of the opening within the main channel, facing upstream. Fall 2018.

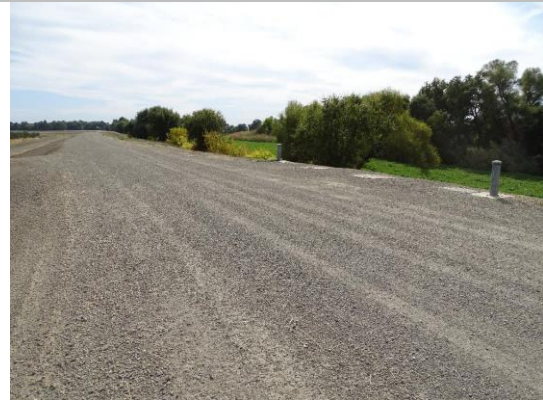
Photo 1 of 3 : UCIP\_FA\_2020\_55749\_82670.jpg

View of levee crown at the crossing

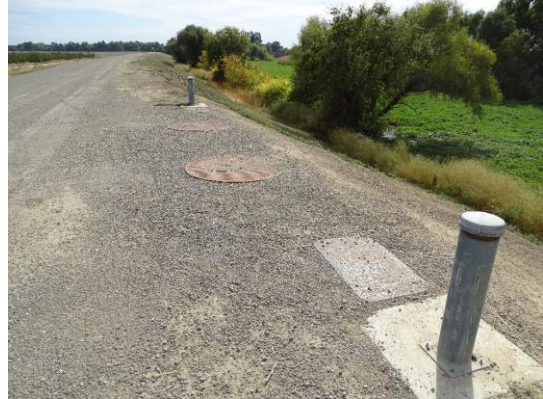
Photo 2 of 3 : UCIP\_FA\_2020\_55749\_82671.jpg

Siphon breaker and positive closure device on WS shoulder

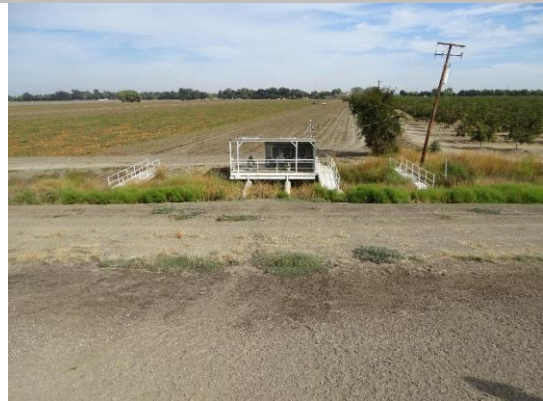
Photo 3 of 3 : UCIP\_FA\_2020\_55749\_82672.jpg

View of LS looking from levee crown

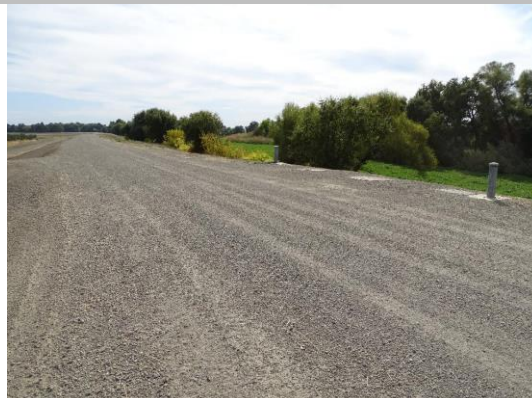
Photo 1 of 3 : UCIP\_FA\_2020\_54351\_82677.jpg

View of levee crown at the crossing

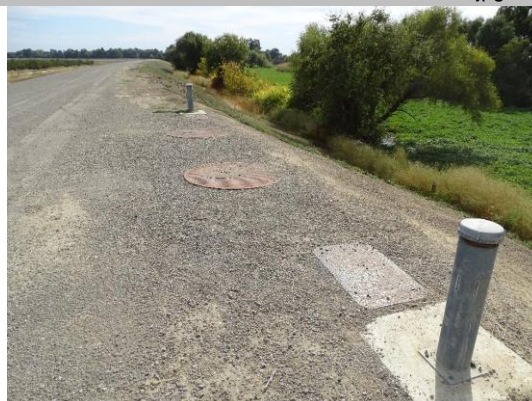
Photo 2 of 3 : UCIP\_FA\_2020\_54351\_82678.jpg

Siphon breaker and positive closure device on WS shoulder

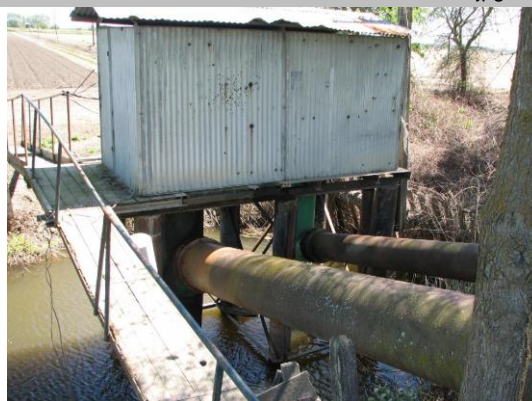
Photo 2 of 3 : UCIP\_FA\_2020\_11293\_18674.jpg

Pump and pipes on LS toe.

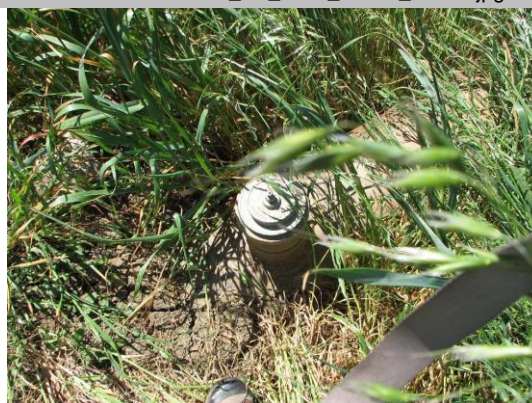
Photo 3 of 3 : UCIP\_FA\_2020\_11293\_18673.jpg

16-inch pipe with siphon breaker on WS shoulder.

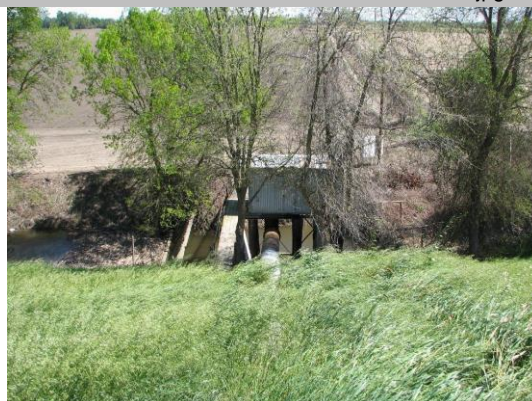
Photo 1 of 3 : UCIP\_FA\_2020\_11291\_18669.jpg

Pumphouse at LS toe.

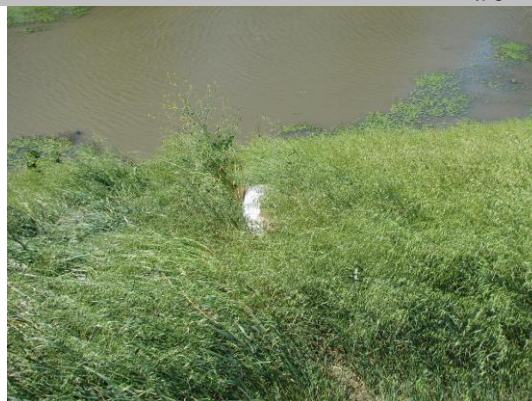
Photo 2 of 3 : UCIP\_FA\_2020\_11291\_18668.jpg

Pipe in grass on WS shoulder.

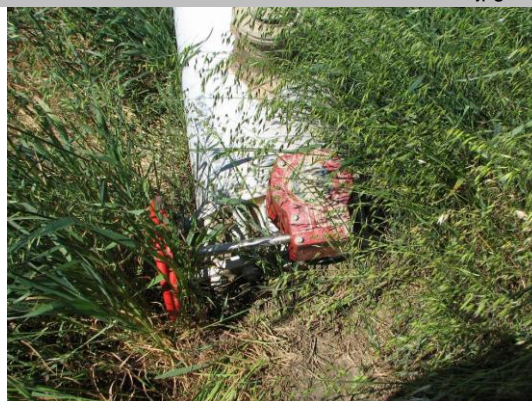
Photo 3 of 3 : UCIP\_FA\_2020\_11291\_18667.jpg

Siphon breaker and butterfly valve on WS shoulder.
