**Flood Control Project Maintenance  
Levee Inspections**

## Maintenance Issue Types Only, Levee Inspection Report By Mile - Fall 2021

### Knights Landing Ridge Drainage District

Waterway	Bank	Unit Miles	Inspection Start/End	Inspector
Unit No. 01 Knights Landing Ridge Cut	Right	6.36	09/07/2021 09/07/2021	Zach Jojola

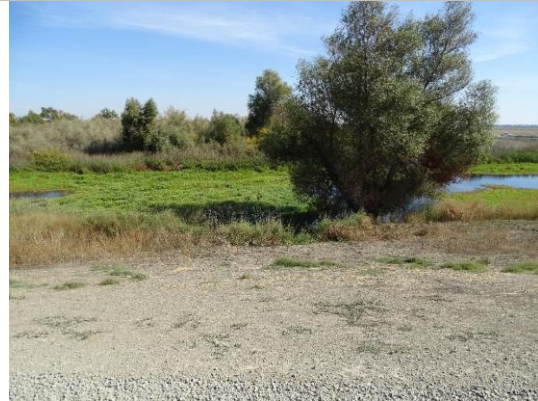
Photo 1 of 3 : UCIP\_FA\_2021\_55381\_81599.jpg

DS\_ID:19360  
FS\_ID:55381  
EP\_NO: 9302  
Repair Type: Non-Urgent  
EVAL Issue: Maintenance Compliance Issue  
Crossing Status: Found  
UCIP Comments: 10/8/2019 Record updated from No Action Needed to Non-Urgent. Concrete distribution box on LS toe has been removed. Slide gate with its metal stand debris should be removed from the channel. Pipe has been grouted in 2015 under Permit 18987. (O.Yakimov - DWR UCIP) 12/07/2018 Need updated photos to show proper pipe abandonment. Update Part VI, 1. Pipe Section to remove part c and e. If crossing was abandoned properly crossing will need to be removed from the LMA responsibility list. (O. Magana - DWR UCIP)05/16/2016 Pipe has been grouted in place under permit 18987, 2015. (T. Hatch - DWR UCIP)04/05/2013 Pipe completely rusted through on LS slope of levee at toe/headwall of concrete distribution box. Pipe needs replacement or proper abandonment. Pipe not visible at outlet. (W. Wylie - DWR UCIP)

View of WS looking from crown

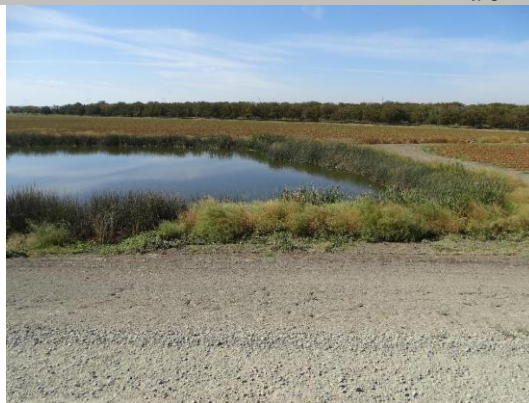
Photo 2 of 3 : UCIP\_FA\_2021\_55381\_81600.jpg

Concrete distribution box on LS toe

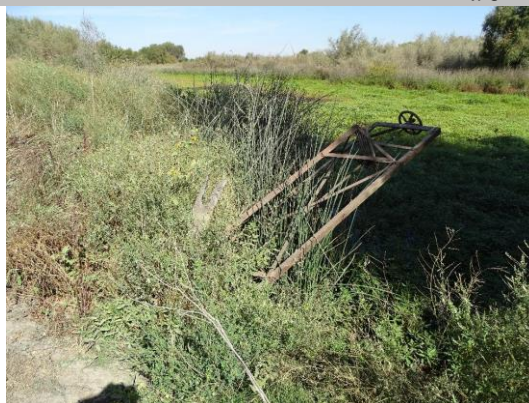
Photo 3 of 3 : UCIP\_FA\_2021\_55381\_81601.jpg

Slide gate on metal stand on WS toe needs removal

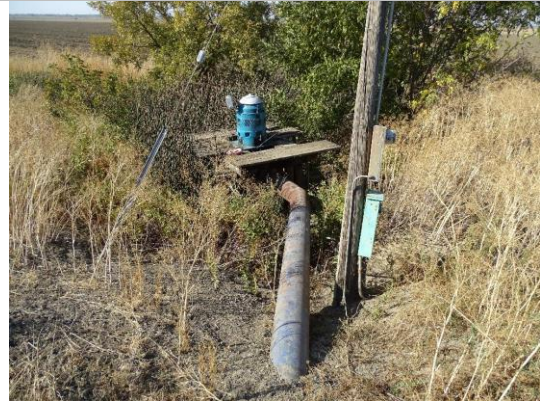
Photo 1 of 3 : UCIP\_FA\_2021\_55698\_82444.jpg

Comment Code						
Inspector Comment						
DS_ID:19364 FS_ID:55698 EP_NO: 9307 Repair Type: Non-Urgent EVAL Issue: Maintenance Compliance Issue Crossing Status: Found UCIP Comments: 0/08/2019 Record remains Non-Urgent, due to maintenance issue. Siphon breaker not found on LS slope: can be burried or broken off. Pipe outlet not found on WS. CVFPB is working with current owner to approve the removal and replacement of existing 14-inch pipe under draft Permit 9307-1. Work under permit 9307-1 not started. (O.Yakimov - DWR UCIP) 04/05/2013 Siphon breaker on LS burried or broken off and missing. (W.Wylie - DWR UCIP) FIELD_STRUCT_DESC: 14-inch steel drainage pipe through the levee, 5.4 feet below the crown. Pump house on a pile structure at the landside (LS) toe. Siphon breaker on the LS slope. Service pole and anchor at the LS toe. (14-inch pipe [HLM 2.62] authorized under Automatic Board Order (ABO) issued as Permit No. 9307, 1974 - Azalene E. Lowe; a 12-foot section of an existing 14-inch pipe on LS scheduled to be replaced and name change under DRAFT Permit No. 9307-1, 2016 - Ann Grube). [Additional Reference(s): DWR Levee Log, 1990. USACE Sacramento O&M Manual 127, June 1953, (Station 123+25)]. FS Date: 10/8/2019 8:30:25 AM

View of LS looking from levee crown

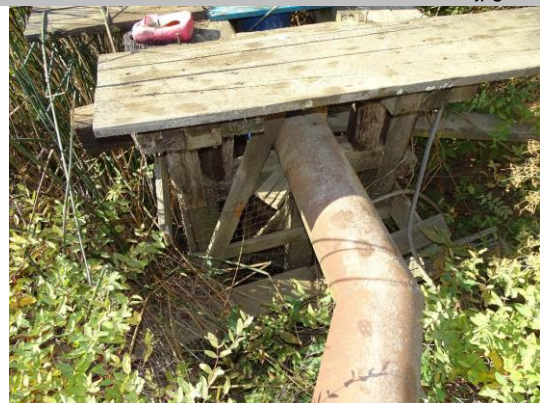
Photo 2 of 3 : UCIP\_FA\_2021\_55698\_82445.jpg

Pumping platform on pile structure

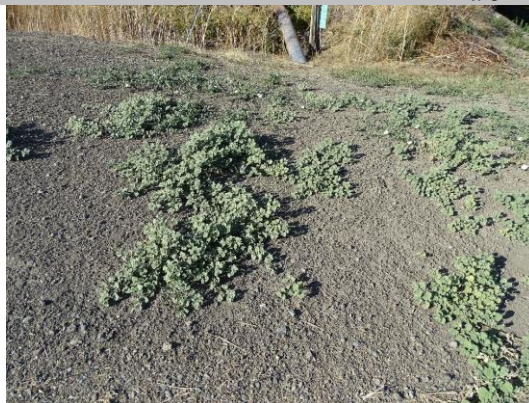
Photo 3 of 3 : UCIP\_FA\_2021\_55698\_82446.jpg

Not found siphon breaker on LS slope

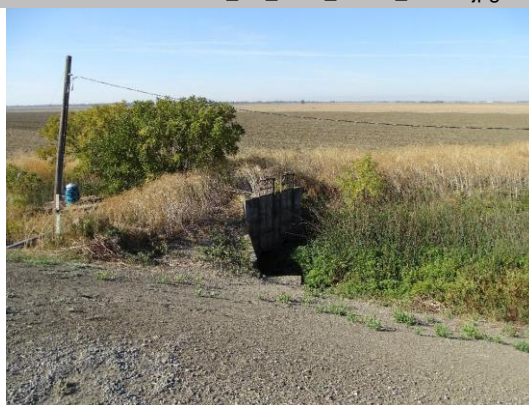
Photo 1 of 3 : UCIP\_FA\_2021\_55708\_82487.jpg

DS\_ID:19391  
 FS\_ID:55708  
 EP\_NO: 9307  
 Repair Type: Non-Urgent  
 EVAL Issue: Maintenance Compliance Issue  
 Crossing Status: Found  
 UCIP Comments: 10/8/2019 Record remains Non-Urgent. slide gate actuator is not accessible without use of equipment. Need to have CVFPB review ABO and determine current owner. (O.Yakimov - DWR UCIP) 04/05/2013 Walkway to actuator slide gate is missing. No method of actuating slide gate. (W.Wylie - DWR UCIP)  
 FIELD\_STRUCT\_DESC: 48-inch by 48-inch reinforced concrete box drainage culvert through the levee, 23 feet below the crown. Walkway to slide gate on the waterside (WS) end. Concrete headwalls on both ends. Service pole and anchor at the landside (LS) toe. Concrete headwalls on both ends. (four foot by four foot culvert [HLM 2.62] authorized under Automatic Board Order (ABO) issued as Permit No. 9307, 1974 - Azalene E. Lowe). [Additional Reference(s): DWR Levee Log, 1990. USACE Sacramento O&M Manual 127, June 1953, (Station 123+55.5)].

View of LS looking from levee crown

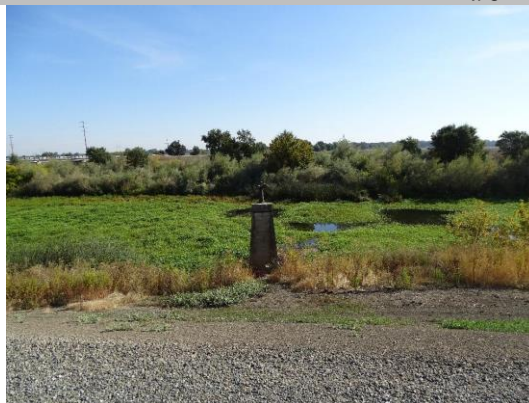
Photo 2 of 3 : UCIP\_FA\_2021\_55708\_82488.jpg

View of WS looking from levee crown

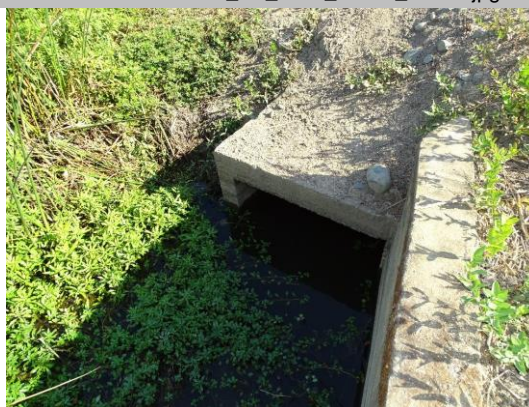
Photo 3 of 3 : UCIP\_FA\_2021\_55708\_82486.jpg

Inlet of 48 x 48 inch concrete culvert. View from LS

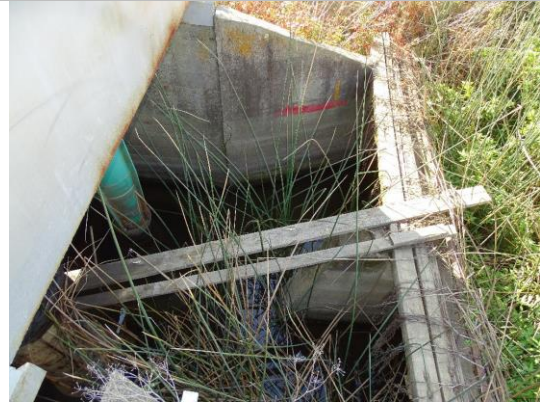
Photo 3 of 3 : UCIP\_FA\_2021\_55711\_82500.jpg

Concrete sump at pumping house

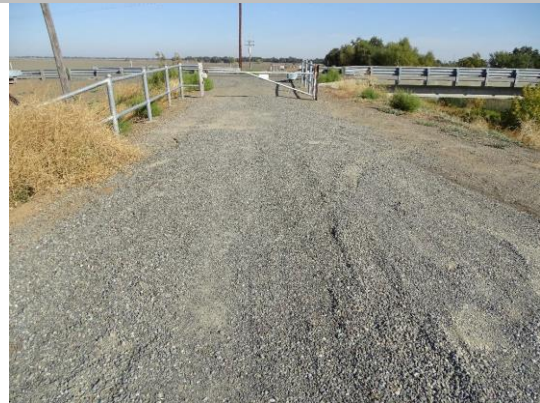
Photo 1 of 3 : UCIP\_FA\_2021\_55712\_82512.jpg

DS\_ID:19392  
FS\_ID:55712  
EP\_NO: 9301  
Repair Type: Non-Urgent  
EVAL Issue: Unauthorized Encroachment, installed decades prior  
Crossing Status: Found  
UCIP Comments: 10/8/2019 Record updated from No Action Needed to Non-Urgent. Need to have CVFPB review ABO and determine current owner. (O.Yakimov - DWR UCIP)  
FIELD\_STRUCT\_DESC: 2 of 2: 24-inch steel drainage pipe through the levee, 7.3 feet below the crown. Pump house mounted on concrete box in irrigation ditch at the landside (LS) toe. Siphon breaker in riser on the waterside (WS) slope. (one 24-inch and one 18-inch pipes [HLM 2.7] authorized under Automatic Board Order (ABO) issued as Permit No. 9301, 1974 - Reclamation District No. 730). [Additional Reference(s): DWR Levee Log, 1990. USACE Sacramento O&M Manual 127, June 1953, (Station 128+00)].  
FS Date: 10/8/2019 1:07:27 PM

View of levee crown at the crossing

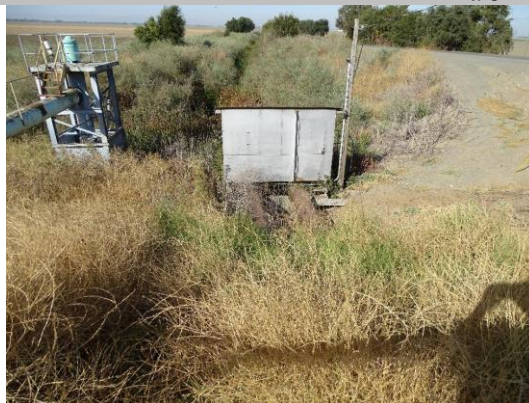
Photo 2 of 3 : UCIP\_FA\_2021\_55712\_82514.jpg

Pumphouse and pipe on LS toe

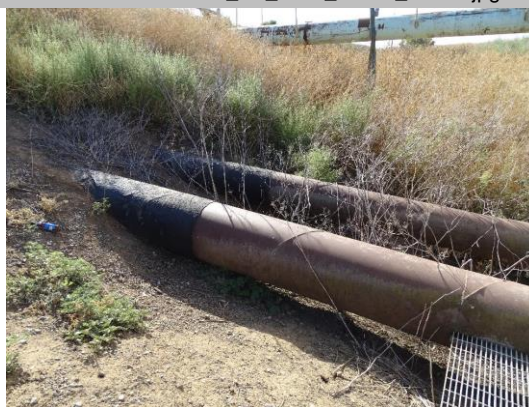
Photo 3 of 3 : UCIP\_FA\_2021\_55712\_82515.jpg

View of pipe on WS slope

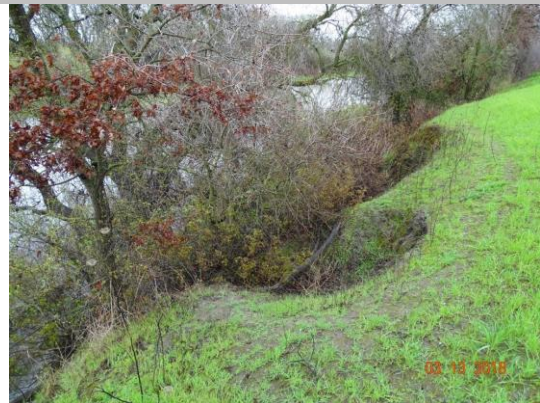
Photo 1 of 1 : FA\_2021\_NA0008\_256\_20\_20210907\_00003.jpg

LM Start	3.50	Rating **	M	Issue No.	20
LM End	3.50	Issue Type +	Ma	Location *	WS
Category	Earthen Levee			GPS Latitude/Longitude	
				Start	End
Item	Erosion / Bank Caving			38.759910 °	38.759910 °
				-121.696920 °	-121.696920 °
DWR ID	DWR_NA0008_01_f_2015_20				
Comment Code					
E2 : Schedule repair of erosion site prior to the next inspection.					
Inspector Comment

View of erosion on the waterside slope. Spring 2018.

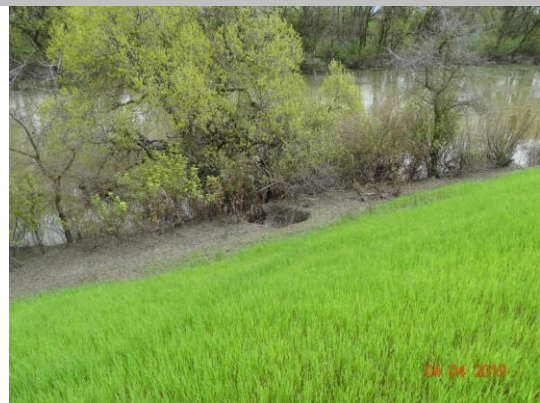
Photo 1 of 1 : FA\_2021\_NA0008\_256\_30\_20210907\_00008.jpg

LM Start	3.78	Rating **	M	Issue No.	30
LM End	3.78	Issue Type +	Ma	Location *	WS
Category	Earthen Levee			GPS Latitude/Longitude	
				Start	End
Item	Erosion / Bank Caving			38.762886 °	38.762886 °
				-121.700406 °	-121.700406 °
DWR ID	DWR_NA0008_01_s_2017_30				
Comment Code					
E2 : Schedule repair of erosion site prior to the next inspection.					
Inspector Comment					
There is a hole from a fallen tree at the waterside toe.

View of hole at the waterside toe. Spring 2019.

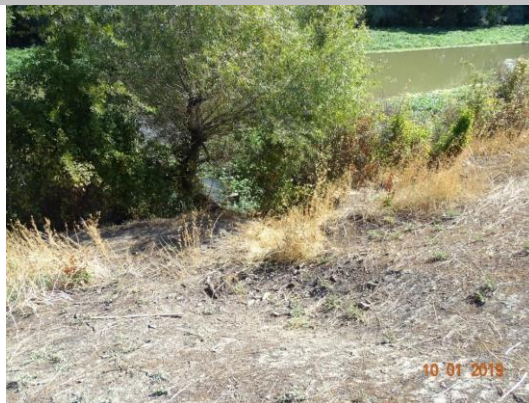
Photo 1 of 2 : FA\_2021\_NA0008\_256\_31\_20210907\_00009.jpg

View of the erosion at the waterside toe. Fall 2019.

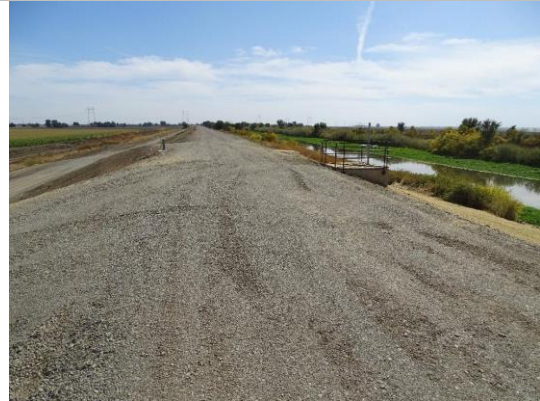
Photo 1 of 3 : UCIP\_FA\_2021\_55761\_82744.jpg

Comment Code						
Inspector Comment						
DS_ID:19399 FS_ID:55761 EP_NO: 9320 Repair Type: Non-Urgent EVAL Issue: Unauthorized Encroachment, installed decades prior Crossing Status: Found UCIP Comments: 10/08/2019 Record updated from No Action Needed to Non-Urgent. Pipe though levee has been replaced as part of the Knights Landing 2015 Levee Repair Project. A concrete box with slide gate was constructed on WS shoulder, a concrete pad with electrical wiring installed at LS toe, pipe inlet on LS is modified and revetted. New flap gate at WS end. Need to have CVFPB review ABO and determine current owner. Encroachment permit is missing. No details provided from Levee Improvement Project. (O.Yakimov - DWR UCIP) FIELD_STRUCT_DESC: *REMOVED & REPLACED with DSID 25597* 24-inch steel drainage pipe through the levee, 21 feet below the crown. Slide gate on the waterside (WS) end. Open on the landside (LS) end. LS toe cobble revetted. Service pole on the LS slope. (24-inch pipe [HLM 1.9] authorized under Automatic Board Order (ABO) issued as Permit No. 9320, 1974 - Ralph W. Pollock). [Additional Reference(s): DWR Levee Log, 1990. USACE Sacramento O&M Manual 127, June 1953, (Station 103+21.8)]. FS Date: 10/8/2019 2:13:30 PM

View of levee crown at the crossing

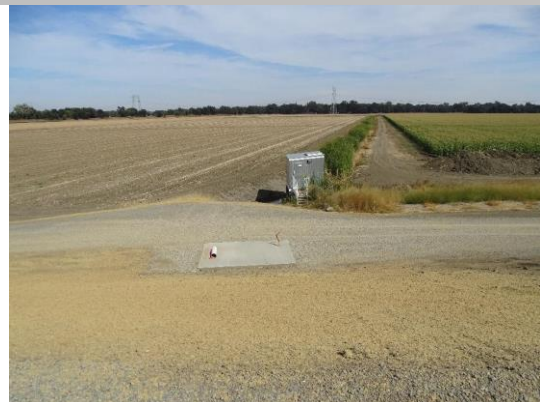
Photo 2 of 3 : UCIP\_FA\_2021\_55761\_82749.jpg

View of LS looking from levee crown

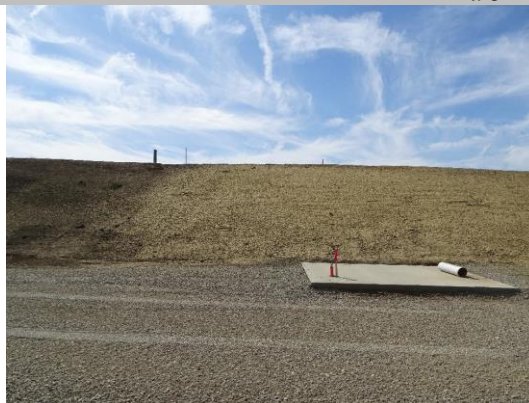
Photo 3 of 3 : UCIP\_FA\_2021\_55761\_82746.jpg

Concrete pad with electrical wiring at LS levee toe

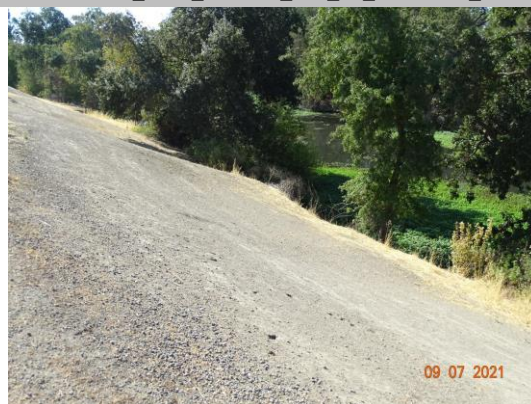
Photo 1 of 1 : FA\_2021\_NA0008\_257\_14\_20210907\_00043.jpg

LM Start	2.98	Rating **	M	Issue No.	9	
LM End	3.11	Issue Type +	Ma	Location *	WS	
Category	Supplemental			GPS Latitude/Longitude		
				Start	End	
Item	2018 USACE Erosion Survey			38.758587 °	38.760053 °	
				-121.693359 °	-121.694686 °	
DWR ID						
Comment Code						
Inspector Comment						
2018 Site ID: KLR 3.1 L						
Status: Eroding						
2018 Field Notes: Last observed in 2011. Access issues prevented inspection in 2017.						
Site History: 2006 - The whole levee toe area is slowly slumping into the channel (creep) due to dewatering and poor slope soils. Occasional piping in the levee slope evident as well. Pistol-butted trees at the levee toe indicate slow retreat. 2011 - Slumping of the levee toe.

View of erosion at waterside toe. Fall 2021.

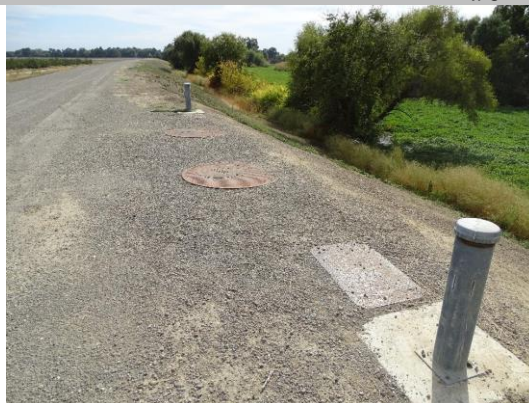
Photo 2 of 3 : UCIP\_FA\_2021\_55749\_82671.jpg

Siphon breaker and positive closure device on WS shoulder

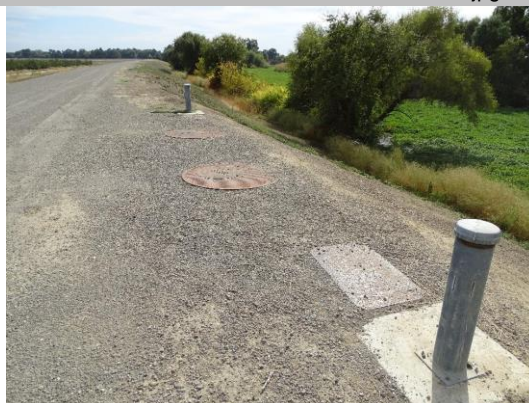
Photo 2 of 3 : UCIP\_FA\_2021\_54351\_82678.jpg

Siphon breaker and positive closure device on WS shoulder

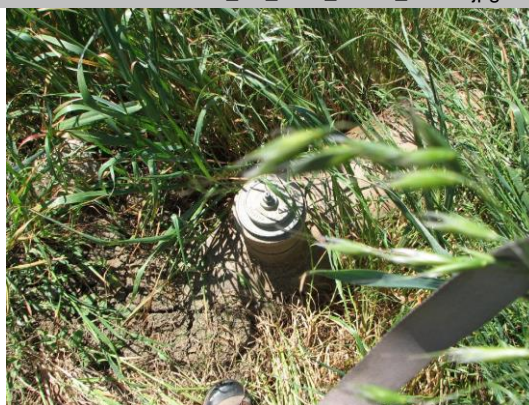
Photo 3 of 3 : UCIP\_FA\_2021\_11293\_18673.jpg

DS\_ID:19374  
 FS\_ID:11293  
 EP\_NO: 9317  
 Repair Type: No Action Needed  
 EVAL Issue:  
 Crossing Status: Found  
 UCIP Comments: 01/14/2019 Pipe has been replaved with a 16-inch pipe under permit 9317-1; new DS-ID 25571. (O.Yakimov - DWR UCIP)  
 FIELD\_STRUCT\_DESC: \*REMOVED\* 1 of 2: 16-inch steel discharge pipe through the levee, 3 feet below the crown. Pump house on pile structure in drainage ditch on the landside (LS). Siphon breaker on the pipe on the waterside (WS). Service pole at the pump house. (16-inch pipe [HLM 3.97] authorized under Automatic Board Order (ABO) issued as Permit No. 9317, 1974 - Reclamation District No. 819). [Additional Reference(s): DWR Levee Log, 1990. USACE Sacramento O&M Manual 127, June 1953, (Station 211+05) (15-inch pipe listed)].  
 FS Date: 4/9/2013

16-inch pipe with siphon breaker on WS shoulder.

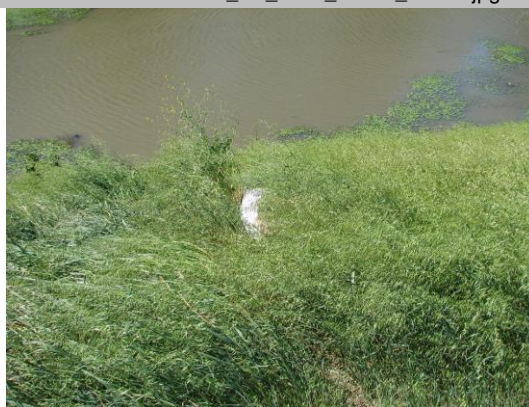
Photo 2 of 3 : UCIP\_FA\_2021\_11291\_18668.jpg

Pipe in grass on WS shoulder.

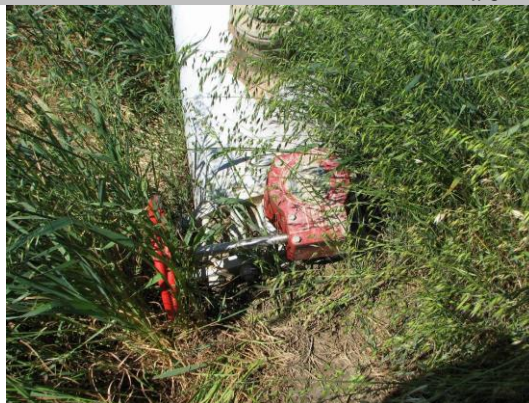
Photo 3 of 3 : UCIP\_FA\_2021\_11291\_18667.jpg

Siphon breaker and butterfly valve on WS shoulder.
