**Flood Control Project Maintenance
Levee Inspections**

Maintenance Issue Types Only, Levee Inspection Report By Mile - Fall 2022

Knights Landing Ridge Drainage District

Waterway	Bank	Unit Miles	Inspection Start/End	Inspector
Unit No. 01 Knights Landing Ridge Cut	Right	6.36	10/07/2022 10/07/2022	Zach Jojola

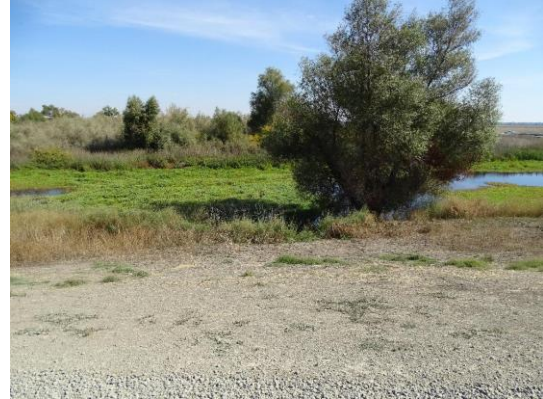
Photo 1 of 3 : UCIP_FA_2022_55381_81599.jpg

Comment Code					
Inspector Comment					
DS_ID:19360 FS_ID:55381 EP_NO: 9302 Repair Type: Non-Urgent EVAL Issue: 11, Maintenance Compliance Issue Crossing Status: Found UCIP Comments: 10/8/2019 Record updated from No Action Needed to Non-Urgent. Concrete distribution box on LS toe has been removed. Slide gate with its metal stand debris should be removed from the channel. Pipe has been grouted in 2015 under Permit 18987. (O.Yakimov - DWR UCIP) 12/07/2018 Need updated photos to show proper pipe abandonment. Update Part VI, 1. Pipe Section to remove part c and e. If crossing was abandoned properly crossing will need to be removed from the LMA responsibility list. (O. Magana - DWR UCIP)05/16/2016 Pipe has been grouted in place under permit 18987, 2015. (T. Hatch - DWR UCIP)04/05/2013 Pipe completely rusted through on LS slope of levee at toe/headwall of concrete distribution box. Pipe needs replacement or proper abandonment. Pipe not visible at outlet. (W. Wylie - DWR UCIP) FIELD_STRUCT_DESC: *ABANDONED* 36-inch corrugated metal drainage pipe through the levee, 27 feet below the crown. Slide gate on the waterside (WS) end. 12-foot by 6-foot concrete box on the landside (LS) end. (36-inch pipe [HLM 1.62] authorized under Automatic Board Order (ABO) issued as Permit No. 9302, 1974 - Barbara Lowe Elliott; 36-inch pipe abandoned by removing ends and pumping pipe full of concrete under Permit No. 18987, 2016 - Knaggs Ranch, LLC, care of John Brennan). [Additional Reference(s): DWR Levee Log, 1990. USACE Sacramento O&M Manual 127, June 1953, (Station 0+30). USACE As-Built Drawing No. 50-04-2185, October 1943, Sheet 1, upstream of STA 185+00, listed as 30-inch pipe]. FS Date: 10/8/2019 2:41:37 PM

View of WS looking from crown

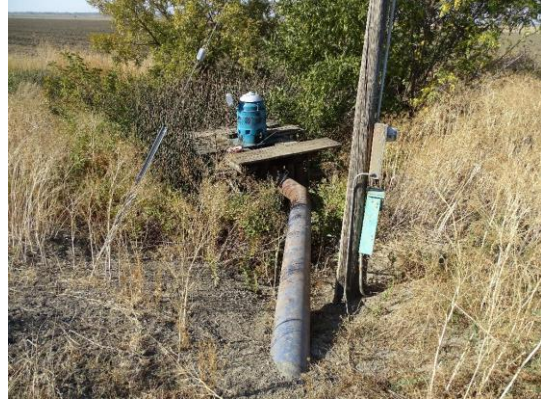
Photo 1 of 3 : UCIP_FA_2022_55698_82444.jpg

Comment Code						
Inspector Comment						
DS_ID:19364 FS_ID:55698 EP_NO: 9307 Repair Type: Non-Urgent EVAL Issue: 11, Maintenance Compliance Issue Crossing Status: Found UCIP Comments: 0/08/2019 Record remains Non-Urgent, due to maintenance issue. Siphon breaker not found on LS slope: can be burried or broken off. Pipe outlet not found on WS. CVFPB is working with current owner to approve the removal and replacement of existing 14-inch pipe under draft Permit 9307-1. Work under permit 9307-1 not started. (O.Yakimov - DWR UCIP) 04/05/2013 Siphon breaker on LS burried or broken off and missing. (W.Wylie - DWR UCIP) FIELD_STRUCT_DESC: 14-inch steel drainage pipe through the levee, 5.4 feet below the crown. Pump house on a pile structure at the landside (LS) toe. Siphon breaker on the LS slope. Service pole and anchor at the LS toe. (14-inch pipe [HLM 2.62] authorized under Automatic Board Order (ABO) issued as Permit No. 9307, 1974 - Azalene E. Lowe; a 12-foot section of an existing 14-inch pipe on LS scheduled to be replaced and name change under DRAFT Permit No. 9307-1, 2016 - Ann Grube). [Additional Reference(s): DWR Levee Log, 1990. USACE Sacramento O&M Manual 127, June 1953, (Station 123+25)]. FS Date: 10/8/2019 8:30:25 AM

View of LS looking from levee crown

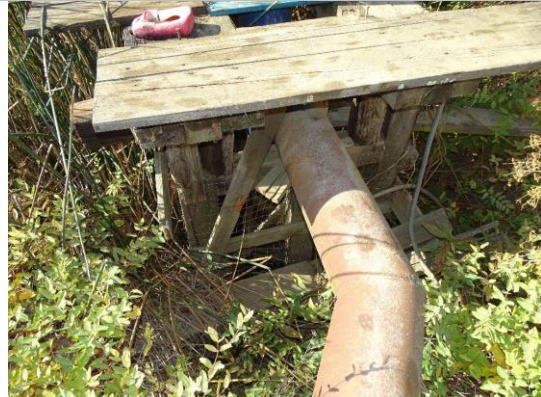
Photo 2 of 3 : UCIP_FA_2022_55698_82445.jpg

Pumping platform on pile structure

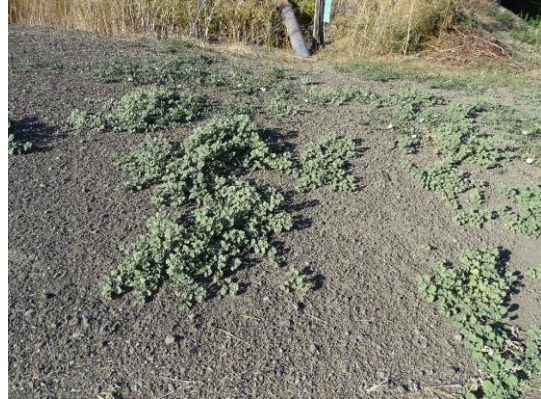
Photo 3 of 3 : UCIP_FA_2022_55698_82446.jpg

Not found siphon breaker on LS slope

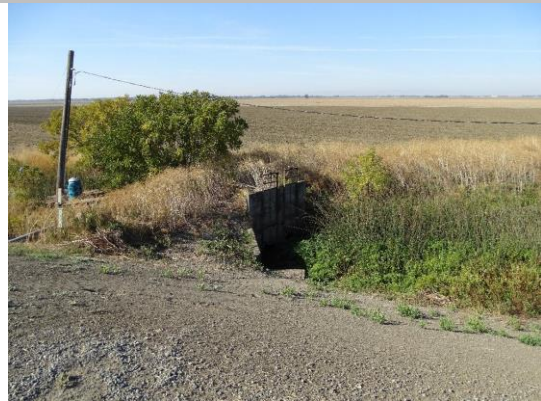
Photo 1 of 3 : UCIP_FA_2022_55708_82487.jpg

DS_ID:19391
FS_ID:55708
EP_NO: 9307
Repair Type: Non-Urgent
EVAL Issue: 11, Maintenance Compliance Issue
Crossing Status: Found
UCIP Comments: 10/8/2019 Record remains Non-Urgent. slide gate actuator is not accessible without use of equipment. Need to have CVFPB review ABO and determine current owner. (O.Yakimov - DWR UCIP) 04/05/2013 Walkway to actuator slide gate is missing. No method of actuating slide gate. (W.Wylie - DWR UCIP)
FIELD_STRUCT_DESC: 48-inch by 48-inch reinforced concrete box drainage culvert through the levee, 23 feet below the crown. Walkway to slide gate on the waterside (WS) end. Concrete headwalls on both ends. Service pole and anchor at the landside (LS) toe. Concrete headwalls on both ends. (four foot by four foot culvert [HLM 2.62] authorized under Automatic Board Order (ABO) issued as Permit No. 9307, 1974 - Azalene E. Lowe). [Additional Reference(s): DWR Levee Log, 1990. USACE Sacramento O&M Manual 127, June 1953, (Station 123+55.5)].

View of LS looking from levee crown

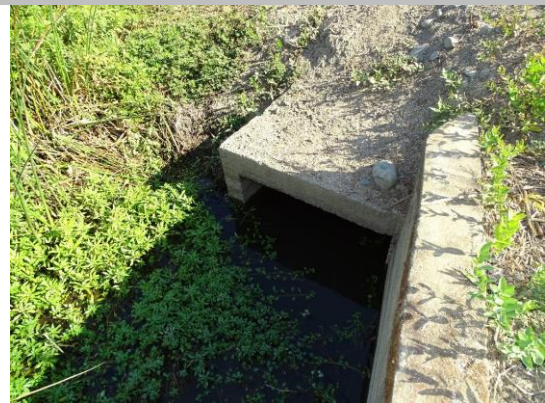
Photo 3 of 3 : UCIP_FA_2022_55708_82486.jpg

Inlet of 48 x 48 inch concrete culvert. View from LS

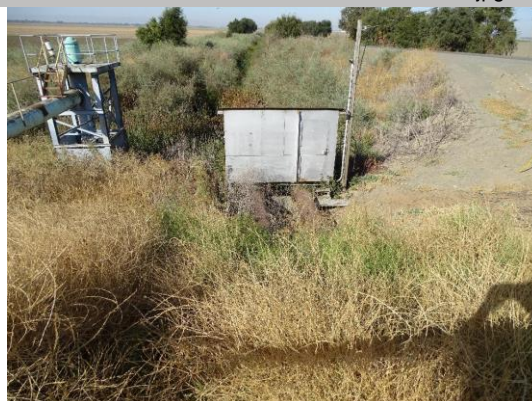
Photo 1 of 3 : UCIP_FA_2022_55711_82498.jpg

Comment Code						
Inspector Comment						
DS_ID:19365 FS_ID:55711 EP_NO: 9301 Repair Type: Non-Urgent EVAL Issue: Crossing Status: Found UCIP Comments: 10/8/2019 Record updated from No Action Needed to Non-Urgent. Need to have CVFPB review ABO and determine current owner. (O.Yakimov - DWR UCIP) FIELD_STRUCT_DESC: 1 of 2: 18-inch steel drainage pipe through the levee, 6.4 feet below the crown. Siphon breaker on the waterside (WS) slope. Pump house mounted on concrete box in irrigation ditch at the landside (LS) toe. (one 18-inch and one 24-inch pipes [HLM 2.7] authorized under Automatic Board Order (ABO) issued as Permit No. 9301, 1974 - Reclamation District No. 730). [Additional Reference(s): DWR Levee Log, 1990. USACE Sacramento O&M Manual 127, June 1953, (Station 128+00)]. FS Date: 10/8/2019 12:58:01 PM

View of LS looking from levee crown

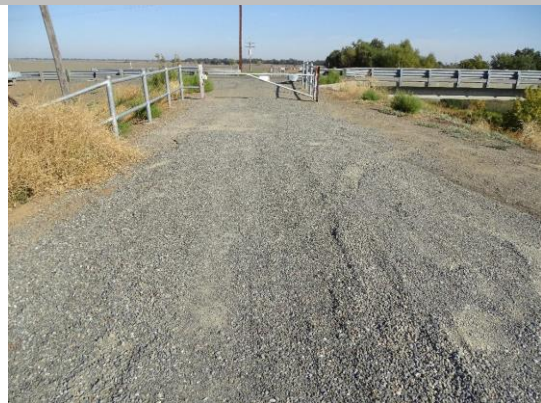
Photo 1 of 3 : UCIP_FA_2022_55712_82512.jpg

DS_ID:19392
 FS_ID:55712
 EP_NO: 9301
 Repair Type: Non-Urgent
 EVAL Issue:
 Crossing Status: Found
 UCIP Comments: 10/8/2019 Record updated from No Action Needed to Non-Urgent. Need to have CVFPB review ABO and determine current owner. (O.Yakimov - DWR UCIP)
 FIELD_STRUCT_DESC: 2 of 2: 24-inch steel drainage pipe through the levee, 7.3 feet below the crown. Pump house mounted on concrete box in irrigation ditch at the landside (LS) toe. Siphon breaker in riser on the waterside (WS) slope. (one 24-inch and one 18-inch pipes [HLM 2.7] authorized under Automatic Board Order (ABO) issued as Permit No. 9301, 1974 - Reclamation District No. 730). [Additional Reference(s): DWR Levee Log, 1990. USACE Sacramento O&M Manual 127, June 1953, (Station 128+00)].
 FS Date: 10/8/2019 1:07:27 PM

View of levee crown at the crossing

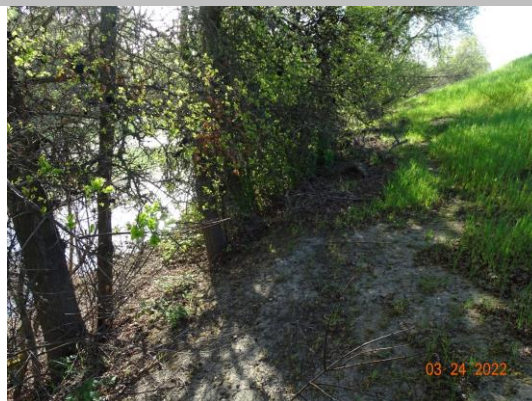
Photo 1 of 1 : FA_2022_NA0008_256_19_20220921_00002.jpg

LM Start	3.36	Rating **	M	Issue No.	19
LM End	3.44	Issue Type +	Ma	Location *	WS
Category	Supplemental			GPS Latitude/Longitude	
				Start	End
Item	2018 USACE Erosion Survey			38.758432 °	38.759332 °
				-121.695158 °	-121.696063 °
DWR ID	DWR_NA0008_01_s_2022_19				
Comment Code					
Inspector Comment					
2018 Site ID: KLR 3.5 R					
Status: Eroding					
2018 Field Notes: Last observed in 2011. Access issues prevented inspection in 2017.					
Site History: 2011 - Toe scour and bank slumping.

View of erosion at the waterside toe. Spring 2022.

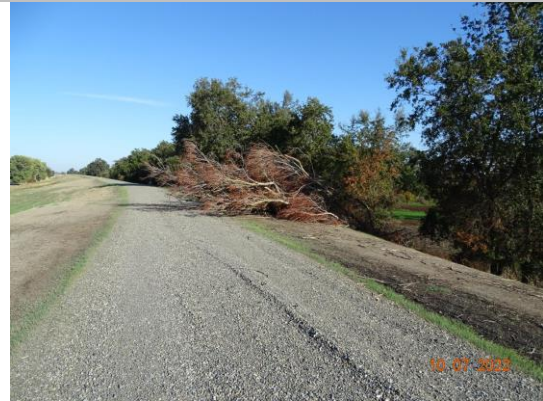
Photo 1 of 1 : FA_2022_NA0008_256_23_20221010_00044.jpg

View of fallen tree on the waterside slope and crown. Fall 2022.

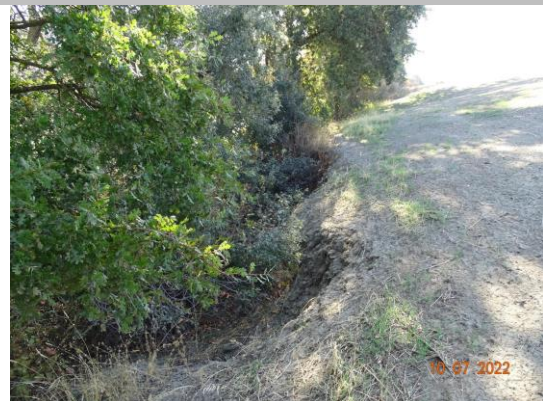
Photo 1 of 1 : FA_2022_NA0008_256_20_20221010_00045.jpg

LM Start	3.50	Rating **	M	Issue No.	20
LM End	3.50	Issue Type +	Ma	Location *	WS
Category	Earthen Levee			GPS Latitude/Longitude	
				Start	End
Item	Erosion / Bank Caving			38.759910 °	38.759910 °
				-121.696920 °	-121.696920 °
DWR ID	DWR_NA0008_01_f_2015_20				
Comment Code					
E2 : Schedule repair of erosion site prior to the next inspection.					
Inspector Comment

View of erosion on the waterside slope. Fall 2022.

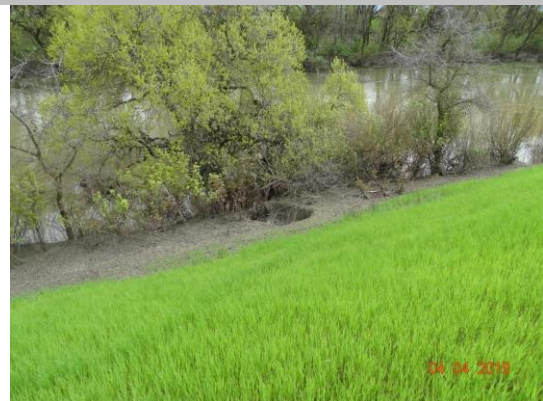
Photo 1 of 1 : FA_2022_NA0008_256_30_20220921_00006.jpg

LM Start	3.78	Rating **	M	Issue No.	30
LM End	3.78	Issue Type +	Ma	Location *	WS
Category	Earthen Levee			GPS Latitude/Longitude	
				Start	End
Item	Erosion / Bank Caving			38.762886 °	38.762886 °
				-121.700406 °	-121.700406 °
DWR ID	DWR_NA0008_01_s_2017_30				
Comment Code					
E2 : Schedule repair of erosion site prior to the next inspection.					
Inspector Comment					
There is a hole from a fallen tree at the waterside toe.

View of hole at the waterside toe. Spring 2019.

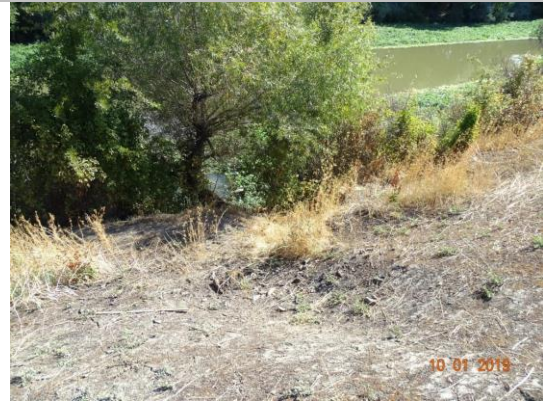
Photo 1 of 2 : FA_2022_NA0008_256_31_20220921_00007.jpg

View of the erosion at the waterside toe. Fall 2019.

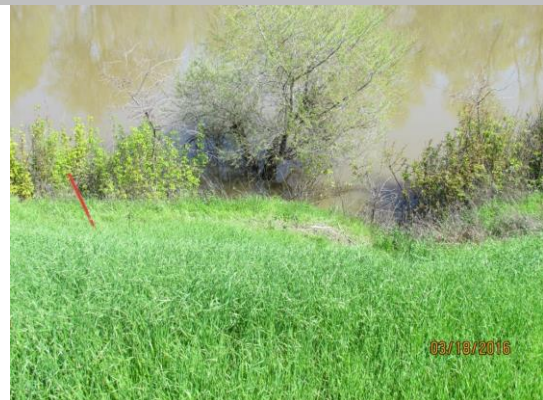
Photo 2 of 2 : FA_2022_NA0008_256_31_20220921_00008.jpg

View of the erosion at the toe of the levee on the waterward side. Spring 2016.

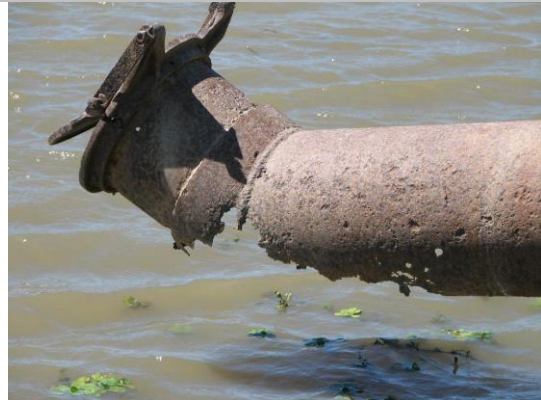
Photo 2 of 3 : UCIP_FA_2022_52538_18705.jpg

Pipe rusted through at flap gate on WS toe.

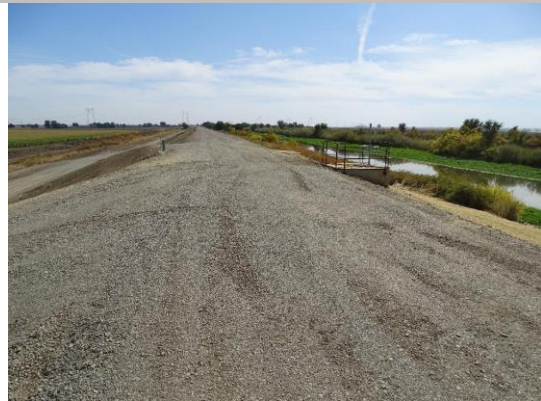
Photo 1 of 3 : UCIP_FA_2022_55761_82744.jpg

DS_ID:19399
 FS_ID:55761
 EP_NO: 9320
 Repair Type: Non-Urgent
 EVAL Issue:
 Crossing Status: Found
 UCIP Comments: 10/08/2019 Record updated from No Action Needed to Non-Urgent. Pipe though levee has been replaced as part of the Knights Landing 2015 Levee Repair Project. A concrete box with slide gate was constructed on WS shoulder, a concrete pad with electrical wiring installed at LS toe, pipe inlet on LS is modified and revetted. New flap gate at WS end. Need to have CVFPB review ABO and determine current owner. Encroachment permit is missing. No details provided from Levee Improvement Project. (O.Yakimov - DWR UCIP)
 FIELD_STRUCT_DESC: *REMOVED & REPLACED with DSID 25597*
 24-inch steel drainage pipe through the levee, 21 feet below the crown. Slide gate on the waterside (WS) end. Open on the landside (LS) end. LS toe cobble revetted. Service pole on the LS slope. (24-inch pipe [HLM 1.9] authorized under Automatic Board Order (ABO) issued as Permit No. 9320, 1974 - Ralph W. Pollock). [Additional Reference(s): DWR Levee Log, 1990. USACE Sacramento O&M Manual 127, June 1953, (Station 103+21.8)].

View of levee crown at the crossing

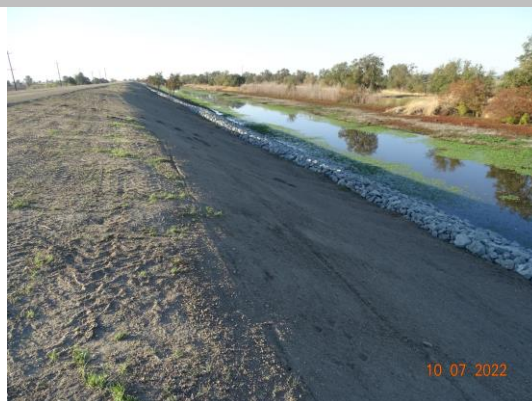
Photo 1 of 1 : FA_2022_NA0008_257_8_20221010_00045.jpg

LM Start	2.72	Rating **	A/W	Issue No.	8
LM End	2.93	Issue Type +	Ma	Location *	WS
Category	Supplemental			GPS Latitude/Longitude	
				Start	End
Item	2018 USACE Erosion Survey			38.754899 °	38.757925 °
				-121.692653 °	-121.693048 °
DWR ID	DWR_NA0008_02_s_2022_8				
Comment Code					
Inspector Comment					
2018 Site ID: KLR 3.0 L Status: Eroding 2018 Field Notes: Last observed in 2011. Access issues prevented inspection in 2017. Site History: 2006 - The whole levee toe area is slowly slumping into the channel (creep) due to dewatering and poor slope soils. Occasional piping in the levee slope evident as well. Pistol-butted trees at the levee toe indicate slow retreat. 2011 - Multiple scallops throughout the site and slumping of the toe. DWR Inspector Comment: District is placing riprap along the toe.

View of repaired waterside slope. Fall 2022.

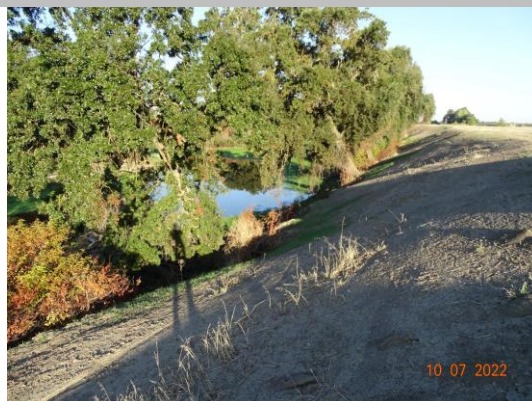
Photo 1 of 1 : FA_2022_NA0008_257_9_20221010_00044.jpg

LM Start	2.98	Rating **	M	Issue No.	9
LM End	3.11	Issue Type +	Ma	Location *	WS
Category	Supplemental			GPS Latitude/Longitude	
				Start	End
Item	2018 USACE Erosion Survey			38.758587 °	38.760053 °
				-121.693359 °	-121.694686 °
DWR ID	DWR_NA0008_02_s_2022_9				
Comment Code					
Inspector Comment					
2018 Site ID: KLR 3.1 L Status: Eroding 2018 Field Notes: Last observed in 2011. Access issues prevented inspection in 2017. Site History: 2006 - The whole levee toe area is slowly slumping into the channel (creep) due to dewatering and poor slope soils. Occasional piping in the levee slope evident as well. Pistol-butted trees at the levee toe indicate slow retreat. 2011 - Slumping of the levee toe. DWR Comment: Erosion due to opening within channel.

View of erosion at waterside edge. Fall 2022.

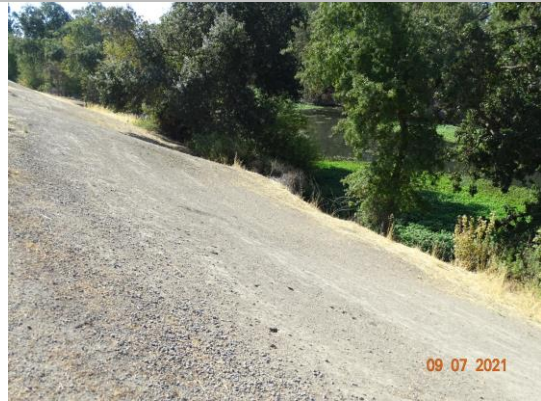
Photo 1 of 1 : FA_2022_NA0008_257_14_20220921_00003.jpg

View of erosion at waterside toe. Fall 2021.

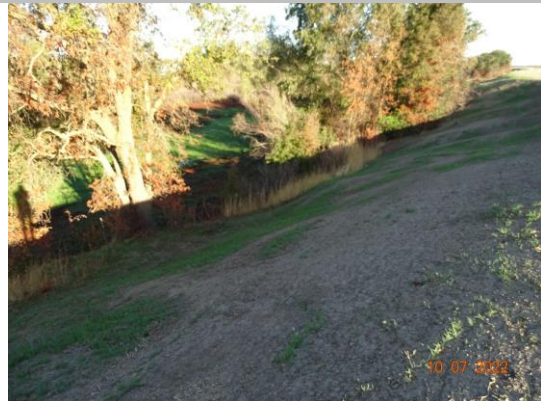
Photo 1 of 1 : FA_2022_NA0008_257_10_20221010_00043.jpg

LM Start	3.60	Rating **	A/W	Issue No.	10
LM End	3.73	Issue Type +	Ma	Location *	WS
Category	Supplemental			GPS Latitude/Longitude	
				Start	End
Item	2018 USACE Erosion Survey			38.765522 °	38.767336 °
				-121.700608 °	-121.701023 °
DWR ID	DWR_NA0008_02_s_2022_10				
Comment Code					
Inspector Comment					
2018 Site ID: KLR 3.7 L					
Status: Eroding					
2018 Field Notes: Last observed in 2011. Access issues prevented inspection in 2017.					
Site History: 2011 - The toe has eroded away and there are a few scallops from bank slumping.					
DWR Comment: Erosion due to opening within channel. Not within the prism. Recommend monitoring.

View of erosion at the waterside edge. Fall 2022.

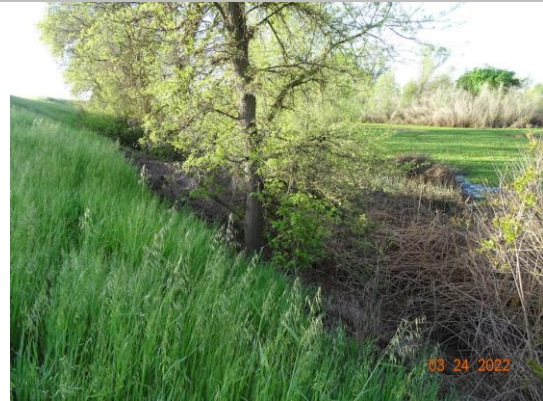
Photo 1 of 1 : FA_2022_NA0008_257_11_20220921_00002.jpg

LM Start	4.30	Rating **	A/W	Issue No.	11
LM End	4.55	Issue Type +	Ma	Location *	WS
Category	Supplemental			GPS Latitude/Longitude	
				Start	End
Item	2018 USACE Erosion Survey			38.775271 °	38.778115 °
				-121.703685 °	-121.706195 °
DWR ID	DWR_NA0008_02_s_2022_11				
Comment Code					
Inspector Comment					
2018 Site ID: KLR 4.7 L					
Status: Eroding					
2018 Field Notes: Last observed in 2011. Access issues prevented inspection in 2017.					
Site History: 2011 - This site is the downstream section of the old KLR 5.3L site. Levee toe is slowly retreating. Cracking on top of the levee may indicate potential mass movement.

View of erosion at waterside toe. Spring 2022.
