**Flood Control Project Maintenance
Levee Inspections**

Maintenance Issue Types Only, Levee Inspection Report By Mile - Fall 2023

Knights Landing Ridge Drainage District

Waterway	Bank	Unit Miles	Inspection Start/End	Inspector
Unit No. 01 Knights Landing Ridge Cut	Right	6.36	10/06/2023 10/06/2023	Zach Jojola

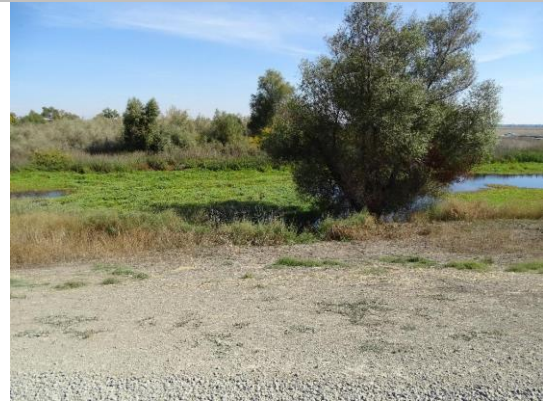
Photo 1 of 3 : UCIP_FA_2023_55381_81599.jpg

Comment Code						
Inspector Comment						
DS_ID:19360 FS_ID:55381 EP_NO: 9302 Repair Type: Non-Urgent EVAL Issue: 11, Maintenance Compliance Issue Crossing Status: Found UCIP Comments: 10/8/2019 Record updated from No Action Needed to Non-Urgent. Concrete distribution box on LS toe has been removed. Slide gate with its metal stand debris should be removed from the channel. Pipe has been grouted in 2015 under Permit 18987. (O.Yakimov - DWR UCIP) 12/07/2018 Need updated photos to show proper pipe abandonment. Update Part VI, 1. Pipe Section to remove part c and e. If crossing was abandoned properly crossing will need to be removed from the LMA responsibility list. (O. Magana - DWR UCIP)05/16/2016 Pipe has been grouted in place under permit 18987, 2015. (T. Hatch - DWR UCIP)04/05/2013 Pipe completely rusted through on LS slope of levee at toe/headwall of concrete distribution box. Pipe needs replacement or proper abandonment. Pipe not visible at outlet. (W. Wylie - DWR UCIP) FIELD_STRUCT_DESC: *ABANDONED* 36-inch corrugated metal drainage pipe through the levee, 27 feet below the crown. Slide gate on the waterside (WS) end. 12-foot by 6-foot concrete box on the landside (LS) end. (36-inch pipe [HLM 1.62] authorized under Automatic Board Order (ABO) issued as Permit No. 9302, 1974 - Barbara Lowe Elliott; 36-inch pipe abandoned by removing ends and pumping pipe full of concrete under Permit No. 18987, 2016 - Knaggs Ranch, LLC, care of John Brennan). [Additional Reference(s): DWR Levee Log, 1990. USACE Sacramento O&M Manual 127, June 1953, (Station 0+30). USACE As-Built Drawing No. 50-04-2185, October 1943, Sheet 1, upstream of STA 185+00, listed as 30-inch pipe]. FS Date: 10/8/2019 2:41:37 PM

View of WS looking from crown

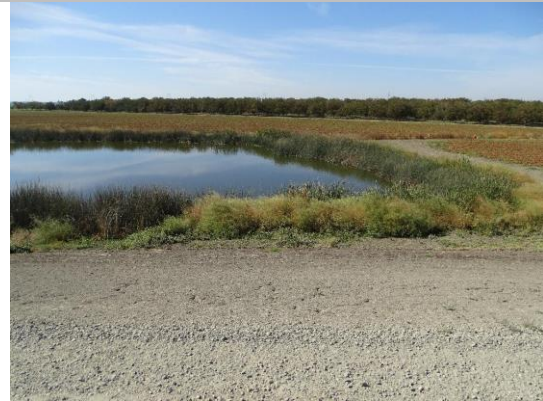
Photo 2 of 3 : UCIP_FA_2023_55381_81600.jpg

Concrete distribution box on LS toe

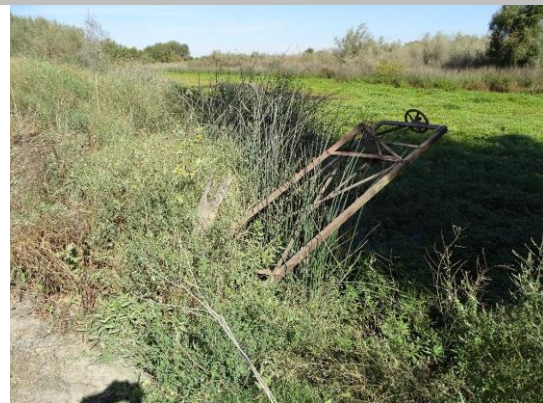
Photo 3 of 3 : UCIP_FA_2023_55381_81601.jpg

Slide gate on metal stand on WS toe needs removal

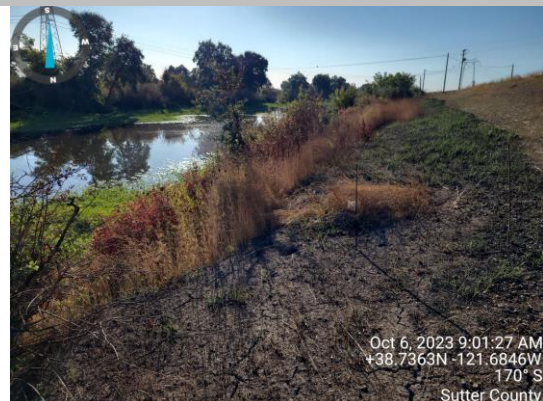
Photo 1 of 1 : FA_2023_NA0008_256_17_20231010_00041.jpg

LM Start	1.66	Rating **	A/W	Issue No.	17
LM End	1.66	Issue Type +	Ma	Location *	WS
Category	Earthen Levee			GPS Latitude/Longitude	
				Start	End
Item	Erosion / Bank Caving			38.736300°	38.736300°
				-121.684600°	-121.684600°
DWR ID	DWR_NA0008_01_f_2023_17				
Comment Code					
E1 : Note and monitor erosion site.					
Inspector Comment					
Erosion within waterside berm. Recommend monitoring.

View of erosion on waterside berm. Fall 2023.

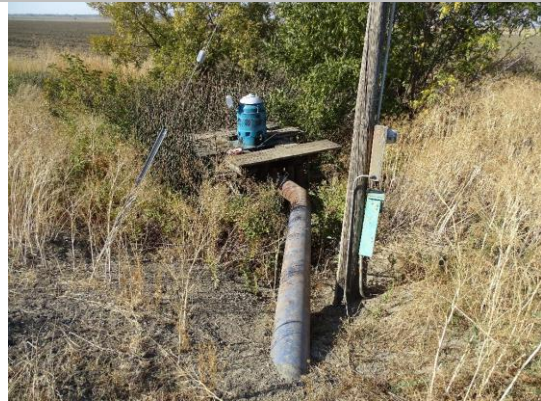
Photo 1 of 3 : UCIP_FA_2023_55698_82444.jpg

Comment Code						
Inspector Comment						
DS_ID:19364 FS_ID:55698 EP_NO: 9307 Repair Type: Non-Urgent EVAL Issue: 11, Maintenance Compliance Issue Crossing Status: Found UCIP Comments: 0/08/2019 Record remains Non-Urgent, due to maintenance issue. Siphon breaker not found on LS slope: can be burried or broken off. Pipe outlet not found on WS. CVFPB is working with current owner to approve the removal and replacement of existing 14-inch pipe under draft Permit 9307-1. Work under permit 9307-1 not started. (O.Yakimov - DWR UCIP) 04/05/2013 Siphon breaker on LS burried or broken off and missing. (W.Wylie - DWR UCIP) FIELD_STRUCT_DESC: 14-inch steel drainage pipe through the levee, 5.4 feet below the crown. Pump house on a pile structure at the landside (LS) toe. Siphon breaker on the LS slope. Service pole and anchor at the LS toe. (14-inch pipe [HLM 2.62] authorized under Automatic Board Order (ABO) issued as Permit No. 9307, 1974 - Azalene E. Lowe; a 12-foot section of an existing 14-inch pipe on LS scheduled to be replaced and name change under DRAFT Permit No. 9307-1, 2016 - Ann Grube). [Additional Reference(s): DWR Levee Log, 1990. USACE Sacramento O&M Manual 127, June 1953, (Station 123+25)]. FS Date: 10/8/2019 8:30:25 AM

View of LS looking from levee crown

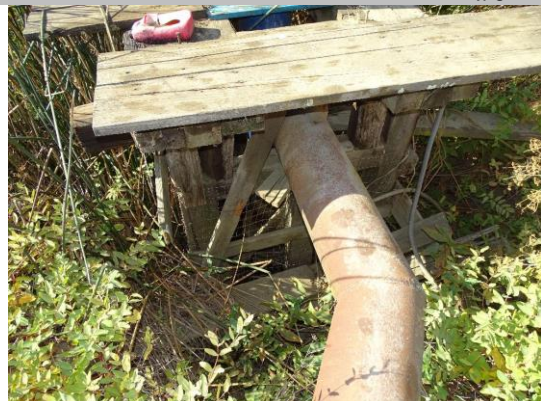
Photo 2 of 3 : UCIP_FA_2023_55698_82445.jpg

Pumping platform on pile structure

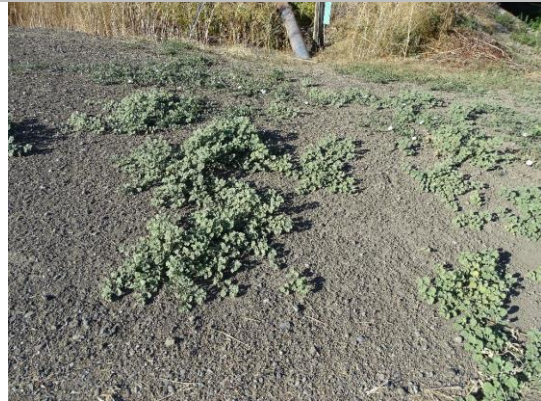
Photo 3 of 3 : UCIP_FA_2023_55698_82446.jpg

Not found siphon breaker on LS slope

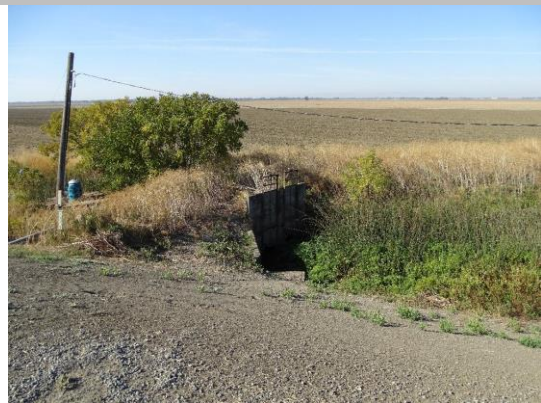
Photo 1 of 3 : UCIP_FA_2023_77842_82487.jpg

View of LS looking from levee crown

DS_ID:19391
 FS_ID:77842
 EP_NO: 9307
 Repair Type: Urgent
 EVAL Issue: 1, Pipe Integrity
 Crossing Status: Found
 UCIP Comments: 12/14/2022 Record updated from Non-Urgent to Urgent. DMP internal video inspection has found pipe integrity issues. LOF of crossing is between 5 and 6. Crossing will be monitored until funding becomes available to address the issues. (O.Yakimov - DWR UCIP)
 10/8/2019 Record remains Non-Urgent. slide gate actuator is not accessible without use of equipment. Need to have CVFPB review ABO and determine current owner. (O.Yakimov - DWR UCIP) 04/05/2013 Walkway to actuator slide gate is missing. No method of actuating slide gate. (W.Wylie - DWR UCIP)
 FIELD_STRUCT_DESC: 48-inch by 48-inch reinforced concrete box drainage culvert through the levee, 23 feet below the crown. Walkway to slide gate on the waterside (WS) end. Concrete headwalls on both ends. Service pole and anchor at the landside (LS) toe. Concrete headwalls on both ends. (four foot by four foot culvert [HLM 2.62] authorized under Automatic Board Order (ABO) issued as Permit No. 9307, 1974 - Azalene E. Lowe). [Additional Reference(s): DWR Levee Log, 1990. USACE Sacramento O&M Manual 127, June 1953, (Station 123+55.5)].

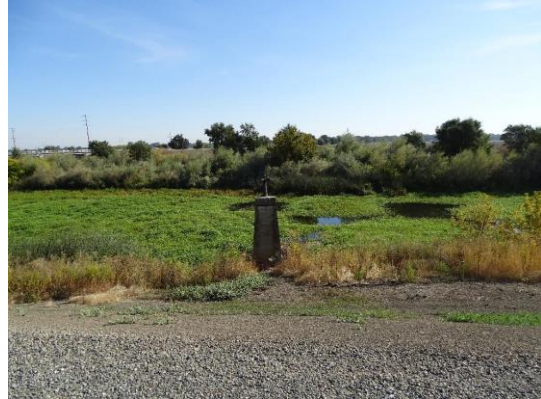
Photo 2 of 3 : UCIP_FA_2023_77842_82488.jpg

View of WS looking from levee crown

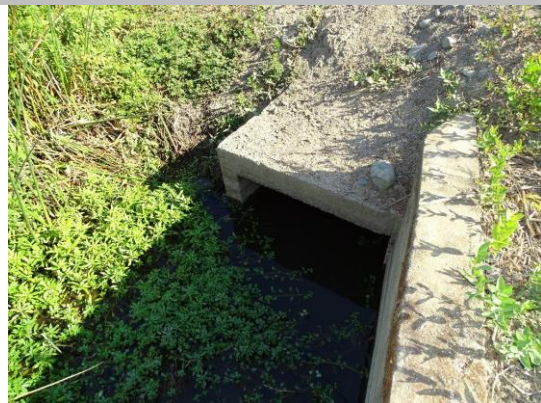
Photo 3 of 3 : UCIP_FA_2023_77842_82486.jpg

Inlet of 48 x 48 inch concrete culvert. View from LS

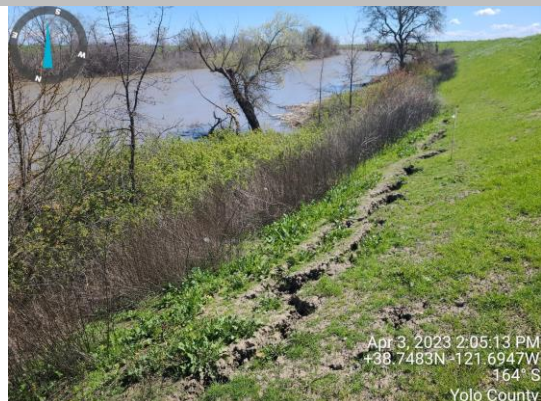
Photo 1 of 1 : FA_2023_NA0008_256_18_20230907_00002.jpg

LM Start	2.66	Rating **	M	Issue No.	18
LM End	2.66	Issue Type +	Ma	Location *	WS
Category	Earthen Levee			GPS Latitude/Longitude	
				Start	End
Item	Cracking			38.748258°	38.748258°
				-121.694821°	-121.694821°
DWR ID	DWR_NA0008_01_s_2023_18				
Comment Code					
CR1 : Monitor and have inspected by geotechnical engineer.					
Inspector Comment					
Appears to be a 50' linear crack at waterside toe. Monitor and have inspected by a geotech.

View of crack on waterside slope near the toe. Spring 2023.

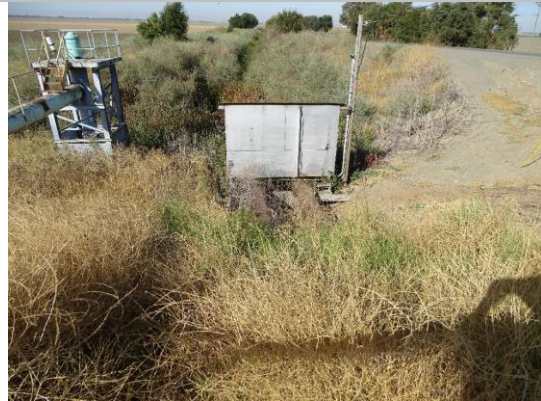
Photo 1 of 3 : UCIP_FA_2023_55711_82498.jpg

Comment Code						
Inspector Comment						
DS_ID:19365 FS_ID:55711 EP_NO: 9301 Repair Type: Non-Urgent EVAL Issue: Crossing Status: Found UCIP Comments: 10/8/2019 Record updated from No Action Needed to Non-Urgent. Need to have CVFPB review ABO and determine current owner. (O.Yakimov - DWR UCIP) FIELD_STRUCT_DESC: 1 of 2: 18-inch steel drainage pipe through the levee, 6.4 feet below the crown. Siphon breaker on the waterside (WS) slope. Pump house mounted on concrete box in irrigation ditch at the landside (LS) toe. (one 18-inch and one 24-inch pipes [HLM 2.7] authorized under Automatic Board Order (ABO) issued as Permit No. 9301, 1974 - Reclamation District No. 730). [Additional Reference(s): DWR Levee Log, 1990. USACE Sacramento O&M Manual 127, June 1953, (Station 128+00)]. FS Date: 10/8/2019 12:58:01 PM

View of LS looking from levee crown

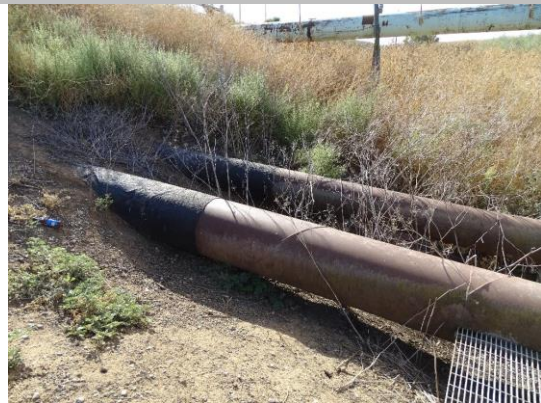
Photo 2 of 3 : UCIP_FA_2023_55711_82499.jpg

View of pipe on WS slope

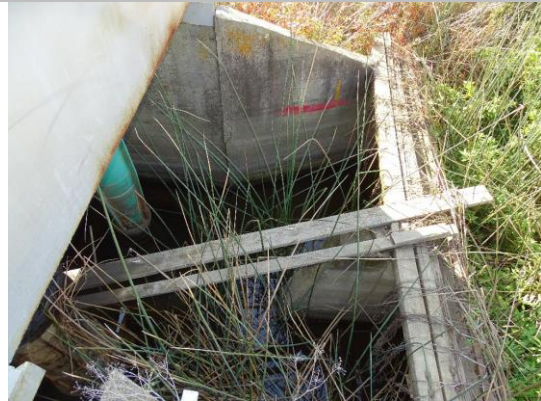
Photo 3 of 3 : UCIP_FA_2023_55711_82500.jpg

Concrete sump at pumping house

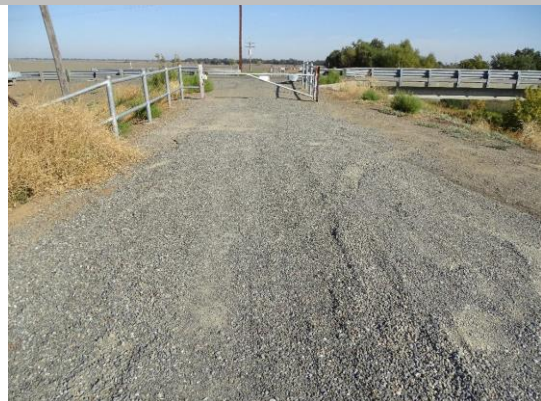
Photo 1 of 3 : UCIP_FA_2023_55712_82512.jpg

DS_ID:19392
 FS_ID:55712
 EP_NO: 9301
 Repair Type: Non-Urgent
 EVAL Issue:
 Crossing Status: Found
 UCIP Comments: 10/8/2019 Record updated from No Action Needed to Non-Urgent. Need to have CVFPB review ABO and determine current owner. (O.Yakimov - DWR UCIP)
 FIELD_STRUCT_DESC: 2 of 2: 24-inch steel drainage pipe through the levee, 7.3 feet below the crown. Pump house mounted on concrete box in irrigation ditch at the landside (LS) toe. Siphon breaker in riser on the waterside (WS) slope. (one 24-inch and one 18-inch pipes [HLM 2.7] authorized under Automatic Board Order (ABO) issued as Permit No. 9301, 1974 - Reclamation District No. 730). [Additional Reference(s): DWR Levee Log, 1990. USACE Sacramento O&M Manual 127, June 1953, (Station 128+00)].
 FS Date: 10/8/2019 1:07:27 PM

View of levee crown at the crossing

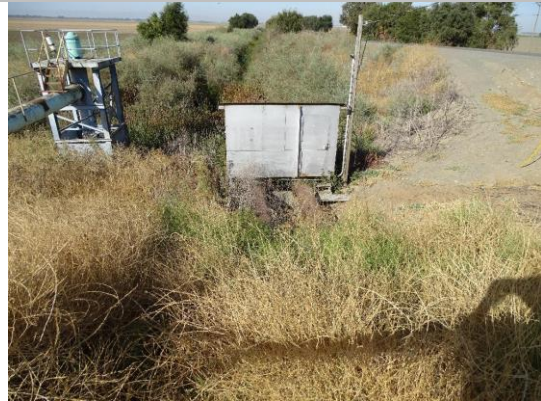
Photo 2 of 3 : UCIP_FA_2023_55712_82514.jpg

Pumphouse and pipe on LS toe

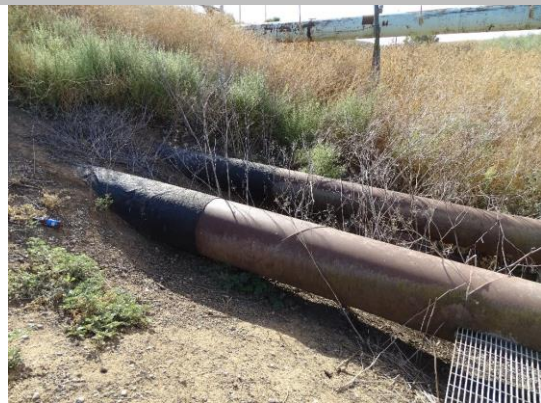
Photo 3 of 3 : UCIP_FA_2023_55712_82515.jpg

View of pipe on WS slope

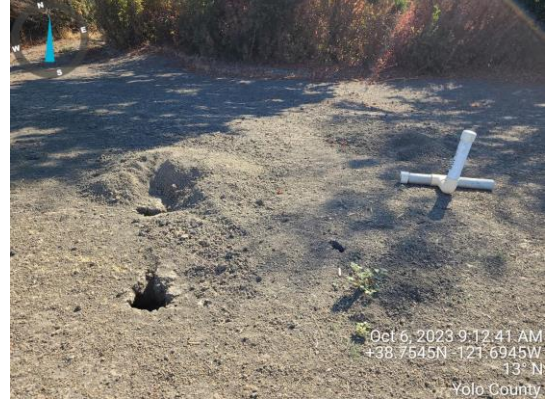
Photo 1 of 1 : FA_2023_NA0008_256_28_20231010_00042.jpg

View of rodent holes on the waterside slope. Fall 2023.

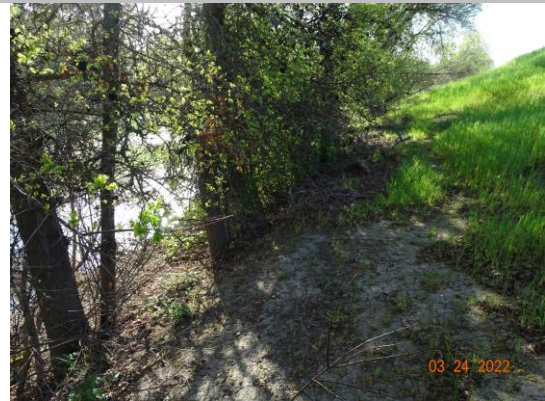
Photo 1 of 1 : FA_2023_NA0008_256_19_20230907_00003.jpg

LM Start	3.36	Rating **	M	Issue No.	19
LM End	3.44	Issue Type +	Ma	Location *	WS
Category	Supplemental			GPS Latitude/Longitude	
				Start	End
Item	2018 USACE Erosion Survey			38.758432°	38.759332°
				-121.695158°	-121.696063°
DWR ID	DWR_NA0008_01_s_2022_19				
Comment Code					
Inspector Comment					
2018 Site ID: KLR 3.5 R					
Status: Eroding					
2018 Field Notes: Last observed in 2011. Access issues prevented inspection in 2017.					
Site History: 2011 - Toe scour and bank slumping.

View of erosion at the waterside toe. Spring 2022.

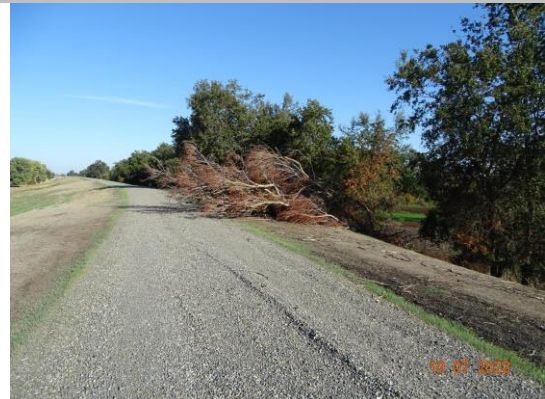
Photo 1 of 1 : FA_2023_NA0008_256_23_20230907_00006.jpg

LM Start	3.37	Rating **	M	Issue No.	23
LM End	3.37	Issue Type +	Ma	Location *	WS
Category	Earthen Levee			GPS Latitude/Longitude	
				Start	End
Item	Trim / Thin Trees			38.758477°	38.758477°
				-121.695431°	-121.695431°
DWR ID	DWR_NA0008_01_f_2022_23				
Comment Code					
T3 : Fallen tree with root ball.					
Inspector Comment

View of fallen tree on the waterside slope and crown. Fall 2022.

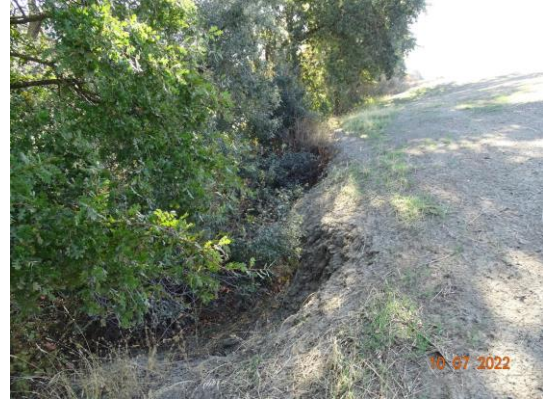
Photo 1 of 1 : FA_2023_NA0008_256_20_20230907_00004.jpg

LM Start	3.50	Rating **	M	Issue No.	20
LM End	3.50	Issue Type +	Ma	Location *	WS
Category	Earthen Levee			GPS Latitude/Longitude	
				Start	End
Item	Erosion / Bank Caving			38.759910°	38.759910°
				-121.696920°	-121.696920°
DWR ID	DWR_NA0008_01_f_2015_20				
Comment Code					
E2 : Schedule repair of erosion site prior to the next inspection.					
Inspector Comment

View of erosion on the waterside slope. Fall 2022.

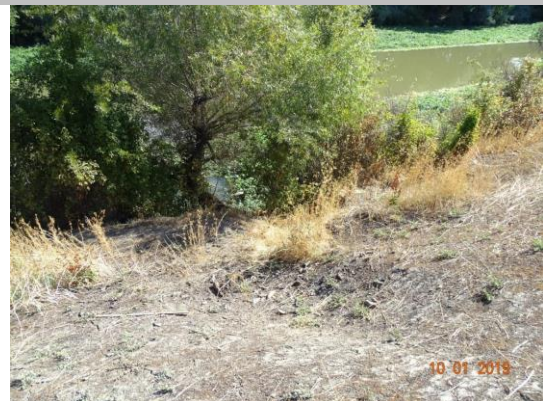
Photo 1 of 1 : FA_2023_NA0008_256_31_20230907_00009.jpg

LM Start	3.86	Rating **	A/W	Issue No.	31
LM End	3.86	Issue Type +	Ma	Location *	WS
Category	Earthen Levee			GPS Latitude/Longitude	
				Start	End
Item	Erosion / Bank Caving			38.763751°	38.763751°
				-121.701398°	-121.701398°
DWR ID	DWR_NA0008_01_s_2018_31				
Comment Code					
E1 : Note and monitor erosion site.					
Inspector Comment					
The erosion appears to be stable. LMA continues to monitor.

View of the erosion at the waterside toe. Fall 2019.

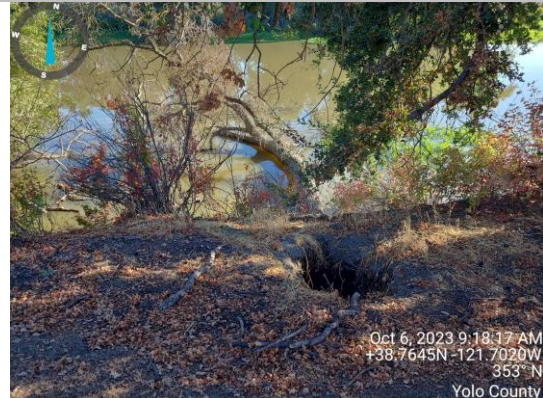
Photo 1 of 1 : FA_2023_NA0008_256_29_20231010_00043.jpg

LM Start	3.88	Rating **	M	Issue No.	21
LM End	3.95	Issue Type +	Ma	Location *	WS
Category	Supplemental			GPS Latitude/Longitude	
				Start	End
Item	2018 USACE Erosion Survey			38.764037°	38.764905°
				-121.701434°	-121.702074°
DWR ID	DWR_NA0008_01_s_2022_21				
Comment Code					
Inspector Comment					
2018 Site ID: KLR 3.9 R					
Status: Eroding					
2018 Field Notes: Last observed in 2011. Access issues prevented inspection in 2017.					
Site History: 2011 - Toe erosion and erosion pockets from tree popouts. More tree popouts are expected due to the eroding toe.

View of fallen tree at the waterside toe. Fall 2023.

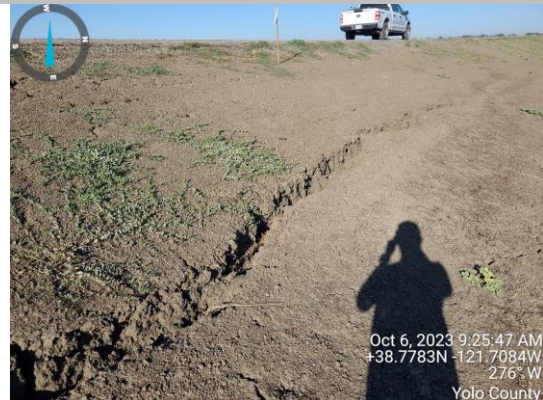
Photo 1 of 1 : FA_2023_NA0008_256_16_20231010_00040.jpg

LM Start	4.96	Rating **	M	Issue No.	16
LM End	4.96	Issue Type +	Ma	Location *	WS
Category	Earthen Levee			GPS Latitude/Longitude	
				Start	End
Item	Cracking			38.778300°	38.778300°
				-121.708400°	-121.708400°
DWR ID	DWR_NA0008_01_f_2023_16				
Comment Code					
CR1 : Monitor and have inspected by geotechnical engineer.					
Inspector Comment					
Appears to be a large 50' desiccation crack on the waterside slope.

View of crack on the waterside slope. Fall 2023.

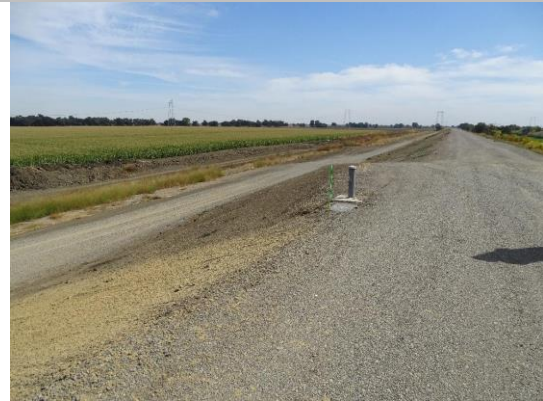
Photo 1 of 3 : UCIP_FA_2023_55758_82732.jpg

Comment Code						
Inspector Comment						
DS_ID:25471 FS_ID:55758 EP_NO: N/A Repair Type: Non-Urgent EVAL Issue: Crossing Status: Found UCIP Comments: 10/08/2019 Record remains Non-Urgent. Encroachment permit is missing. No details provided from Levee Improvement Project. (O.Yakimov - DWR UCIP) 09/27/2017 Previous 12-inch pipe (see DSID 19371) was replaced with new 18-inch steel pipe as part of the Knights Landing 2015 Levee Repair Project. No integrity issues were recorded by DWR levee inspector Zachary Jojola. Inspector located the concrete headwall, flap gate, and manual operator for the 12-inch pipe. No as-builts have been received to confirm the details of the new pipe or the abandoned structures allowed to remain from the previous structure. UCIP staff will need to follow-up with LMA to obtain as-built records and authorizing permit. (DWR UCIP - O. Magana)09/01/2016 - pipe was replaced as part of the knights landing 2015 levee repair project. UCIP has requested the As-builts from the LMA and will update the record when those are received. (T. Hatch/UCIP) FIELD_STRUCT_DESC: Replacement of DSID 19371. 18-inch steel drainage pipe through the levee, at an unknown depth. Pump in a metal pump house on the landside (LS) toe in a drainage canal. Concrete headwall on the waterside (WS) toe. Flap gate on the WS at the headwall. Manhole labeled storm drain at the WS shoulder, ait vent on LS shoulder. (18-inch steel pipe installed as part of the Knights Landing 2015 Levee Repair Project, as a replacement of 12-inch pipe). FS Date: 10/8/2019 1:36:03 PM

Air vent on LS shoulder

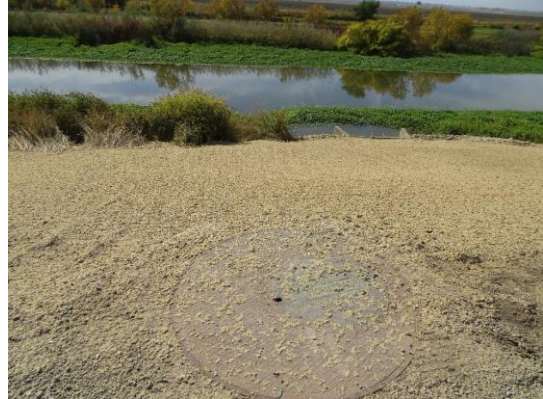
Photo 2 of 3 : UCIP_FA_2023_55758_82731.jpg

Closure device in manhole at WS soulder

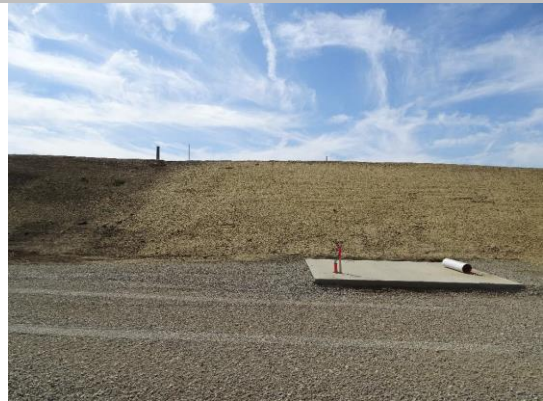
Photo 3 of 3 : UCIP_FA_2023_55758_82730.jpg

LS levee slope looking towards levee

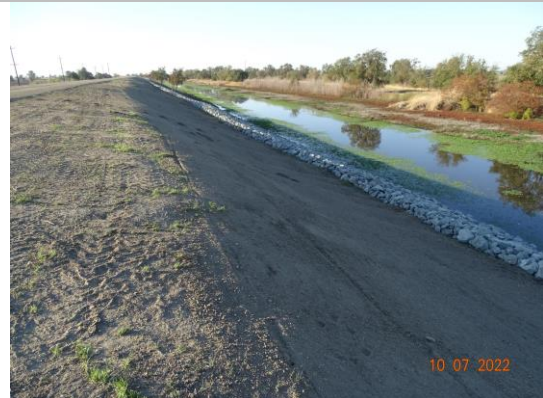
Photo 1 of 1 : FA_2023_NA0008_257_8_20230907_00002.jpg

LM Start	2.72	Rating **	A/W	Issue No.	8
LM End	2.93	Issue Type +	Ma	Location *	WS
Category	Supplemental			GPS Latitude/Longitude	
				Start	End
Item	2018 USACE Erosion Survey			38.754899°	38.757925°
				-121.692653°	-121.693048°
DWR ID	DWR_NA0008_02_s_2022_8				
Comment Code					
Inspector Comment					
2018 Site ID: KLR 3.0 L Status: Eroding 2018 Field Notes: Last observed in 2011. Access issues prevented inspection in 2017. Site History: 2006 - The whole levee toe area is slowly slumping into the channel (creep) due to dewatering and poor slope soils. Occasional piping in the levee slope evident as well. Pistol-butted trees at the levee toe indicate slow retreat. 2011 - Multiple scallops throughout the site and slumping of the toe. DWR Inspector Comment: District is placing riprap along the toe.

View of repaired waterside slope. Fall 2022.

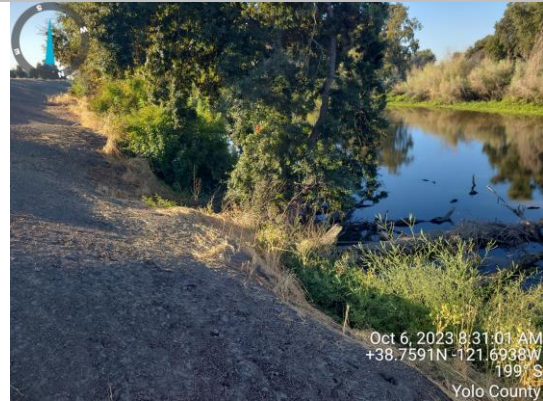
Photo 1 of 1 : FA_2023_NA0008_257_9_20231010_00021.jpg

LM Start	2.98	Rating **	M	Issue No.	9
LM End	3.11	Issue Type +	Ma	Location *	WS
Category	Supplemental			GPS Latitude/Longitude	
Item				Start	End
	2018 USACE Erosion Survey	38.758587°	38.760053°		
			-121.693359°	-121.694686°	
DWR ID	DWR_NA0008_02_s_2022_9				
Comment Code					
Inspector Comment					
2018 Site ID: KLR 3.1 L					
Status: Eroding					
2018 Field Notes: Last observed in 2011. Access issues prevented inspection in 2017.					
Site History: 2006 - The whole levee toe area is slowly slumping into the channel (creep) due to dewatering and poor slope soils. Occasional piping in the levee slope evident as well. Pistol-butted trees at the levee toe indicate slow retreat. 2011 - Slumping of the levee toe.					
DWR Comment: Erosion due to opening within channel.

View of erosion at waterside edge. Fall 2023.

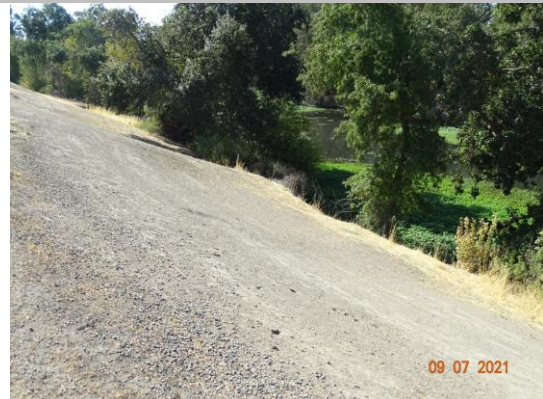
Photo 1 of 1 : FA_2023_NA0008_257_14_20230907_00006.jpg

LM Start	3.31	Rating **	A/W	Issue No.	14
LM End	3.31	Issue Type +	Ma	Location *	WS
Category	Earthen Levee			GPS Latitude/Longitude	
				Start	End
Item	Erosion / Bank Caving			38.762301°	38.762301°
				-121.697190°	-121.697190°
DWR ID	DWR_NA0008_02_f_2018_14				
Comment Code					
E1 : Note and monitor erosion site.					
Inspector Comment					
The primary channel changes course throughout the water year and erodes the slope through an opening in the center barrier. The slope appears to be stable and erosion is not within the prism. The levee is further reinforced by the newly constructed berm on the landside. Recommend monitoring.

View of erosion at waterside toe. Fall 2021.

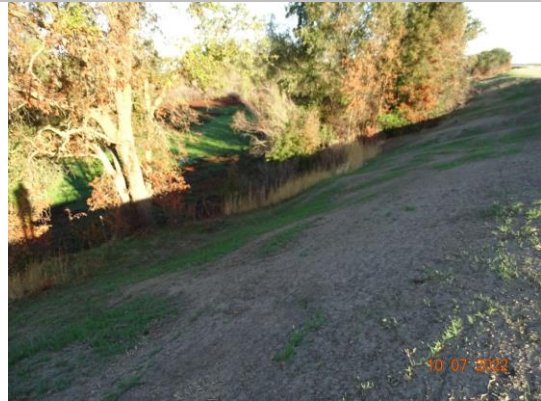
Photo 1 of 1 : FA_2023_NA0008_257_10_20230907_00004.jpg

LM Start	3.60	Rating **	A/W	Issue No.	10
LM End	3.73	Issue Type +	Ma	Location *	WS
Category	Supplemental			GPS Latitude/Longitude	
				Start	End
Item	2018 USACE Erosion Survey			38.765522°	38.767336°
				-121.700608°	-121.701023°
DWR ID	DWR_NA0008_02_s_2022_10				
Comment Code					
Inspector Comment					
2018 Site ID: KLR 3.7 L Status: Eroding 2018 Field Notes: Last observed in 2011. Access issues prevented inspection in 2017. Site History: 2011 - The toe has eroded away and there are a few scallops from bank slumping.					
DWR Comment: Erosion due to opening within channel. Not within the prism. Recommend monitoring.

View of erosion at the waterside edge. Fall 2022.

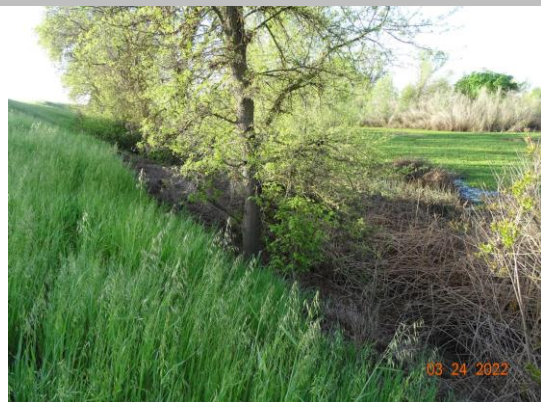
Photo 1 of 1 : FA_2023_NA0008_257_11_20230907_00005.jpg

LM Start	4.30	Rating **	A/W	Issue No.	11
LM End	4.55	Issue Type +	Ma	Location *	WS
Category	Supplemental			GPS Latitude/Longitude	
				Start	End
Item	2018 USACE Erosion Survey			38.775271°	38.778115°
				-121.703685°	-121.706195°
DWR ID	DWR_NA0008_02_s_2022_11				
Comment Code					
Inspector Comment					
2018 Site ID: KLR 4.7 L					
Status: Eroding					
2018 Field Notes: Last observed in 2011. Access issues prevented inspection in 2017.					
Site History: 2011 - This site is the downstream section of the old KLR 5.3L site. Levee toe is slowly retreating. Cracking on top of the levee may indicate potential mass movement.

View of erosion at waterside toe. Spring 2022.
