**Flood Control Project Maintenance  
Levee Inspections**

## Maintenance Issue Types Only, Levee Inspection Report By Mile - Fall 2024

### Knights Landing Ridge Drainage District

Waterway	Bank	Unit Miles	Inspection Start/End	Inspector
Unit No. 01 Knights Landing Ridge Cut	Right	6.36	09/23/2024 09/23/2024	Zach Jojola

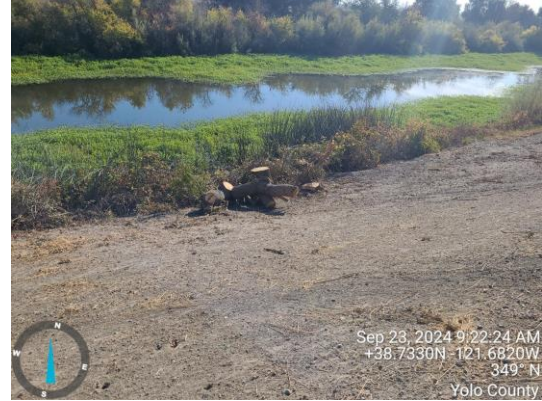
Photo 1 of 1 : FA\_2024\_NA0008\_256\_28\_20240923\_00051.jpg

LM Start	1.40	Rating **	M	Issue No.	28
LM End	1.40	Issue Type +	Ma	Location *	WS
Category	Earthen Levee			GPS Latitude/Longitude	
				Start	End
Item	Trim / Thin Trees			38.733163°	38.733163°
				-121.681901°	-121.681901°
DWR ID	DWR_NA0008_01_f_2024_28				
Comment Code					
T2 : Tree or limb.					
Inspector Comment					
Tree trunk and limbs on the waterside slope.

View of tree trunk and limbs on the waterside slope. Fall 2024.

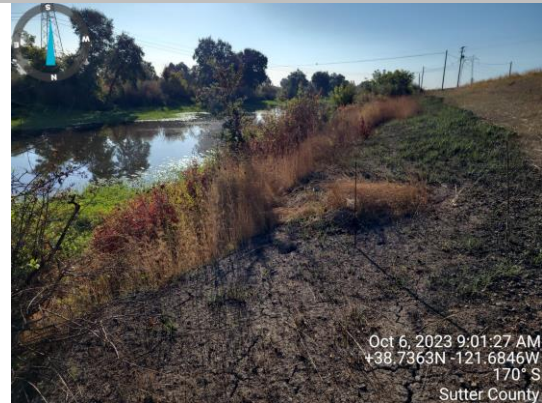
Photo 1 of 1 : FA\_2024\_NA0008\_256\_17\_20240909\_00002.jpg

LM Start	1.66	Rating **	A/W	Issue No.	17
LM End	1.66	Issue Type +	Ma	Location *	WS
Category	Earthen Levee			GPS Latitude/Longitude	
				Start	End
Item	Erosion / Bank Caving			38.736300°	38.736300°
				-121.684600°	-121.684600°
DWR ID	DWR_NA0008_01_f_2023_17				
Comment Code					
E1 : Note and monitor erosion site.					
Inspector Comment					
Erosion within waterside berm. Recommend monitoring.

View of erosion on waterside berm. Fall 2023.

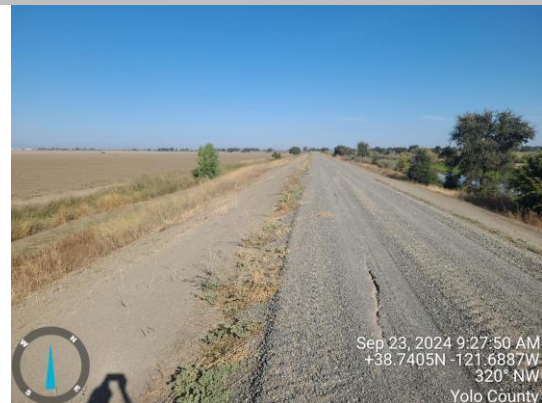
Photo 1 of 1 : FA\_2024\_NA0008\_256\_34\_20240923\_00052.jpg

LM Start	2.03	Rating **	M	Issue No.	34
LM End	2.04	Issue Type +	Ma	Location *	CR
Category	Earthen Levee			GPS Latitude/Longitude	
				Start	End
Item	Cracking			38.740511°	38.740688°
				-121.688702°	-121.688867°
DWR ID	DWR_NA0008_01_f_2024_34				
Comment Code					
CR1 : Monitor and have inspected by geotechnical engineer.					
Inspector Comment					
There is a 100' crack on the crown near the landside shoulder. District is aware of the crack and had it inspected by a Geotech. Recommend monitoring for future movement.

View of crack on the crown. Fall 2024.

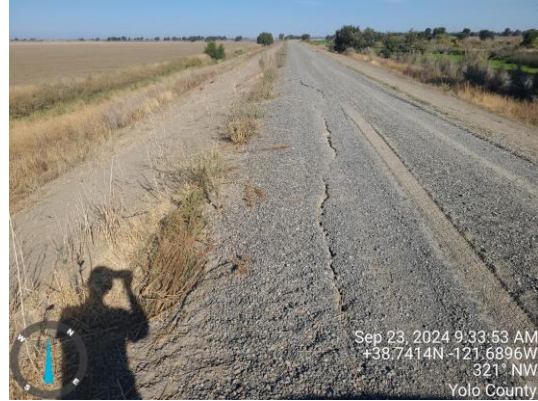
Photo 1 of 1 : FA\_2024\_NA0008\_256\_35\_20240923\_00053.jpg

LM Start	2.10	Rating **	M	Issue No.	35
LM End	2.12	Issue Type +	Ma	Location *	CR
Category	Earthen Levee			GPS Latitude/Longitude	
				Start	End
Item	Cracking			38.741440°	38.741643°
				-121.689562°	-121.689745°
DWR ID	DWR_NA0008_01_f_2024_35				
Comment Code					
CR1 : Monitor and have inspected by geotechnical engineer.					
Inspector Comment					
There is a 100' crack on the crown near the landside shoulder. The district is aware of the issue and had it inspected by a Geotech. Recommend monitoring for further movement.

View of crack on the crown. Fall 2024.

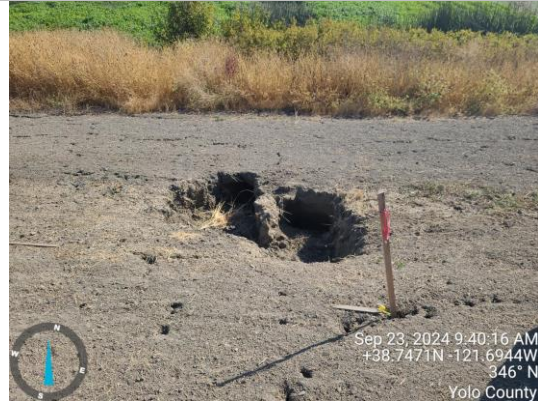
Photo 1 of 1 : FA\_2024\_NA0008\_256\_25\_20240923\_00054.jpg

LM Start	2.57	Rating **	A/W	Issue No.	25
LM End	2.57	Issue Type +	Ma	Location *	WS
Category	Earthen Levee			GPS Latitude/Longitude	
				Start	End
Item	Erosion / Bank Caving			38.746987°	38.746987°
				-121.694364°	-121.694364°
DWR ID	DWR_NA0008_01_s_2024_25				
Comment Code					
E2 : Schedule repair of erosion site prior to the next inspection.					
Inspector Comment					
A sinkhole is located on the waterside slope. The pipe is visible from the sinkhole. This is also captured in the U rated UCIP pipe #19364.

View of sinkhole on the waterside slope. Fall 2024.

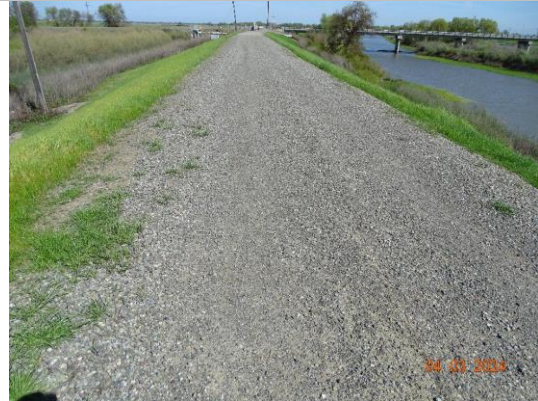
Photo 1 of 3 : UCIP\_FA\_2024\_83872\_123245.jpg

DS\_ID:19391  
FS\_ID:83872  
EP\_NO: 9307  
Repair Type: Urgent  
EVAL Issue: 1, Pipe Integrity  
Crossing Status: Found  
UCIP Comments: 04/03/2024 Record remains Urgent. DMP internal video inspection has found severe pipe defects. Erosion observed on both sides of concrete headwall at riverbank. Still missing walkway to the slide gate actuator on waterside. No permit has been identified authorizing pipe. Need to have CVFPB review ABO and determine current owner. (O. Yakimov - DWR UCIP)  
12/14/2022 Record updated from Non-Urgent to Urgent. DMP internal video inspection has found pipe integrity issues. LOF of crossing is between 5 and 6. Crossing will be monitored until funding becomes available to address the issues. (O.Yakimov - DWR UCIP)  
10/8/2019 Record remains Non-Urgent. slide gate actuator is not accessible without use of equipment. Need to have CVFPB review ABO and determine current owner. (O.Yakimov - DWR UCIP) 04/05/2013 Walkway to actuator slide gate is missing. No method of actuating slide gate. (W.Wylie - DWR UCIP)

Top of Levee: View of levee crown looking upstream

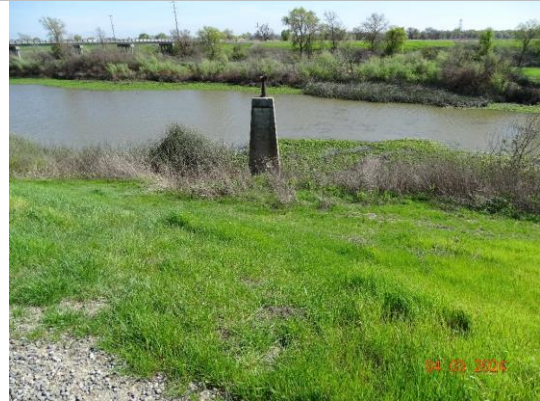
Photo 2 of 3 : UCIP\_FA\_2024\_83872\_123246.jpg

Water-Side: View of levee slope looking from crown. Concrete headwall with slide gate at riverbank

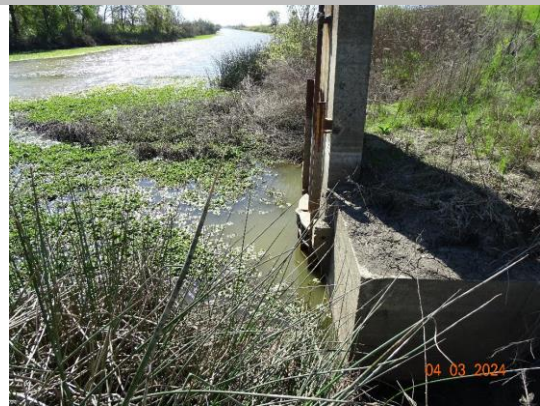
Photo 3 of 3 : UCIP\_FA\_2024\_83872\_123242.jpg

Water-Side: Concrete headwall with slide gate at riverbank. Erosion on both sides of headwall

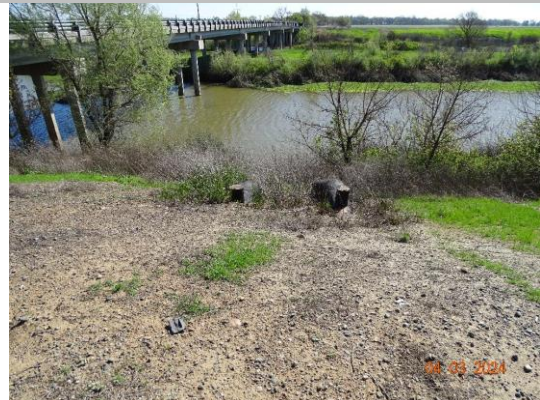
Photo 2 of 3 : UCIP\_FA\_2024\_83884\_123283.jpg

Water-Side: View of levee slope looking from crown. Pipes daylight on the slope

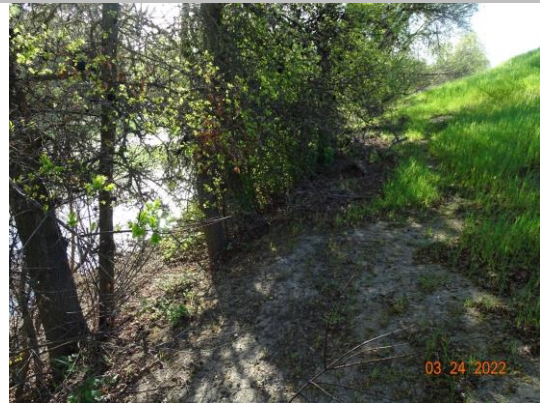
Photo 1 of 1 : FA\_2024\_NA0008\_256\_19\_20240909\_00003.jpg

LM Start	3.36	Rating **	M	Issue No.	19
LM End	3.44	Issue Type +	Ma	Location *	WS
Category	Supplemental			GPS Latitude/Longitude	
				Start	End
Item	2018 USACE Erosion Survey			38.758432°	38.759332°
				-121.695158°	-121.696063°
DWR ID	DWR_NA0008_01_s_2022_19				
Comment Code					
Inspector Comment					
2018 Site ID: KLR 3.5 R					
Status: Eroding					
2018 Field Notes: Last observed in 2011. Access issues prevented inspection in 2017.					
Site History: 2011 - Toe scour and bank slumping.

View of erosion at the waterside toe. Spring 2022.

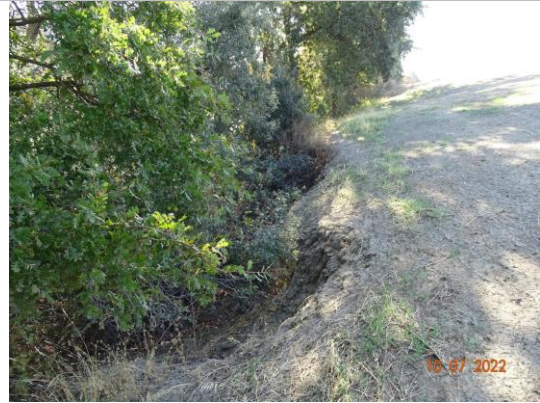
Photo 1 of 1 : FA\_2024\_NA0008\_256\_20\_20240909\_00004.jpg

LM Start	3.50	Rating **	M	Issue No.	20
LM End	3.50	Issue Type +	Ma	Location *	WS
Category	Earthen Levee			GPS Latitude/Longitude	
				Start	End
Item	Erosion / Bank Caving			38.759910°	38.759910°
				-121.696920°	-121.696920°
DWR ID	DWR_NA0008_01_f_2015_20				
Comment Code					
E2 : Schedule repair of erosion site prior to the next inspection.					
Inspector Comment

View of erosion on the waterside slope. Fall 2022.

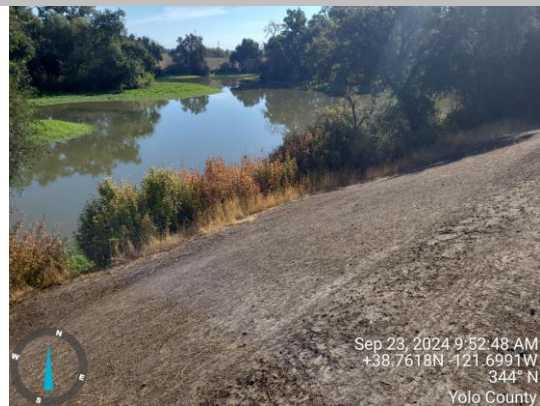
Photo 1 of 1 : FA\_2024\_NA0008\_256\_36\_20240923\_00055.jpg

LM Start	3.67	Rating **	A/W	Issue No.	36
LM End	3.67	Issue Type +	Ma	Location *	WS
Category	Earthen Levee			GPS Latitude/Longitude	
				Start	End
Item	Erosion / Bank Caving			38.761681°	38.761681°
				-121.698991°	-121.698991°
DWR ID	DWR_NA0008_01_f_2024_36				
Comment Code					
E1 : Note and monitor erosion site.					
Inspector Comment					
Section of levee where the middle channel divider opens up and there is more turbulent flow. Waterside toe has a vertical wall, but there is no erosion within the prism. Recommend monitoring.

View of erosion at the waterside toe. Fall 2024.

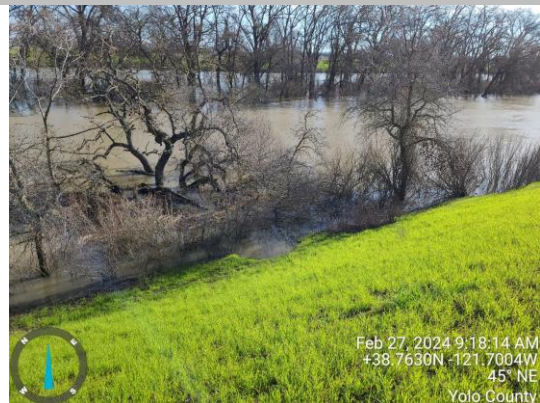
Photo 1 of 1 : FA\_2024\_NA0008\_256\_30\_20240909\_00010.jpg

LM Start	3.78	Rating **	U	Issue No.	30
LM End	3.78	Issue Type +	Ma	Location *	WS
Category	Earthen Levee			GPS Latitude/Longitude	
				Start	End
Item	Erosion / Bank Caving			38.762886°	38.762886°
				-121.700406°	-121.700406°
DWR ID	DWR_NA0008_01_s_2017_30				
Comment Code					
E2 : Schedule repair of erosion site prior to the next inspection.					
Inspector Comment					
There is a hole from a fallen tree at the waterside toe.

View of erosion at the waterside toe. Spring 2024.

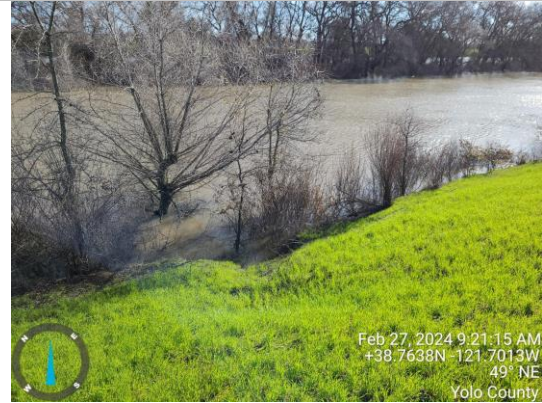
Photo 1 of 1 : FA\_2024\_NA0008\_256\_31\_20240909\_00011.jpg

LM Start	3.86	Rating **	M	Issue No.	31
LM End	3.86	Issue Type +	Ma	Location *	WS
Category	Earthen Levee			GPS Latitude/Longitude	
				Start	End
Item	Erosion / Bank Caving			38.763751°	38.763751°
				-121.701398°	-121.701398°
DWR ID	DWR_NA0008_01_s_2018_31				
Comment Code					
E2 : Schedule repair of erosion site prior to the next inspection.					
Inspector Comment					
The erosion appears to be stable but should be repaired.

View of erosion at the waterside toe. Spring 2024.

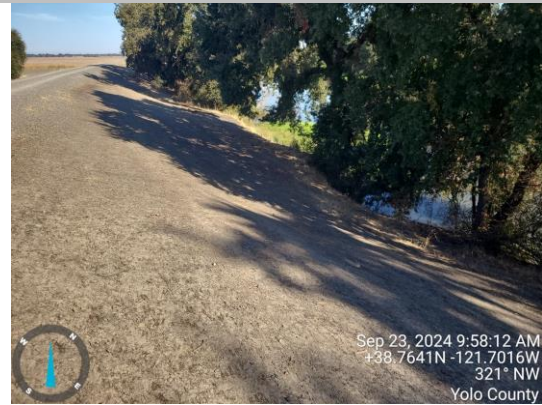
Photo 1 of 1 : FA\_2024\_NA0008\_256\_21\_20240923\_00056.jpg

LM Start	3.88	Rating **	M	Issue No.	21
LM End	3.95	Issue Type +	Ma	Location *	WS
Category	Supplemental			GPS Latitude/Longitude	
				Start	End
Item	2018 USACE Erosion Survey			38.764037°	38.764905°
				-121.701434°	-121.702074°
DWR ID	DWR_NA0008_01_s_2022_21				
Comment Code					
Inspector Comment					
2018 Site ID: KLR 3.9 R					
Status: Eroding					
2018 Field Notes: Last observed in 2011. Access issues prevented inspection in 2017.					
Site History: 2011 - Toe erosion and erosion pockets from tree popouts. More tree popouts are expected due to the eroding toe.

View of erosion at the waterside toe. Fall 2024.

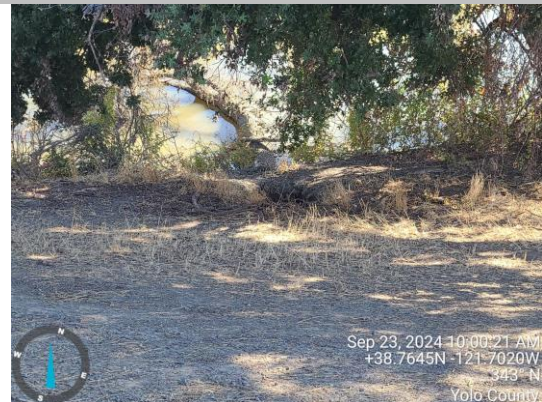
Photo 1 of 1 : FA\_2024\_NA0008\_256\_29\_20240923\_00057.jpg

LM Start	3.92	Rating **	M	Issue No.	29
LM End	3.92	Issue Type +	Ma	Location *	WS
Category	Earthen Levee			GPS Latitude/Longitude	
				Start	End
Item	Trim / Thin Trees			38.764500°	38.764500°
				-121.702000°	-121.702000°
DWR ID	DWR_NA0008_01_f_2023_29				
Comment Code					
T3 : Fallen tree with root ball.					
Inspector Comment					
Fallen tree with root ball at the waterside toe.

View of fallen tree and hole on the waterside slope. Fall 2024.

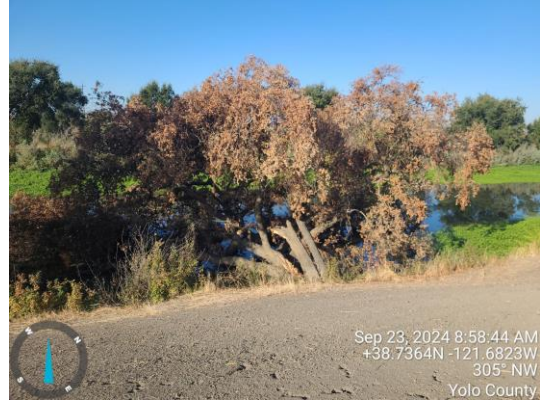
Photo 1 of 1 : FA\_2024\_NA0008\_257\_13\_20240923\_00030.jpg

LM Start	1.27	Rating **	A/W	Issue No.	13
LM End	1.27	Issue Type +	Ma	Location *	WS
Category	Earthen Levee			GPS Latitude/Longitude	
				Start	End
Item	Trim / Thin Trees			38.736359°	38.736359°
				-121.682424°	-121.682424°
DWR ID	DWR_NA0008_02_s_2024_13				
Comment Code					
T2 : Tree or limb.					
Inspector Comment					
Fallen tree in the channel. No root ball, but could potentially cause erosion in the future. Recommend monitoring.

View of fallen tree at the waterside toe. Fall 2024.

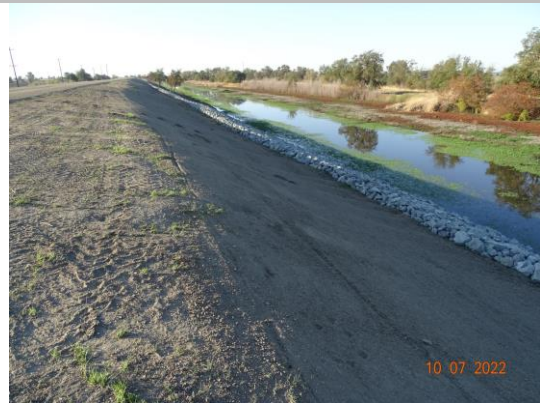
Photo 1 of 1 : FA\_2024\_NA0008\_257\_8\_20240909\_00003.jpg

LM Start	2.72	Rating **	A/W	Issue No.	8
LM End	2.93	Issue Type +	Ma	Location *	WS
Category	Supplemental			GPS Latitude/Longitude	
				Start	End
Item	2018 USACE Erosion Survey			38.754899°	38.757925°
				-121.692653°	-121.693048°
DWR ID	DWR_NA0008_02_s_2022_8

2018 Site ID: KLR 3.0 L  
Status: Eroding  
2018 Field Notes: Last observed in 2011. Access issues prevented inspection in 2017.  
Site History: 2006 - The whole levee toe area is slowly slumping into the channel (creep) due to dewatering and poor slope soils. Occasional piping in the levee slope evident as well. Pistol-butted trees at the levee toe indicate slow retreat. 2011 - Multiple scallops throughout the site and slumping of the toe.

View of repaired waterside slope. Fall 2022.

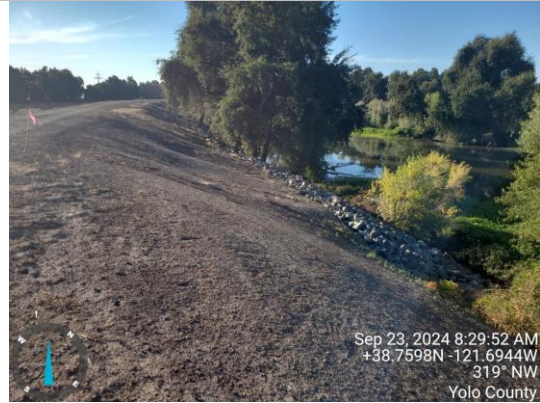
Photo 1 of 1 : FA\_2024\_NA0008\_257\_9\_20240923\_00029.jpg

LM Start	2.98	Rating **	A/W	Issue No.	9
LM End	3.11	Issue Type +	Ma	Location *	WS
Category	Supplemental			GPS Latitude/Longitude	
				Start	End
Item	2018 USACE Erosion Survey			38.758587°	38.760053°
				-121.693359°	-121.694686°
DWR ID	DWR_NA0008_02_s_2022_9				
Comment Code					
Inspector Comment					
2018 Site ID: KLR 3.1 L					
Status: Eroding					
2018 Field Notes: Last observed in 2011. Access issues prevented inspection in 2017.					
Site History: 2006 - The whole levee toe area is slowly slumping into the channel (creep) due to dewatering and poor slope soils. Occasional piping in the levee slope evident as well. Pistol-butted trees at the levee toe indicate slow retreat. 2011 - Slumping of the levee toe.					
DWR Comment: As of this inspection date, the district has a contractor repairing this section of levee.

View of erosion repair at the waterside toe. Fall 2024.

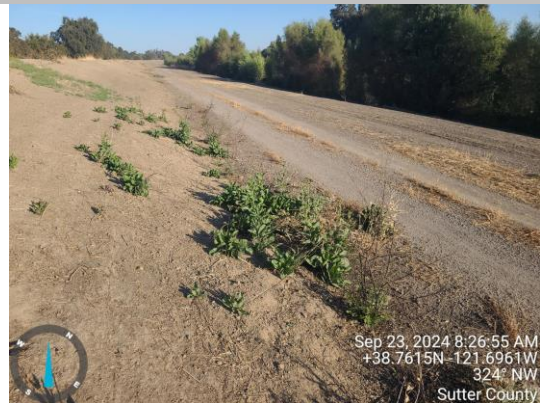
Photo 1 of 1 : FA\_2024\_NA0008\_257\_16\_20240923\_00028.jpg

LM Start	3.23	Rating **	M	Issue No.	16
LM End	3.23	Issue Type +	Ma	Location *	LS
Category	Earthen Levee			GPS Latitude/Longitude	
				Start	End
Item	Vegetation			38.761431°	38.761431°
				-121.696120°	-121.696120°
DWR ID	DWR_NA0008_02_f_2024_16				
Comment Code					
V2 : Remove the wild growth and woody vegetation other than native grasses from the levee slopes.					
Inspector Comment					
Small oak trees on the landside toe. Recommend removing.

View of woody vegetation at the landside toe. Fall 2024.

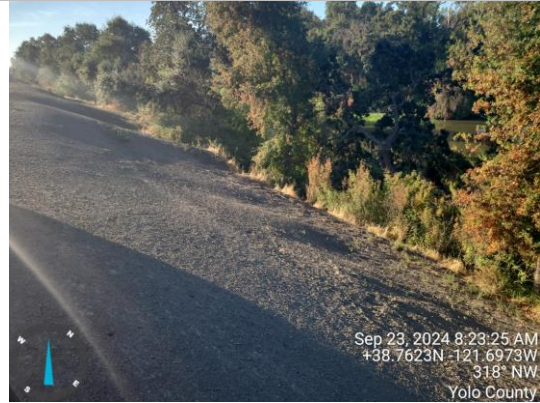
Photo 1 of 1 : FA\_2024\_NA0008\_257\_14\_20240923\_00027.jpg

View of erosion at the waterside toe. Fall 2024.

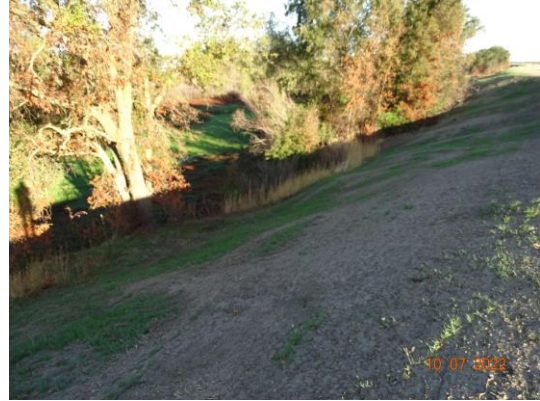
Photo 1 of 1 : FA\_2024\_NA0008\_257\_10\_20240909\_00005.jpg

LM Start	3.60	Rating **	A/W	Issue No.	10
LM End	3.73	Issue Type +	Ma	Location *	WS
Category	Supplemental			GPS Latitude/Longitude	
				Start	End
Item	2018 USACE Erosion Survey			38.765522°	38.767336°
				-121.700608°	-121.701023°
DWR ID	DWR_NA0008_02_s_2022_10				
Comment Code					
Inspector Comment					
2018 Site ID: KLR 3.7 L					
Status: Eroding					
2018 Field Notes: Last observed in 2011. Access issues prevented inspection in 2017.					
Site History: 2011 - The toe has eroded away and there are a few scallops from bank slumping.					
DWR Comment: Erosion due to opening within channel. Not within the prism. Recommend monitoring.

View of erosion at the waterside edge. Fall 2022.

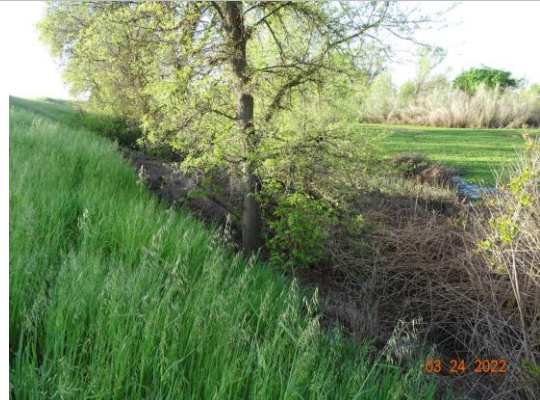
Photo 1 of 1 : FA\_2024\_NA0008\_257\_11\_20240909\_00006.jpg

LM Start	4.30	Rating **	A/W	Issue No.	11
LM End	4.55	Issue Type +	Ma	Location *	WS
Category	Supplemental			GPS Latitude/Longitude	
				Start	End
Item	2018 USACE Erosion Survey			38.775271°	38.778115°
				-121.703685°	-121.706195°
DWR ID	DWR_NA0008_02_s_2022_11				
Comment Code					
Inspector Comment					
2018 Site ID: KLR 4.7 L					
Status: Eroding					
2018 Field Notes: Last observed in 2011. Access issues prevented inspection in 2017.					
Site History: 2011 - This site is the downstream section of the old KLR 5.3L site. Levee toe is slowly retreating. Cracking on top of the levee may indicate potential mass movement.

View of erosion at waterside toe. Spring 2022.
