**Flood Control Project Maintenance
Levee Inspections**

Maintenance Issue Types Only, Levee Inspection Report By Mile - Spring 2015

Knights Landing Ridge Drainage District

Waterway	Bank	Unit Miles	Inspection Start/End	Inspector
Unit No. 01 Knights Landing Ridge Cut	Right	6.36	04/23/2015 04/23/2015	Jai Lor

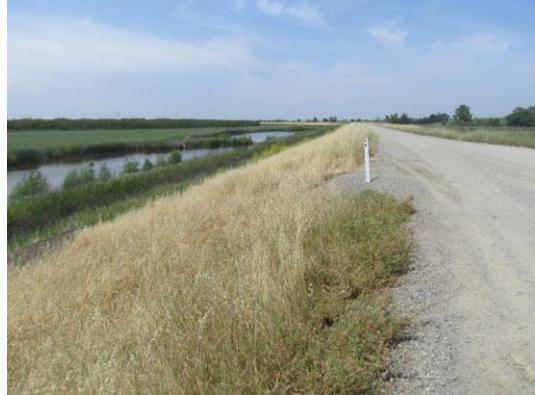
Photo 1 of 1 : SP_2015_NA0008_256_14_20150423_00013.jpg

LM Start	0.00	Rating **	M	Issue No.	14
LM End	6.34	Issue Type +	Ma	Location *	LS
Category	Earthen Levee		GPS Latitude/Longitude		
			Start	End	
Item	Vegetation		38.719088 °	38.792433 °	
			-121.664146 °	-121.726610 °	
DWR ID	DWR_NA0008_01_s_2015_14				
Action/Comments					
Control annual grass and weeds on the levee slopes and easements.

View of the vegetation on the landward side of the levee looking upstream. Spring 2015.

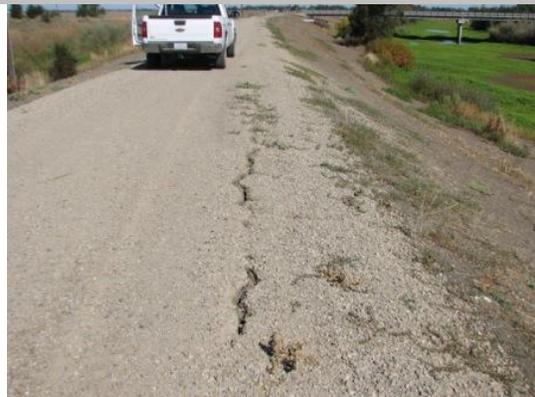
Photo 1 of 1 : SP_2015_NA0008_256_19_20150401_00003.jpg

LM Start	2.58	Rating **	A/W	Issue No.	19
LM End	2.58	Issue Type +	Ma	Location *	WS
Category	Earthen Levee		GPS Latitude/Longitude		
			Start	End	
Item	Cracking		38.747218 °	38.747218 °	
			-121.694450 °	-121.694450 °	
DWR ID	DWR_NA0008_01_f_2013_19				
Action/Comments					
Monitor and have inspected by geotechnical engineer. Inspector Comments: Cracks along crown and down waterside slope.

Cracking along the waterside shoulder of the crown the length of 20 feet. Fall 2013

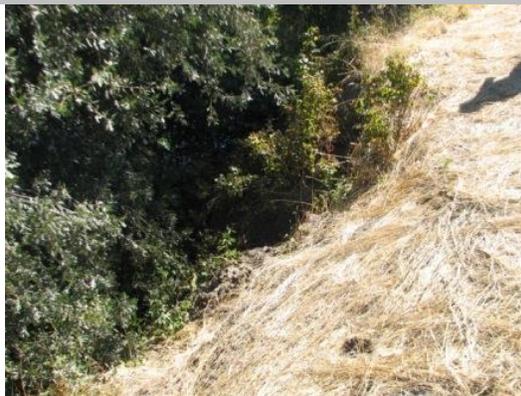
Photo 1 of 2 : SP_2015_NA0008_256_20_20150401_00004.jpg

LM Start	3.50	Rating **	M	Issue No.	20
LM End	3.50	Issue Type +	Ma	Location *	WS
Category	Earthen Levee			GPS Latitude/Longitude	
				Start	End
Item	Erosion / Bank Caving			38.759910 °	38.759910 °
				-121.696920 °	-121.696920 °
DWR ID	DWR_NA0008_01_f_2013_20				
Action/Comments					
Note and monitor erosion site.

Another view of the erosion cutting into the slope. Fall 2013

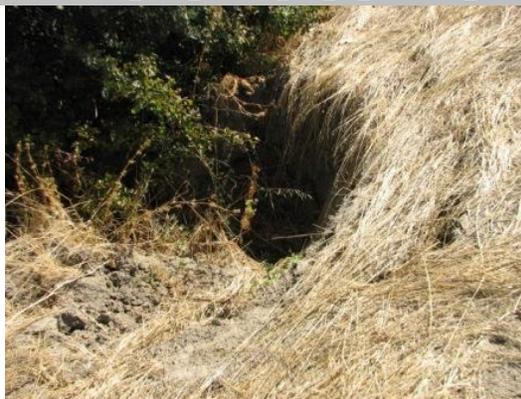
Photo 2 of 2 : SP_2015_NA0008_256_20_20150401_00005.jpg

Deep erosion at the bottom of the waterside slope 3-4 foot cut. Fall 2013

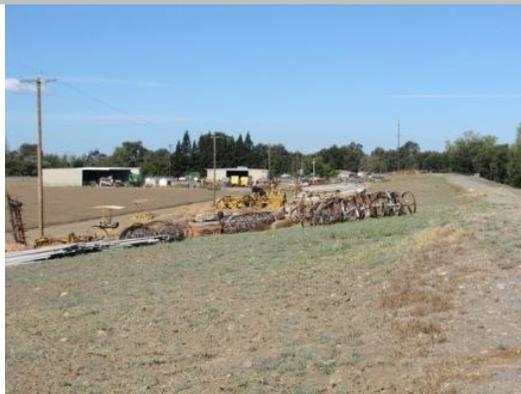
Photo 1 of 2 : SP_2015_NA0008_256_7_20150401_00001.jpg

LM Start	6.10	Rating **	M	Issue No.	7
LM End	6.34	Issue Type +	Ma	Location *	LS
Category	Earthen Levee			GPS Latitude/Longitude	
				Start	End
Item	Encroachments			38.790007 °	38.792433 °
				-121.723308 °	-121.726463 °
DWR ID	DWR_NA0008_01_s_2012_7				
Action/Comments					
Equipment

Equipment and irrigation pipe lays on the landside levee slope. Fall 2013

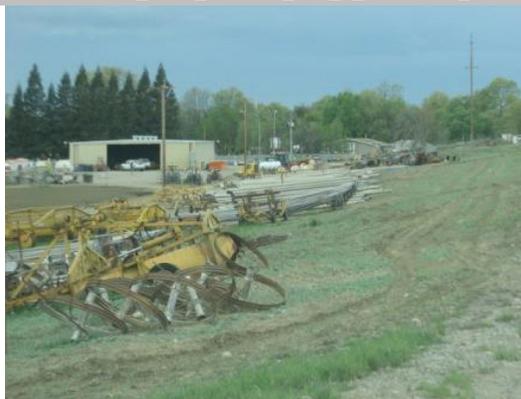
Photo 2 of 2 : SP_2015_NA0008_256_7_20150401_00002.jpg

A current view of the equipment on the levee slope. Spring 2014

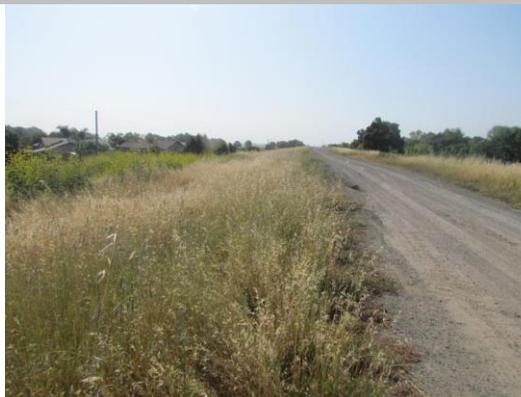
Photo 1 of 1 : SP_2015_NA0008_257_13_20150423_00015.jpg

LM Start	0.00	Rating **	M	Issue No.	13
LM End	5.92	Issue Type +	Ma	Location *	LS
Category	Earthen Levee		GPS Latitude/Longitude		
			Start	End	
Item	Vegetation		38.724259 °	38.792471 °	
			-121.665230 °	-121.723844 °	
DWR ID	DWR_NA0008_02_s_2015_13				
Action/Comments					
Control annual grass and weeds on the levee slopes and easements.

View of the vegetation on the landward side of the levee looking downstream. Spring 2015.

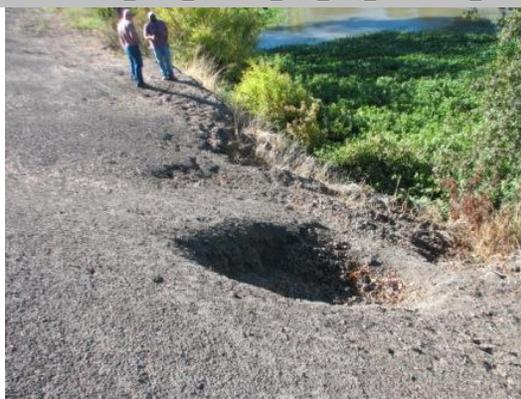
Photo 1 of 1 : SP_2015_NA0008_257_230_20150401_00010.jpg

LM Start	3.02	Rating **	U	Issue No.	230
LM End	3.02	Issue Type +	Ma	Location *	WS
Category	Earthen Levee			GPS Latitude/Longitude	
				Start	End
Item	Erosion / Bank Caving			38.759112 °	38.759112 °
				-121.693638 °	-121.693638 °
DWR ID	DWR_NA0008_02_f_2013_230				
Action/Comments					
Note and monitor erosion site.

Erosion at the bottom of the slope. It appears that a fallen tree has caused a sink hole. Fall 2013

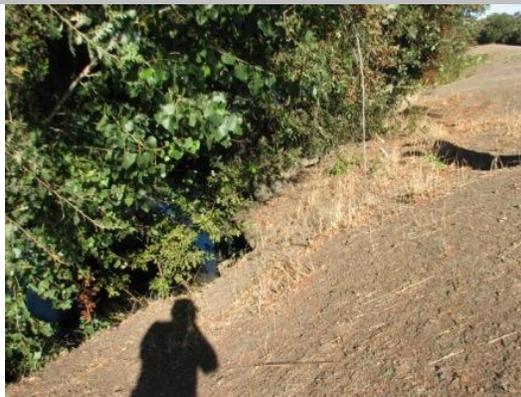
Photo 1 of 2 : SP_2015_NA0008_257_229_20150401_00008.jpg

LM Start	3.06	Rating **	U	Issue No.	229
LM End	3.06	Issue Type +	Ma	Location *	WS
Category	Earthen Levee			GPS Latitude/Longitude	
				Start	End
Item	Erosion / Bank Caving			38.759542 °	38.759542 °
				-121.694007 °	-121.694007 °
DWR ID	DWR_NA0008_02_f_2013_229				
Action/Comments					
Note and monitor erosion site. Inspector Comments: Erosion is undermining large oak tree and is growing.

Another view of the vertical cut at the bottom of the slope. Fall 2013

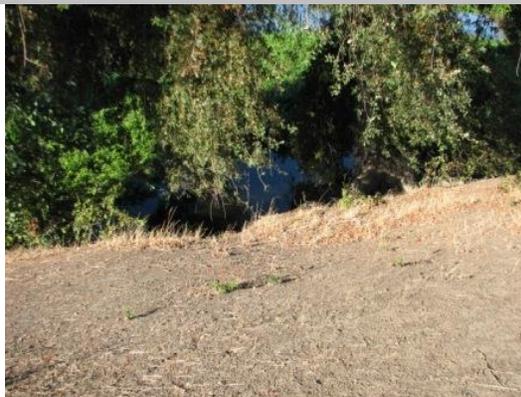
Photo 2 of 2 : SP_2015_NA0008_257_229_20150401_00009.jpg

LM Start	3.06	Rating **	U	Issue No.	229 (cont)
LM End	3.06	Issue Type +	Ma	Location *	WS
Category	Earthen Levee			GPS Latitude/Longitude	
				Start	End
Item	Erosion / Bank Caving			38.759542 °	38.759542 °
				-121.694007 °	-121.694007 °
DWR ID	DWR_NA0008_02_f_2013_229				
Action/Comments					
Note and monitor erosion site. Inspector Comments: Erosion is undermining large oak tree and is growing.

Waterside eroison vertical cut at bottom of slope. Fall 2013

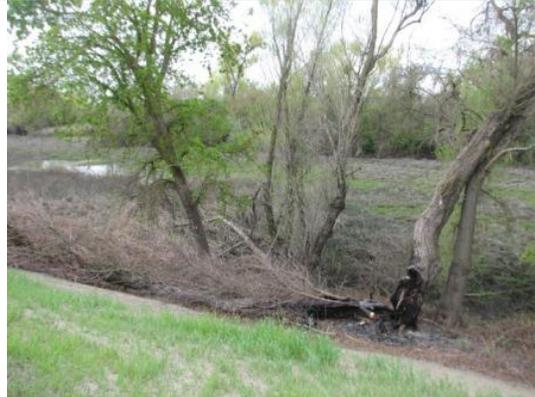
Photo 1 of 1 : SP_2015_NA0008_257_15_20150401_00004.jpg

LM Start	4.56	Rating **	U	Issue No.	15
LM End	4.56	Issue Type +	Ma	Location *	WS
Category	Earthen Levee		GPS Latitude/Longitude		
			Start	End	
Item	Vegetation		38.778402 °	38.778402 °	
			-121.706022 °	-121.706022 °	
DWR ID	DWR_NA0008_02_s_2014_15				
Action/Comments					
Trees / Woody Vegetation

A cottonwood tree may have been struck by lightning. The tree is split into three parts. Spring 2014

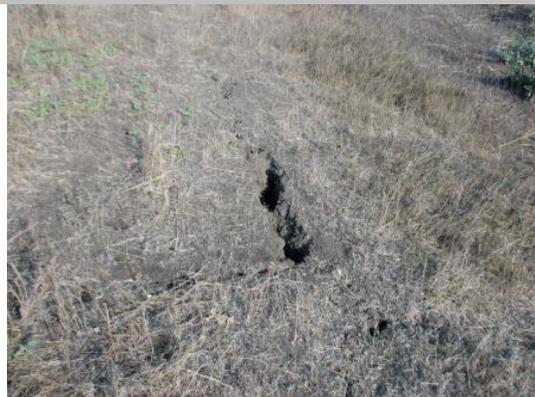
Photo 1 of 1 : SP_2015_NA0008_257_226_20150401_00005.jpg

LM Start	4.79	Rating **	A/W	Issue No.	226
LM End	4.82	Issue Type +	Ma	Location *	LS
Category	Earthen Levee		GPS Latitude/Longitude		
			Start	End	
Item	Cracking		38.780858 °	38.781102 °	
			-121.709093 °	-121.709385 °	
DWR ID	DWR_NA0008_02_f_2013_226				
Action/Comments					
Monitor and have inspected by geotechnical engineer.

Cracking on the landside is 3-4 inches wide and 12 inches deep. Fall 2013

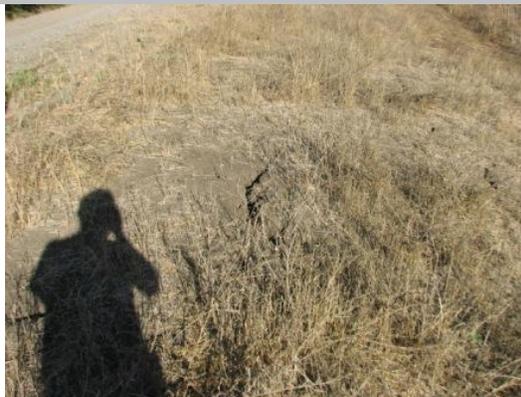
Photo 1 of 2 : SP_2015_NA0008_257_227_20150401_00006.jpg

LM Start	4.79	Rating **	A/W	Issue No.	227
LM End	4.79	Issue Type +	Ma	Location *	WS
Category	Earthen Levee			GPS Latitude/Longitude	
				Start	End
Item	Cracking			38.780858 °	38.780858 °
				-121.709095 °	-121.709095 °
DWR ID	DWR_NA0008_02_f_2013_227				
Action/Comments					
Monitor and have inspected by geotechnical engineer.

Another view of the cracking on the levee slope. Fall 2013

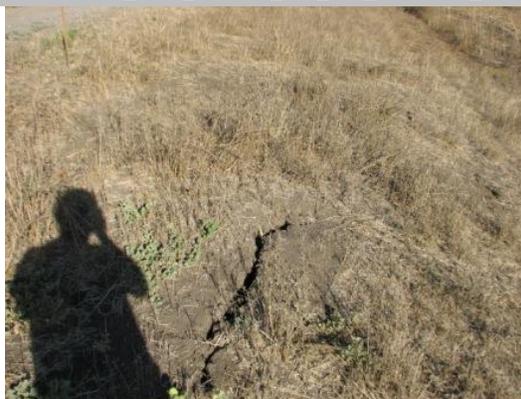
Photo 2 of 2 : SP_2015_NA0008_257_227_20150401_00007.jpg

Cracking on levee slope 1-2 inches wide and 6 inches deep. Fall 2013
