**Flood Control Project Maintenance
Levee Inspections**
LMA District Cover Sheet
Spring 2011 Levee Inspection Results

Knights Landing Ridge Drainage District

Spring 2011 Levee Inspection Results

Waterway	Bank	Unit Miles
Unit No. 01 Knights Landing Ridge Cut	Right	6.43

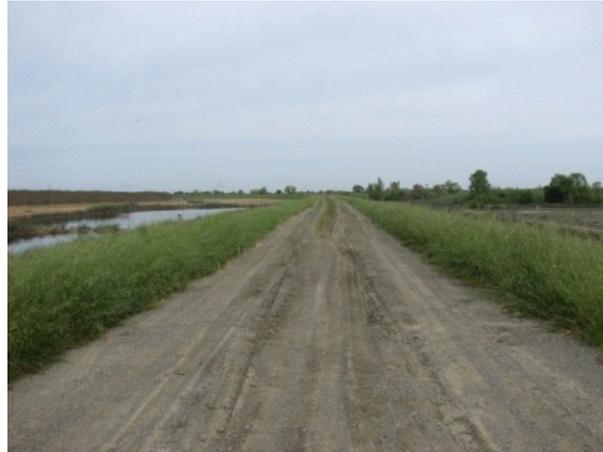
Levee Mile Report Line	2
Start Levee Mile	0.02
End Levee Mile	1.57
Location	Crown
Category	Earthen Levee
Item	Crown Surface / Depressions / Rutting
<p>The crown in this area is a common use road by the farmers in the bypass. In the winter the crown roadway becomes rutted.</p>	
<p>johngw_s_20110425_444.jpg</p>

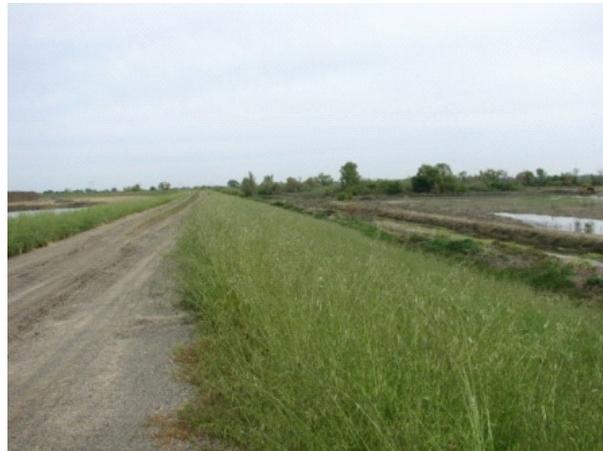
Levee Mile Report Line	3
Start Levee Mile	0.02
End Levee Mile	6.41
Location	Water Side
Category	Earthen Levee
Item	Vegetation
<p>The view is of the waterside levee slope with grasses taller than 12".</p>	
<p>johngw_s_20110425_445.jpg</p>

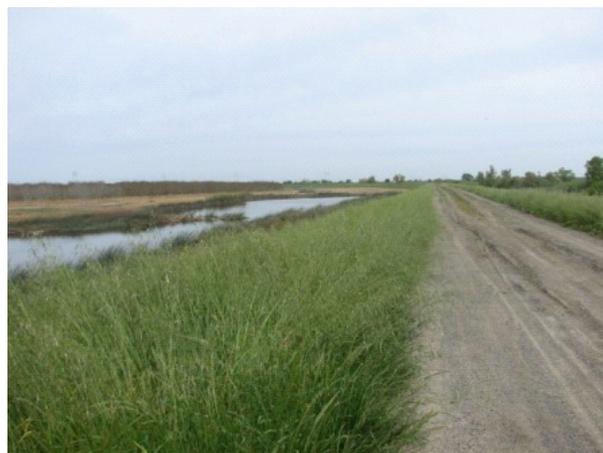
Levee Mile Report Line	4
Start Levee Mile	0.02
End Levee Mile	6.41
Location	Land Side
Category	Earthen Levee
Item	Vegetation
<p>The photo is of the landside levee slope.</p>	
<p>johngw_s_20110425_446.jpg</p>

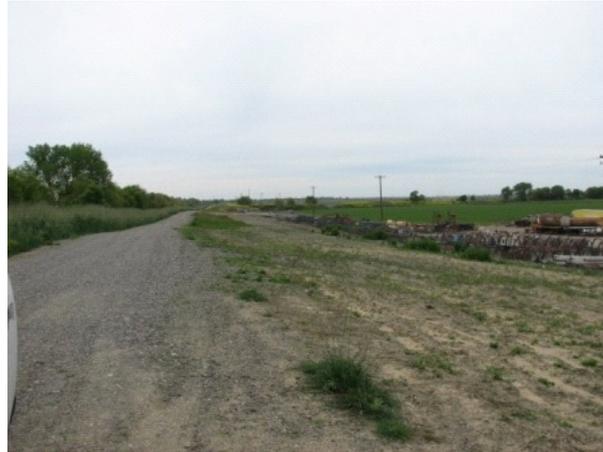
Levee Mile Report Line	12
Start Levee Mile	6.17
End Levee Mile	6.41
Location	Land Side
Category	Earthen Levee
Item	Encroachments

The equipment and pipe is stored on the slope and the toe of the levee.

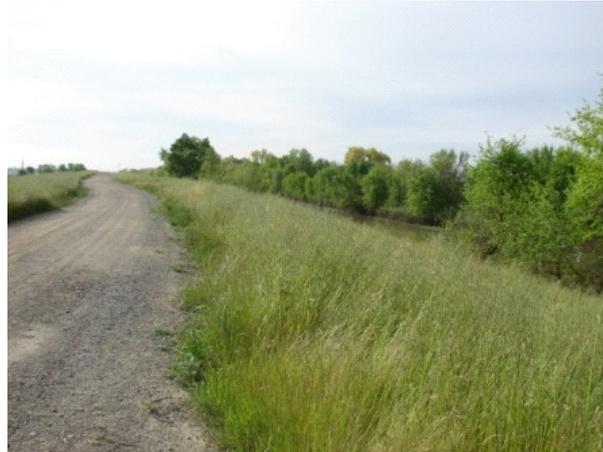
Levee Mile Report Line	1
Start Levee Mile	0.04
End Levee Mile	6.04
Location	Water Side
Category	Earthen Levee
Item	Vegetation
The photo is of the waterside levee slope.	
johngw_s_20110425_449.jpg

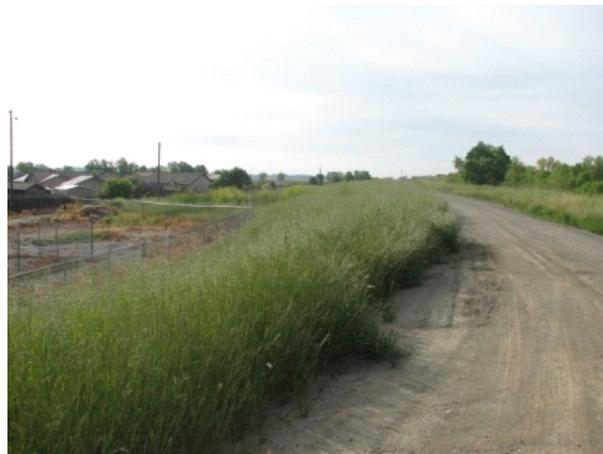
Levee Mile Report Line	2
Start Levee Mile	0.04
End Levee Mile	6.04
Location	Land Side
Category	Earthen Levee
Item	Vegetation
The grasses are taller than 12" on the landside levee slope.	
johngw_s_20110425_448.jpg

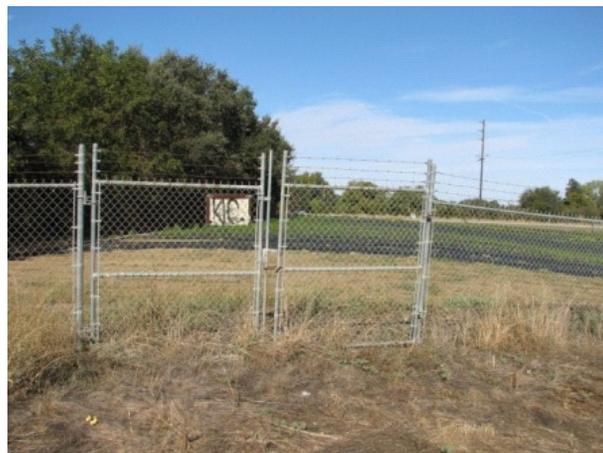
Levee Mile Report Line	8
Start Levee Mile	6.05
End Levee Mile	6.12
Location	Land Side
Category	Earthen Levee
Item	Encroachments
The well established strawberry crop is an encroachment at the end of unit 2.	
johngw_s_20110228_103.jpg
