**Flood Control Project Maintenance
Levee Inspections
LMA District Cover Sheet
Spring 2013 Levee Inspection Results**

Knights Landing Ridge Drainage District

Levee Inspection Report By Mile - Spring 2013

Waterway	Bank	Unit Miles	Inspection Start/End	Inspector
Unit No. 01 Knights Landing Ridge Cut	Right	6.43		John Williamson

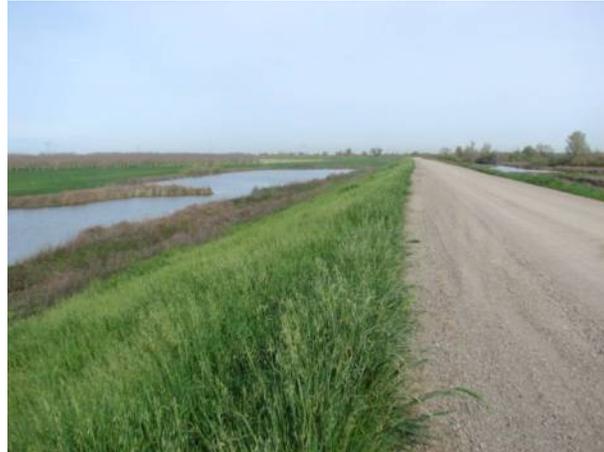
Levee Mile Report Line	4
Start Levee Mile	0.03
End Levee Mile	6.41
Location	Land Side
Category	
Item	Vegetation
The grasses are taller than 12". Spring 2013	
johngw_s_20130325_850.JPG

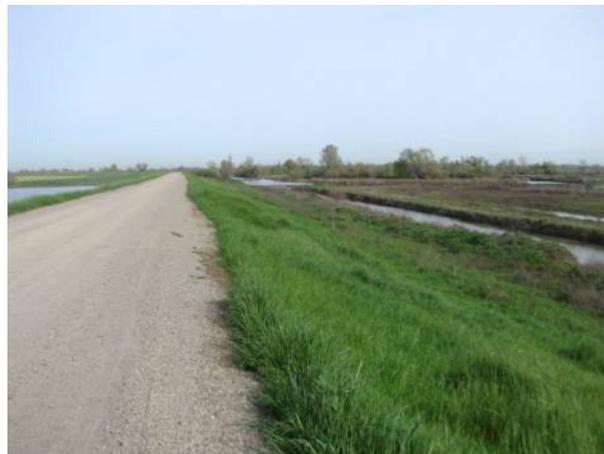
Levee Mile Report Line	5
Start Levee Mile	0.03
End Levee Mile	6.41
Location	Water Side
Category	
Item	Vegetation
The grasses are taller than 12". Spring 2013	
johngw_s_20130325_851.JPG

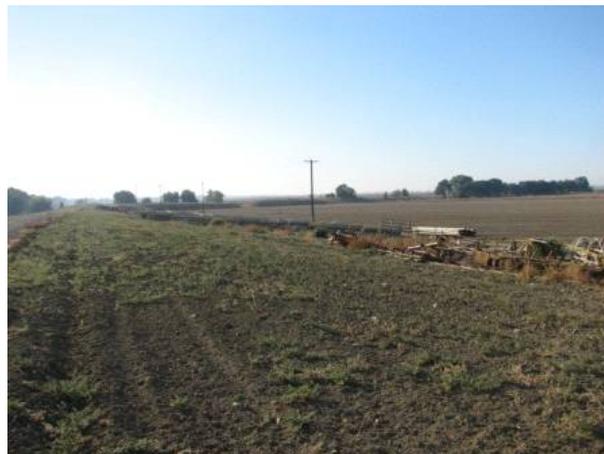
Levee Mile Report Line	9
Start Levee Mile	6.17
End Levee Mile	6.41
Location	Land Side
Category	
Item	Encroachments
Equipment and irrigation pipe along the slope of the landside levee. Fall 2012	
johngw_s_20130221_235.jpg

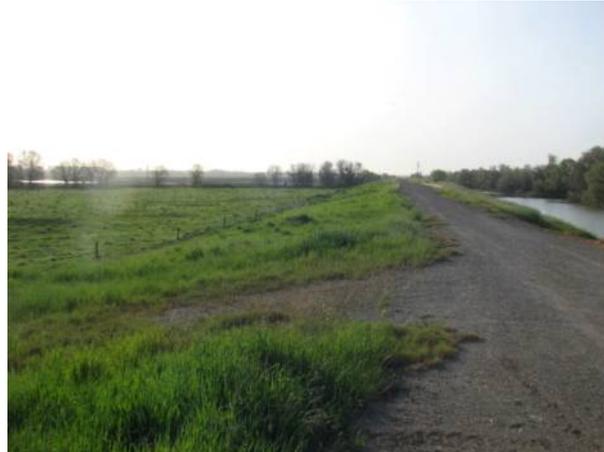
Levee Mile Report Line	1
Start Levee Mile	0.02
End Levee Mile	6.04
Location	Land Side
Category	
Item	Vegetation
The grasses are taller than 12". Spring 2013	
johngw_s_20130325_848.JPG

LMIR No.	Levee Mile		Category	Item	Location	Rating	Action/Comment	GPS Latitude/Longitude		Issue No. Photo
	Start	End						Start	End	
1	0.02	6.04		Vegetation	LS	M Ob	V1 : Control annual grass and weeds on the levee slopes and easements.	38.724487 ° -121.665507 °	38.792668 ° -121.724088 °	9 Y
DWR ID: DWR_NA0008_02_s_2012_9										
2	0.02	6.04		Vegetation	WS	M Ob	V1 : Control annual grass and weeds on the levee slopes and easements.	38.724482 ° -121.665502 °	38.792667 ° -121.724088 °	10 Y
DWR ID: DWR_NA0008_02_s_2012_10										
3	2.53	2.53		Slope Stability	CR	C Ma	S1 : Repair slope instability.	38.751823 ° -121.692795 °	38.751823 ° -121.692795 °	8
DWR ID: DWR_NA0008_02_f_2012_8										
4	2.72	2.72	Supplemental	USACE Erosion Survey	WS	M Ma	Inspector Comments: 2006 - The whole levee toe area is slowly slumping into the channel (creep) due to dewatering and poor slope soils. Occasional piping in the levee slope evident as well. Pistol-butted trees at the levee toe indicate slow retreat. 2011 - Multiple scallops throughout the site and slumping of the toe. 2012: Site is part of the extended inventory, last inspected 2011. [2012 Site ID: KLR_3-0_L]	38.757925 ° -121.693048 °	38.754899 ° -121.692653 °	2

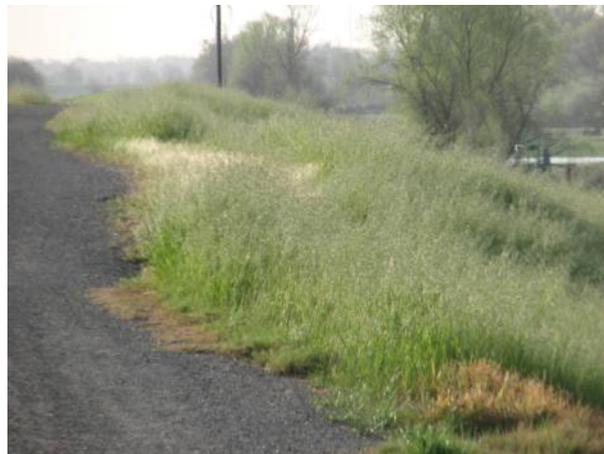
Levee Mile Report Line	2
Start Levee Mile	0.02
End Levee Mile	6.04
Location	Water Side
Category	
Item	Vegetation
The grasses are taller than 12". Spring 2013	
johngw_s_20130325_849.JPG

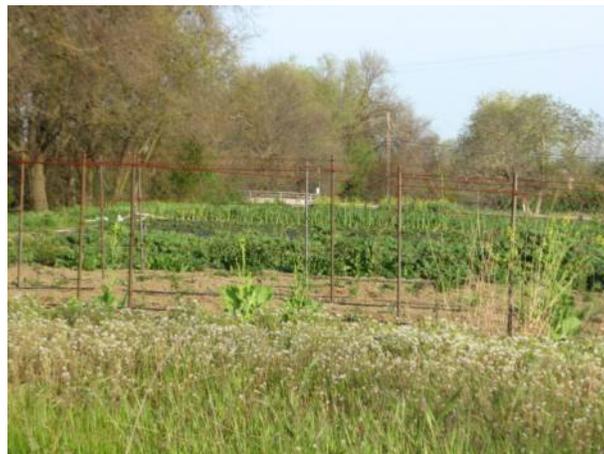
LMIR No.	Levee Mile		Category	Item	* Location	+ Rating	Action/Comment	GPS Latitude/Longitude		Issue No. Photo
	Start	End						Start	End	
10	6.05	6.12	Encroachments	LS M	En	CR : Crops Inspector Comments: No access; strawberries are being grown landside levee slope and crown	38.792735 ° -121.724092 °	38.792735 ° -121.724092 °	1 Y

Levee Mile Report Line	10
Start Levee Mile	6.05
End Levee Mile	6.12
Location	Land Side
Category	
Item	Encroachments
Strawberry patch on levee crown and slope. Spring 2013	
johngw_s_20130325_847.JPG
