**Flood Control Project Maintenance
Levee Inspections**
LMA District Cover Sheet
Spring 2014 Levee Inspection Results

Lake County Watershed Protection District

Spring 2014 Levee Inspection Results

Waterway	Bank	Unit Miles
Unit No. 01 Middle Creek	Left	3.42

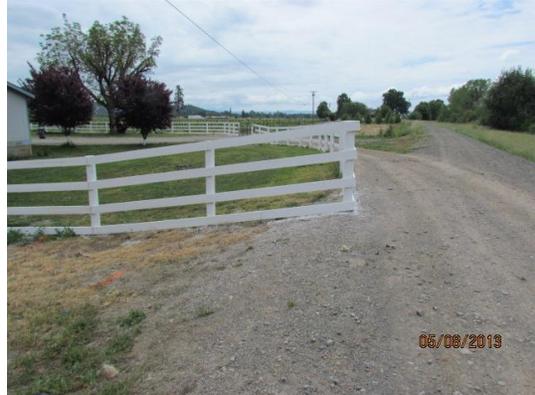
Photo 1 of 1 : rduffey_s_20140304_539.jpg

View of the unauthorized encroachment fence along landside slope.

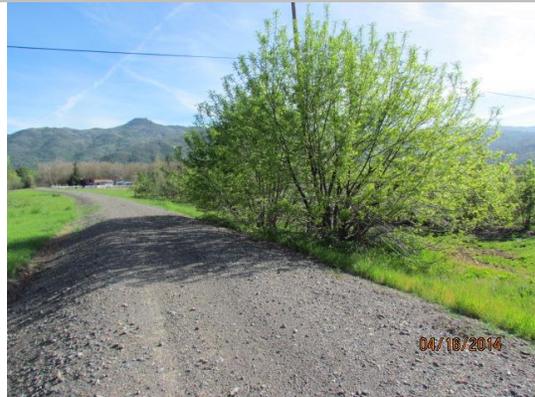
Photo 1 of 1 : rduffey_s_20140421_171.jpg

LM Start	0.25	Rating **	M	Issue No.	11
LM End	0.25	Issue Type +	Ma	Location *	LS
Category	Earthen Levee		GPS Latitude/Longitude		
			Start	End	
Item	Trim / Thin Trees		39.186777 °	39.186777 °	
			-122.908102 °	-122.908102 °	
DWR ID	DWR_NA0009_01_s_2013_11				
Action/Comments					
Trim and thin trees to allow visibility of the ground and room to flood fight.

Remove the trees from the landside slope.

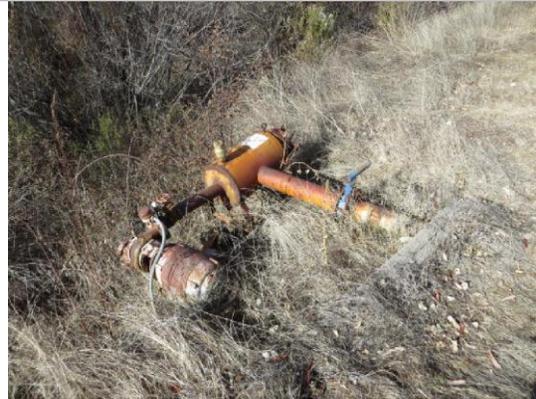
Photo 1 of 1 : UCIP_5373.jpg

LM Start	0.56	Rating **	M	Issue No.	18
LM End	0.56	Issue Type +	En	Location *	LS
Category	Supplemental			GPS Latitude/Longitude	
				Start	End
Item	DWR UCIP Field Study			39.183519 °	39.183519 °
				-122.911379 °	-122.911379 °
DWR ID	DWR_NA0009_01_s_2014_18				
Action/Comments					
Inspector Comments: FS_ID:26943 EP_NO: 5237 Repair Type: Crossing Status: UCIP Comments: Pipe appears abandoned and should be done so properly. FIELD_STRUCT_DESC: 6-inch steel pipe possibly sleeved through an 8-inch steel pipe, 3.0-feet below the crown. Siphon breaker in 24-inch CMP riser on the landward slope. Reinforced concrete cutoff wall at center of levee. Butterfly valve on the waterward side at pump on concrete base on the waterward bank, installed under Permit No. 5237 (1971). Pole on the waterward berm, with overhead power line supplying electricity to pump. Originally included in the 1961 O+M manual. FS Date: 1/9/2014

Pump and butterfly valve on WS berm.

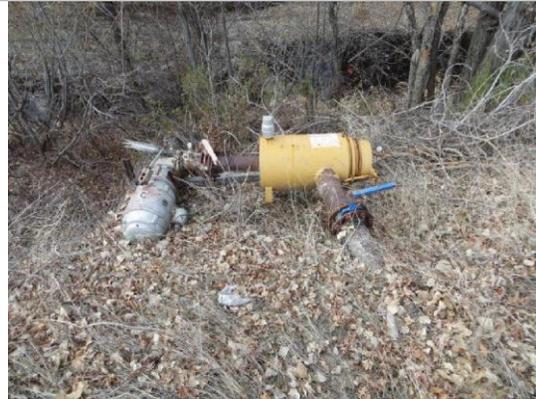
Photo 1 of 1 : UCIP_5376.jpg

LM Start	0.85	Rating **	M	Issue No.	19
LM End	0.85	Issue Type +	En	Location *	LS
Category	Supplemental			GPS Latitude/Longitude	
				Start	End
Item	DWR UCIP Field Study			39.179533 °	39.179533 °
				-122.912511 °	-122.912511 °
DWR ID	DWR_NA0009_01_s_2014_19				
Action/Comments					
Inspector Comments: FS_ID:26946 EP_NO: N/A Repair Type: Crossing Status: UCIP Comments: Pump and pipe appear abandoned and should be done so properly. FIELD_STRUCT_DESC: 8-inch steel irrigation pipe through the levee, 3.0 feet below the crown. Siphon breaker in 24-inch CMP riser on landward slope. Pump on the waterward bank with a butterfly valve. Service pole on the waterward berm. (USACE-1961). This entry matches the Drainage or Irrigation Structure referenced in O&M manual (HLM 0.83). FS Date: 1/9/2014

Pump and butterfly valve visible on WS berm.

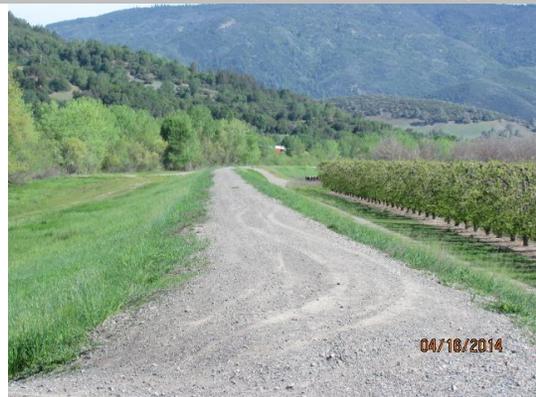
Photo 1 of 1 : rduffey_s_20140421_176.jpg

LM Start	2.01	Rating **	A	Issue No.	21
LM End	2.01	Issue Type +	Ma	Location *	LS
Category	Earthen Levee			GPS Latitude/Longitude	
				Start	End
Item	Vegetation			39.163537 °	39.163537 °
				-122.915628 °	-122.915628 °
DWR ID	DWR_NA0009_01_s_2014_21				
Action/Comments					
Control annual grass and weeds on the levee slopes and easements.

View of the native grasses on both slopes.

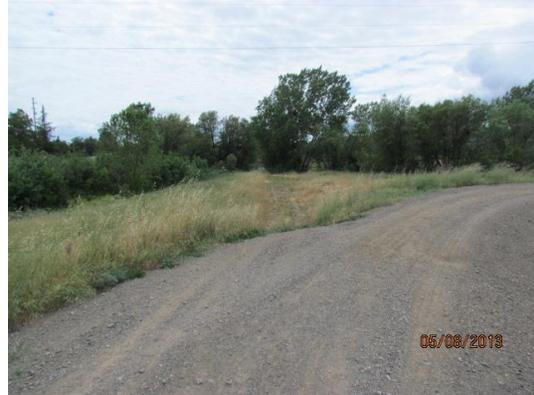
Photo 1 of 1 : rduffey_s_20140304_540.jpg

LM Start	2.29	Rating **	M	Issue No.	13
LM End	2.29	Issue Type +	Ma	Location *	WS
Category	Earthen Levee			GPS Latitude/Longitude	
				Start	End
Item	Slope Stability			39.160285 °	39.160285 °
				-122.913481 °	-122.913481 °
DWR ID	DWR_NA0009_01_s_2013_13				
Action/Comments					
Repair the levee slope damaged by vehicle traffic and prevent access where possible.

View of the vehicle erosion along the waterside slope.

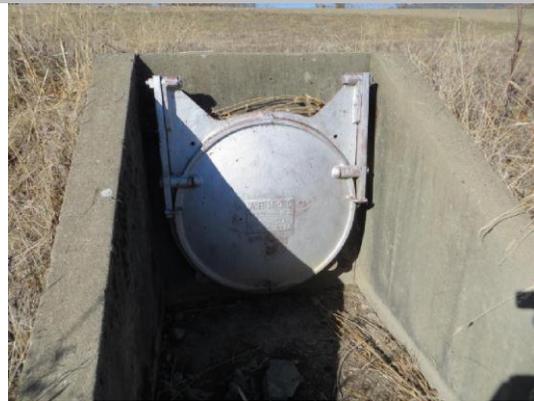
Photo 1 of 1 : UCIP_5380.jpg

LM Start	2.35	Rating **	M	Issue No.	20
LM End	2.35	Issue Type +	En	Location *	WS
Category	Supplemental			GPS Latitude/Longitude	
				Start	End
Item	DWR UCIP Field Study			39.161002 °	39.161002 °
				-122.912843 °	-122.912843 °
DWR ID	DWR_NA0009_01_s_2014_20				
Action/Comments					
Inspector Comments: FS_ID:27004 EP_NO: 11460 Repair Type: Crossing Status: UCIP Comments: Heavy vegetation on LS at inlet should be removed. FIELD_STRUCT_DESC: 42-inch CM drainpipe through the levee, 10.0 feet below the crown. Flap gate on waterward end. Concrete headwall on both ends. Originally included in 1961 O+M manual. Pipe retained under ABO No. 11460 (1975). FS Date: 1/14/2014

Concrete U-shaped headwall and flap gate on WS berm.

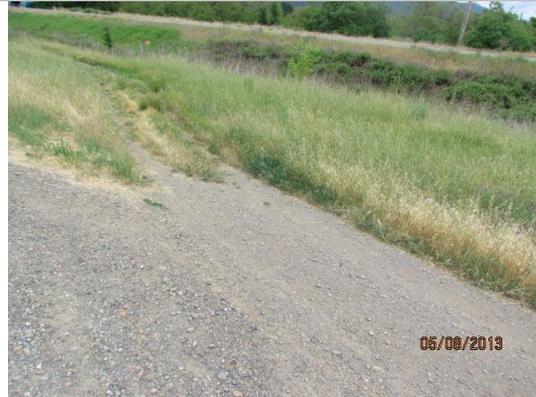
Photo 1 of 1 : rduffey_s_20140304_541.jpg

LM Start	2.37	Rating **	M	Issue No.	14
LM End	2.37	Issue Type +	Ma	Location *	WS
Category	Earthen Levee		GPS Latitude/Longitude		
			Start	End	
Item	Slope Stability		39.161153 °	39.161153 °	
			-122.912740 °	-122.912740 °	
DWR ID	DWR_NA0009_01_s_2013_14				
Action/Comments					
Repair the levee slope damaged by vehicle traffic and prevent access where possible.

View of the vehicle erosion along the waterside slope.

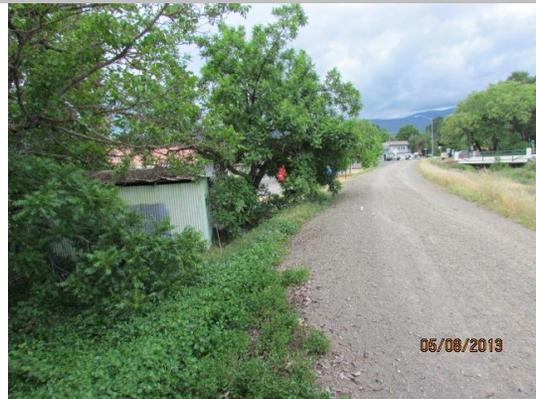
Photo 1 of 1 : rduffey_s_20140304_542.jpg

LM Start	2.37	Rating **	M	Issue No.	15
LM End	2.41	Issue Type +	Ma	Location *	LS
Category	Earthen Levee		GPS Latitude/Longitude		
			Start	End	
Item	Trim / Thin Trees		39.161381 °	39.161708 °	
			-122.912551 °	-122.912168 °	
DWR ID	DWR_NA0009_01_s_2013_15				
Action/Comments					
Trim trees to at least five feet above ground level.

Trim the trees up 5 feet to allow visibility.

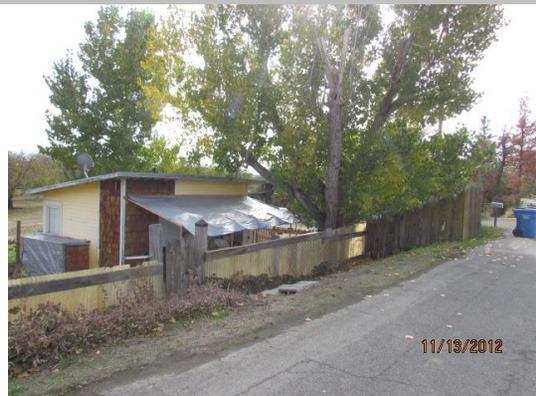
Photo 1 of 1 : rduffey_s_20140304_537.jpg

LM Start	2.40	Rating **	M	Issue No.	7
LM End	2.40	Issue Type +	En	Location *	LS
Category	Earthen Levee		GPS Latitude/Longitude		
			Start	End	
Item	Encroachments		39.160217 °	39.161692 °	
			-122.912957 °	-122.911748 °	
DWR ID	DWR_NA0009_01_s_2012_7				
Action/Comments					
Building

View of a building & fence along the toe of the levee.

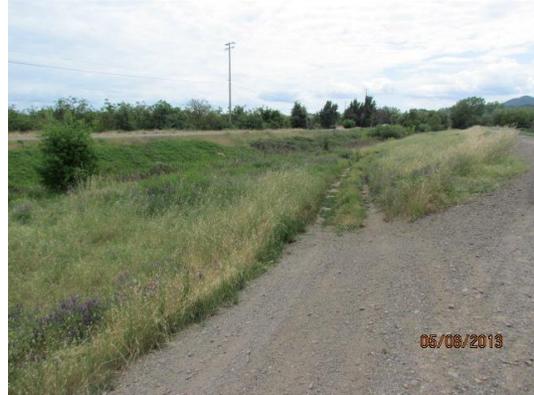
Photo 1 of 1 : rduffey_s_20140304_543.jpg

LM Start	2.40	Rating **	M	Issue No.	16
LM End	2.40	Issue Type +	Ma	Location *	WS
Category	Earthen Levee		GPS Latitude/Longitude		
			Start	End	
Item	Slope Stability		39.161601 °	39.161601 °	
			-122.912303 °	-122.912303 °	
DWR ID	DWR_NA0009_01_s_2013_16				
Action/Comments					
Repair the levee slope damaged by vehicle traffic and prevent access where possible.

View of the vehicle erosion along the waterside slope.

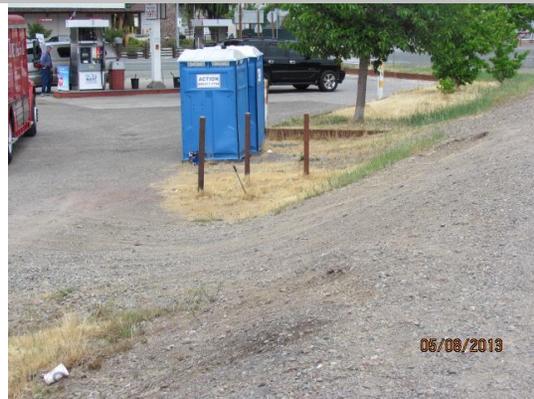
Photo 1 of 1 : rduffey_s_20140304_544.jpg

LM Start	2.42	Rating **	M	Issue No.	17
LM End	2.42	Issue Type +	Ma	Location *	LS
Category	Earthen Levee		GPS Latitude/Longitude		
			Start	End	
Item	Slope Stability		39.161802 °	39.161802 °	
			-122.912020 °	-122.912020 °	
DWR ID	DWR_NA0009_01_s_2013_17				
Action/Comments					
Repair the levee slope damaged by vehicle traffic and prevent access where possible.

View of vehicle erosion along landside slope.

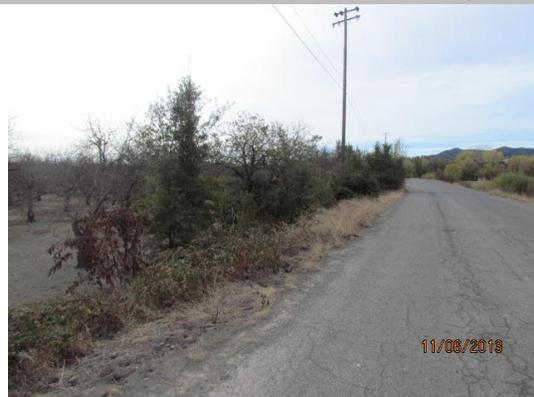
Photo 1 of 1 : rduffey_s_20140304_535.jpg

LM Start	2.48	Rating **	M	Issue No.	3
LM End	2.55	Issue Type +	Ma	Location *	LS
Category	Earthen Levee		GPS Latitude/Longitude		
			Start	End	
Item	Vegetation		39.161615 °	39.160795 °	
			-122.911733 °	-122.912442 °	
DWR ID	DWR_NA0009_01_s_2012_3				
Action/Comments					
Remove the wild growth other than native grasses from the levee slopes.

View of the vegetation along the landside slope.

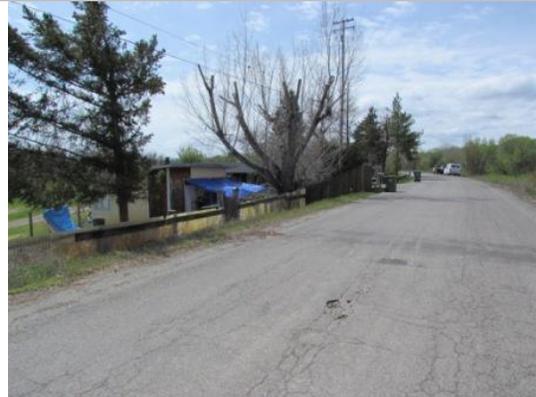
Photo 1 of 1 : rduffey_s_20140304_536.jpg

View of the fences at the L/S toe.

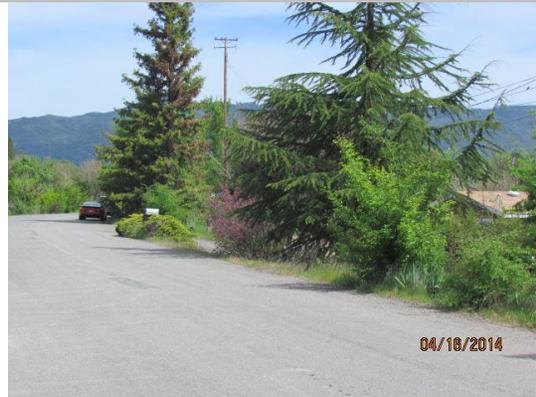
Photo 1 of 1 : rduffey_s_20140421_177.jpg

LM Start	2.62	Rating **	M	Issue No.	5
LM End	2.67	Issue Type +	En	Location *	LS
Category	Earthen Levee		GPS Latitude/Longitude		
			Start	End	
Item	Vegetation		39.159657 °	39.159657 °	
			-122.913345 °	-122.913345 °	
DWR ID	DWR_NA0009_01_s_2012_5				
Action/Comments					
Landscaping

View of the landscape along the landside slope.

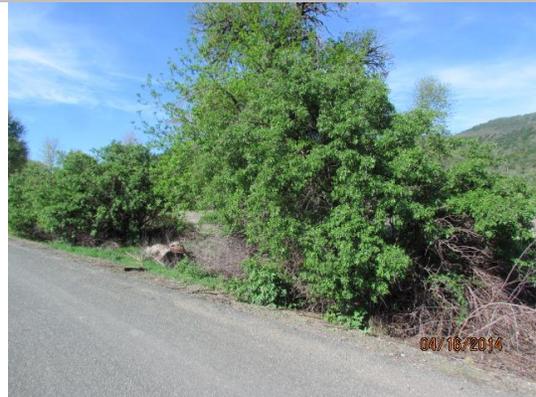
Photo 1 of 1 : rduffey_s_20140421_172.jpg

LM Start	0.07	Rating **	M	Issue No.	19
LM End	0.07	Issue Type +	Ma	Location *	LS
Category	Earthen Levee		GPS Latitude/Longitude		
			Start	End	
Item	Vegetation		39.188772 °	39.188772 °	
			-122.908465 °	-122.908465 °	
DWR ID	DWR_NA0009_02_s_2014_19				
Action/Comments					
Elderberries are blocking visibility and flood fight capability.

View of the elderberries along the landside slope.

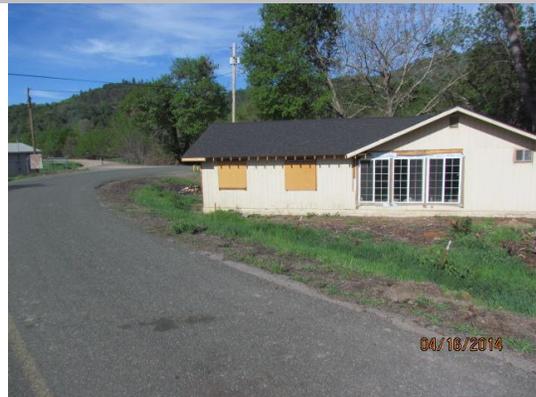
Photo 1 of 1 : rduffey_s_20140421_175.jpg

LM Start	0.20	Rating **	U	Issue No.	1
LM End	0.20	Issue Type +	En	Location *	LS
Category	Earthen Levee		GPS Latitude/Longitude		
			Start	End	
Item	Encroachments		39.187039 °	39.187039 °	
			-122.908880 °	-122.908880 °	
DWR ID	DWR_NA0009_02_s_2012_1				
Action/Comments					
Building

View of the building that all vegetation has been removed.

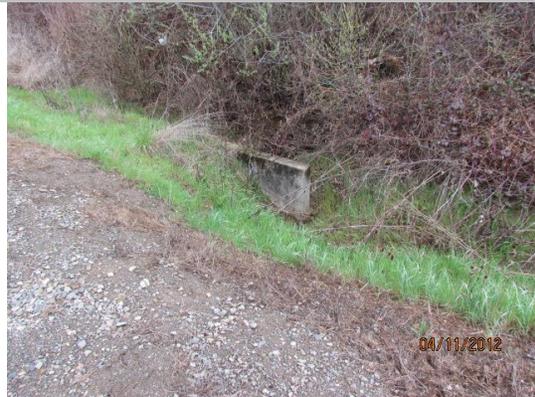
Photo 1 of 1 : rduffey_s_20140304_553.jpg

LM Start	0.39	Rating **	M	Issue No.	8
LM End	0.39	Issue Type +	Ma	Location *	LS
Category	Earthen Levee		GPS Latitude/Longitude		
			Start	End	
Item	Slope Stability		39.185160 °	39.185160 °	
			-122.911138 °	-122.911138 °	
DWR ID	DWR_NA0009_02_s_2012_8				
Action/Comments					
Repair slope instability.

View of erosion along slope of the levee by both sides of the headwall.

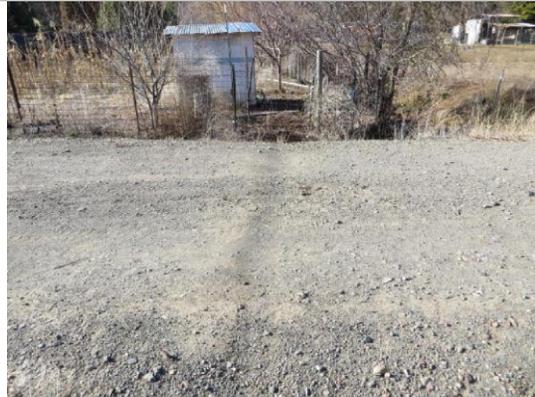
Photo 1 of 1 : UCIP_5446.jpg

LM Start	0.48	Rating **	M	Issue No.	6
LM End	0.48	Issue Type +	En	Location *	LS
Category	Supplemental			GPS Latitude/Longitude	
				Start	End
Item	DWR UCIP Field Study			39.184080 °	39.184080 °
				-122.912130 °	-122.912130 °
DWR ID	DWR_NA0009_02_s_2014_6				
Action/Comments					
Inspector Comments: FS_ID:27563 EP_NO: N/A Repair Type: Crossing Status: UCIP Comments: No Permit identified for crossing. FIELD_STRUCT_DESC: 1.5-inch HDPE irrigation pipe through the levee at unknown depth below the crown. Pipe visible on WS berm slope. Pumphouse on LS toe. FS Date: 1/14/2014 7:19:18 AM

cut across levee crown visible along pipe alignment.

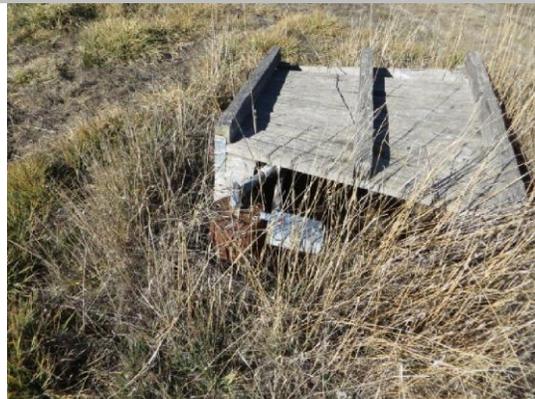
Photo 1 of 1 : UCIP_5395.jpg

LM Start	0.50	Rating **	M	Issue No.	11
LM End	0.50	Issue Type +	En	Location *	LS
Category	Supplemental			GPS Latitude/Longitude	
				Start	End
Item	DWR UCIP Field Study			39.183775 °	39.183775 °
				-122.912187 °	-122.912187 °
DWR ID	DWR_NA0009_02_s_2014_11				
Action/Comments					
Inspector Comments: FS_ID:27202 EP_NO: 8513 Repair Type: Crossing Status: UCIP Comments: Appears pipe is leaking on WS toe of Levee at mud pit FIELD_STRUCT_DESC: 1 of 2: 1.25-inch steel pipe through the levee, 2.0 feet below the levee. Steel cutoff wall around pipe at center of levee. Well with 8-inch casing on waterward slope. (Permit No. 8513-1974) FS Date: 1/14/2014

Pump and pipe visible at wooden box on WS berm.

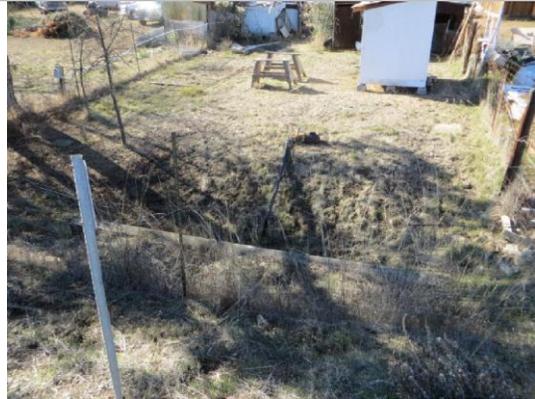
Photo 1 of 1 : UCIP_5398.jpg

LM Start	0.55	Rating **	M	Issue No.	12
LM End	0.55	Issue Type +	En	Location *	LS
Category	Supplemental			GPS Latitude/Longitude	
				Start	End
Item	DWR UCIP Field Study			39.183130 °	39.183130 °
				-122.912198 °	-122.912198 °
DWR ID	DWR_NA0009_02_s_2014_12				
Action/Comments					
Inspector Comments: FS_ID:27208 EP_NO: 11482 Repair Type: Crossing Status: UCIP Comments: Fence on LS slope creates access issue. FIELD_STRUCT_DESC: 36-inch CM drainpipe through the levee, 9.0 feet below the crown. Flap gate on the waterward end. Concrete headwalls on both ends. (USACE-1961). This entry matches the Drainage or Irrigation Structure referenced in O&M manual (HLM 0.54). This pipe was retained under ABO No. 11482 (1975). FS Date: 1/14/2014

Concrete headwall on LS toe.

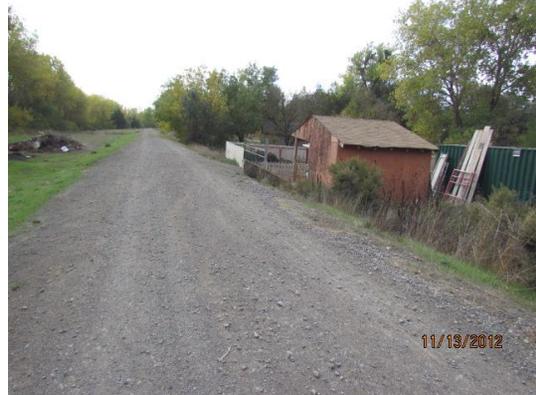
Photo 1 of 1 : rduffey_s_20140304_552.jpg

View of building & vegetation along the levee toe.

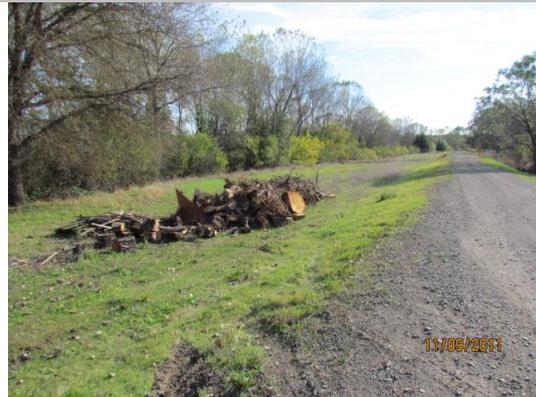
Photo 1 of 1 : rduffey_s_20140304_550.jpg

LM Start	1.06	Rating **	M	Issue No.	3
LM End	1.06	Issue Type +	Ma	Location *	LS
Category	Earthen Levee		GPS Latitude/Longitude		
			Start	End	
Item	Encroachments		39.176835 °	39.176835 °	
			-122.913558 °	-122.913558 °	
DWR ID	DWR_NA0009_02_s_2012_3				
Action/Comments					
Tree or limb

View of the tree prunings on the W/S toe.

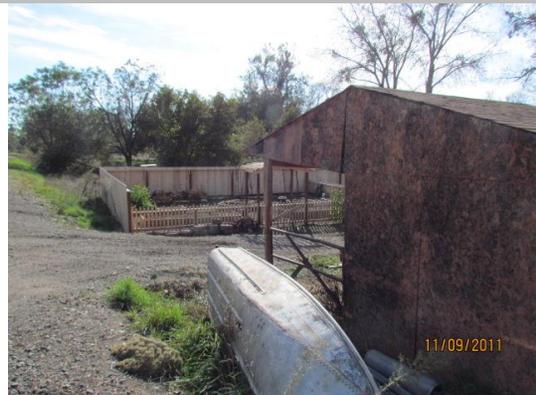
Photo 1 of 1 : rduffey_s_20140304_549.jpg

LM Start	1.06	Rating **	U	Issue No.	2
LM End	1.06	Issue Type +	En	Location *	LS
Category	Earthen Levee		GPS Latitude/Longitude		
			Start	End	
Item	Encroachments		39.176815 °	39.176815 °	
			-122.913540 °	-122.913540 °	
DWR ID	DWR_NA0009_02_s_2012_2				
Action/Comments					
Fence

View of the building & fence along the L/S toe.

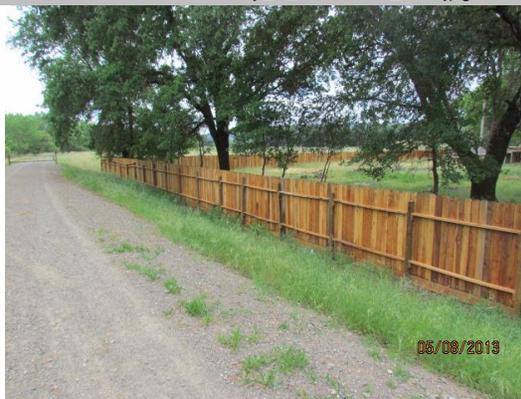
Photo 1 of 1 : rduffey_s_20140304_555.jpg

View of the unauthorized fence along the landside toe.

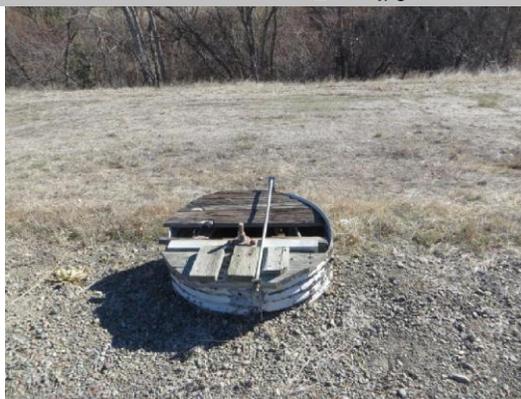
Photo 1 of 1 : UCIP_5451.jpg

LM Start	1.23	Rating **	M	Issue No.	13
LM End	1.23	Issue Type +	En	Location *	LS
Category	Supplemental			GPS Latitude/Longitude	
				Start	End
Item	DWR UCIP Field Study			39.174370 °	39.174370 °
				-122.913543 °	-122.913543 °
DWR ID	DWR_NA0009_02_s_2014_13				
Action/Comments					
Inspector Comments: FS_ID:27590 EP_NO: 11483 Repair Type: Crossing Status: UCIP Comments: Pipe appears abandoned and if so, should be done so properly. FIELD_STRUCT_DESC: 30-inch CM drainpipe through the levee, 17.8 feet below the crown. Slide gate in 44-inch diameter CMP riser waterward slope. Flap gate on the waterward end at concrete headwall. 6'X8' concrete sump at landward toe. (USACE-1961). Originally included in O&M manual (HLM 1.22). This pipe was retained under ABO No. 11483 (1975). FS Date: 1/22/2014

Slide gate in 44-inch CMP riser on WS shoulder.

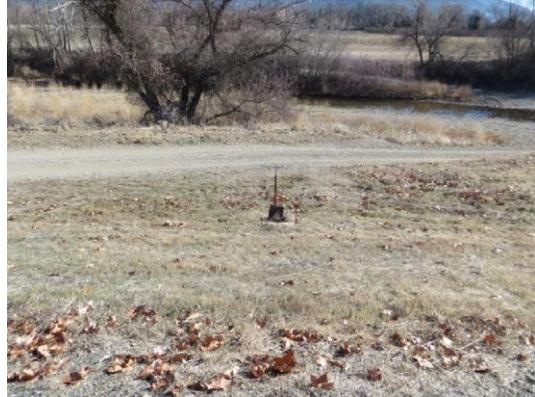
Photo 1 of 1 : UCIP_5453.jpg

LM Start	1.77	Rating **	M	Issue No.	14
LM End	1.77	Issue Type +	En	Location *	LS
Category	Supplemental			GPS Latitude/Longitude	
				Start	End
Item	DWR UCIP Field Study			39.167155 °	39.167155 °
				-122.916610 °	-122.916610 °
DWR ID	DWR_NA0009_02_s_2014_14				
Action/Comments					
Inspector Comments: FS_ID:27606 EP_NO: 15825 Repair Type: Crossing Status: UCIP Comments: Pipe with closure device not visible on WS toe. Clear soil from pipe and cover for better verification of closure. FIELD_STRUCT_DESC: 8-inch steel pipe through the levee, 2.0 feet below the crown. Siphon breaker on apex of pipe at landward shoulder. Exposed filter at landward slope. Seasonal pump on waterward slope. (Permit No. 15825-1992) FS Date: 1/22/2014

T-post at WS toe may indicate location of pipe end. Covered with soil.

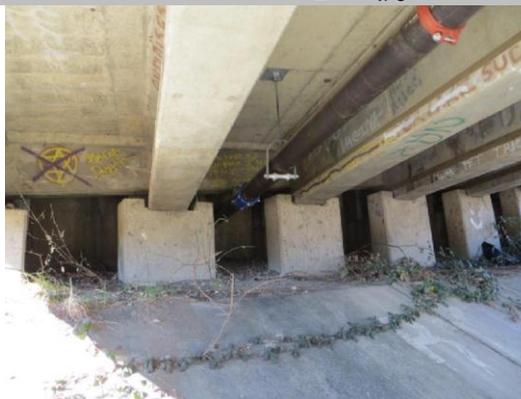
Photo 1 of 1 : UCIP_5456.jpg

LM Start	2.03	Rating **	M	Issue No.	16
LM End	2.03	Issue Type +	En	Location *	LS
Category	Supplemental			GPS Latitude/Longitude	
				Start	End
Item	DWR UCIP Field Study			39.163414 °	39.163414 °
				-122.916741 °	-122.916741 °
DWR ID	DWR_NA0009_02_s_2014_16				
Action/Comments					
Inspector Comments: FS_ID:27624 EP_NO: 15865 Repair Type: Crossing Status: UCIP Comments: Permit number likely revised from 15865. Verify with inspector and modify entry as required. FIELD_STRUCT_DESC: 8-inch steel sewer line (pressurized) through the levee, 3.0 feet below the crown. Cutoff wall around pipe at center of levee. Siphon breaker on waterward levee shoulder. Pipe visible under bridge (Permit No. 15865-1991). FS Date: 1/22/2014

Pipe visible under bridge.

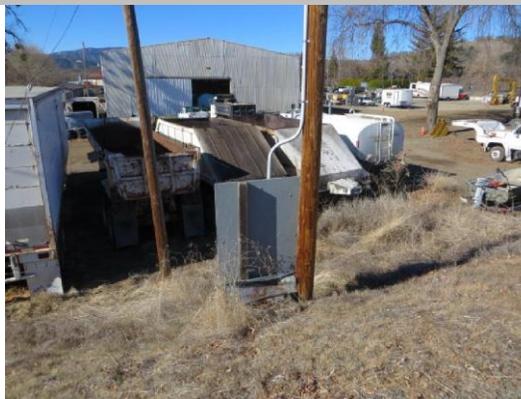
Photo 1 of 1 : UCIP_5458.jpg

LM Start	2.07	Rating **	M	Issue No.	17
LM End	2.07	Issue Type +	En	Location *	LS
Category	Supplemental			GPS Latitude/Longitude	
				Start	End
Item	DWR UCIP Field Study			39.162753 °	39.162753 °
				-122.916811 °	-122.916811 °
DWR ID	DWR_NA0009_02_s_2014_17				
Action/Comments					
Inspector Comments: FS_ID:27629 EP_NO: 17191 Repair Type: Crossing Status: UCIP Comments: Appears abandoned, if so it should be done so properly. FIELD_STRUCT_DESC: 2 of 2: 2-inch PVC pipe through the levee, 2.0 feet below the crown. Well and electric pump at waterward toe. Pole and meter(Permit No. 17191-2000) FS Date: 1/22/2014

Meter and control on LS slope next to pole.

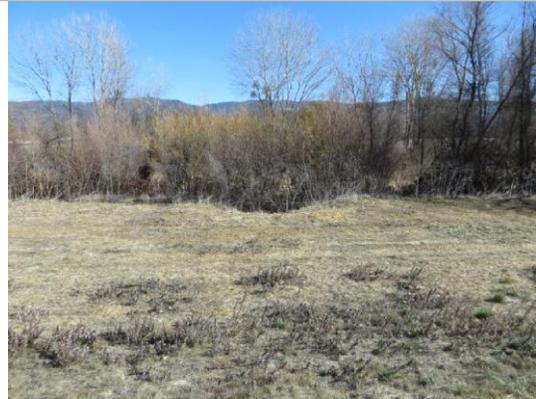
Photo 1 of 1 : UCIP_5460.jpg

LM Start	2.92	Rating **	M	Issue No.	18
LM End	2.92	Issue Type +	En	Location *	LS
Category	Supplemental			GPS Latitude/Longitude	
				Start	End
Item	DWR UCIP Field Study			39.151257 °	39.151257 °
				-122.914908 °	-122.914908 °
DWR ID	DWR_NA0009_02_s_2014_18				
Action/Comments					
Inspector Comments: FS_ID:27630 EP_NO: 11481 Repair Type: Crossing Status: UCIP Comments: Soil partially blocking inlet and outlet. FIELD_STRUCT_DESC: 24-inch CM drainpipe through the levee, 12.0 feet below the crown. Flap gate on the waterward end. Concrete headwalls on both ends. (USACE-1961). This entry matches the Drainage or Irrigation Structure referenced in O&M manual (HLM 2.93). This pipe was retained under ABO No. 11481 (1975). FS Date: 1/22/2014

Concrete headwall and flapgate visible at WS berm.

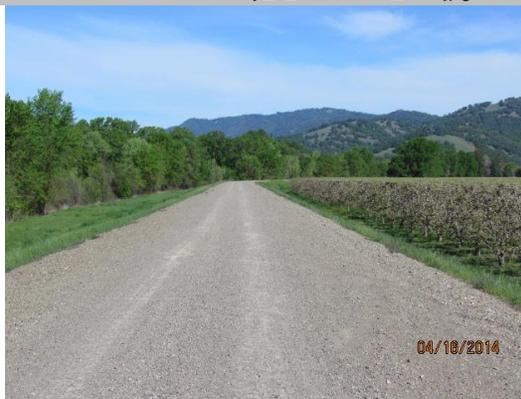
Photo 1 of 1 : rduffey_s_20140421_173.jpg

View of the native grasses on both slopes.

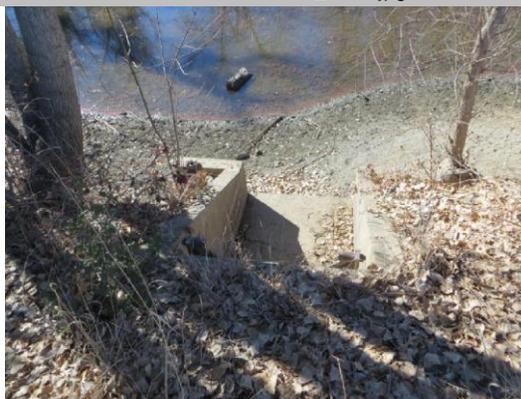
Photo 1 of 1 : UCIP_5536.jpg

LM Start	0.53	Rating **	M	Issue No.	2
LM End	0.53	Issue Type +	En	Location *	LS
Category	Supplemental			GPS Latitude/Longitude	
				Start	End
Item	DWR UCIP Field Study			39.154786 °	39.154786 °
				-122.918703 °	-122.918703 °
DWR ID	DWR_NA0009_03_s_2014_2				
Action/Comments					
Inspector Comments: FS_ID:27863 EP_NO: 11492 Repair Type: Crossing Status: UCIP Comments: Vegetation at inlet and wooden box failing at LS toe. FIELD_STRUCT_DESC: 42-inch CM drainpipe through the levee, 12.0 feet below the crown. Flap gate on the waterward end. Concrete headwalls on both ends with a wooden retaining wall drop inlet at LS toe (USACE-1961). Originally included in O&M manual (HLM 0.55). This pipe was retained under ABO No. 11492 (1975). USACE O&M DWG No. CC-4-4-29. FS Date: 1/22/2014

Concrete headwall and flapgate visible at WS berm.

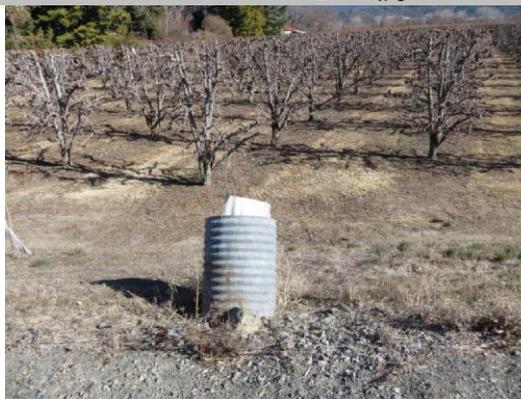
Photo 1 of 1 : UCIP_5540.jpg

LM Start	0.74	Rating **	M	Issue No.	3
LM End	0.74	Issue Type +	En	Location *	LS
Category	Supplemental			GPS Latitude/Longitude	
				Start	End
Item	DWR UCIP Field Study			39.157443 °	39.157443 °
				-122.920110 °	-122.920110 °
DWR ID	DWR_NA0009_03_s_2014_3				
Action/Comments					
Inspector Comments: FS_ID:27891 EP_NO: 11492 Repair Type: Crossing Status: UCIP Comments: Appears abandoned and if so should be done so properly. FIELD_STRUCT_DESC: 4-inch steel pipe through the levee, 2.5 feet below the crown. Siphon breaker in 24-inch CMP riser on LS shoulder. Pump on concrete platform on waterward side. Hose chute and concrete stairway on waterward slope. This pipe was retained under ABO No. 11492 (1975). FS Date: 1/22/2014

Siphon at LS shoulder inside 24-inch CMP riser.

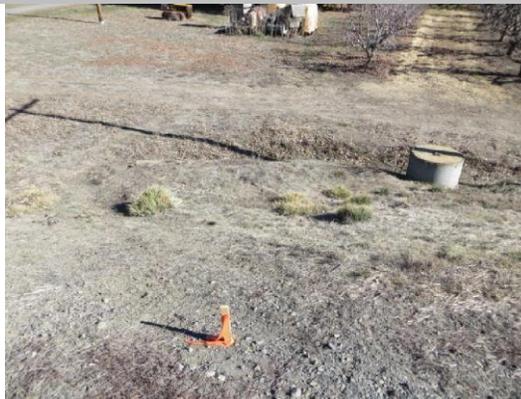
Photo 1 of 1 : UCIP_5545.jpg

LM Start	0.76	Rating **	M	Issue No.	4
LM End	0.76	Issue Type +	En	Location *	LS
Category	Supplemental			GPS Latitude/Longitude	
				Start	End
Item	DWR UCIP Field Study			39.157759 °	39.157759 °
				-122.920301 °	-122.920301 °
DWR ID	DWR_NA0009_03_s_2014_4				
Action/Comments					
Inspector Comments: FS_ID:27892 EP_NO: 11492 Repair Type: Crossing Status: UCIP Comments: Some sediment buildup at inlet. FIELD_STRUCT_DESC: 24-inch CM drainpipe through the levee, 10.0 feet below the crown. Flap gate on the waterward end. Concrete headwalls on both ends. Concrete spillway on waterward slope to bottom of channel. (USACE-1961). This entry matches the Drainage or Irrigation Structure referenced in O&M manual (HLM 0.79). This pipe was retained under ABO No. 11492 (1975). FS Date: 1/22/2014

Concrete headwall visible next to concrete standpipe on LS toe.

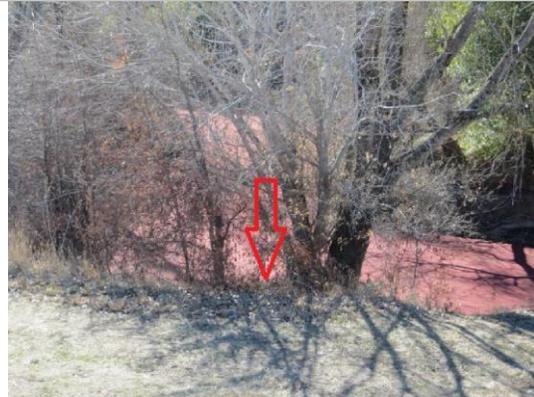
Photo 1 of 1 : UCIP_5550.jpg

LM Start	0.91	Rating **	M	Issue No.	5
LM End	0.91	Issue Type +	En	Location *	LS
Category	Supplemental			GPS Latitude/Longitude	
				Start	End
Item	DWR UCIP Field Study			39.159736 °	39.159736 °
				-122.921042 °	-122.921042 °
DWR ID	DWR_NA0009_03_s_2014_5				
Action/Comments					
Inspector Comments: FS_ID:27894					
EP_NO: 11488					
Repair Type:					
Crossing Status:					
UCIP Comments: Concrete headwall on WS berm is being undermined. 2-foot of scour under headwall.					
FIELD_STRUCT_DESC: 42-inch CM drainpipe through the levee, 16.5 feet below the crown. Flap gate on the waterward end. Concrete headwalls on both ends. (USACE-1961). This entry matches the Drainage or Irrigation Structure referenced in O&M manual (HLM 0.94). This pipe was retained under ABO No. 11488 (1975). FS Date: 1/22/2014

Flapgate and headwall off WS toe.

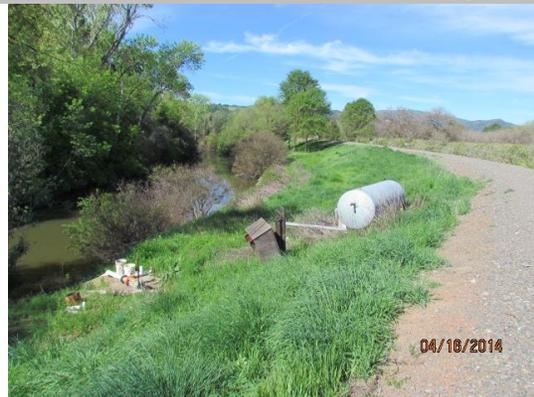
Photo 1 of 1 : rduffey_s_20140421_174.jpg

View of the tank on the waterside slope that has a permit on it.

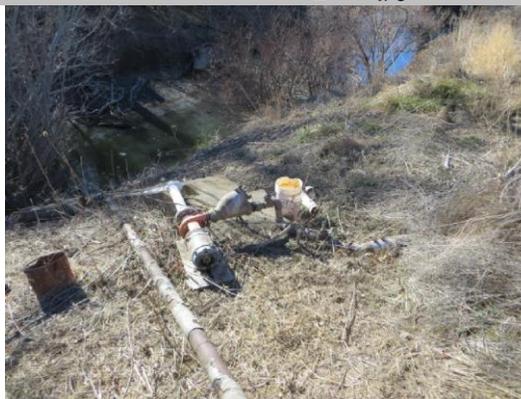
Photo 1 of 1 : UCIP_5555.jpg

LM Start	0.99	Rating **	M	Issue No.	6
LM End	0.99	Issue Type +	En	Location *	WS
Category	Supplemental			GPS Latitude/Longitude	
				Start	End
Item	DWR UCIP Field Study			39.160129 °	39.160129 °
				-122.922117 °	-122.922117 °
DWR ID	DWR_NA0009_03_s_2014_6				
Action/Comments					
Inspector Comments: FS_ID:27903 EP_NO: 11488 Repair Type: Crossing Status: UCIP Comments: Siphon breaker standpipe knocked over and covered with dirt. Pipe and appurtances appear to be in disrepair. Gate valves next to tank broken. FIELD_STRUCT_DESC: 6-inch steel irrigation pipe through the levee, 2.5 feet below the crown. Siphon breaker in 24-cmp riser on LS shoulder. Screw gate on waterside slope next to pump and 300-gallon tank. (USACE-1961). This entry matches the Drainage or Irrigation Structure referenced in O&M manual (HLM 1.02). This pipe was retained under ABO No. 11488 (1975). FS Date: 1/22/2014

Pump at concrete pad on WS berm.

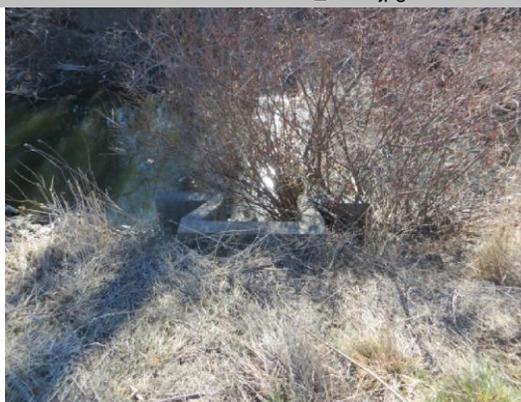
Photo 1 of 1 : UCIP_5559.jpg

LM Start	1.01	Rating **	M	Issue No.	7
LM End	1.01	Issue Type +	En	Location *	WS
Category	Supplemental			GPS Latitude/Longitude	
				Start	End
Item	DWR UCIP Field Study			39.160117 °	39.160117 °
				-122.922144 °	-122.922144 °
DWR ID	DWR_NA0009_03_s_2014_7				
Action/Comments					
Inspector Comments: FS_ID:27943 EP_NO: 11488 Repair Type: Crossing Status: UCIP Comments: Some vegetation buildup at inlet and outlet. FIELD_STRUCT_DESC: 24-inch CM drainpipe through the levee, 14.0 feet below the crown. Flap gate on the waterward end. Concrete headwalls on both ends. (USACE-1961). This entry matches the Drainage or Irrigation Structure referenced in O&M manual (HLM 1.01). This pipe was retained under ABO No. 11488 (1975). FS Date: 1/22/2014

Concrete Headwall on WS berm.

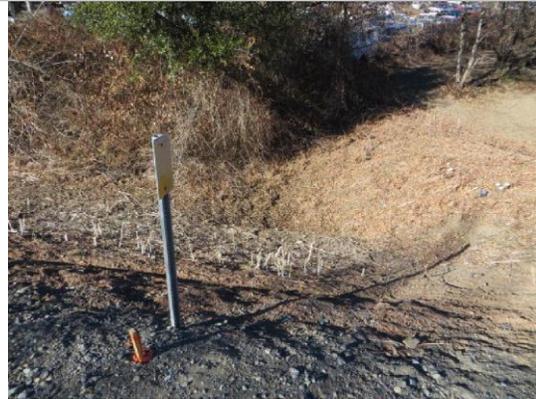
Photo 1 of 1 : UCIP_5563.jpg

LM Start	1.06	Rating **	M	Issue No.	8
LM End	1.06	Issue Type +	En	Location *	WS
Category	Supplemental			GPS Latitude/Longitude	
				Start	End
Item	DWR UCIP Field Study			39.159803 °	39.159803 °
				-122.923501 °	-122.923501 °
DWR ID	DWR_NA0009_03_s_2014_8				
Action/Comments					
Inspector Comments: FS_ID:27944 EP_NO: 11489 Repair Type: Crossing Status: UCIP Comments: Some sedimentation buildup at inlet and through pipe. FIELD_STRUCT_DESC: 24-inch CM drainpipe through the levee, 12.5 feet below the crown. Flap gate on the waterward end. Concrete headwalls on both ends. (USACE-1961). This entry matches the Drainage or Irrigation Structure referenced in O&M manual (HLM 1.09). This pipe was retained under ABO No. 11489 (1975). FS Date: 1/22/2014

Flasher on crown marks pipe location.

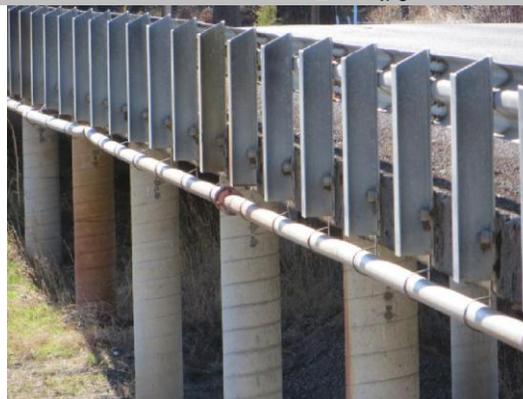
Photo 1 of 1 : UCIP_5366.jpg

Pipe visible on upstream side of bridge.

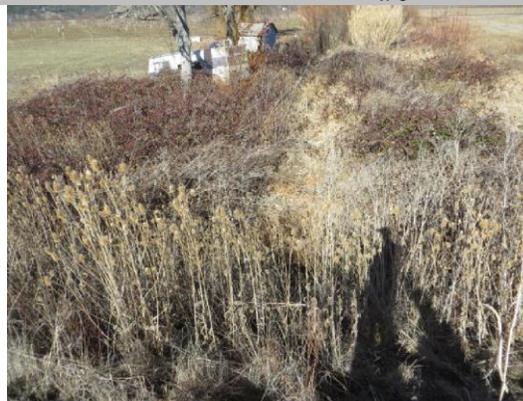
Photo 1 of 1 : UCIP_5371.jpg

Drainage canal at inlet on LS toe.

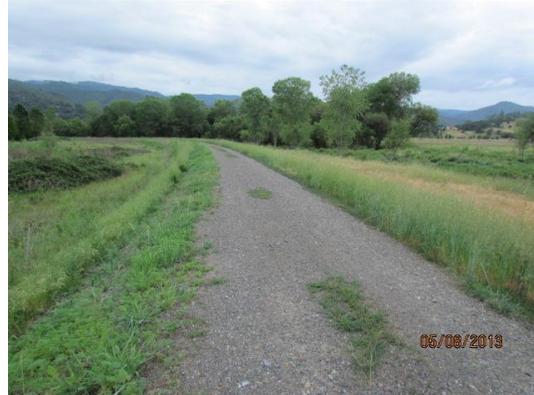
Photo 1 of 1 : rduffey_s_20140304_572.jpg

View of tall native grasses on both slopes.

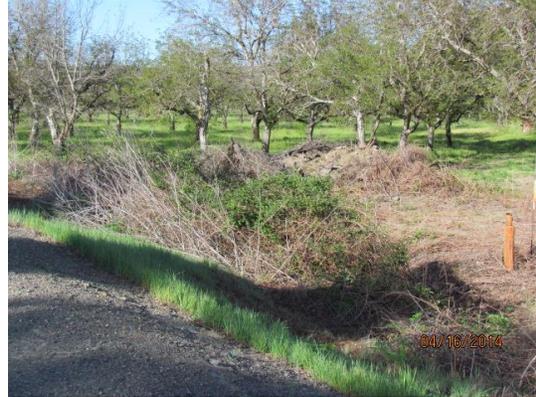
Photo 1 of 1 : rduffey_s_20140421_170.jpg

View of the vegetation growing at the toe.

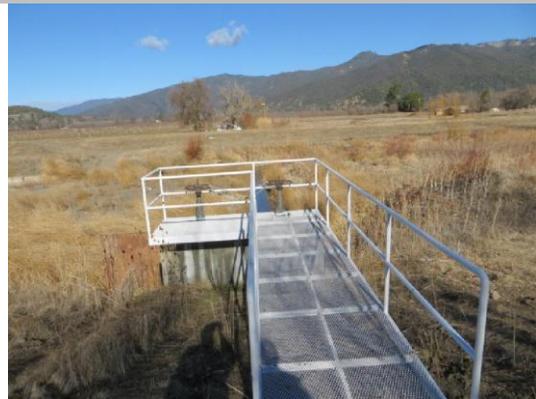
Photo 1 of 1 : UCIP_5364.jpg

Slide gate at steel walkway on WS toe.

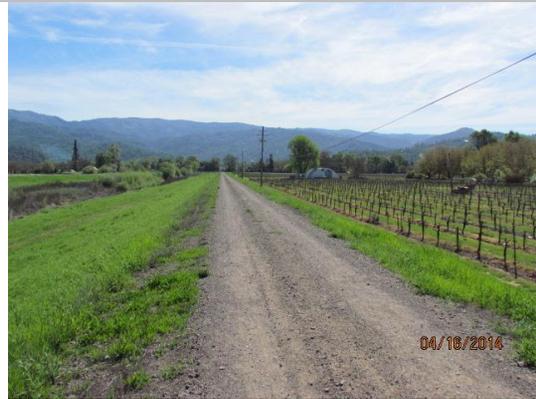
Photo 1 of 1 : rduffey_s_20140421_190.jpg

View of the native grasses on both slopes.
