**Flood Control Project Maintenance
Levee Inspections
LMA District Cover Sheet
Spring 2013 Levee Inspection Results**

Lake County Watershed Protection District

Spring 2013 Levee Inspection Results

Waterway		Bank	Unit Miles
Unit No. 01 Middle Creek		Left	3.42

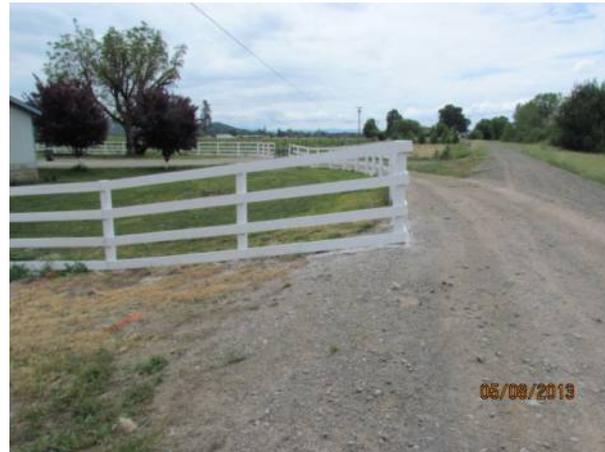
Levee Mile Report Line	4
Start Levee Mile	0.12
End Levee Mile	0.12
Location	Land Side
Category	
Item	Encroachments
View of the unauthorized encroachment fence along landside slope.	
rduffey_s_20130513_406.JPG

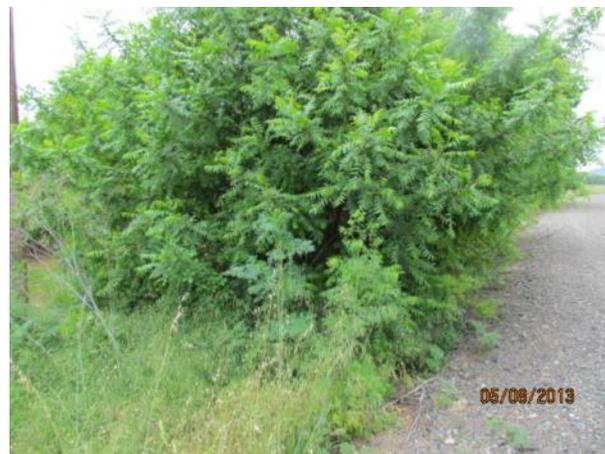
Levee Mile Report Line	5
Start Levee Mile	0.25
End Levee Mile	0.25
Location	Land Side
Category	
Item	Trim / Thin Trees
Remove the trees from the landside slope.	
rduffey_s_20130513_404.JPG

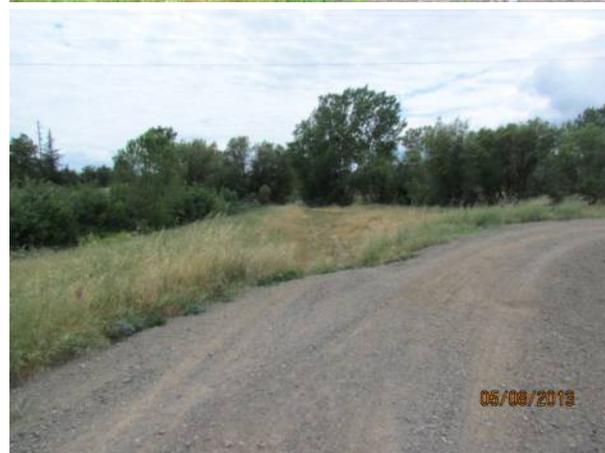
Levee Mile Report Line	6
Start Levee Mile	2.29
End Levee Mile	2.29
Location	Water Side
Category	
Item	Slope Stability
View of the vehicle erosion along the waterside slope.	
rduffey_s_20130513_411.JPG

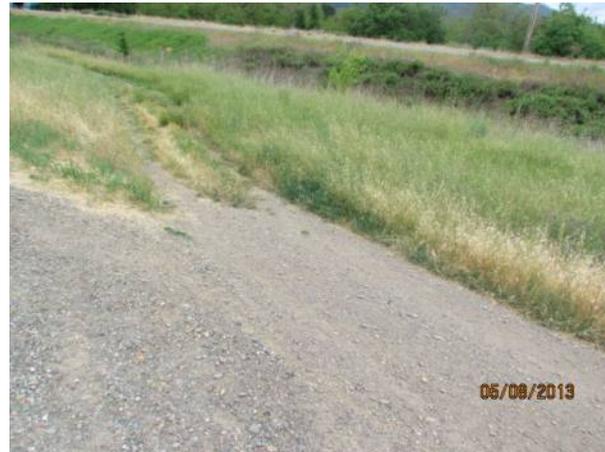
Levee Mile Report Line	7
Start Levee Mile	2.37
End Levee Mile	2.37
Location	Water Side
Category	
Item	Slope Stability
View of the vehicle erosion along the waterside slope.	
rduffey_s_20130513_412.JPG

DWR ID: DWR_NA0009_01_s_2013_13										
7	2.37	2.37		Slope Stability	WS	M Ma	S3 : Repair the levee slope damaged by vehicle traffic and prevent access where possible.	39.161153 ° -122.912740 °	39.161153 ° -122.912740 °	14 Y
DWR ID: DWR_NA0009_01_s_2013_14										
8	2.37	2.41		Trim / Thin Trees	LS	M Ma	T1 : Trim trees to at least five feet above ground level.	39.161381 ° -122.912551 °	39.161708 ° -122.912168 °	15 Y
DWR ID: DWR_NA0009_01_s_2013_15										
9	2.40	2.40		Encroachments	LS	M En	BU : Building	39.160217 ° -122.912957 °	39.161692 ° -122.911748 °	7 Y
DWR ID: DWR_NA0009_01_s_2012_7										
10	2.40	2.40		Slope Stability	WS	M Ma	S3 : Repair the levee slope damaged by vehicle traffic and prevent access where possible.	39.161601 ° -122.912303 °	39.161601 ° -122.912303 °	16 Y
DWR ID: DWR_NA0009_01_s_2013_16										
11	2.42	2.42		Slope Stability	LS	M Ma	S3 : Repair the levee slope damaged by vehicle traffic and prevent access where possible.	39.161802 ° -122.912020 °	39.161802 ° -122.912020 °	17 Y

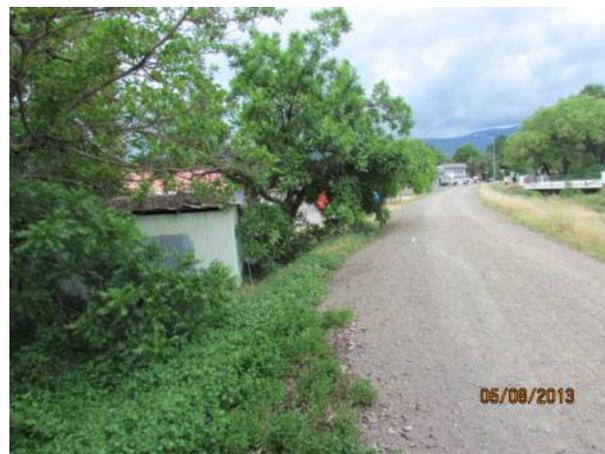
Levee Mile Report Line	8
Start Levee Mile	2.37
End Levee Mile	2.41
Location	Land Side
Category	
Item	Trim / Thin Trees
Trim the trees up 5 feet to allow visibility.	
rduffey_s_20130513_413.JPG

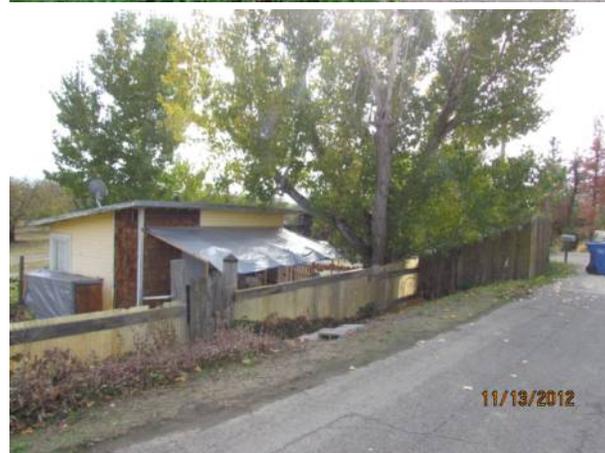
Levee Mile Report Line	9
Start Levee Mile	2.40
End Levee Mile	2.40
Location	Land Side
Category	
Item	Encroachments
View of a building & fence along the toe of the levee.	
rduffey_s_20130225_133.JPG

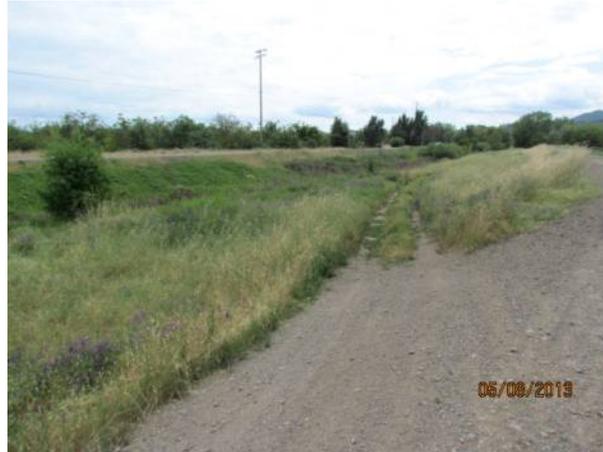
Levee Mile Report Line	10
Start Levee Mile	2.40
End Levee Mile	2.40
Location	Water Side
Category	
Item	Slope Stability
View of the vehicle erosion along the waterside slope.	
rduffey_s_20130513_415.JPG

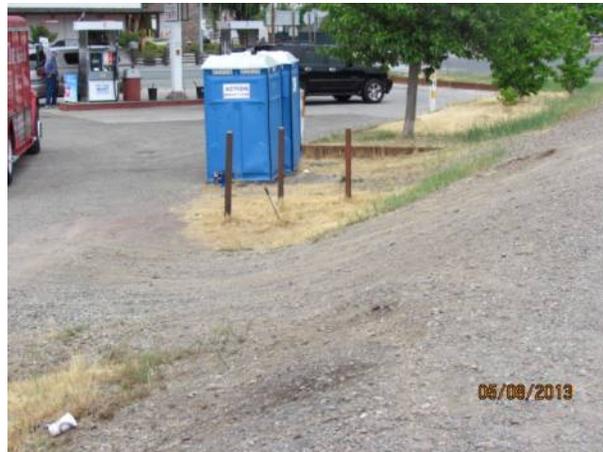
Levee Mile Report Line	11
Start Levee Mile	2.42
End Levee Mile	2.42
Location	Land Side
Category	
Item	Slope Stability
View of vehicle erosion along landside slope.	
rduffey_s_20130513_416.JPG

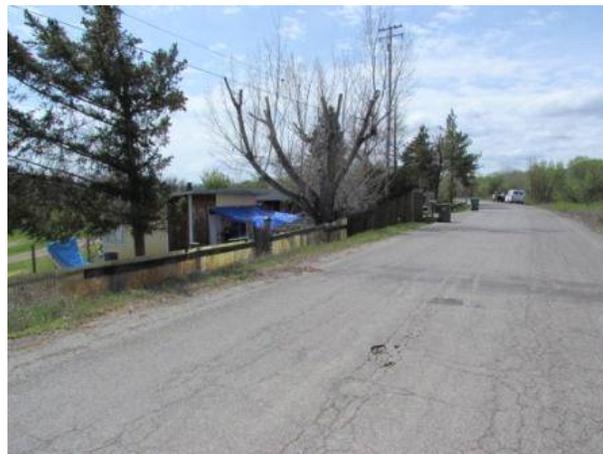
Levee Mile Report Line	13
Start Levee Mile	2.58
End Levee Mile	2.61
Location	Land Side
Category	
Item	Encroachments
View of the fences at the L/S toe.	
rduffey_s_20130225_132.jpg

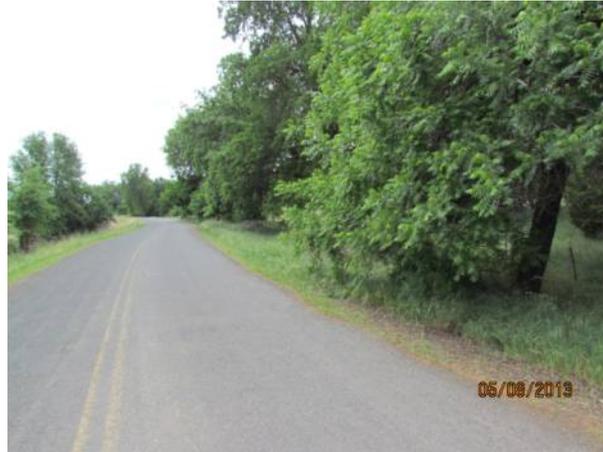
Levee Mile Report Line	1
Start Levee Mile	0.02
End Levee Mile	0.13
Location	Land Side
Category	
Item	Trim / Thin Trees
Trim the trees up 5 feet to allow visibility.	
rduffey_s_20130513_407.JPG

LMR No.	Levee Mile		Category	Item	Location	Rating	Action/Comment	GPS Latitude/Longitude		Issue No. Photo
	Start	End						Start	End	
1	0.02	0.13		Trim / Thin Trees	LS	M Ma	T1 : Trim trees to at least five feet above ground level.	39.189540 ° -122.908065 °	39.187900 ° -122.908655 °	4 Y
DWR ID: DWR_NA0009_02_s_2013_4										
2	0.14	0.21		Vegetation	LS	M Ma	V2 : Remove the wild growth other than native grasses from the levee slopes.	39.187640 ° -122.908671 °	39.186976 ° -122.909034 °	6 Y
DWR ID: DWR_NA0009_02_s_2013_6										
3	0.20	0.20		Encroachments	LS	U En	BU : Building	39.187039 ° -122.908880 °	39.187039 ° -122.908880 °	1 Y
DWR ID: DWR_NA0009_02_s_2012_1										
4	0.24	0.29		Trim / Thin Trees	LS	M Ma	T2 : Thin trees to allow visibility of the ground and room to flood fight.	39.186739 ° -122.909436 °	39.186038 ° -122.909948 °	9 Y
DWR ID: DWR_NA0009_02_s_2013_9										
5	0.39	0.39		Slope Stability	LS	M Ma	S1 : Repair slope instability.	39.185160 ° -122.911138 °	39.185160 ° -122.911138 °	8 Y

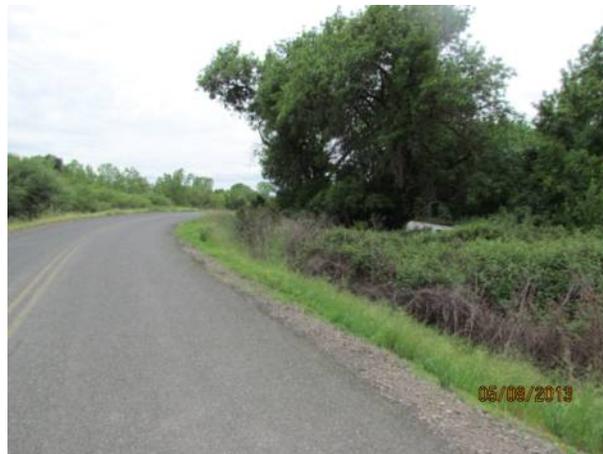
Levee Mile Report Line	2
Start Levee Mile	0.14
End Levee Mile	0.21
Location	Land Side
Category	
Item	Vegetation
Remove the vegetation from the landside slope.	
rduffey_s_20130513_408.JPG

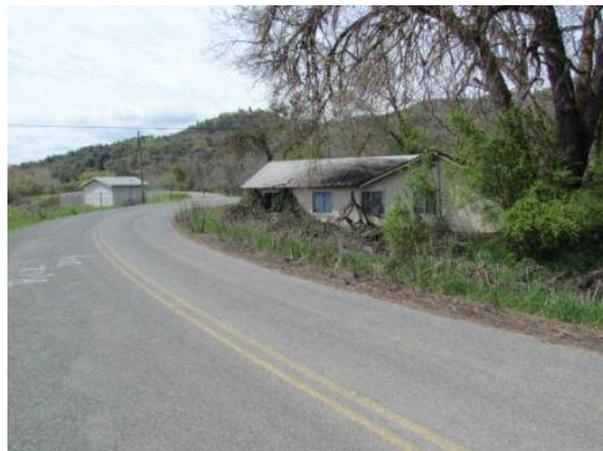
Levee Mile Report Line	3
Start Levee Mile	0.20
End Levee Mile	0.20
Location	Land Side
Category	
Item	Encroachments
View of the vegetation and building next to the landside toe of levee.	
rduffey_s_20130225_134.jpg

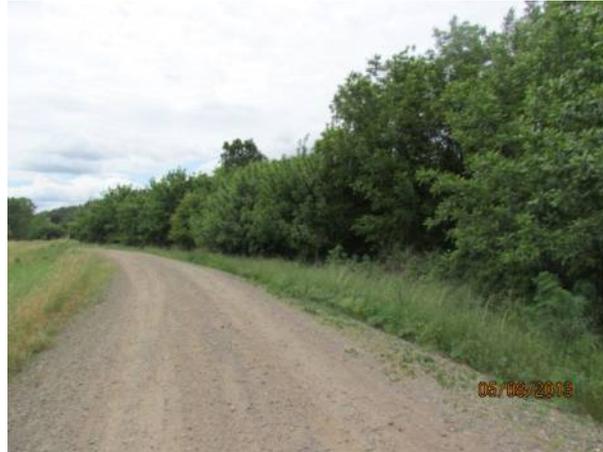
Levee Mile Report Line	4
Start Levee Mile	0.24
End Levee Mile	0.29
Location	Land Side
Category	
Item	Trim / Thin Trees
Trim the trees up 5 feet to allow visibility.	
rduffey_s_20130513_409.JPG

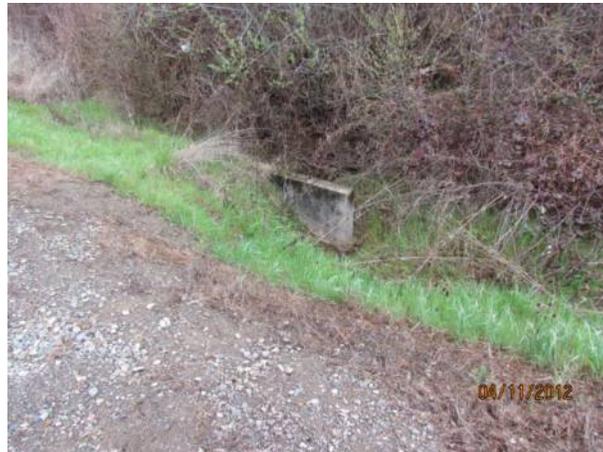
Levee Mile Report Line	5
Start Levee Mile	0.39
End Levee Mile	0.39
Location	Land Side
Category	
Item	Slope Stability
View of erosion along slope of the levee by both sides of the headwall.	
rduffey_s_20130225_138.jpg

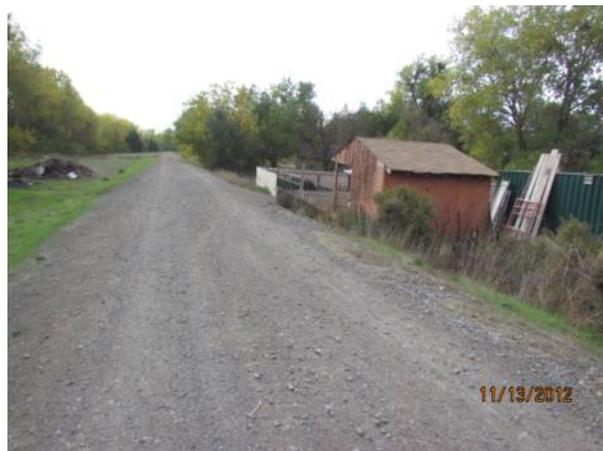
Levee Mile Report Line	7
Start Levee Mile	1.05
End Levee Mile	1.05
Location	Land Side
Category	
Item	Encroachments
View of building & vegetation along the levee toe.	
rduffey_s_20130225_137.JPG

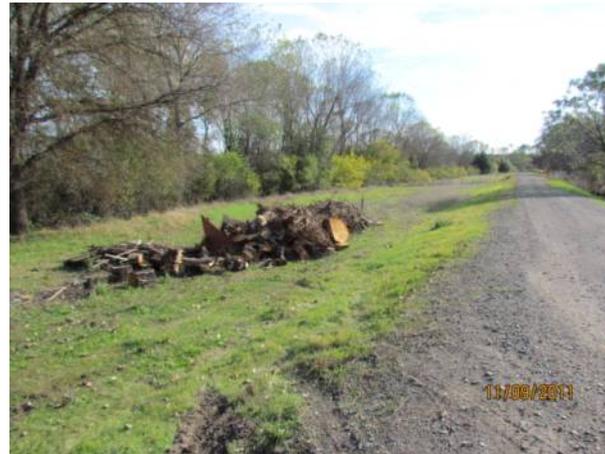
Levee Mile Report Line	8
Start Levee Mile	1.06
End Levee Mile	1.06
Location	Land Side
Category	
Item	Encroachments
View of the tree prunings on the W/S toe.	
rduffey_s_20130225_136.jpg

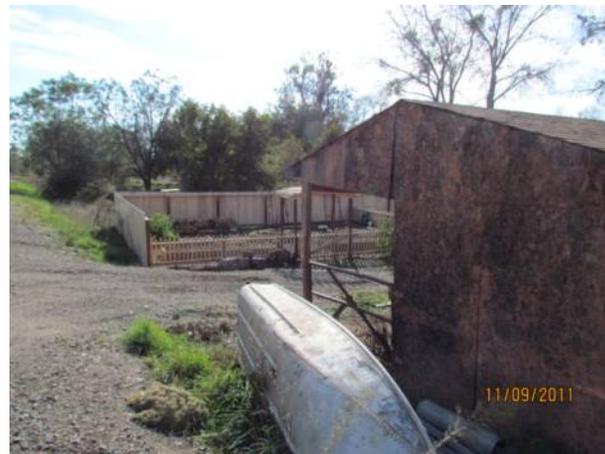
Levee Mile Report Line	9
Start Levee Mile	1.06
End Levee Mile	1.06
Location	Land Side
Category	
Item	Encroachments
View of the building & fence along the L/S toe.	
rduffey_s_20130225_135.jpg

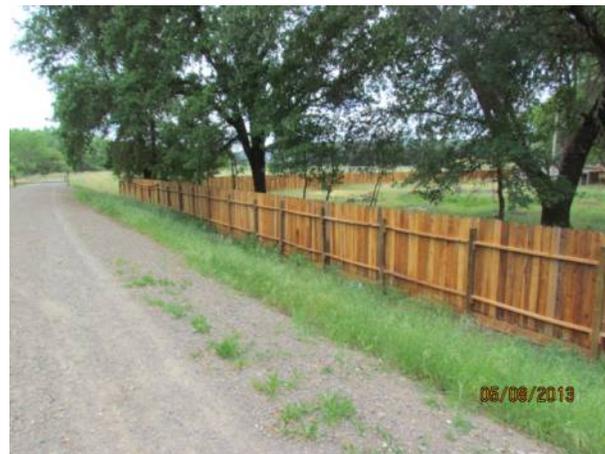
Levee Mile Report Line	10
Start Levee Mile	1.15
End Levee Mile	1.18
Location	Land Side
Category	
Item	Encroachments
View of the unauthorized fence along the landside toe.	
rduffey_s_20130513_410.JPG

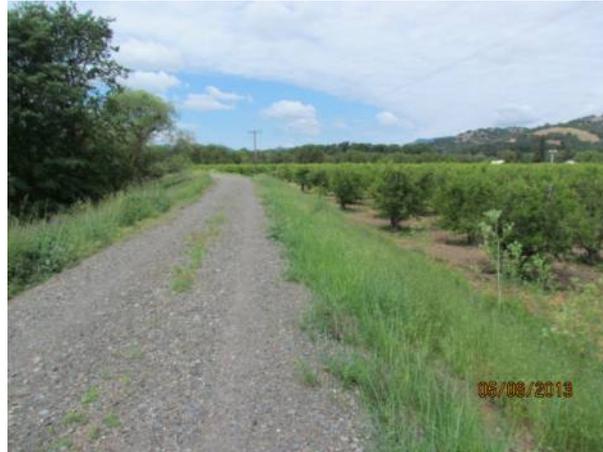
Levee Mile Report Line	1
Start Levee Mile	0.92
End Levee Mile	0.92
Location	Land Side
Category	
Item	Vegetation
View of the tall native vegetation on both slopes.	
rduffey_s_20130513_405.JPG

LMIR No.	Levee Mile		Category	Item	* Location	** Rating	Action/Comment	GPS Latitude/Longitude		Issue No. Photo
	Start	End						Start	End	
1	0.92	0.92	Vegetation		LS Ma	M	V2 : Remove the wild growth other than native grasses from the levee slopes.	39.159759 ° -122.921151 °	39.159759 ° -122.921151 °	2 Y
DWR ID: DWR_NA0009_03_s_2013_2										
2	0.97	0.97	Encroachments		WS En	M	TA : Tank	39.160108 ° -122.922110 °	39.160108 ° -122.922110 °	1 Y
DWR ID: DWR_NA0009_03_s_2012_1										
3	1.06	1.12	Vegetation		LS Ma	M	V2 : Remove the wild growth other than native grasses from the levee slopes.	39.159772 ° -122.923540 °	39.159605 ° -122.924610 °	4
DWR ID: DWR_NA0009_03_s_2012_4

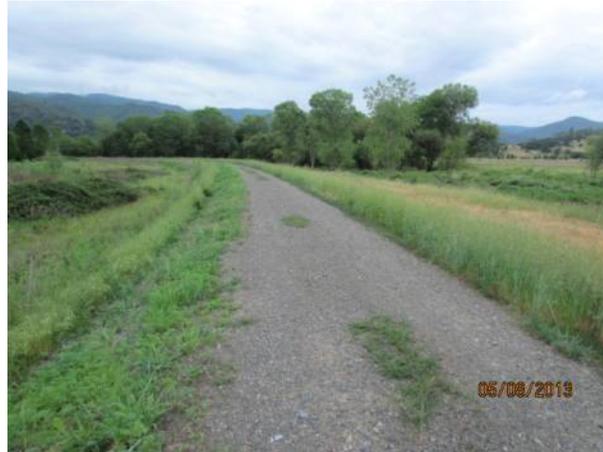
Levee Mile Report Line	1
Start Levee Mile	0.79
End Levee Mile	0.79
Location	Land Side
Category	
Item	Vegetation
View of tall native grasses on both slopes.	
rduffey_s_20130513_400.JPG

LMR No.	Levee Mile		Category	Item	* Location	+ Rating	Action/Comment	GPS Latitude/Longitude		Issue No. Photo
	Start	End						Start	End	
1	0.79	0.79	Vegetation		LS Ma	M	V2 : Remove the wild growth other than native grasses from the levee slopes.	39.177730 ° °	122.898700 ° °	1 Y
DWR ID: DWR_NA0009_04_s_2013_1										
2	0.82	0.87	Encroachments		LS En	M	FE : Fence	° °	° °	3
DWR ID: DWR_NA0009_04_s_2012_3										
3	1.05	1.18	Trim / Thin Trees		LS Ma	M	T1 : Trim trees to at least five feet above ground level.	39.180479 ° -122.896567 °	39.181947 ° -122.895112 °	2 Y
DWR ID: DWR_NA0009_04_s_2012_2										
4	1.19	1.19	Encroachments		LS En	C	PR : Prunings	39.182074 ° -122.895053 °	39.182074 ° -122.895053 °	8
DWR ID: DWR_NA0009_04_s_2013_8										
5	1.19	1.26	Vegetation		LS Ma	M	V2 : Remove the wild growth other than native grasses from the levee slopes.	39.182154 ° -122.895005 °	39.182951 ° -122.894409 °	9

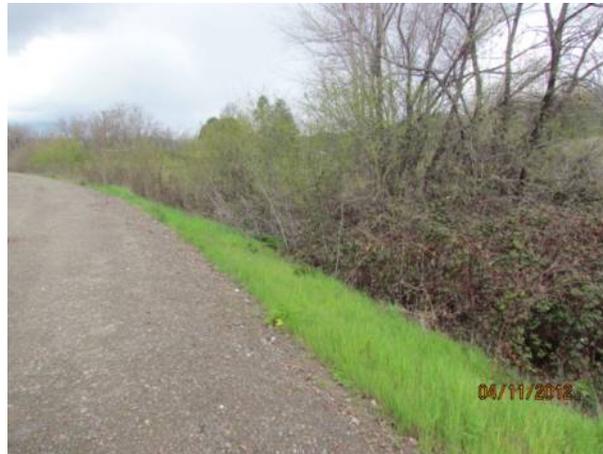
Levee Mile Report Line	3
Start Levee Mile	1.05
End Levee Mile	1.18
Location	Land Side
Category	
Item	Trim / Thin Trees
Remove the trees and vegetation from the toe of the levee.	
rduffey_s_20130225_140.jpg

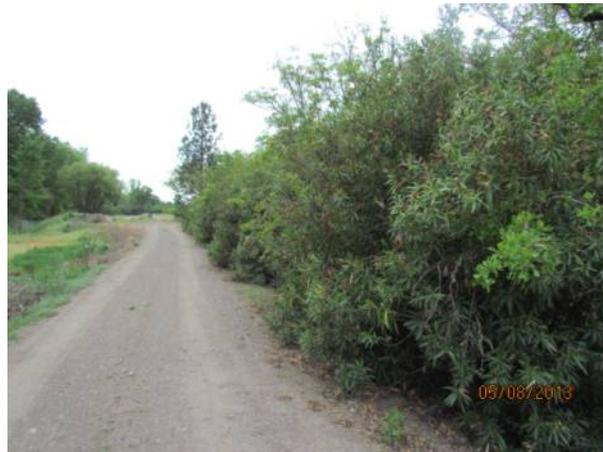
Levee Mile Report Line	6
Start Levee Mile	1.43
End Levee Mile	1.46
Location	Land Side
Category	
Item	Trim / Thin Trees
Remove the oleanders from the landside toe.	
rduffey_s_20130513_402.JPG

DWR ID: DWR_NA0009_04_s_2012_9										
6	1.43	1.46	Trim / Thin Trees		LS Ma	U	T3 : Trim and thin trees to allow visibility of the ground and room to flood fight.	39.185165 ° -122.893400 °	39.185629 ° -122.893344 °	4 Y
DWR ID: DWR_NA0009_04_s_2013_4

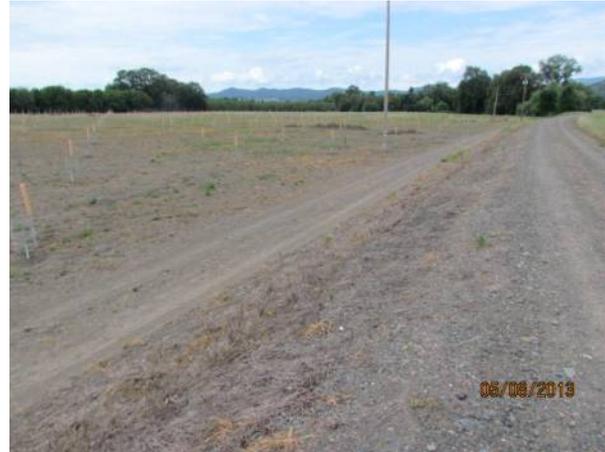
Levee Mile Report Line	1
Start Levee Mile	0.17
End Levee Mile	0.17
Location	Land Side
Category	
Item	Vegetation
View of no vegetation on the landside slope.	
rduffey_s_20130513_403.JPG
