Flood Control Project Maintenance

2008 Structure Summary Report

Lake County Watershed Protection District

Clover Creek Diversion Structure

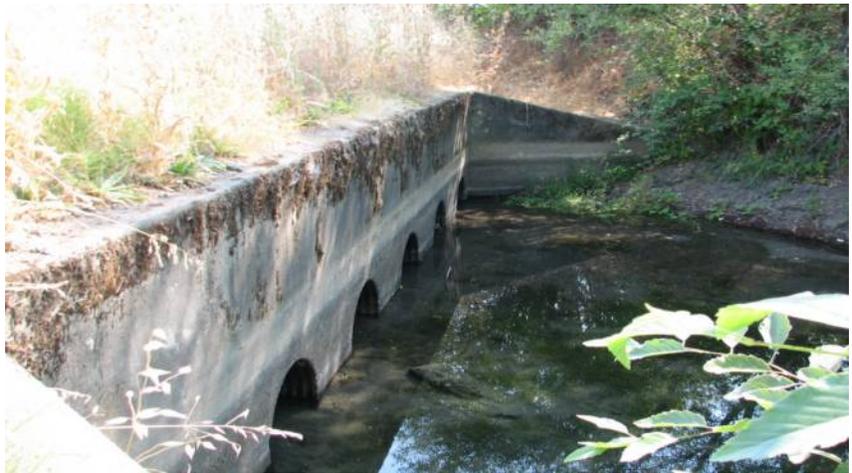
RptLine	Category	Item	Location *	Rating **	Comment	GPS	Photo	Issue
1	Structures & Concrete Lined Channels	Culverts: Inlets / Outlets	WS	M	Gravel has accumulated around the outlet pipes and in the channel.	39.177100 ° -122.898880 °	Y	2
2	Structures & Concrete Lined Channels	Sluice/Slide Gates	WS	A	The concrete weir structure, wing walls, bulkhead, control gates and mechanism are acceptable. The channel appears to have been altered, the concrete weir downstream also appears altered.	39.177100 ° -122.898880 °	Y	1
3	Structures & Concrete Lined Channels	Concrete Surfaces	WS	M	The concrete weir downstream of the diversion structure appears to have been altered, the channel appears to have a build up of materials.	39.177100 ° -122.898900 °	Y	3

Report Line	1
Location	Water Side
Category	Structures & Concrete Lined Channels
Item	Culverts: Inlets / Outlets
View of the structure outlet with gravel buildup.

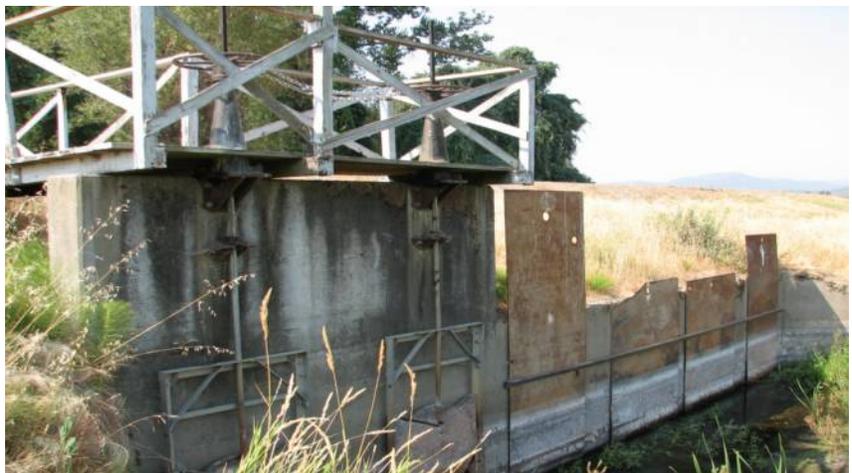
Report Line	2
Location	Water Side
Category	Structures & Concrete Lined Channels
Item	Sluice/Slide Gates
View of the diversion structure gates at the intake.

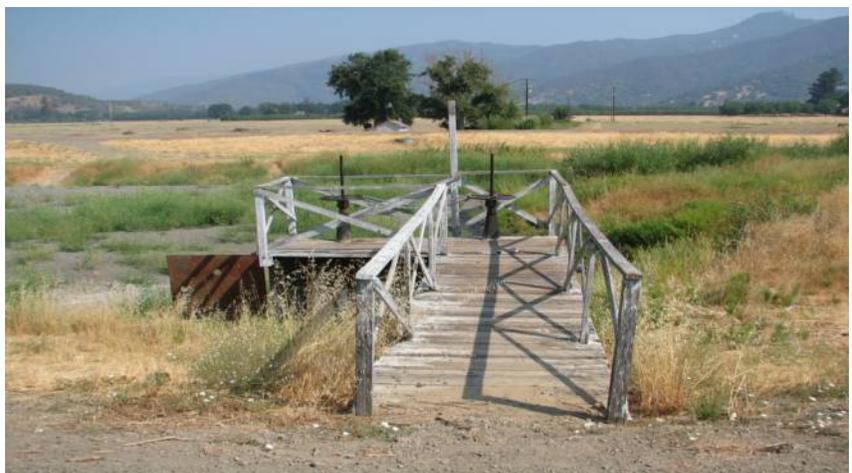
Report Line	2
Location	Water Side
Category	Structures & Concrete Lined Channels
Item	Sluice/Slide Gates
View of the walkway and control mechanism.

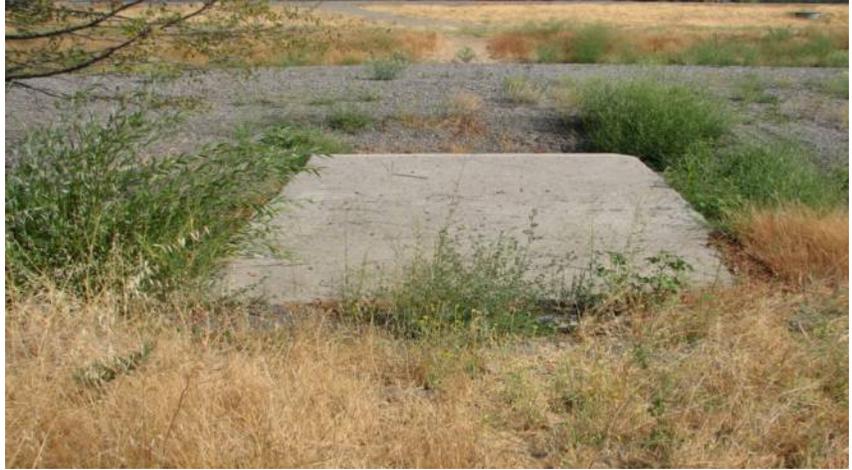
Report Line	3
Location	Water Side
Category	Structures & Concrete Lined Channels
Item	Concrete Surfaces

This is the concrete weir after alteration, material build up in the channel.

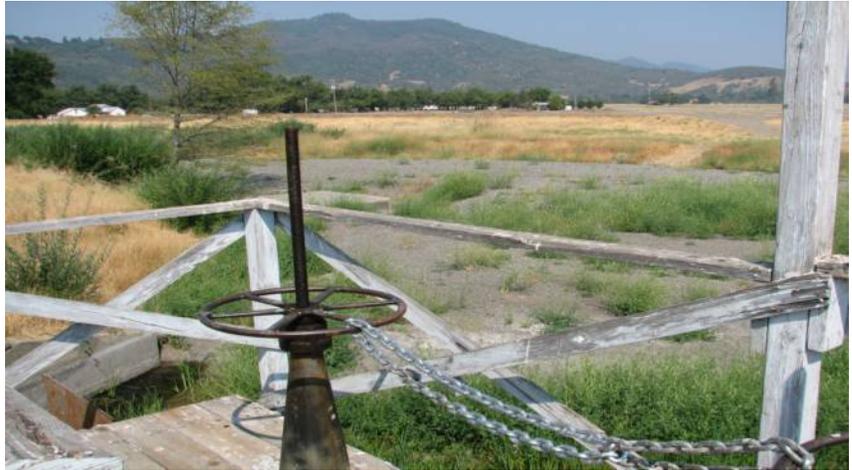
Report Line	3
Location	Water Side
Category	Structures & Concrete Lined Channels
Item	Concrete Surfaces

This view is from diversion structure looking at the concrete weir and the material in the channel.

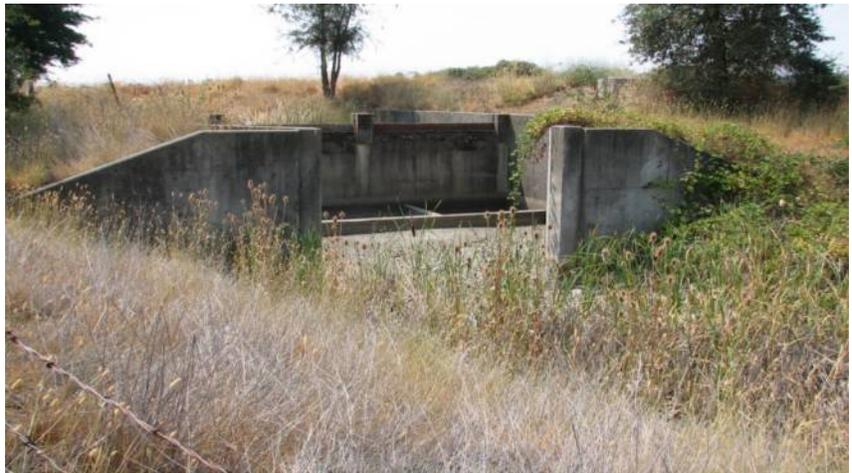
Report Line	1
Location	Water Side
Category	Structures & Concrete Lined Channels
Item	Culverts: Inlets / Outlets
The concrete weir and diversion pipe intake.

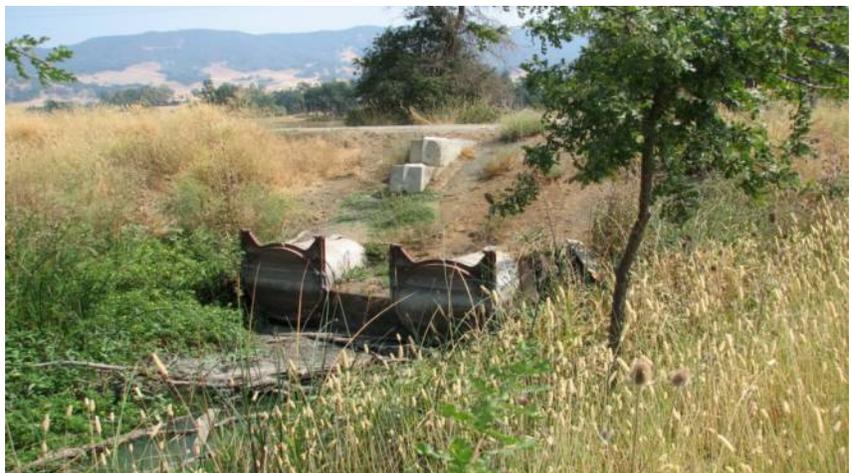
Report Line	1
Location	Water Side
Category	Structures & Concrete Lined Channels
Item	Culverts: Inlets / Outlets
View of the outlet pipes and channel.
