Flood Control Project Maintenance
2010 Structure Summary Report
Overall Unit and Item Ratings

Lake County Watershed Protection District

Clover Creek Diversion Structure

2010 Structure Inspection Results

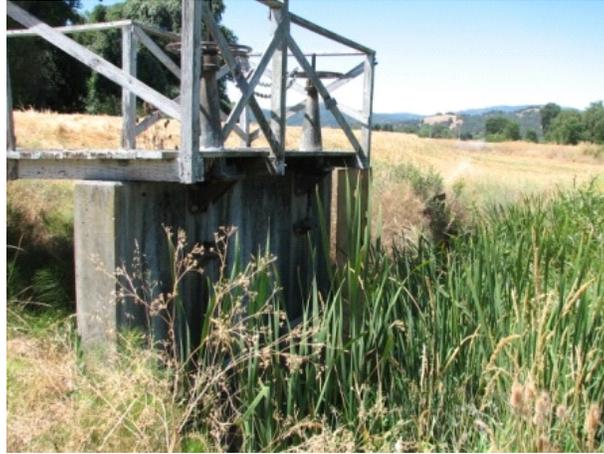
Levee Mile Report Line	1
Start Levee Mile	0.00
End Levee Mile	0.00
Location	
Category	Structures
Item	Photo Documentation
The view of the diversion structure gates at the intake.	
cathom_t_20100812_035.jpg

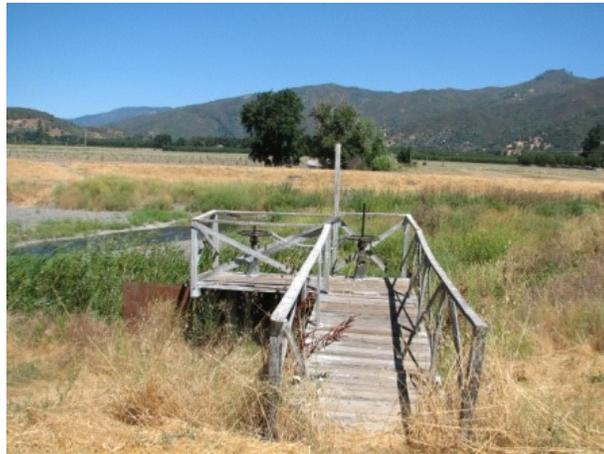
Levee Mile Report Line	1
Start Levee Mile	0.00
End Levee Mile	0.00
Location	
Category	Structures
Item	Photo Documentation
Walkway and control gate mechanism.	
cathom_t_20100812_036.jpg

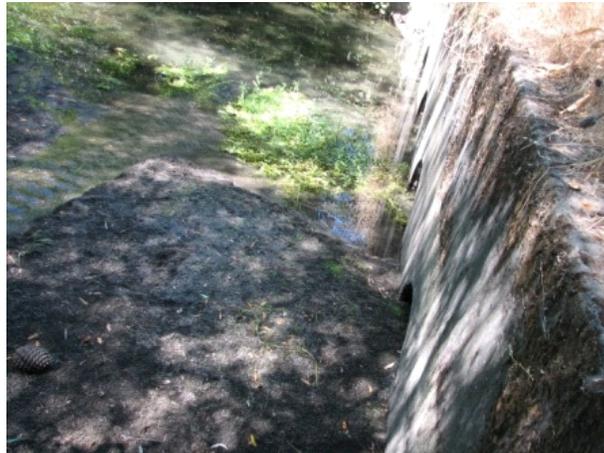
Levee Mile Report Line	1
Start Levee Mile	0.00
End Levee Mile	0.00
Location	
Category	Structures
Item	Photo Documentation
View of the structure outlet, sediment buildup has reduced the flow.	
cathom_t_20100812_037.jpg

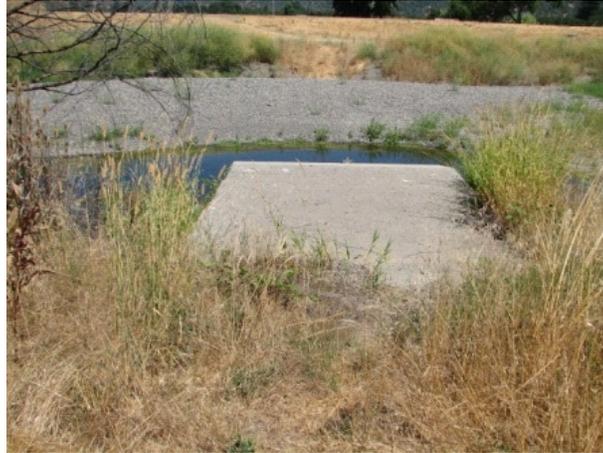
Levee Mile Report Line	1
Start Levee Mile	0.00
End Levee Mile	0.00
Location	
Category	Structures
Item	Photo Documentation
View of the concrete weir downstream of the diversion structure in the bypass channel.	
cathom_t_20100812_038.jpg

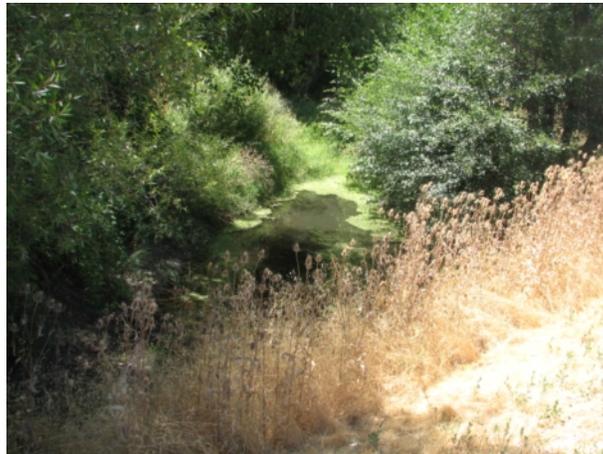
Levee Mile Report Line	2
Start Levee Mile	0.00
End Levee Mile	0.00
Location	
Category	Structures
Item	Vegetation & Obstructions
Vegetation in the outlet channel.	
cathom_t_20100805_015.jpg

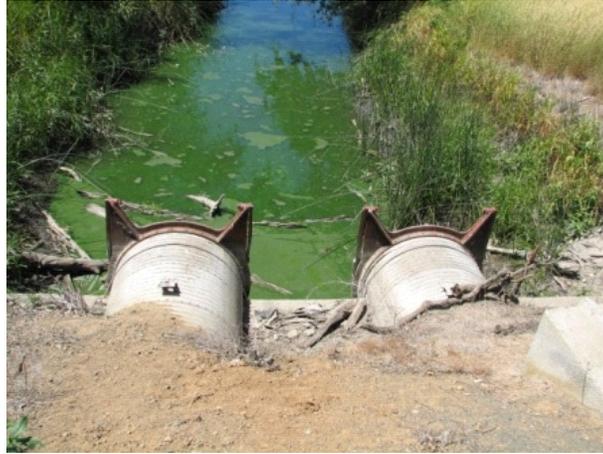
Levee Mile Report Line	1
Start Levee Mile	0.00
End Levee Mile	0.00
Location	
Category	Structures
Item	Photo Documentation
The view of the outlet pipes and channel.	
cathom_t_20100813_039.jpg

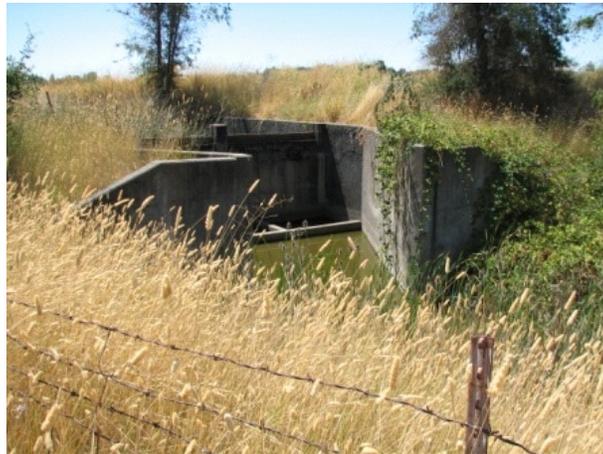
Levee Mile Report Line	1
Start Levee Mile	0.00
End Levee Mile	0.00
Location	
Category	Structures
Item	Photo Documentation
The concrete weir and the diversion pipe intake.	
cathom_t_20100813_040.jpg

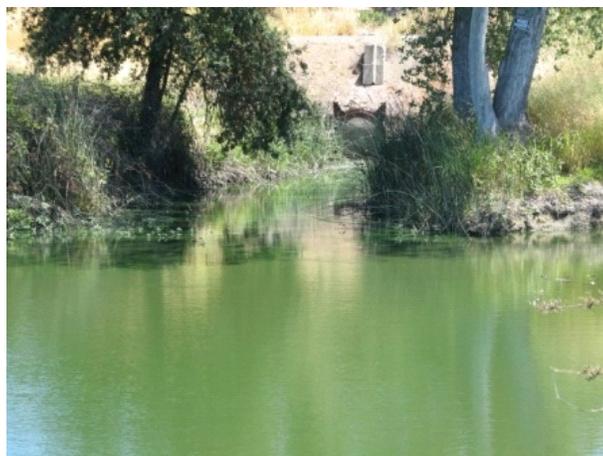
Levee Mile Report Line	1
Start Levee Mile	0.00
End Levee Mile	0.00
Location	
Category	Structures
Item	Photo Documentation
One of the flap gates on the outlet pipes.	
cathom_t_20100813_041.jpg
