Flood Control Project Maintenance
2014 Structure Summary Report
Overall Unit and Item Ratings

Lake County Watershed Protection District

Clover Creek Diversion Structure

Structure Rating	A
Date of Inspection	08/12/2014
DWR Inspector	Pavel Kazi
Accompanied By	Bob Duffey DWR

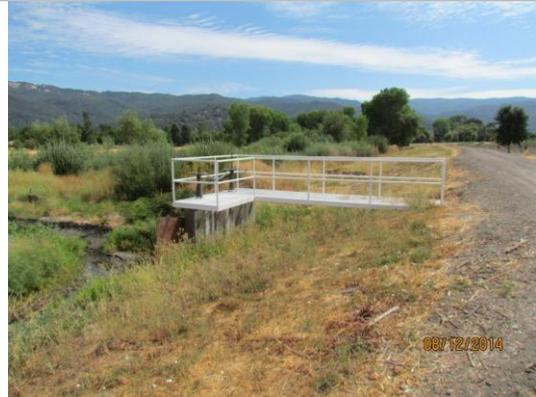
Photo 1 of 1 : ST_2014_NA0009_36_1_20140813_00009.jpg

LM Start	0.00	Rating **	N	Issue No.	1
LM End	0.00	Issue Type +	Ma	Location *	
Category	Structures & Concrete Lined Channels		GPS Latitude/Longitude		
			Start	End	
Item	Photo Documentation		39.177050 °	39.177050 °	
			-122.898750 °	-122.898750 °	
DWR ID	DWR_NA0009_36_t_2012_1				
Action/Comments					
Inspector Comments: Clover Creek Diversion Structure has three culverts with two flap and slide gates to divert the water during high water season.

View of the new diversion structure.

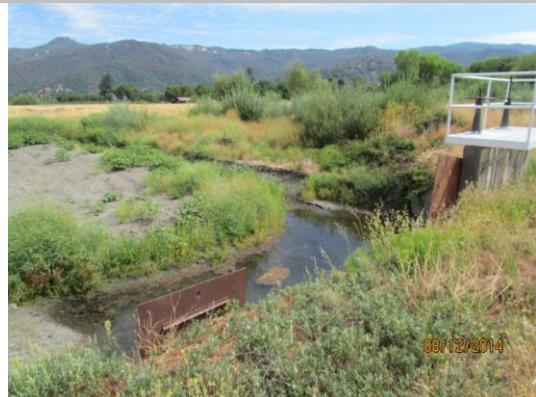
Photo 1 of 2 : ST_2014_NA0009_36_2_20140813_00010.jpg

LM Start	0.00	Rating **	A	Issue No.	2
LM End	0.00	Issue Type +	Ma	Location *	
Category	Structures & Concrete Lined Channels		GPS Latitude/Longitude		
			Start	End	
Item	Vegetation & Obstructions		39.177050 °	39.177050 °	
			-122.898750 °	-122.898750 °	
DWR ID	DWR_NA0009_36_t_2012_2				
Action/Comments					
Inspector Comments: The channel had minimal vegetation and scattered obstructions, but the flow is not impeded.

View of the vegetation at the inlet of the structure.

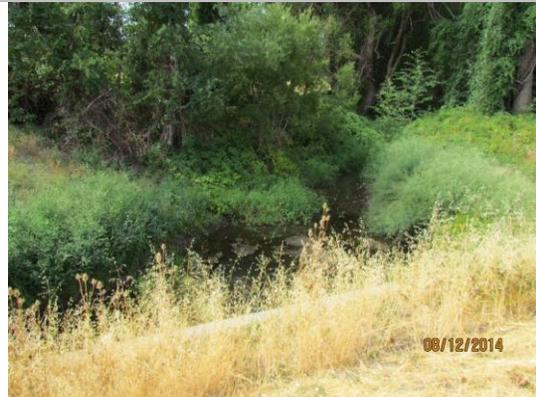
Photo 2 of 2 : ST_2014_NA0009_36_2_20140813_00011.jpg

View of the vegetation at the outlet of the structure.

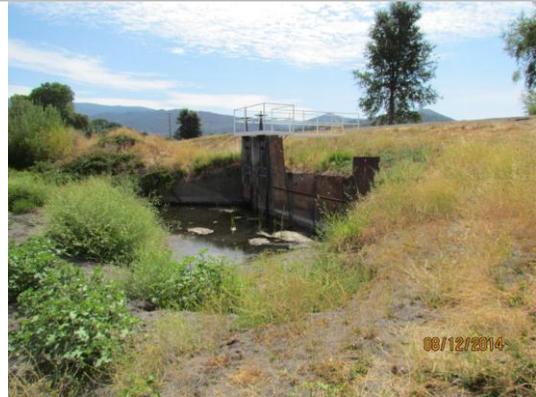
Photo 1 of 2 : ST_2014_NA0009_36_7_20140813_00015.jpg

LM Start	0.00	Rating **	A	Issue No.	7
LM End	0.00	Issue Type +	Ma	Location *	
Category	Structures & Concrete Lined Channels		GPS Latitude/Longitude		
			Start	End	
Item	Culverts: Inlets / Outlets		39.177050 °	39.177050 °	
			-122.898750 °	-122.898750 °	
DWR ID	DWR_NA0009_36_t_2012_7				
Action/Comments					
Inspector Comments: Minimal vegetation was found on the outlet culvert of the structure.

View of the culvert inlet.

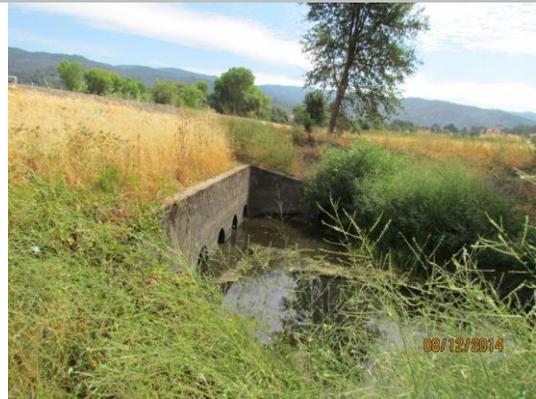
Photo 2 of 2 : ST_2014_NA0009_36_7_20140813_00013.jpg

View of the culvert outlet.

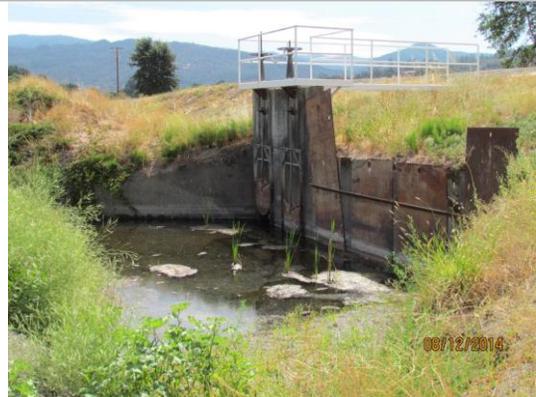
Photo 1 of 1 : ST_2014_NA0009_36_12_20140813_00014.jpg

LM Start	0.00	Rating **	A	Issue No.	12
LM End	0.00	Issue Type +	Ma	Location *	
Category	Structures & Concrete Lined Channels		GPS Latitude/Longitude		
			Start	End	
Item	Sluice/Slide Gates		39.177050 °	39.177050 °	
			-122.898750 °	-122.898750 °	
DWR ID	DWR_NA0009_36_t_2012_12				
Action/Comments					
Inspector Comments: The slide gates appeared to be in good working condition.

View of the slide gate.

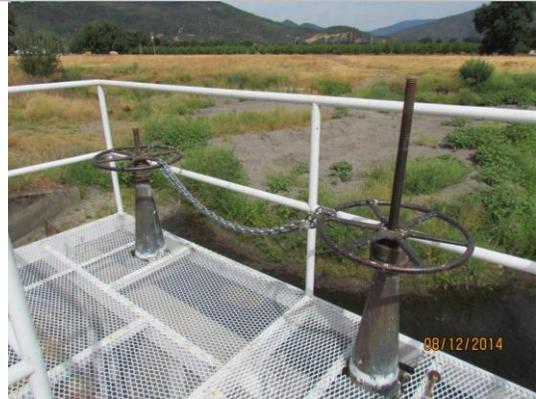
Photo 1 of 2 : ST_2014_NA0009_36_14_20140813_00016.jpg

LM Start	0.00	Rating **	A	Issue No.	14
LM End	0.00	Issue Type +	Ma	Location *	
Category	Structures & Concrete Lined Channels		GPS Latitude/Longitude		
			Start	End	
Item	Manual Gate Operators		39.177050 °	39.177050 °	
			-122.898750 °	-122.898750 °	
DWR ID	DWR_NA0009_36_t_2012_14				
Action/Comments					
Inspector Comments: The manual gate operators appeared to be operational.

View of the manual gate operator during 2014 inspection.

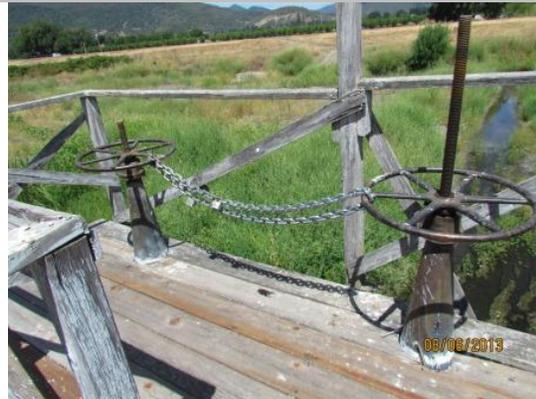
Photo 2 of 2 : ST_2014_NA0009_36_14_20140709_00007.jpg

View of the manual gate operator during 2013 inspection.

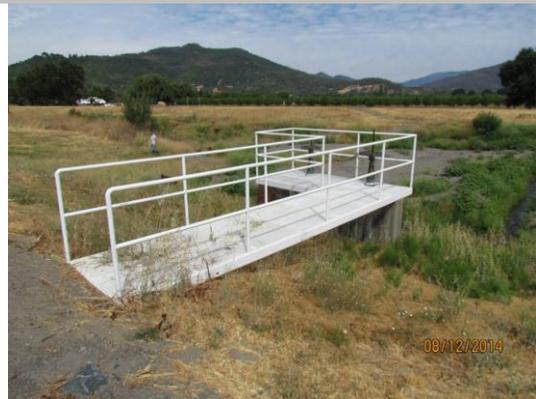
Photo 1 of 2 : ST_2014_NA0009_36_23_20140813_00017.jpg

LM Start	0.00	Rating **	A	Issue No.	23
LM End	0.00	Issue Type +	Ma	Location *	
Category	Structures & Concrete Lined Channels		GPS Latitude/Longitude		
			Start	End	
Item	Safety		39.177050 °	39.177050 °	
			-122.898750 °	-122.898750 °	
DWR ID	DWR_NA0009_36_t_2012_23				
Action/Comments					
Inspector Comments: New steel handrail was placed around the structure. No safety hazard was present.

View of the new steel handrails during 2014 inspection.

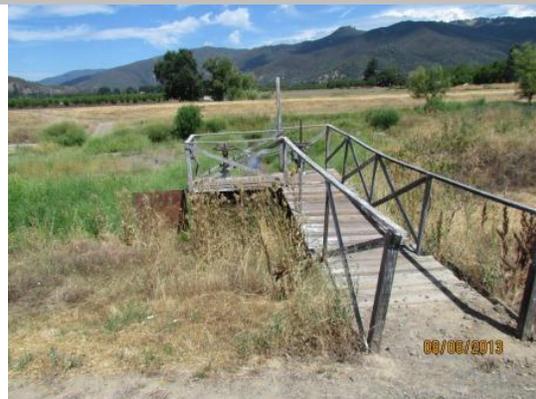
Photo 2 of 2 : ST_2014_NA0009_36_23_20140709_00008.jpg

View of the wooden guard rail during 2013 inspection.
