Flood Control Project Maintenance
2015 Structure Summary Report
Overall Unit and Item Ratings

Clover Creek Diversion Structure

2015 Structure Inspection Results

Structure Rating	A
Date of Inspection	07/21/2015
DWR Inspector	Pavel Kazi
Accompanied By	Bob Duffey DWR

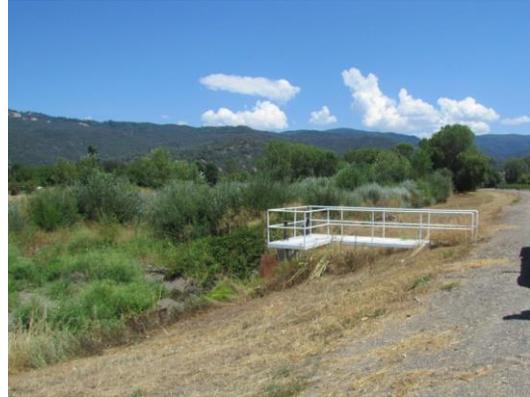
Photo 1 of 1 : ST_2015_NA0009_36_1_20150810_00011.jpg

LM Start	0.00	Rating **	N	Issue No.	1
LM End	0.00	Issue Type +	Ma	Location *	
Category	Structures & Concrete Lined Channels		GPS Latitude/Longitude		
			Start	End	
Item	Photo Documentation		39.177050 °	39.177050 °	
			-122.898750 °	-122.898750 °	
DWR ID	DWR_NA0009_36_t_2012_1				
Action/Comments					
Inspector Comments: Clover Creek Diversion Structure has three culverts with two slide gates, and a gate to divert the water during high water season.

View of the structure.

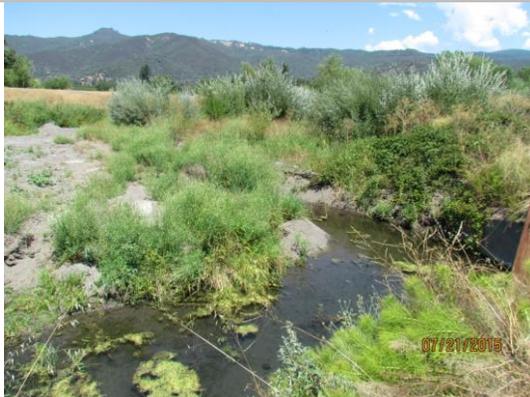
Photo 1 of 2 : ST_2015_NA0009_36_2_20150810_00012.jpg

LM Start	0.00	Rating **	A	Issue No.	2
LM End	0.00	Issue Type +	Ma	Location *	
Category	Structures & Concrete Lined Channels		GPS Latitude/Longitude		
			Start	End	
Item	Vegetation & Obstructions		39.177050 °	39.177050 °	
			-122.898750 °	-122.898750 °	
DWR ID	DWR_NA0009_36_t_2012_2				
Action/Comments					
Inspector Comments: The channel had minimal vegetation and scattered obstructions, but the flow is not impeded.

View of the vegetation at the inlet of the structure.

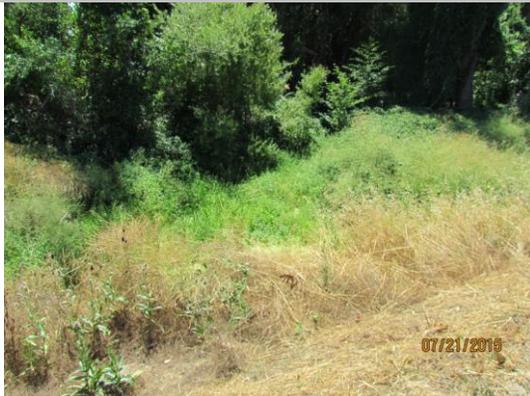
Photo 2 of 2 : ST_2015_NA0009_36_2_20150810_00013.jpg

View of the vegetation at the outlet of the structure.

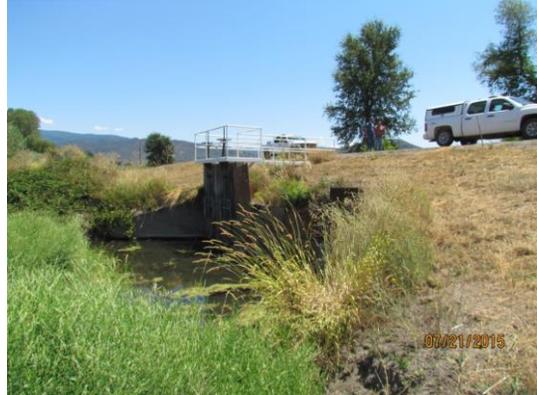
Photo 1 of 2 : ST_2015_NA0009_36_7_20150810_00014.jpg

LM Start	0.00	Rating **	M	Issue No.	7
LM End	0.00	Issue Type +	Ma	Location *	
Category	Structures & Concrete Lined Channels		GPS Latitude/Longitude		
			Start	End	
Item	Culverts: Inlets / Outlets		39.177050 °	39.177050 °	
			-122.898750 °	-122.898750 °	
DWR ID	DWR_NA0009_36_t_2012_7				
Action/Comments					
Inspector Comments: Vegetation was found on the outlet culvert of the structure.

View of the culvert inlet.

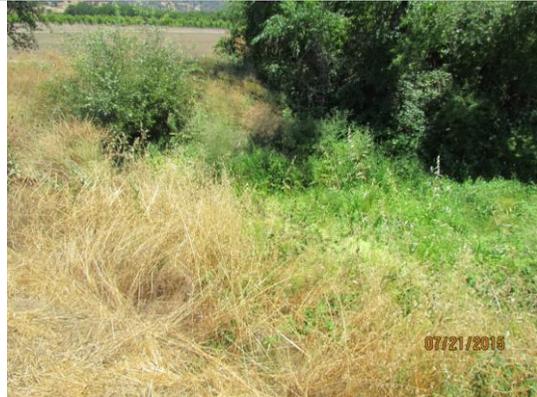
Photo 2 of 2 : ST_2015_NA0009_36_7_20150810_00015.jpg

View of the culvert outlet.

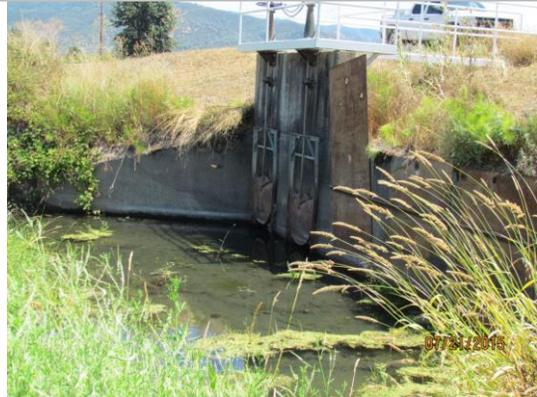
Photo 1 of 1 : ST_2015_NA0009_36_12_20150810_00016.jpg

LM Start	0.00	Rating **	A	Issue No.	12
LM End	0.00	Issue Type +	Ma	Location *	
Category	Structures & Concrete Lined Channels		GPS Latitude/Longitude		
			Start	End	
Item	Sluice/Slide Gates		39.177050 °	39.177050 °	
			-122.898750 °	-122.898750 °	
DWR ID	DWR_NA0009_36_t_2012_12				
Action/Comments					
Inspector Comments: The slide gates appeared to be in good working condition.

View of the slide gates.

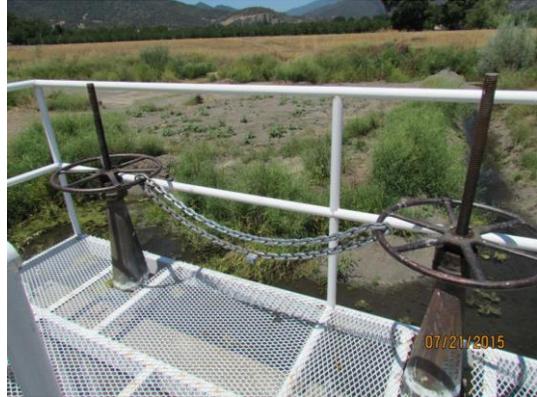
Photo 1 of 2 : ST_2015_NA0009_36_14_20150810_00017.jpg

LM Start	0.00	Rating **	A	Issue No.	14
LM End	0.00	Issue Type +	Ma	Location *	
Category	Structures & Concrete Lined Channels		GPS Latitude/Longitude		
			Start	End	
Item	Manual Gate Operators		39.177050 °	39.177050 °	
			-122.898750 °	-122.898750 °	
DWR ID	DWR_NA0009_36_t_2012_14				
Action/Comments					
Inspector Comments: The manual gate operators appeared to be operational.

View of the manual gate operator during 2015 inspection.

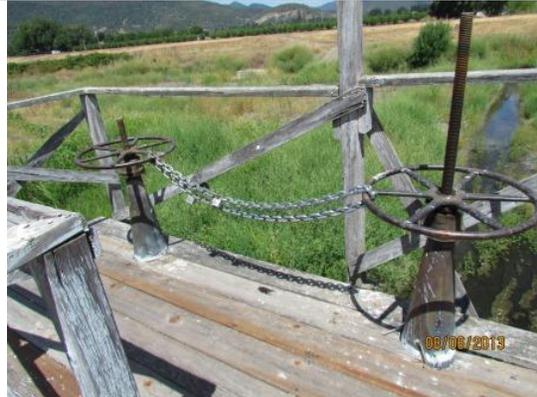
Photo 2 of 2 : ST_2015_NA0009_36_14_20150710_00008.jpg

View of the manual gate operator during 2013 inspection.

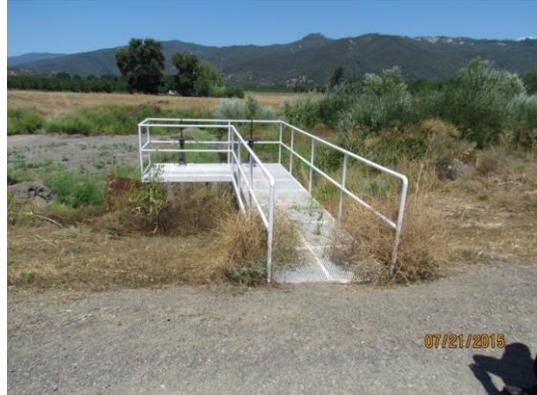
Photo 1 of 2 : ST_2015_NA0009_36_23_20150810_00018.jpg

LM Start	0.00	Rating **	A	Issue No.	23
LM End	0.00	Issue Type +	Ma	Location *	
Category	Structures & Concrete Lined Channels		GPS Latitude/Longitude		
			Start	End	
Item	Safety		39.177050 °	39.177050 °	
			-122.898750 °	-122.898750 °	
DWR ID	DWR_NA0009_36_t_2012_23				
Action/Comments					
Inspector Comments: New steel handrail was placed around the structure. No safety hazard was present.

View of the handrails on the structure during 2015 inspection.

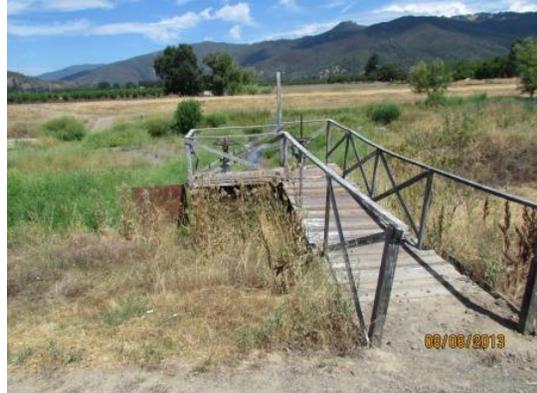
Photo 2 of 2 : ST_2015_NA0009_36_23_20150710_00010.jpg

View of the wooden guard rail during 2013 inspection.
